CRINGILA PUBLIC SCHOOL INDOOR AIR QUALITY RISK ASSESSMENT

Summary Report
05/04/2021 – 16/04/2021

Cringila Public School

35 Sheffield Street
Cringila NSW 2502

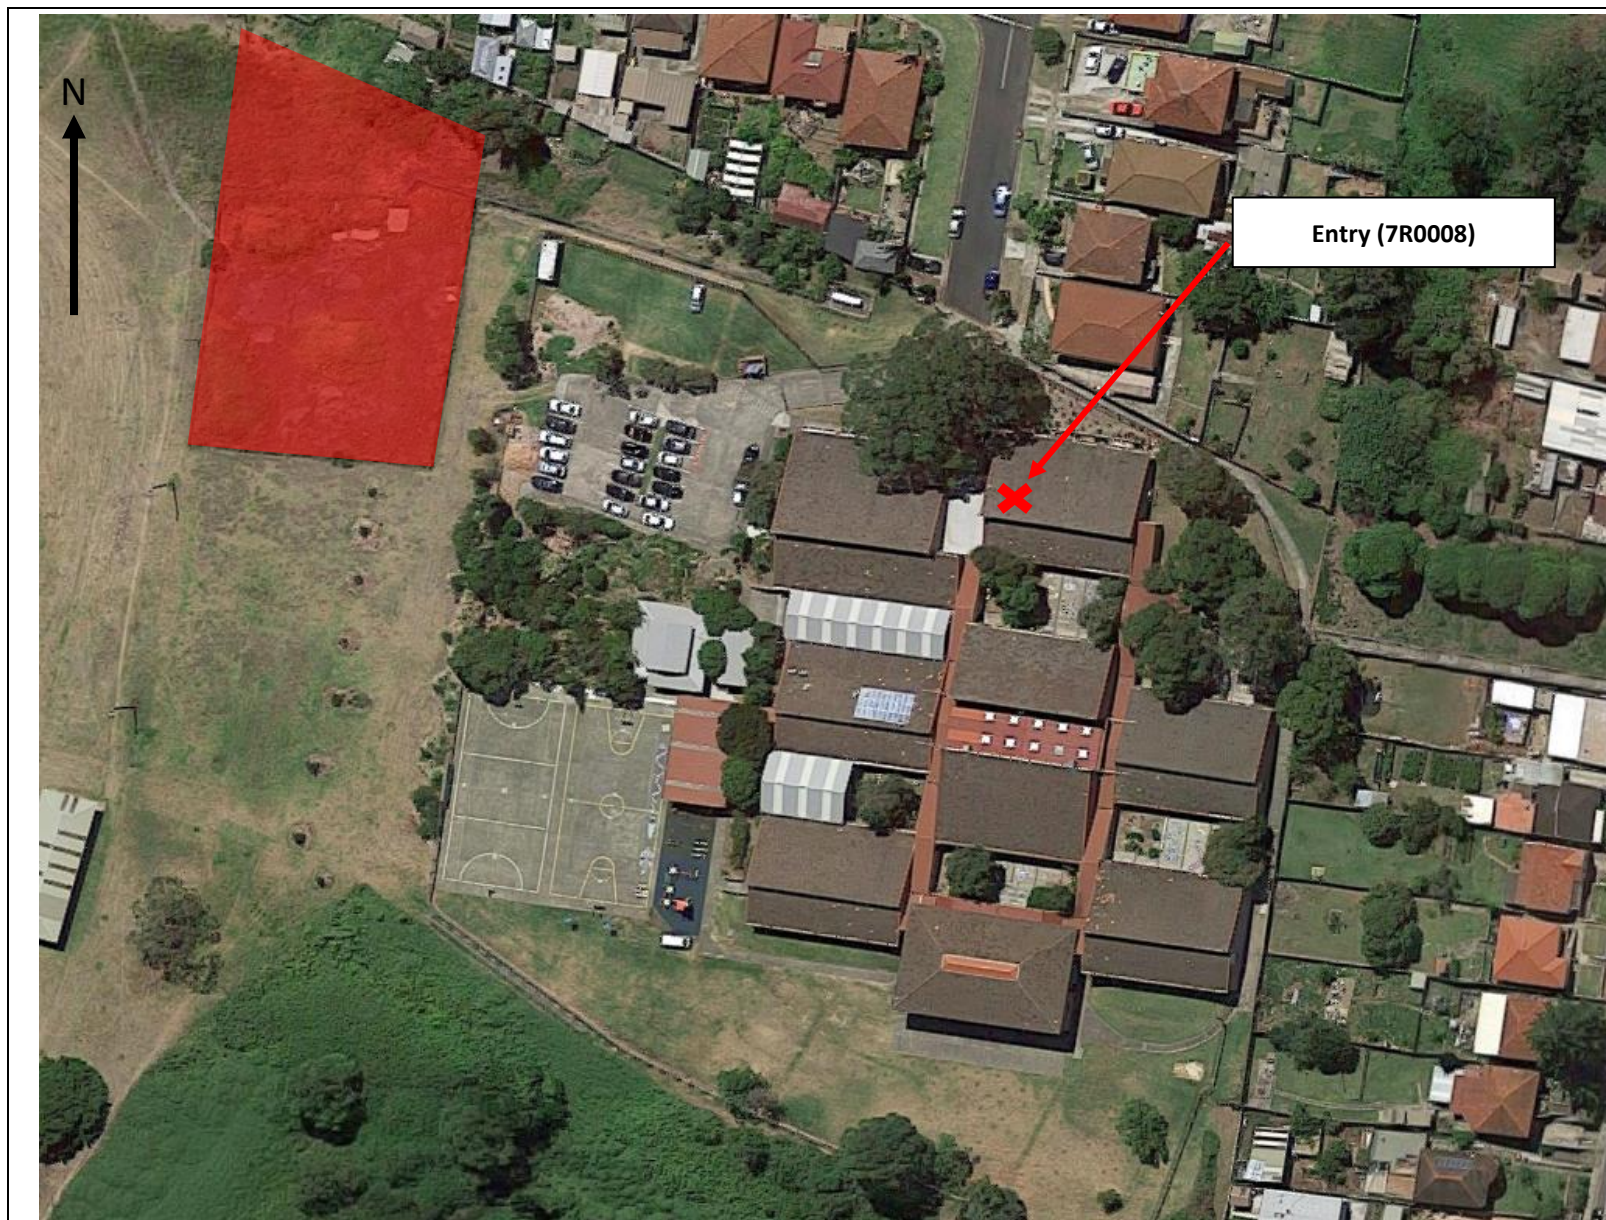
Appendix A: Site Map and Sampling Location

Site	Cringila Public School
Monitoring Location	Entry (7R0008)
Date	5 th April 2021 - 16 th April 2021
Job Number	J172171
Report	IAQ-04
Version	1.0
