**Quarterly Subsurface  
Gas Monitoring Report  
– Q4 2024**

Cringila Public School –  
35 Sheffield Street,  
Cringila NSW

December 2024

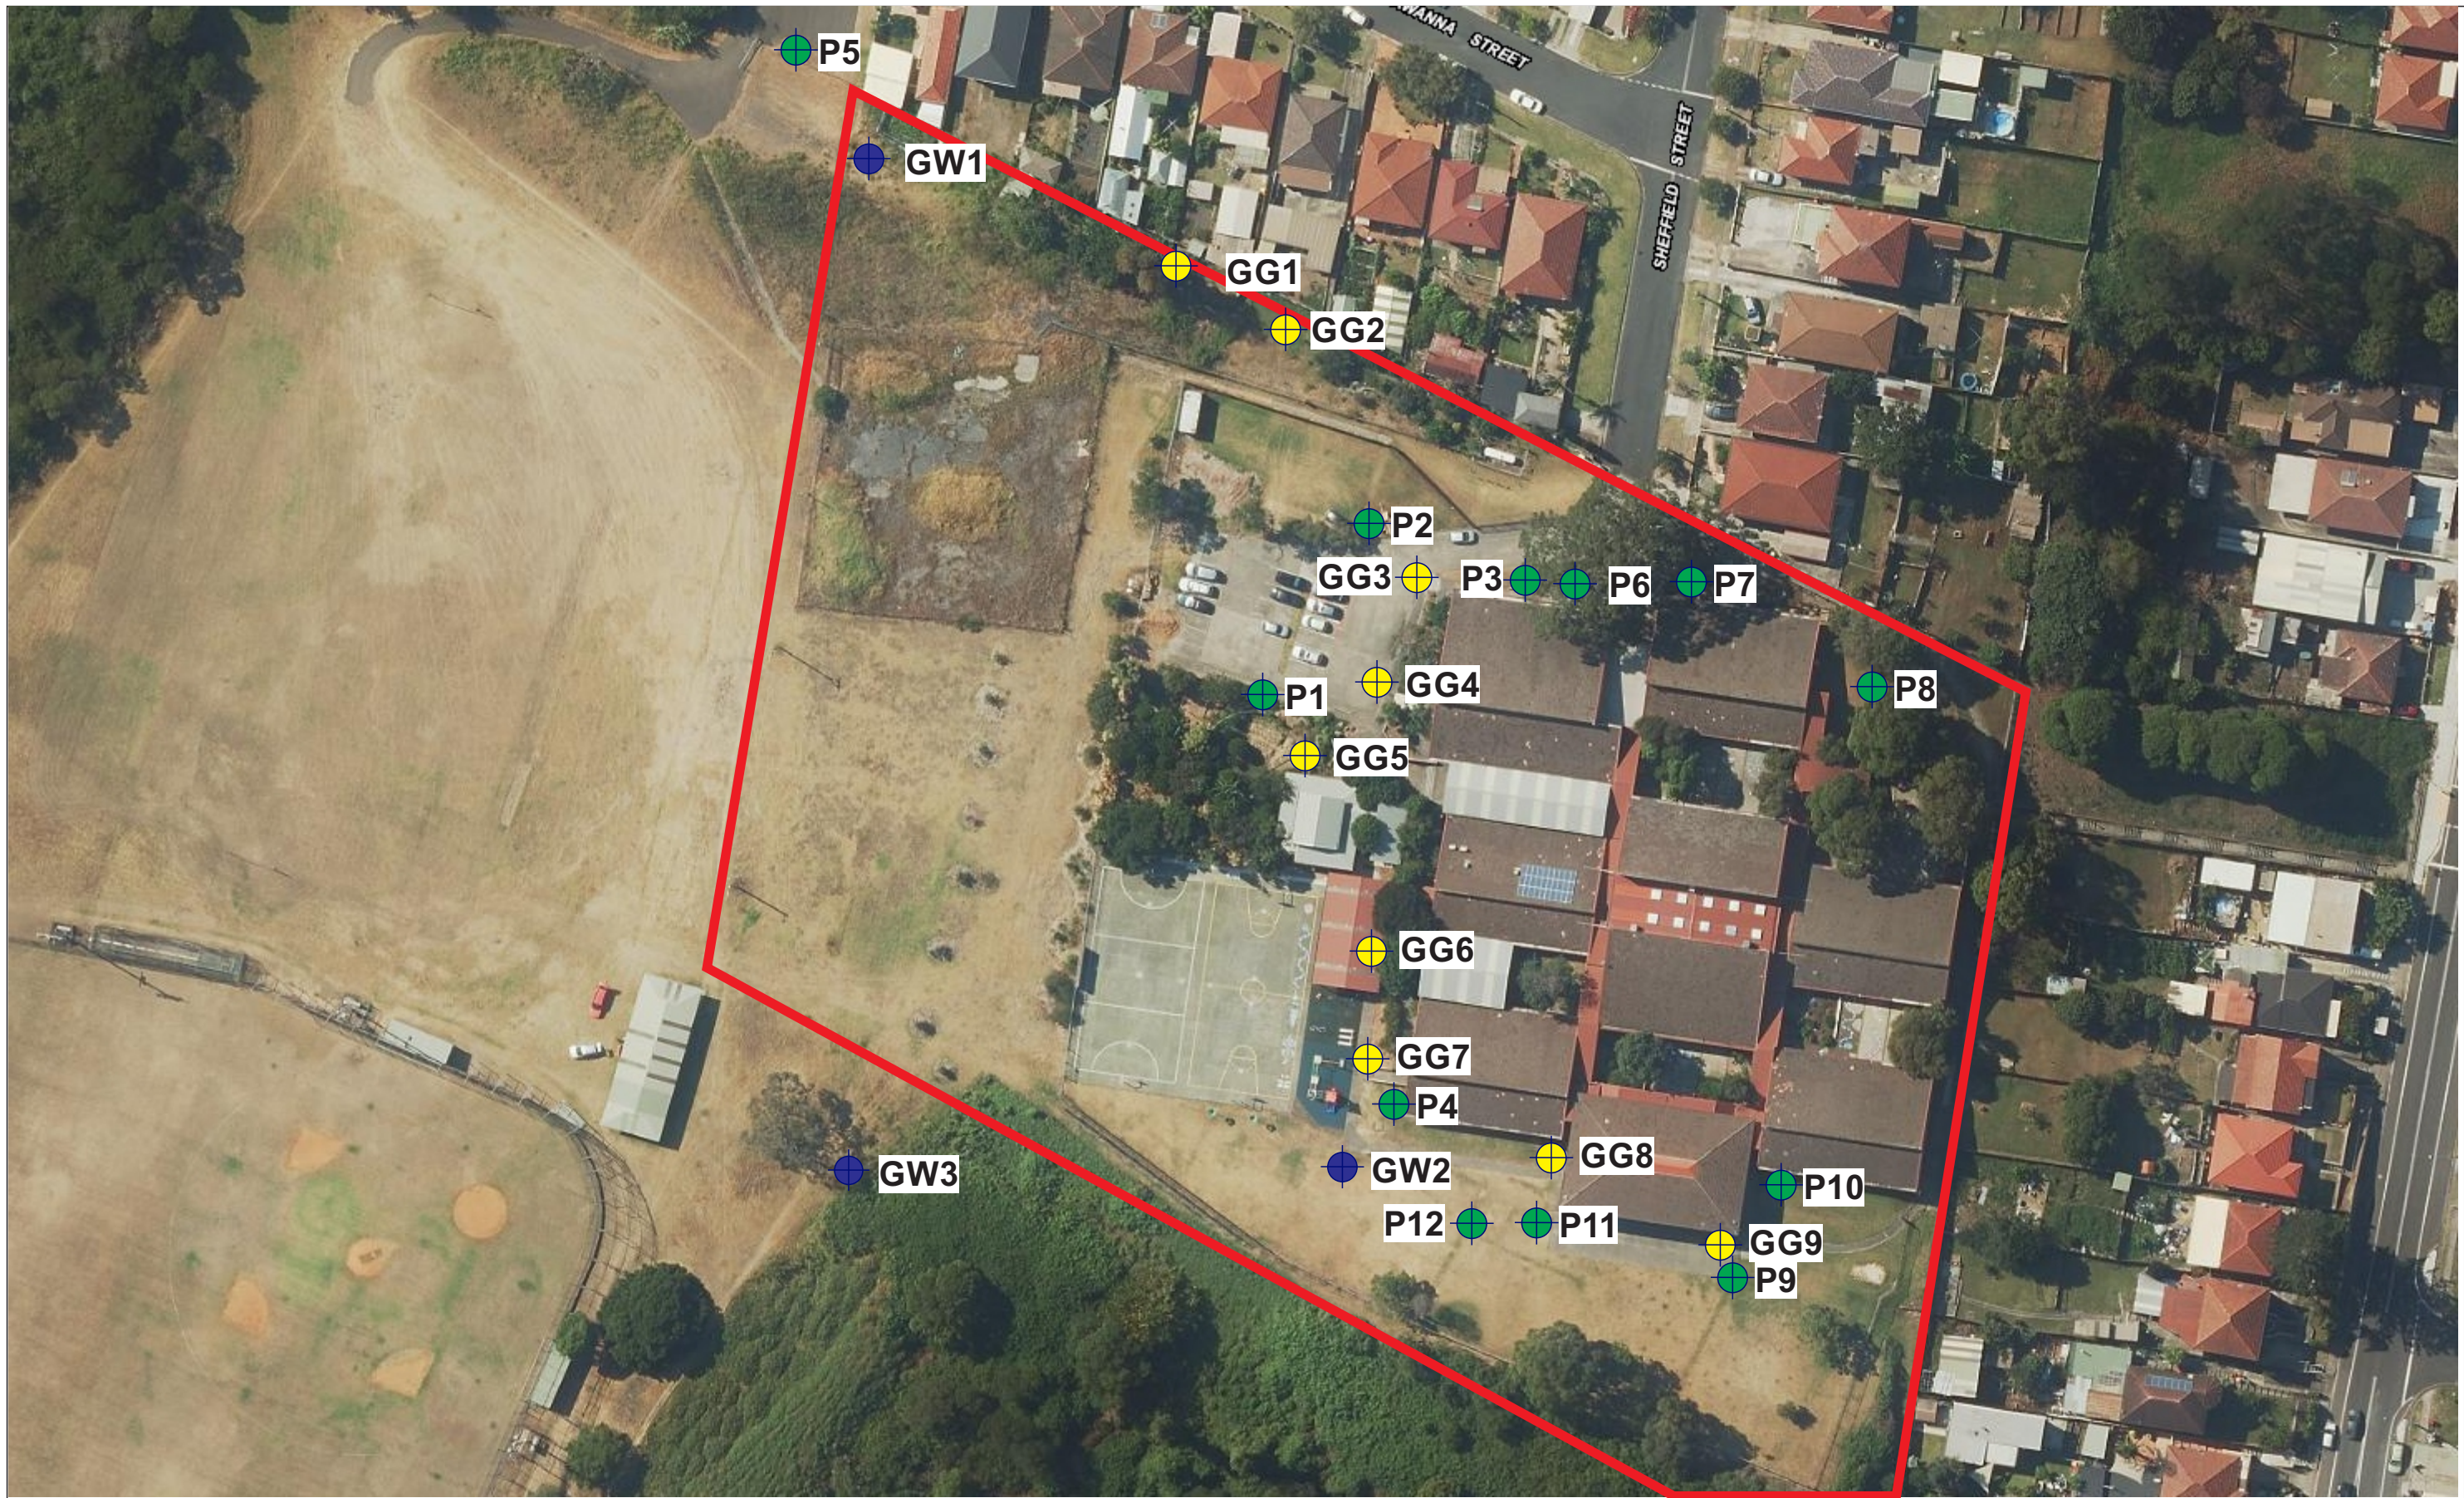
| Figure 2 | | Groundwater Well, Gas Well and Service Pit Locations | | | |

The monitoring ports of the GA5000 were fitted to the X-cap of each of the 9 (GG1 to GG9) subsurface monitoring wells. Subsurface gas and flow rate were recorded as well as concentrations of the following hazardous gases (refer to Figure 2 of Appendix A for monitoring locations):

Service pits were assessed by inserting the GA5000 nozzle into the pits with the sampling tube inserted at least 30 cm below the cover grate for a minimum of 30 seconds. The locations of service pits monitored (P1 to P12) are presented in Figure 2 of Appendix A.
