Near-Surface and In-Situ Temperature Monitoring Investigation Summary Report – March 2025

Cringila Public School –
35 Sheffield Street,
Cringila NSW

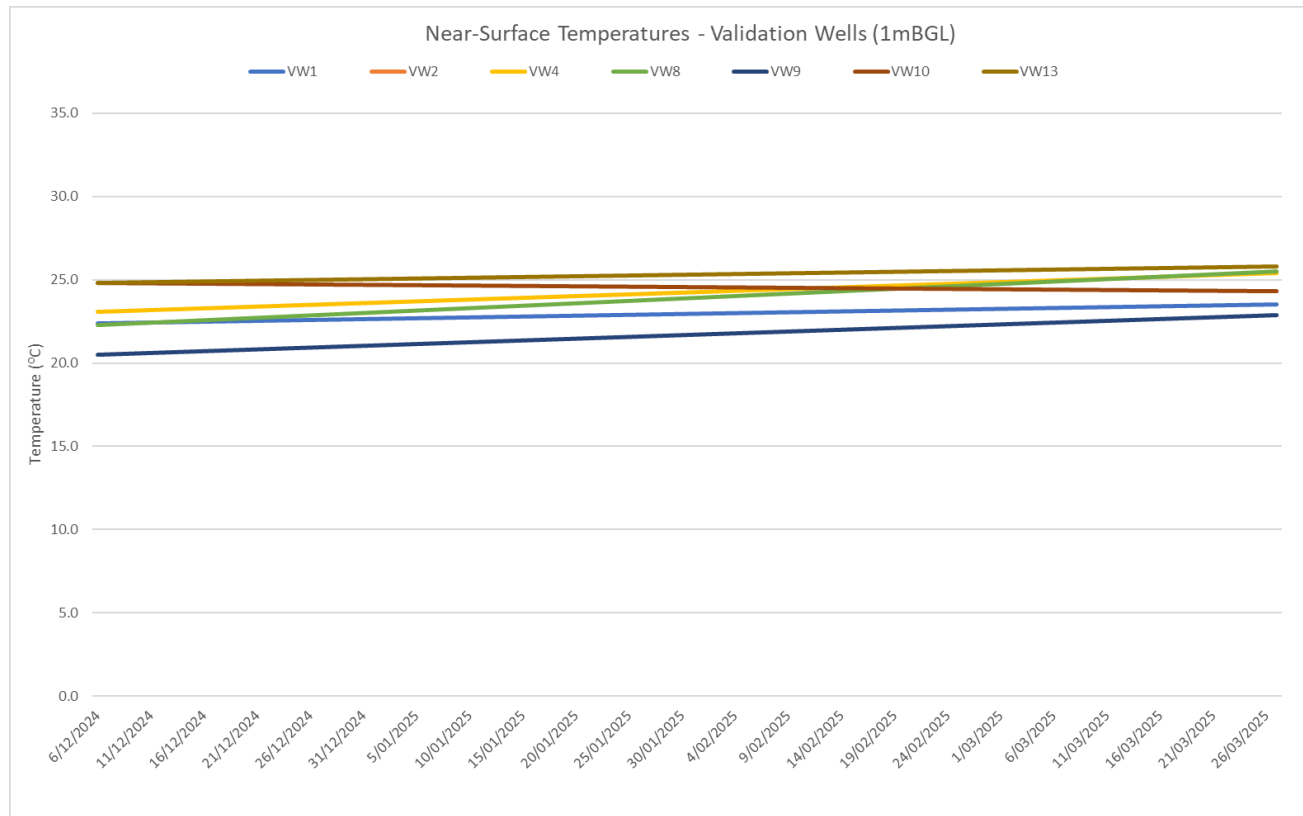
3.2 Near-Surface Temperature Graph – Validation Wells

Near-surface temperature measurements taken at 1 m below ground level from representative validation wells installed across the northwestern hotspot area. All other Validation well temperatures in the northwestern hotspot area displayed temperatures similar to the data displayed in the below graph.

Temperature data gathered in validation monitoring locations during this monitoring period were mostly found to be below 30°C.

The data suggests that, at the monitored points, remediation works have had a successful cooling effect.

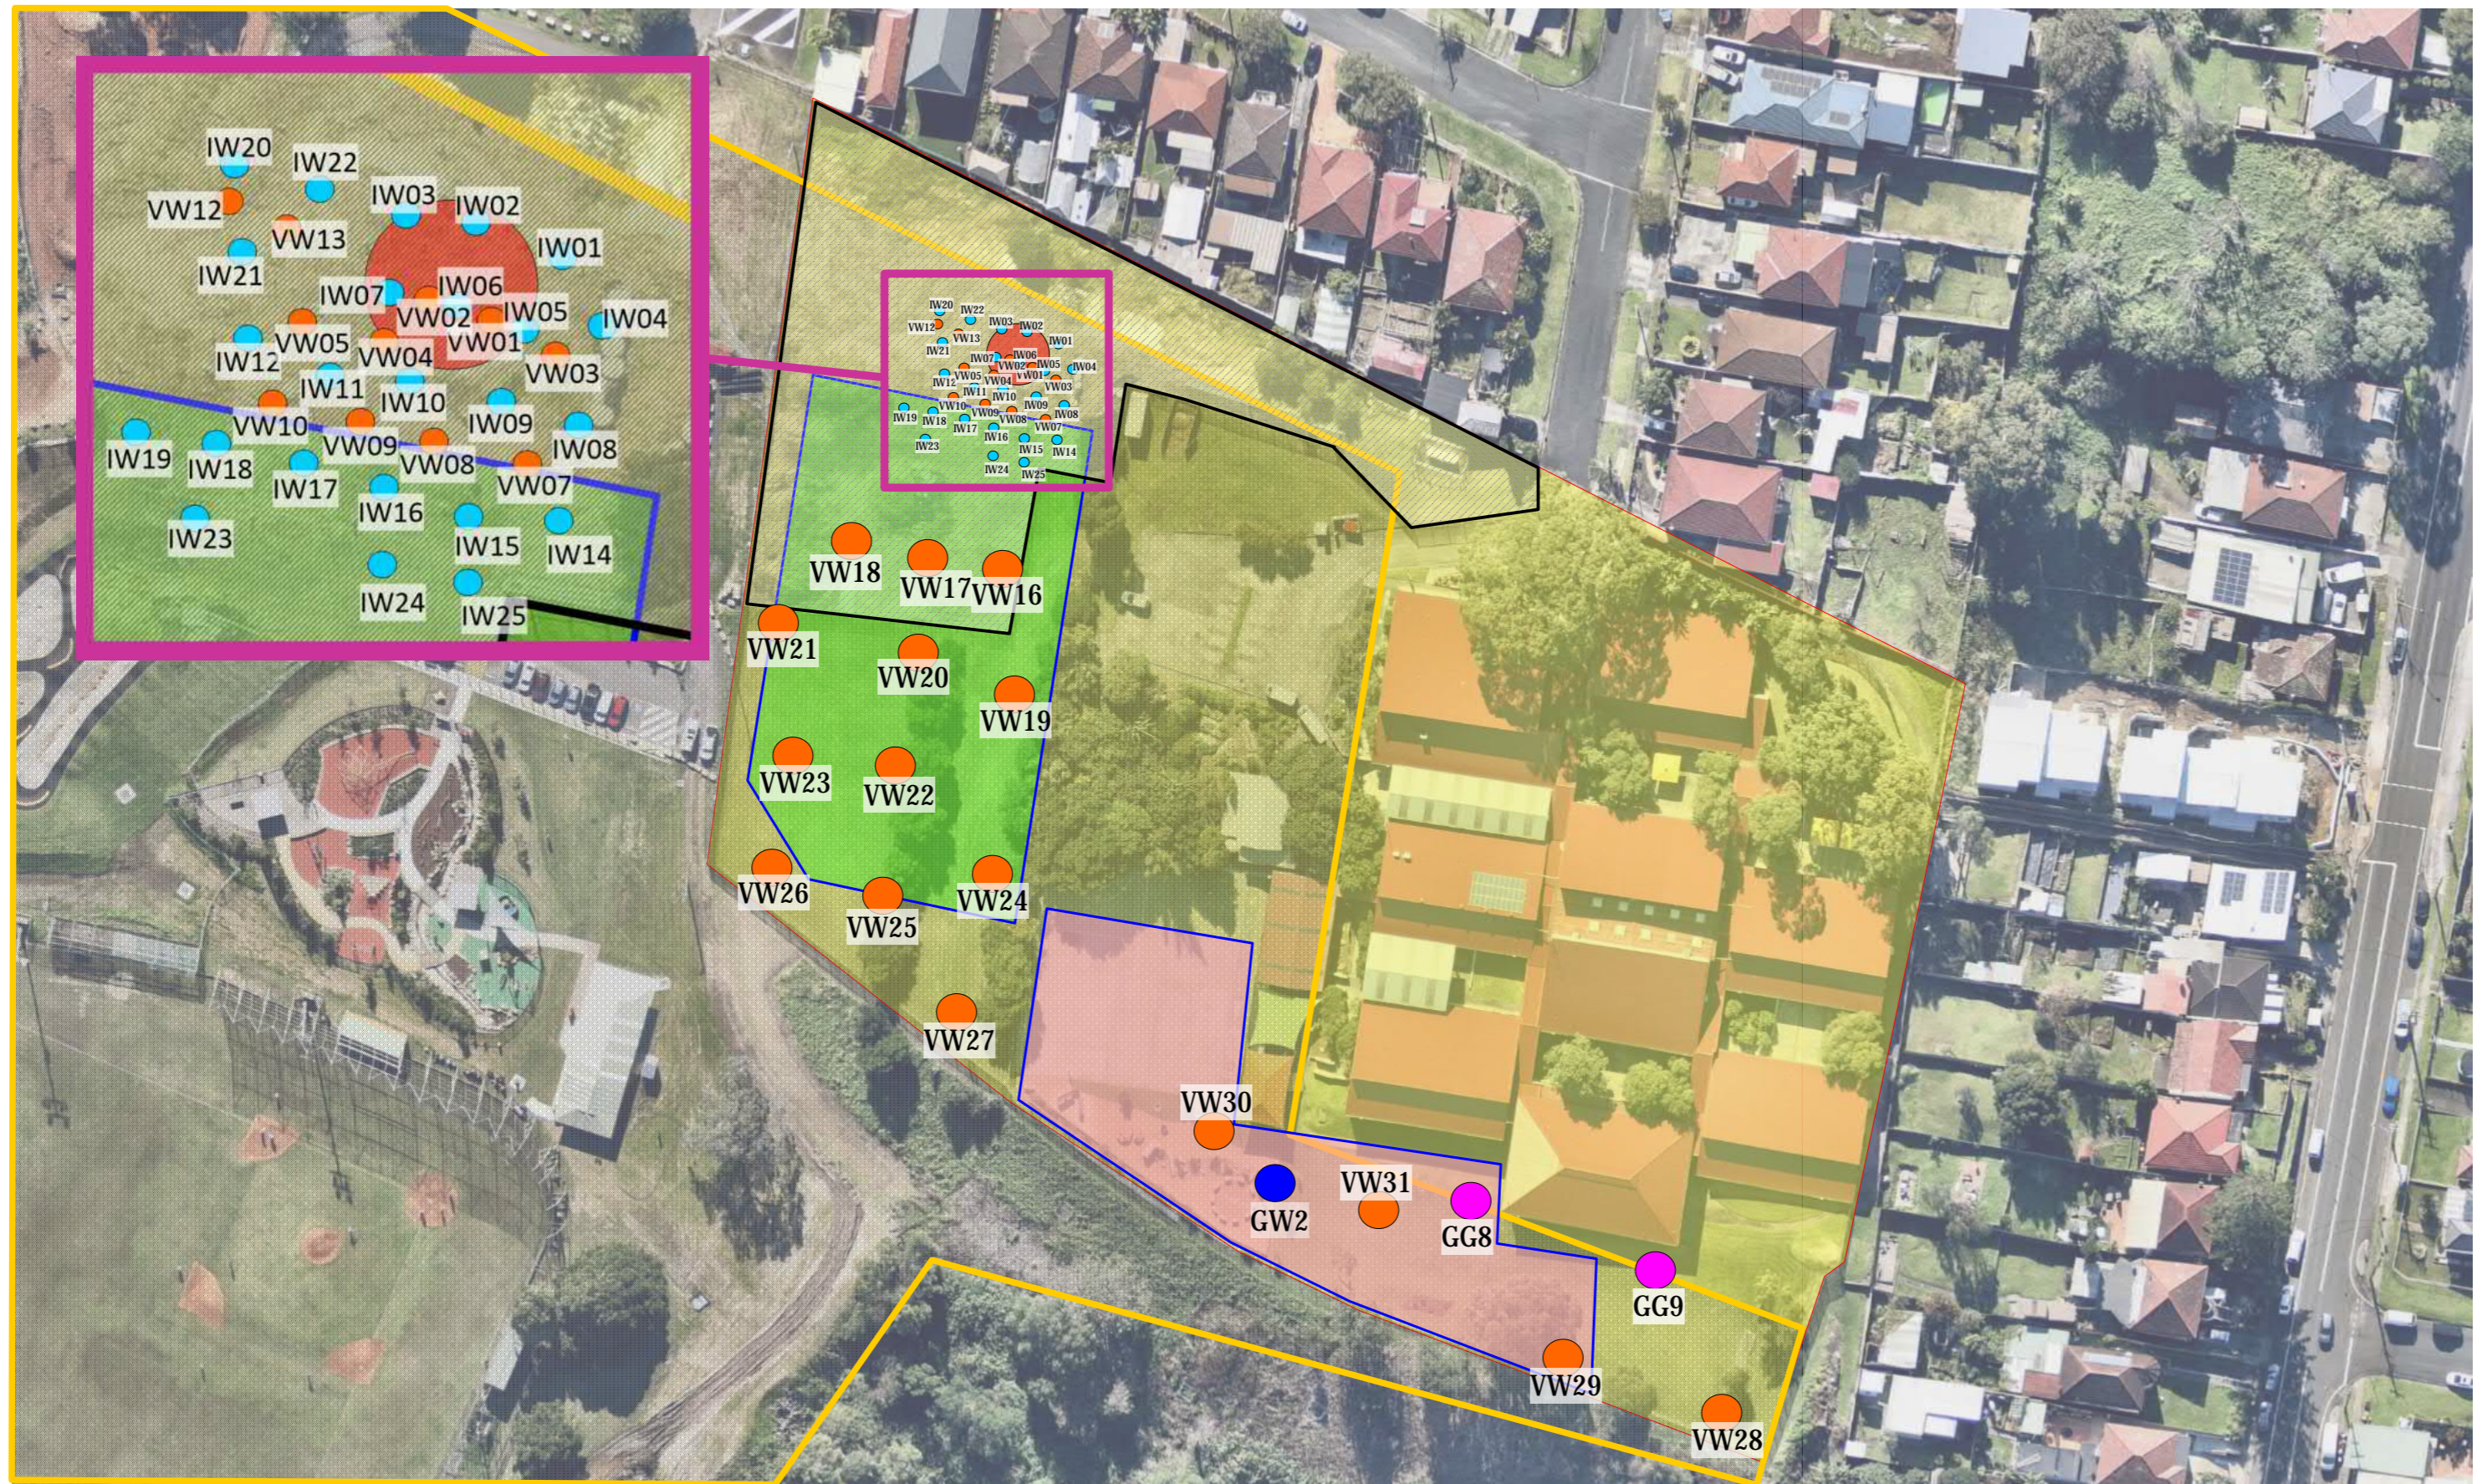
Monitoring locations
