Upgrades to Chatswood Public School and Chatswood High School

Appendix 12 - Geotech, Environmental & Hazmat Investigation

Results of Geotechnical, Environmental and Hazmat Investigation

PSM3730-006R Rev3 18 February 2020

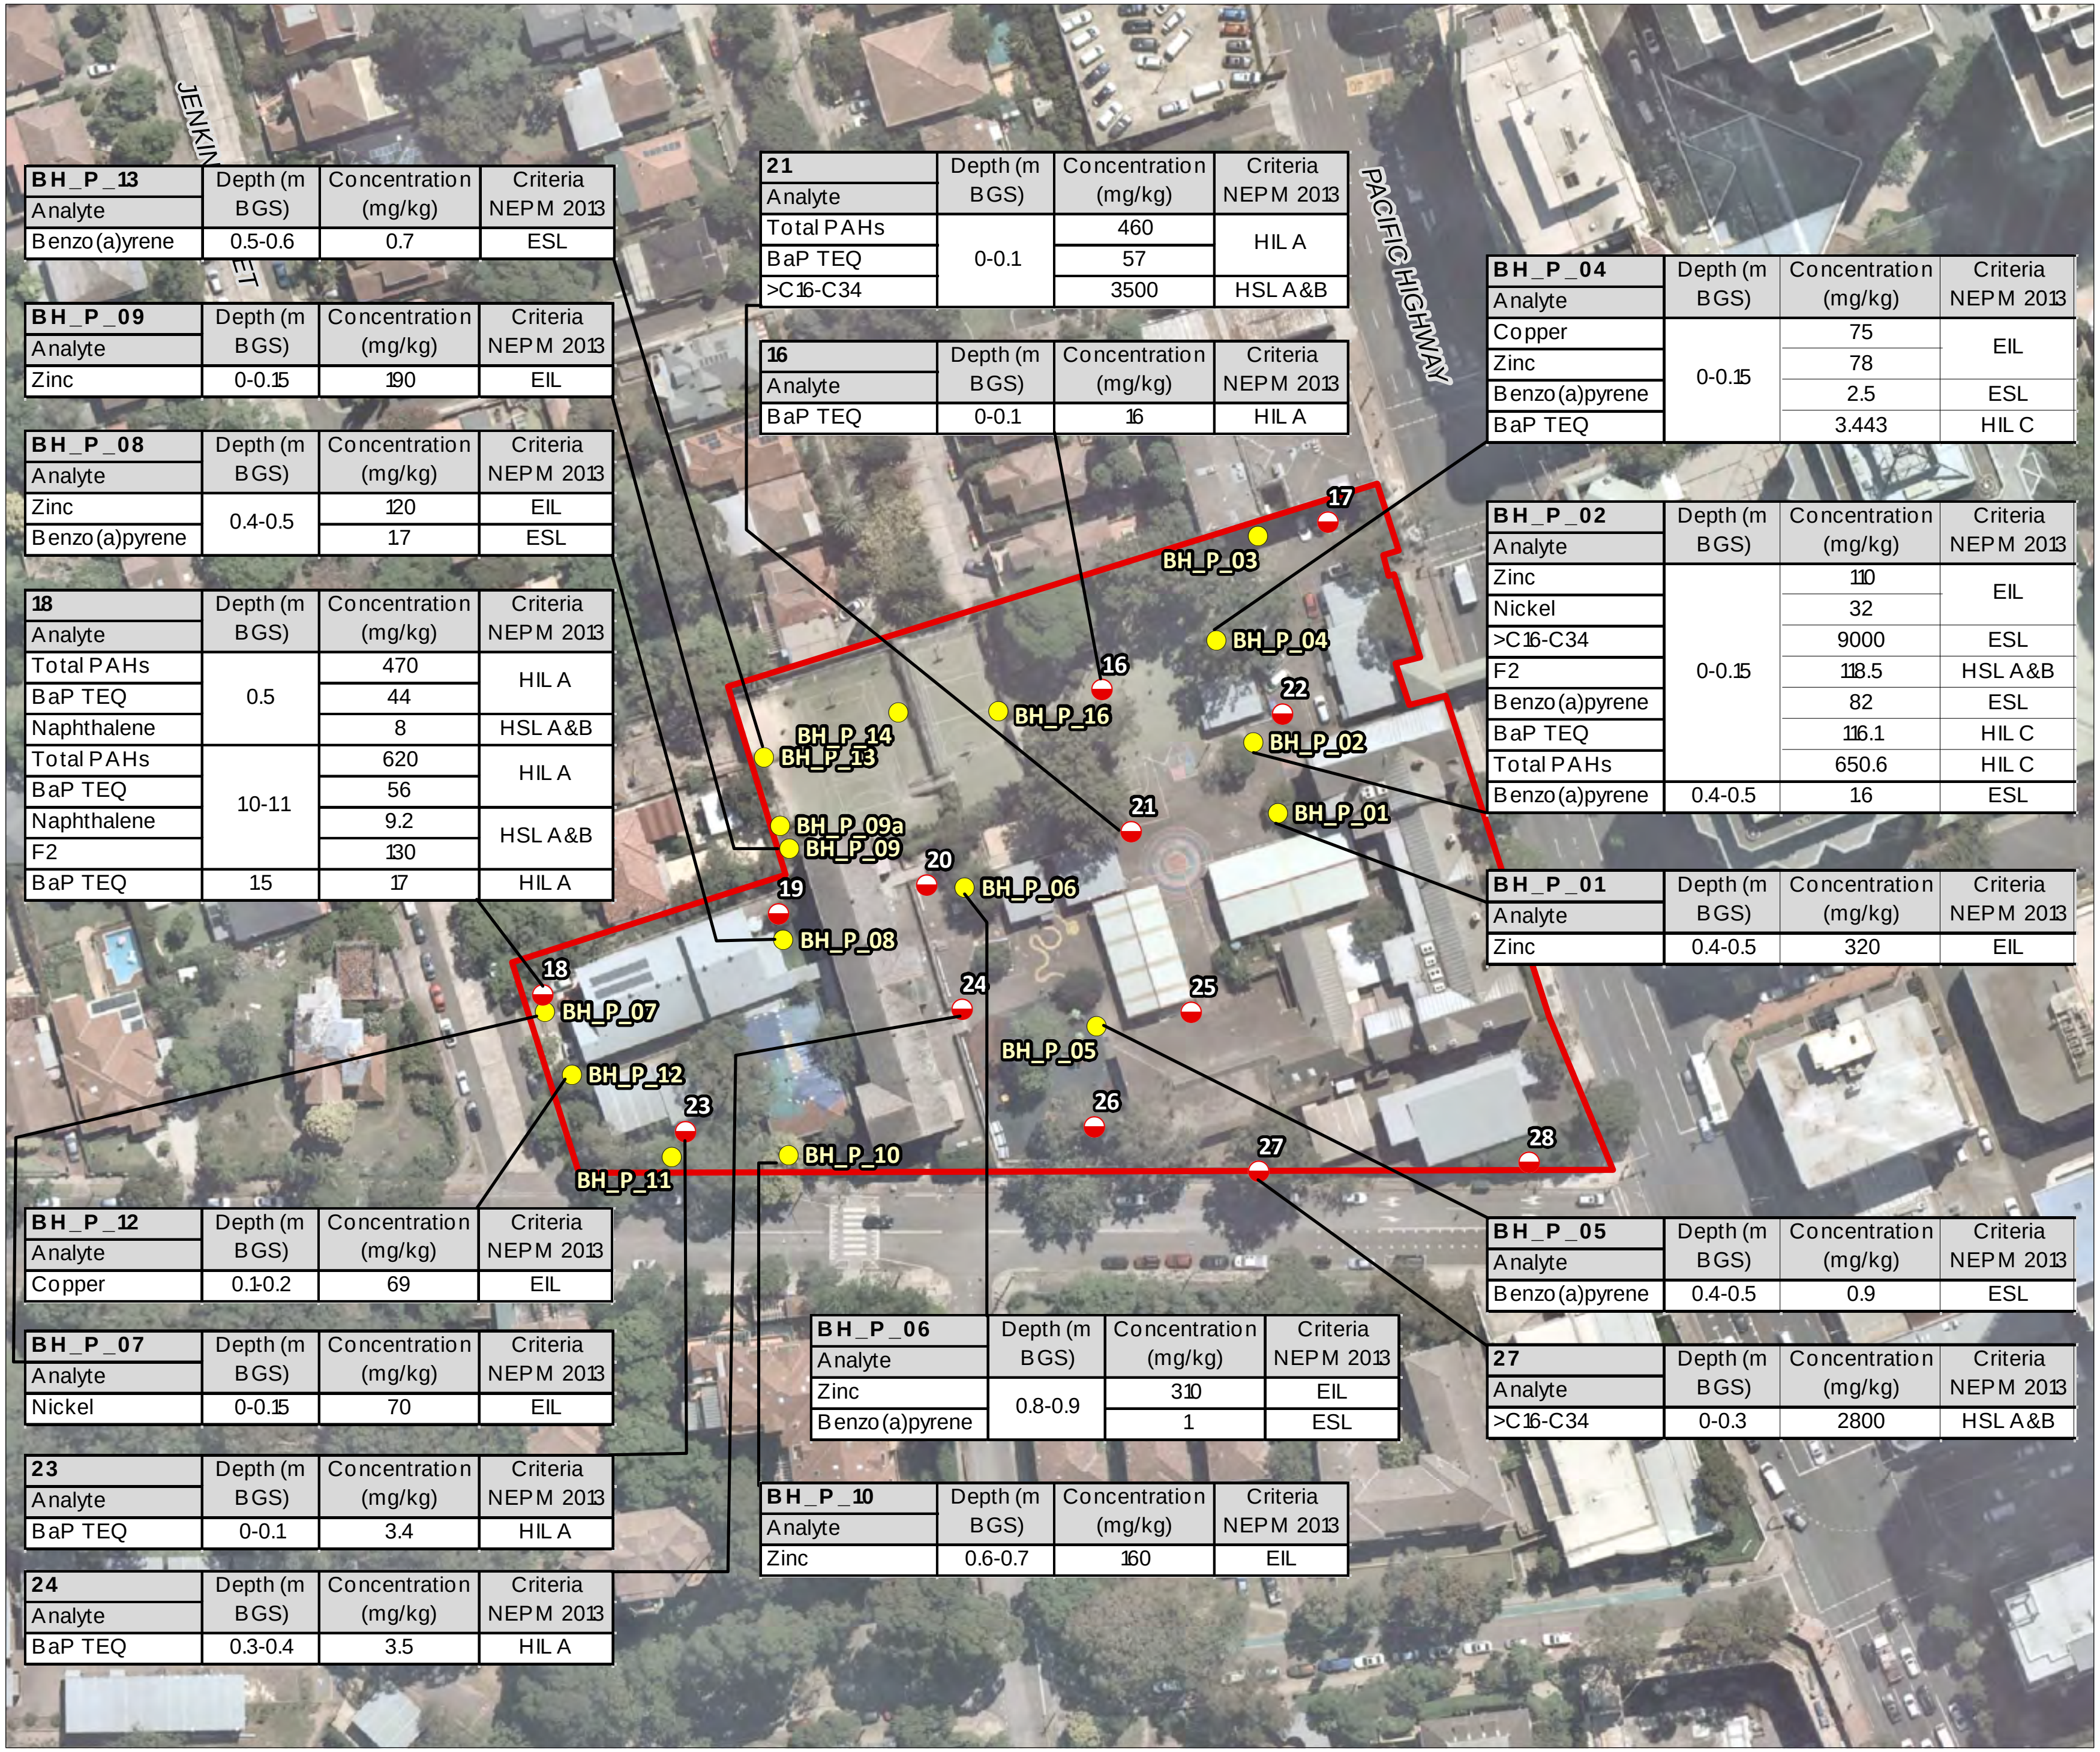
BH_P_13	Depth (m BGS)	Concentration (mg/kg)	Criteria NEPM 2013
Analyte			
Benzo(a)yrene	0.5-0.6	0.7	ESL

BH_P_09	Depth (m BGS)	Concentration (mg/kg)	Criteria NEPM 2013
Analyte			
Zinc	0-0.15	190	EIL
