# DARLINGTON PUBLIC SCHOOL REDEVELOPMENT

## Appendix Q — Detailed Site Investigation

Report on  
Detailed Site Investigation for Contamination

Proposed Upgrade Works  
Darlington Public School, 417 Abercrombie Street,  
Darlington, NSW

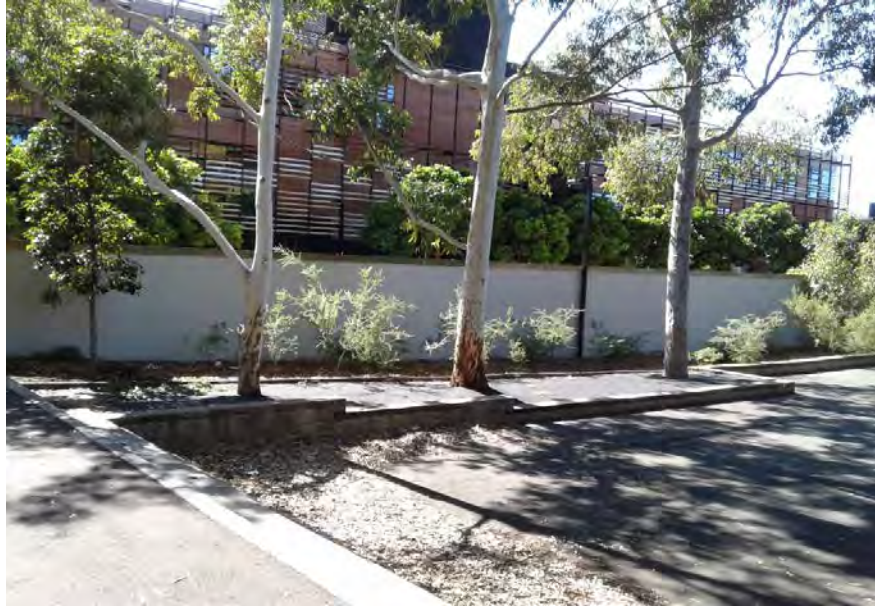
Photograph 5 - Unsealed garden bed adjacent to sites eastern boundary

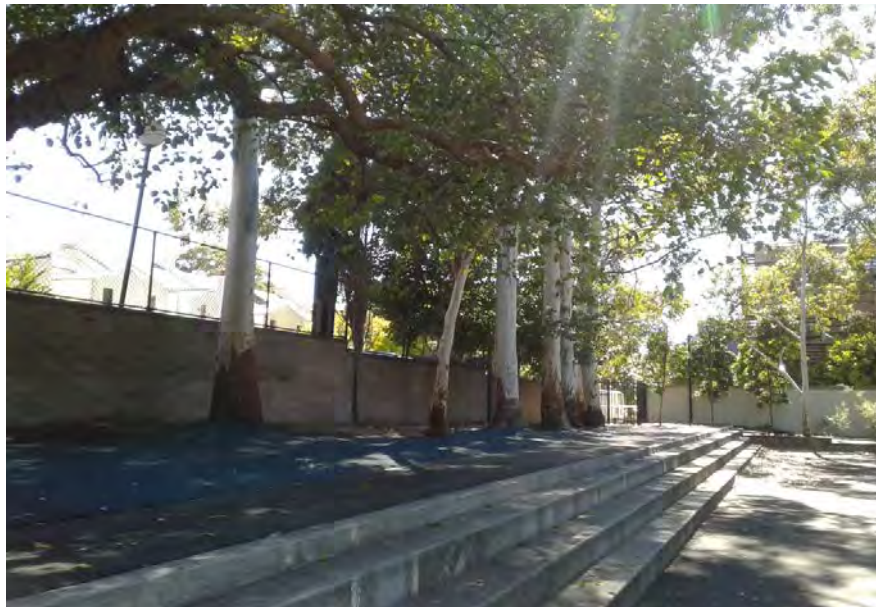
Photograph 6 - Far northern portion of site . Elevated area with rubber safety seal material covering majority of area.

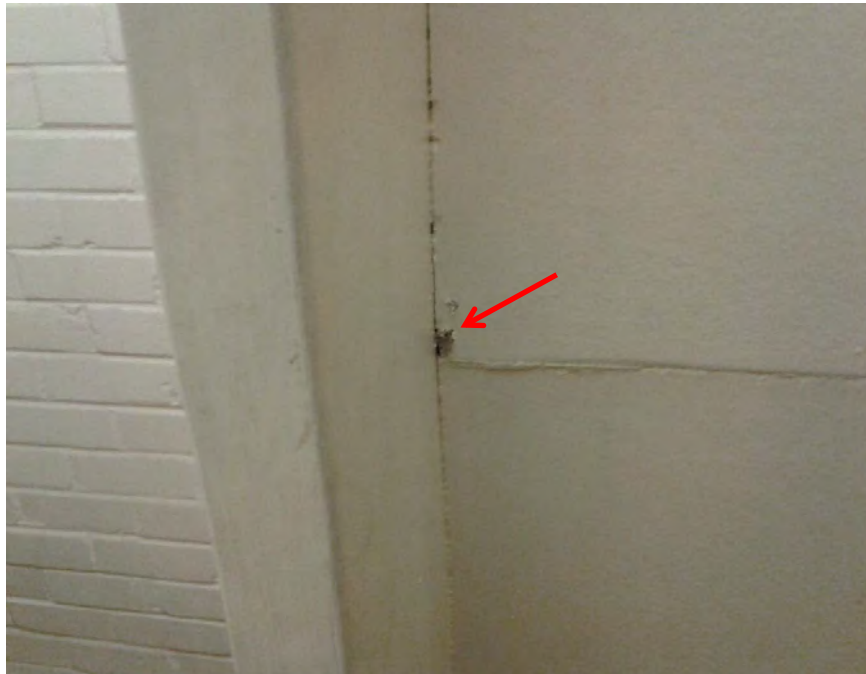
Photograph 10: B00A - R0022, Interior, Partitions in toilet, Compressed FCS sheeting, asbestos detected by analysis.

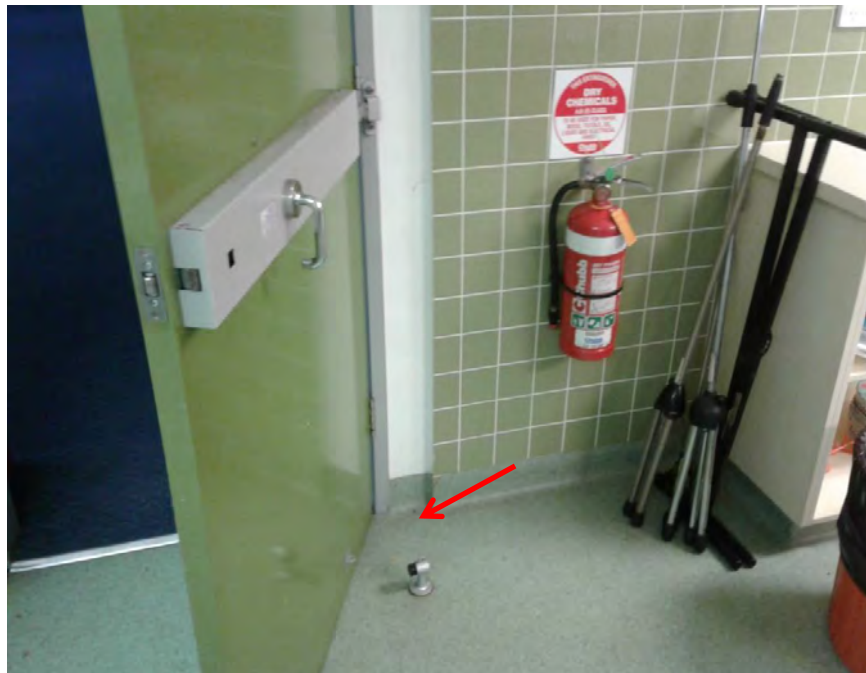
Photograph 12: B00A - R0025, Interior, Flooring material, Vinyl tiles, no asbestos detected by analysis.

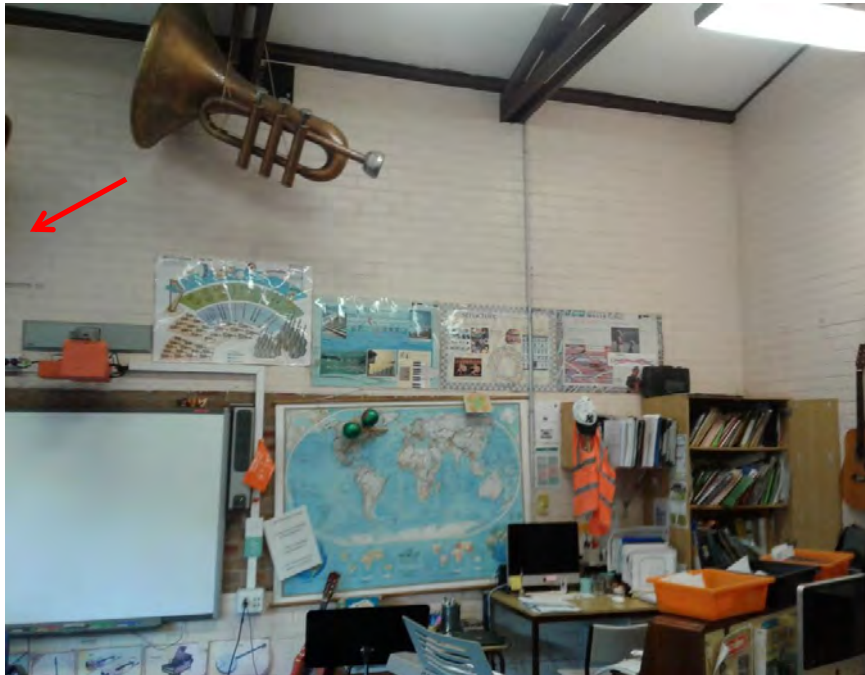
Photograph 14: B00A - R1001, Interior, Brick walls, Beige paint, non-lead paint ( $\leq 0.1\%$  lead w/w).

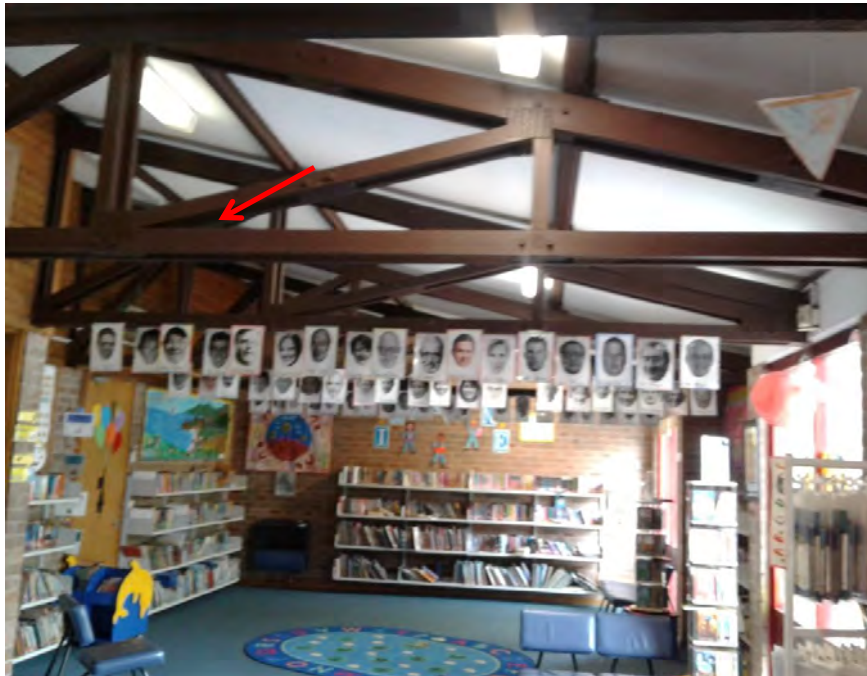
Photograph 16: B00A - R1003, Interior, Timber rafters, Brown paint, non-lead paint ( $\leq 0.1\%$  lead w/w).

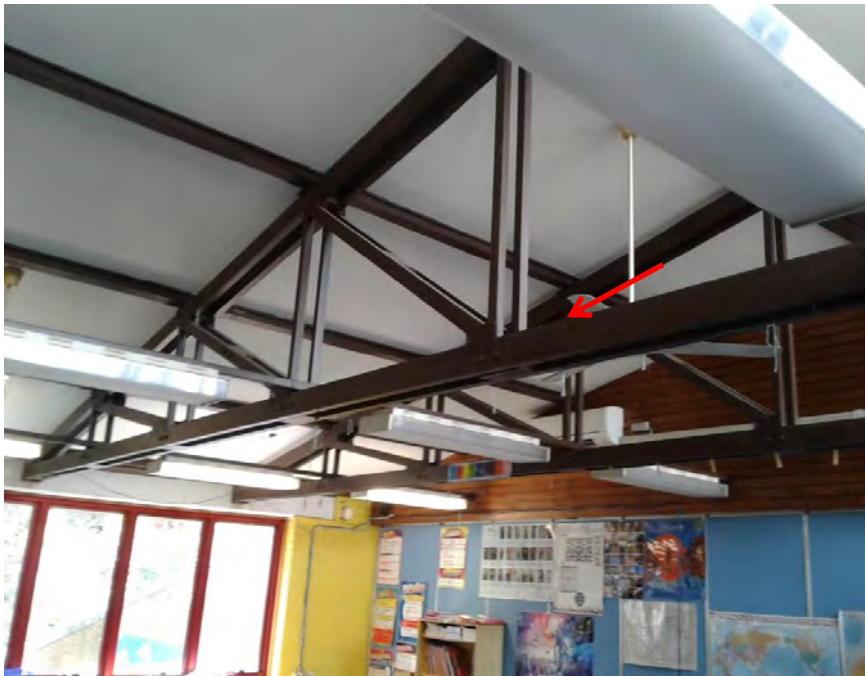
Photograph 27: B00B - R1008, Interior, Timber rafters, Brown paint, non-lead paint ( $\leq 0.1\%$  lead w/w).

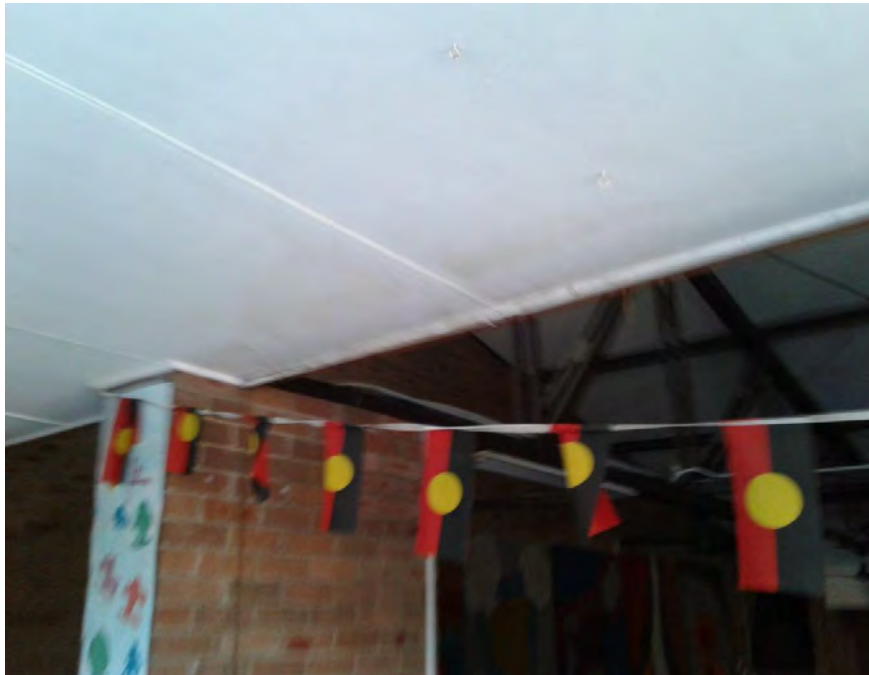
Photograph 37: B00C - R0025, Interior, Brick column, Dust above column, elevated lead (>0.5 mg/m2).

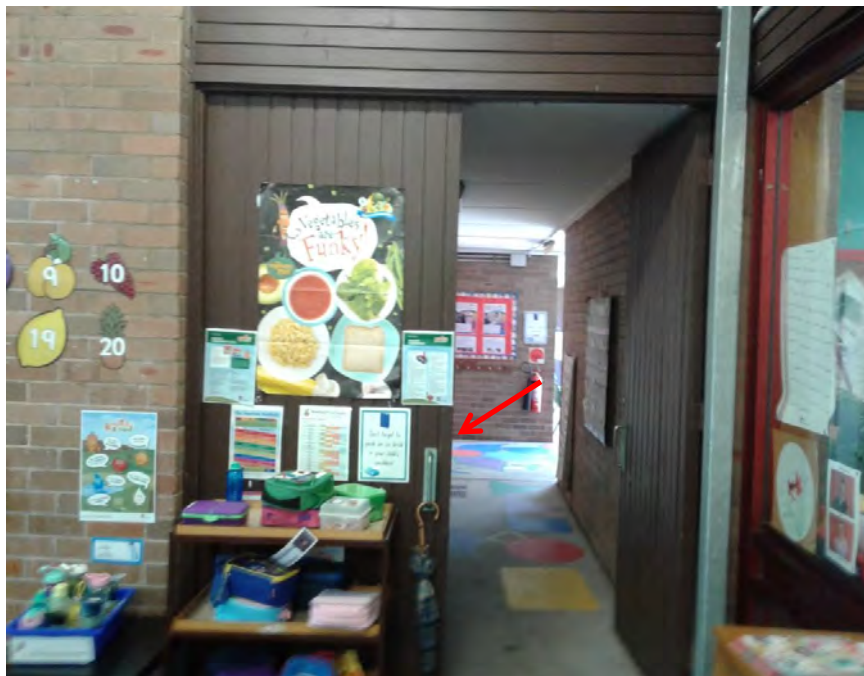
Photograph 39: B00C - R0034, Interior, Timber door, Brown Paint, non-lead paint ( $\leq 0.1\%$  lead w/w).
