Fort Street Public School

ARBORICULTURAL DEVELOPMENT IMPACT ASSESSMENT REPORT

Prepared by Birds Tree Consultancy

25 January 2021

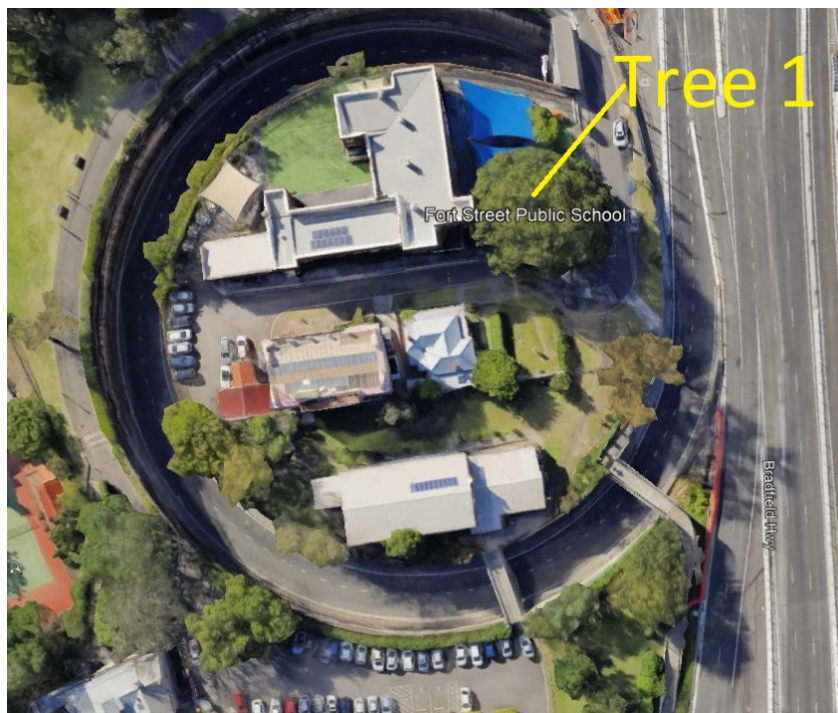
Figure 1 - Tree Location

Tree numbering has been retained from Birds Tree Consultancy Arboricultural Development Impact Assessment Report Revision E dated 18 September 2020. The subject Tree is identified as Tree 1 in this previous report as well as Figure 1.
