Construction Hazardous Material Management Plan (CHMMP)

Kingscliff Public School Upgrade

SSD-8378620

November 2023

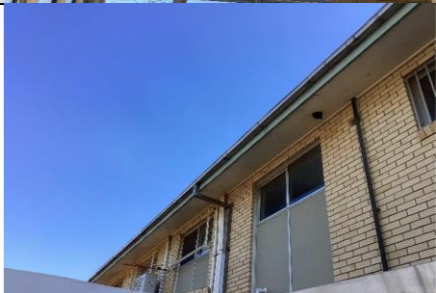
12	9/09/2023	Asbestos	External, level 1	Southern side of building	High level soffit	Fibre cement sheeting	Ref: AS01/AS04	Positive	Non-Friable	Good	35m2	Low Risk

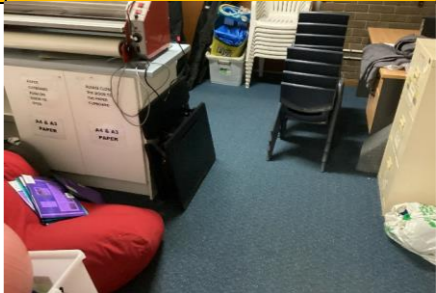
ID	Date Identified	Hazmat Type	Area / Level	Location / Room	Feature	Item Description	Sample No.	Sample Status	Friability	Condition	Qty (m ²)	Risk Assessment	Comments	Photo
36	9/09/2023	Asbestos	Internal, ground level	AR0001 (eastern side)	Floor beneath carpet	Orange vinyl floor tiles	Ref: AS13	Assumed Positive	Non-Friable	Good	20m2	Low Risk	Serpentine detected - Chrysotile* detected following X-ray diffraction (XRD) Analysis.

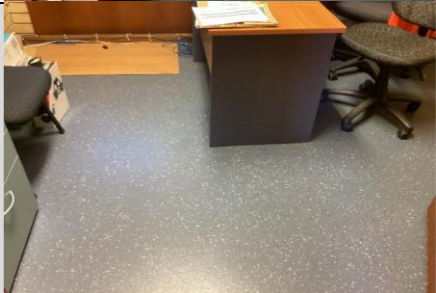
37	9/09/2023	Asbestos	Internal, ground level	AR002	Floor	Sheet vinyl	AS19	Negative	-	-	-	-	-

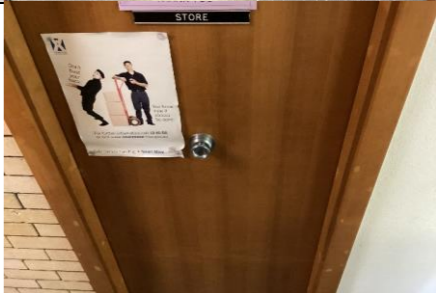
38	9/09/2023	Asbestos	Internal, ground level	AR006	Floor	Orange vinyl floor tiles	Ref: AS13	Assumed Positive	Non-Friable	Good	10m2	Low Risk	Serpentine detected - Chrysotile* detected following X-ray diffraction (XRD) Analysis.

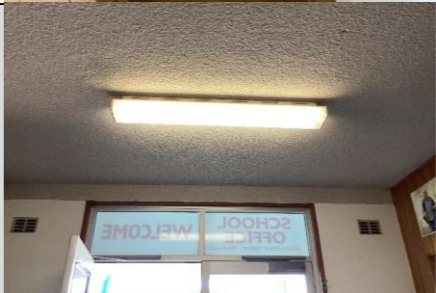
39	9/09/2023	Asbestos	Internal, ground level	Throughout western half	Ceiling	Sprayed vermiculite	AS20	Negative	-	-	-	-	Composite sample collected from multiple rooms

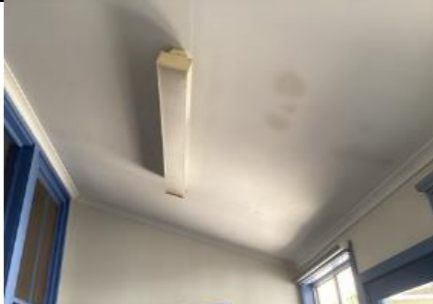
ID	Date Identified	Hazmat Type	Area / Level	Location / Room	Feature	Item Description	Sample No.	Sample Status	Friability	Condition	Qty (m ²)	Risk Assessment	Comments	Photo
46	16/09/2023	Asbestos	Internal, Ground level	CR0028	Ceiling	Low Density Board	Ref: AS27	Assumed Positive	Friable	Good	10	Medium Risk

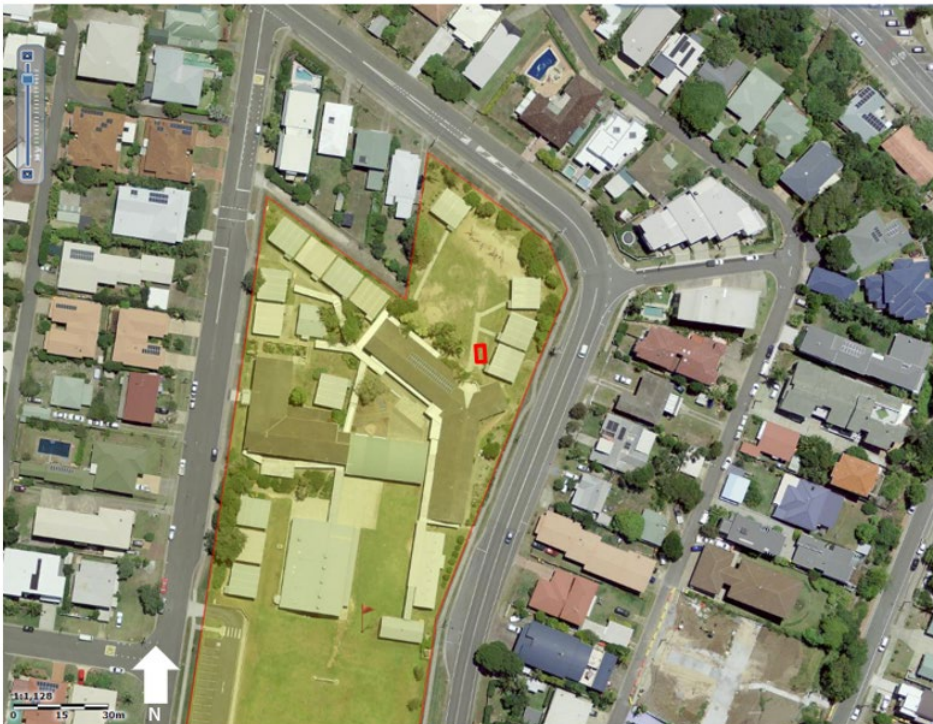
ENV Services Pty Ltd (ENV) was engaged by Richard Crooke Constructions to undertake soil sampling of a small excavation trench and associated spoil material located within a play area of Kingscliff Public School following the discovery of a potential asbestos containing fragment (ACF). It is understood that the trench had been excavated as part of an archaeological dig and the spoil material had been sifted prior to the discovery of the ACF (Figure 1).

Given the negative sample results for asbestos in all four soil samples, and the removal of the asbestos fragment from the site, ENV considers that the area is safe for re-occupation if the following recommendations are applied:

- All excavation material should be turned over prior to sifting to check for ACFs within the soils.
 - A P2 respirator should be worn during excavation works.

- If any ACFs or other suspected asbestos materials are found, works should cease pending an investigation by an occupational hygienist.
- School students and staff should be discouraged from undertaking any excavation within the area.

- If any ACFs or other suspected asbestos materials are found by school staff, the areas should be cordoned off pending investigations by an occupational hygienist.

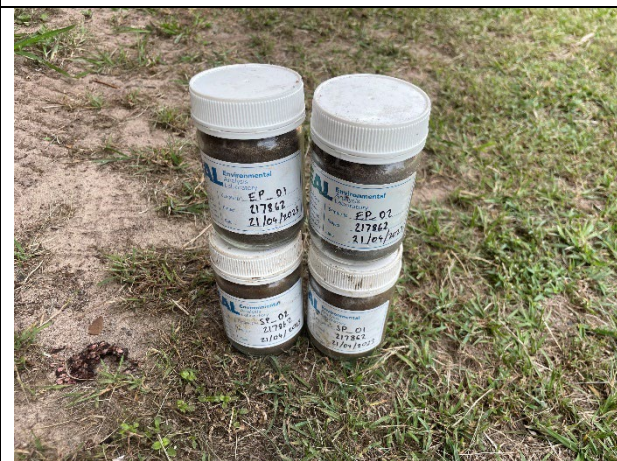
Photo 5: Four soil samples collected from stockpile and trench
