REPORT: Arboricultural Impact Assessment Our Ref: 20153 V8Jm

Pendle Hill High School Cornock Avenue Toongabbie NSW 2146

> 5th of May, 2021 Version 9.1

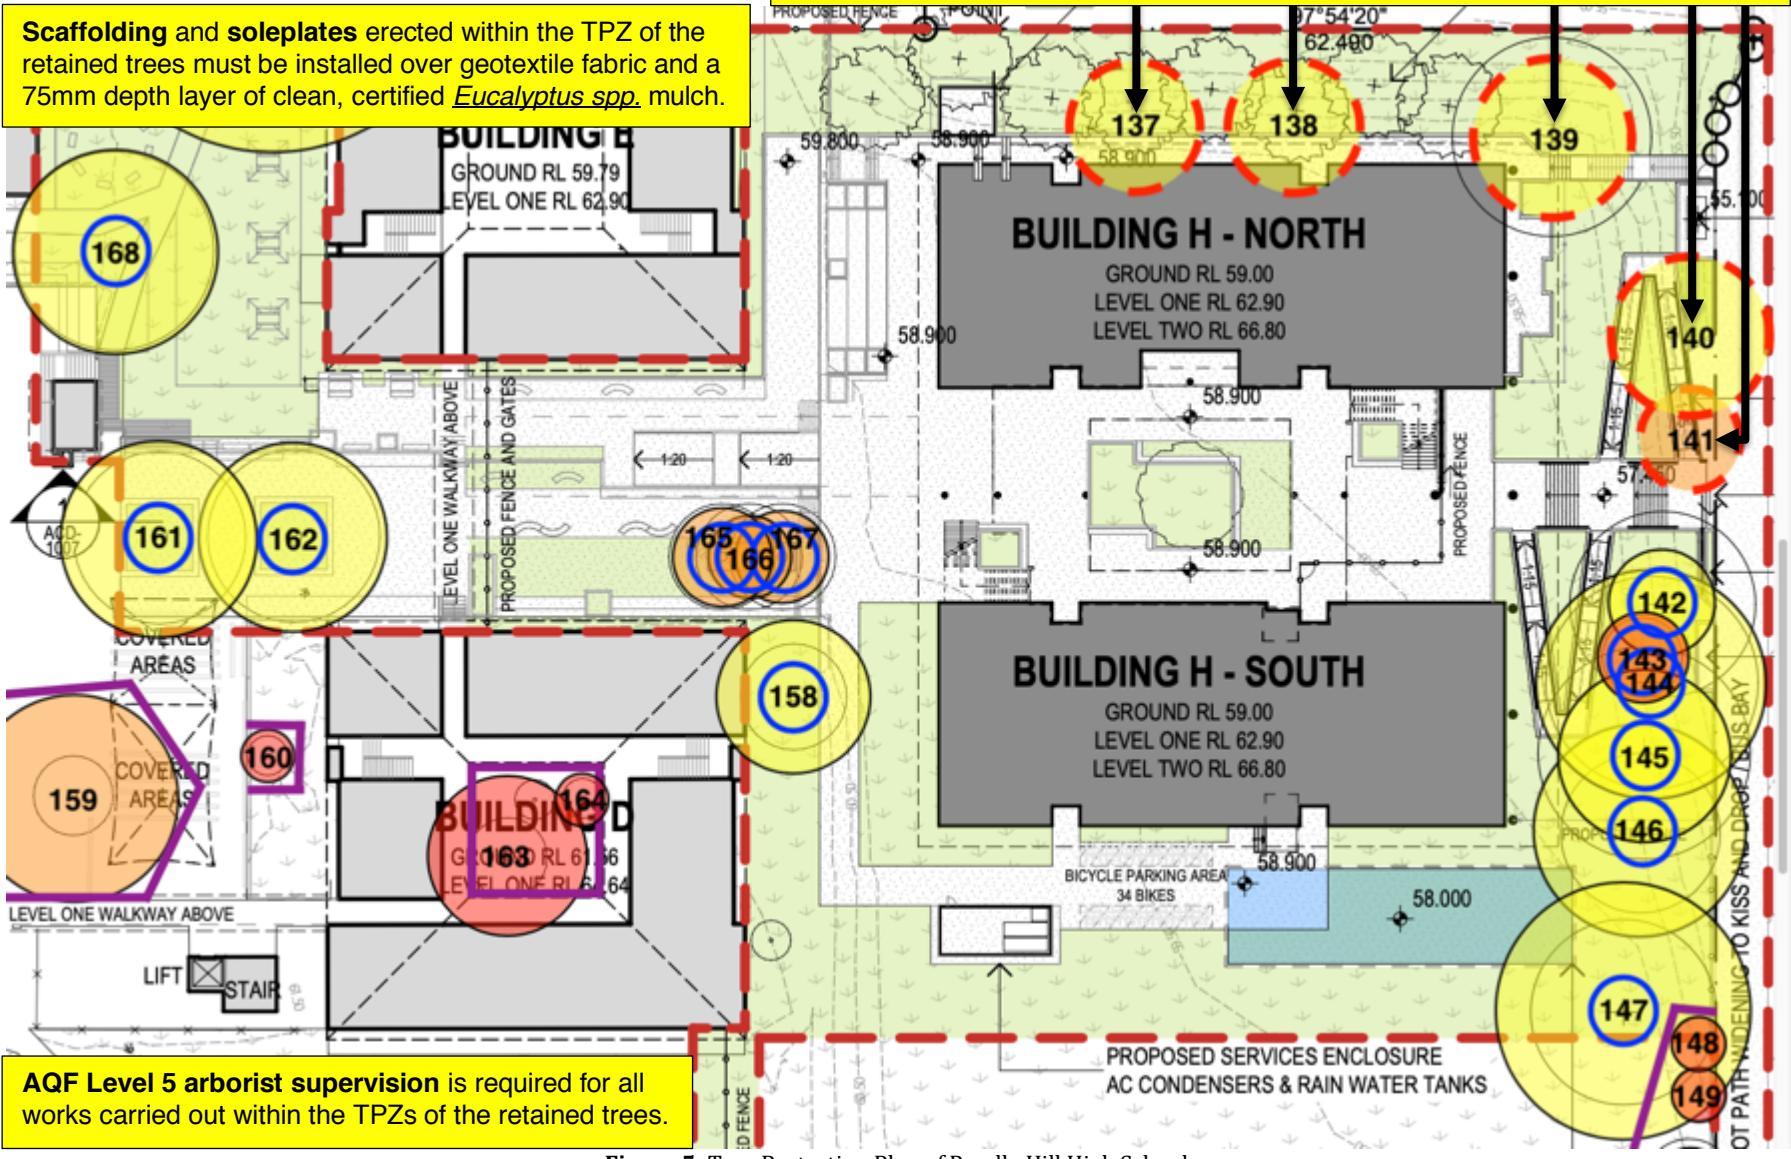
Figure 5: Tree Protection Plan of Pendle Hill High School.

Five (5) trees numbered: 137, 138, 139, 140 & 141 require **removal** and **replenishment**, due to high anticipated impacts from the proposed development.

12.3 One hundred and seventy-two (172) trees require **retention** and **protection**, and six (6) additional trees which are dead or noxious will be retained as prescribed in the Tree Management Plan (Figures 4 to 7), Discussion 11.6, and the Tree Impacts Table (Table 3). Tree protection measures are to be certified by an AQF Level 5 arborist prior to any demolition and construction, in accordance with *Australian Standard AS 4970-2009* – *Protection of Trees on Development Sites*. Tree trunk protection includes utilising geofabric wrap (or hessian) around the trunk with hardwood timber batons of 2m x 100mm x 50mm strapped vertically around the trunk with air gaps of 150mm.
