**BIRZULIS ASSOCIATES Pty Ltd**  
Consulting Structural + Civil Engineers

**RE: SAMUEL GILBERT PUBLIC SCHOOL  
RIDGECROP DRIVE, CASTLE HILL NSW  
(OUR REF: 7738)  
DILAPIDATION REPORT FOR PUBLIC INFRASTRUCTURE**

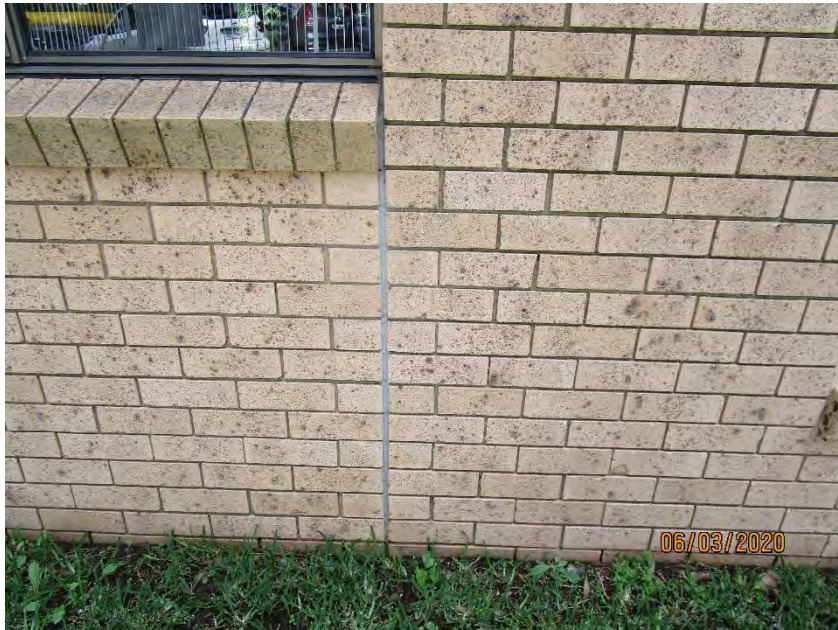
Photo 1

<b><u>Photo</u></b>	<b><u>Comments</u></b>
1-5	Front façade of childcare centre. Structure appears to be in reasonable condition.
6-9	Western wall of childcare centre. Structure is generally in good condition.
10-11	Masonry pavement in reasonable condition. Some areas with minor vertical displacement.
12	Roof framing on western side of building. No signs of structural distress and generally in good condition.
13-24	Western wall of childcare centre. Structure is generally in good condition.
25-30	South-western corner of building. Generally in good condition with no signs of structural defects.
32-42	Rear wall of the building. Generally in good condition with no signs of structural defects.
43-52	Masonry pavement in reasonable condition. Some areas with minor vertical displacement.
54-55	Concrete pavement generally in reasonable condition. Some areas with vertical displacement.
56-60	Cracking on concrete pavement.

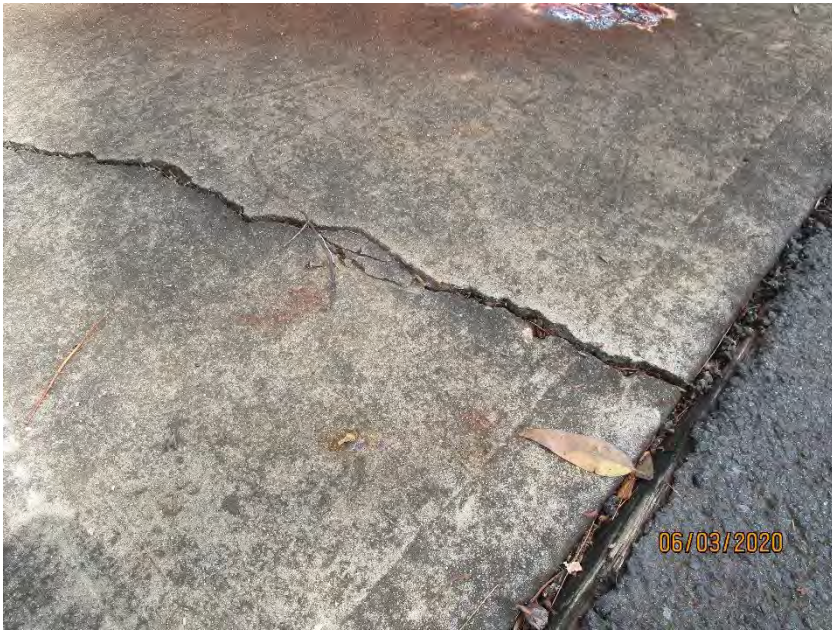
Photo 61

61-62	Minor cracking in asphaltic pavement.
63-64	Cracking on concrete pavement.
65-70	Concrete pavement in reasonable condition.
71-76	Concrete pavement generally in reasonable condition. Some areas with vertical displacement.
77	Cracking in asphaltic pavement around trees.
78-82	Most of asphaltic pavement in good condition.
83-84	Moderate cracking in asphaltic pavement at front entry to childcare building.
85-90	Cracking in concrete pavement at rear side of building.
91-96	Outdoor structures appear to be in reasonable condition.
97	Timber splitting in outdoor timber structure.
98-101	Outdoor structures appear to be in reasonable condition.
102	External Covered Outdoor Learning Area (COLA) appears to be in good condition.
103-105	External shelter to the childcare centre generally in reasonable condition.
106-117	COLA structure appears to be in reasonable condition with no signs of structural defects.

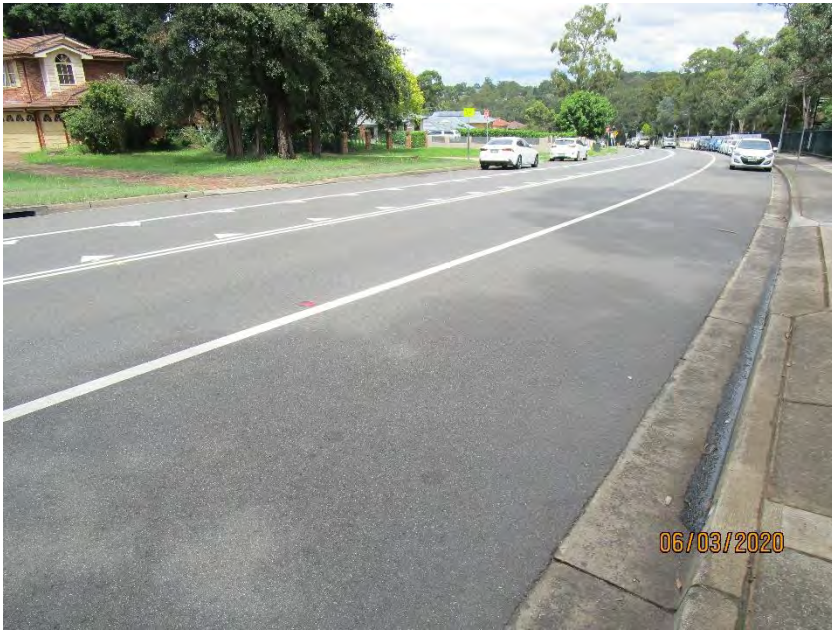
Photo 118

118	Eastern side of front façade generally in good condition.
119	Road condition on Gilbert Road generally in good condition.
120	Damage to stormwater outlet pipe on Gilbert Road.
121	Kerb and gutter on Gilbert Road generally in good condition.
122-124	Cracking in concrete kerb and gutter on Gilbert Road.
125	Concrete pavement on Gilbert Road generally in good condition.
126	Castle Glen signage generally in good condition.
127	Concrete pavement on Gilbert Road generally in good condition.
128-129	Damage to stormwater outlet pipe on Gilbert Road.

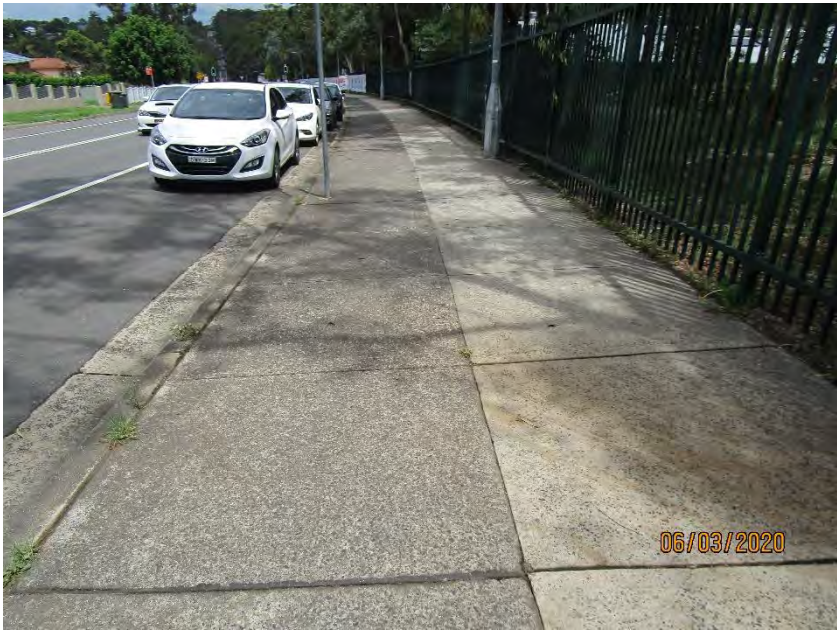
Photo 130

130	Concrete pavement on Gilbert Road generally in good condition.
131	Lighting post generally in good condition.
132	Road sign generally in good condition.
133-134	Cracking in concrete pavement at base of street light.
135	Road condition on Gilbert Road generally in good condition.
136	Concrete pavement on Gilbert Road generally in good condition.
137-138	Concrete cracking on kerb and gutter on Gilbert Road.
139-140	Schools signage and fencing generally in good condition.
141	Concrete pavement on Gilbert Road generally in good condition.
142	Cracking in concrete pavement on Gilbert Road.
143-144	Cracking on concrete kerb on Gilbert Road.
145-146	Concrete pavement on Gilbert Road generally in good condition.
147	Concrete cracking on kerb and gutter on Gilbert Road.
148-149	Cracking in concrete pavement adjacent to services lid.
150	Concrete pavement on Gilbert Road generally in good condition.
151	Concrete cracking on kerb and gutter on Gilbert Road.

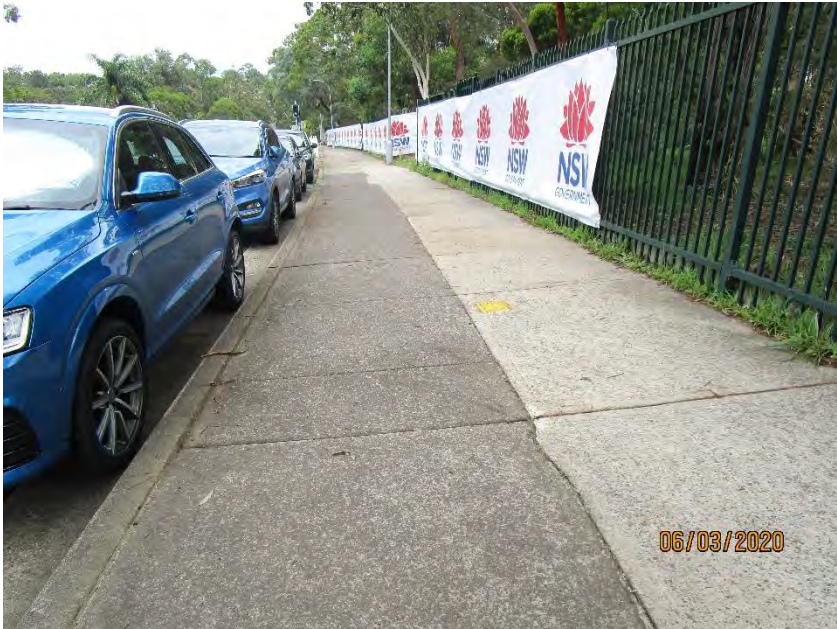
Photo 152

152	Concrete pavement on Gilbert Road generally in good condition.
153	Kerb and gutter on Gilbert Road generally in good condition.
154	Concrete cracking on kerb and gutter on Gilbert Road.
155	Concrete pavement on Gilbert Road generally in good condition.
156	Kerb inlet pit on Gilbert Road generally in good condition.
157-159	Concrete pavement on Gilbert Road generally in good condition.
160	Road condition on Gilbert Road generally in good condition.
161	Damage to 'Keep Left' sign on Gilbert Road.
162-163,165	Concrete pavement on Gilbert Road generally in good condition.
164	Street sign on Gilbert Road generally in good condition.
166	Street lights on Gilbert Road generally in good condition.
167-168	Cracking in concrete pavement at light crossing.
169	Street lights on Gilbert Road generally in good condition.
170	Concrete pavement at intersection of Gilbert Road and Ridgescrop Drive generally in good condition.

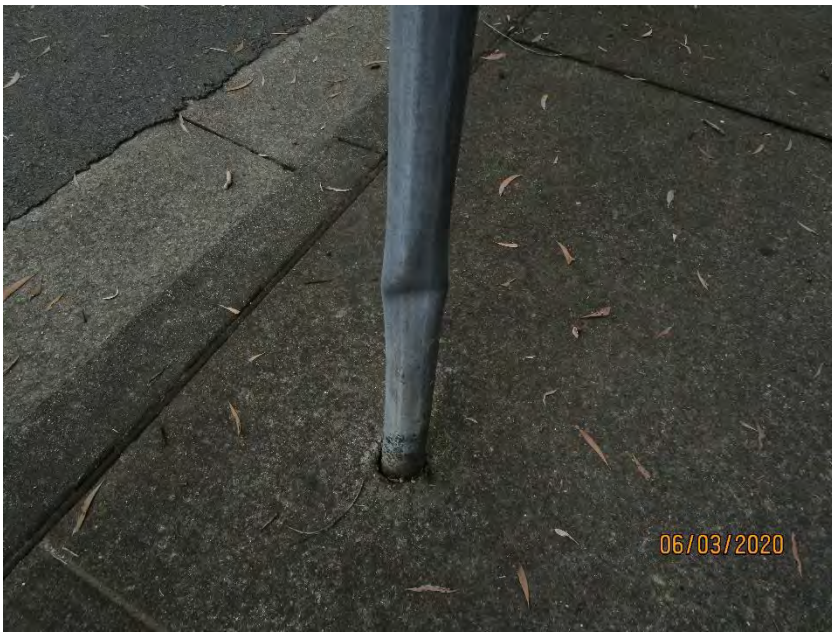
Photo 171

171-173	Damage to street sign at intersection of Gilbert Road and Ridgescrop Drive
174	Concrete pavement at intersection of Gilbert Road and Ridgescrop Drive generally in good condition.
175	Damage to street post at intersection of Gilbert Road and Ridgescrop Drive
176-177	Concrete pavement generally in reasonable condition. Some areas with vertical displacement.
178-183	Street signs on Ridgescrop Drive generally in good condition.
184	Spray paint on street sign on Ridgescrop Drive.
185	Concrete pavement generally in reasonable condition. Some areas with vertical displacement.
186-187	Cracking in concrete pavement on Ridgescrop Drive.
188	Concrete pavement generally in reasonable condition. Some areas with vertical displacement.
189-190	Displacement in balustrade on Ridgescrop Drive.
191	Minor cracking in kerb and gutter, asphaltic pavement.
192	Seating bench on Ridgescrop Drive generally in good condition.

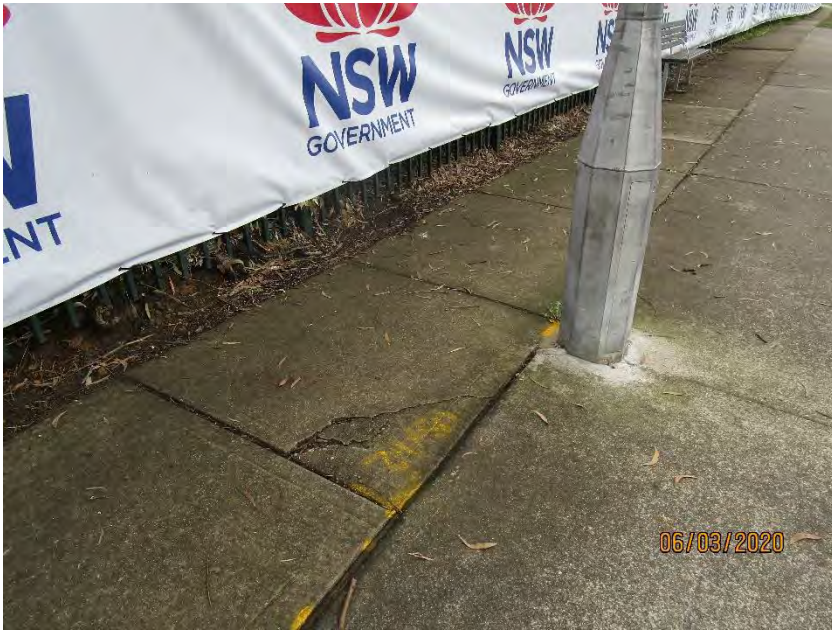
Photo 195

195-196	Cracking on concrete pavement on Ridgecrop Drive.
197	Seating bench on Ridgecrop Drive generally in good condition.
198-199	Damage to balustrade on Ridgecrop Drive.
200	Cracking in concrete pavement on Ridgecrop Drive.
201-204	Concrete pavement and asphaltic road on Ridgecrop Drive generally in good condition.
205-206	Road crossing on Ridgecrop drive generally in good condition.
207	Cracking in kerb on Ridgecrop Drive.
208	Damage to signage posts at crossing on Ridgecrop Drive
209-210	Cracking in concrete pavement on Ridgecrop Drive.
211-212	Damage to signage posts on Ridgecrop Drive
213	Damage to signage posts on Ridgecrop Drive
214	Cracking on concrete kerb and gutter on Ridgecrop Drive.
215	Concrete pavement and asphaltic road on Ridgecrop Drive generally in good condition.
216	Cracking on concrete kerb and gutter on Ridgecrop Drive.
