# Arborist Assessment Report

PROJECT: SSD-21854025 Wee Waa High School

Site Address: 105-107 Mitchel Wee Waa NSW

Date of Inspection: 16<sup>th</sup> February 2022

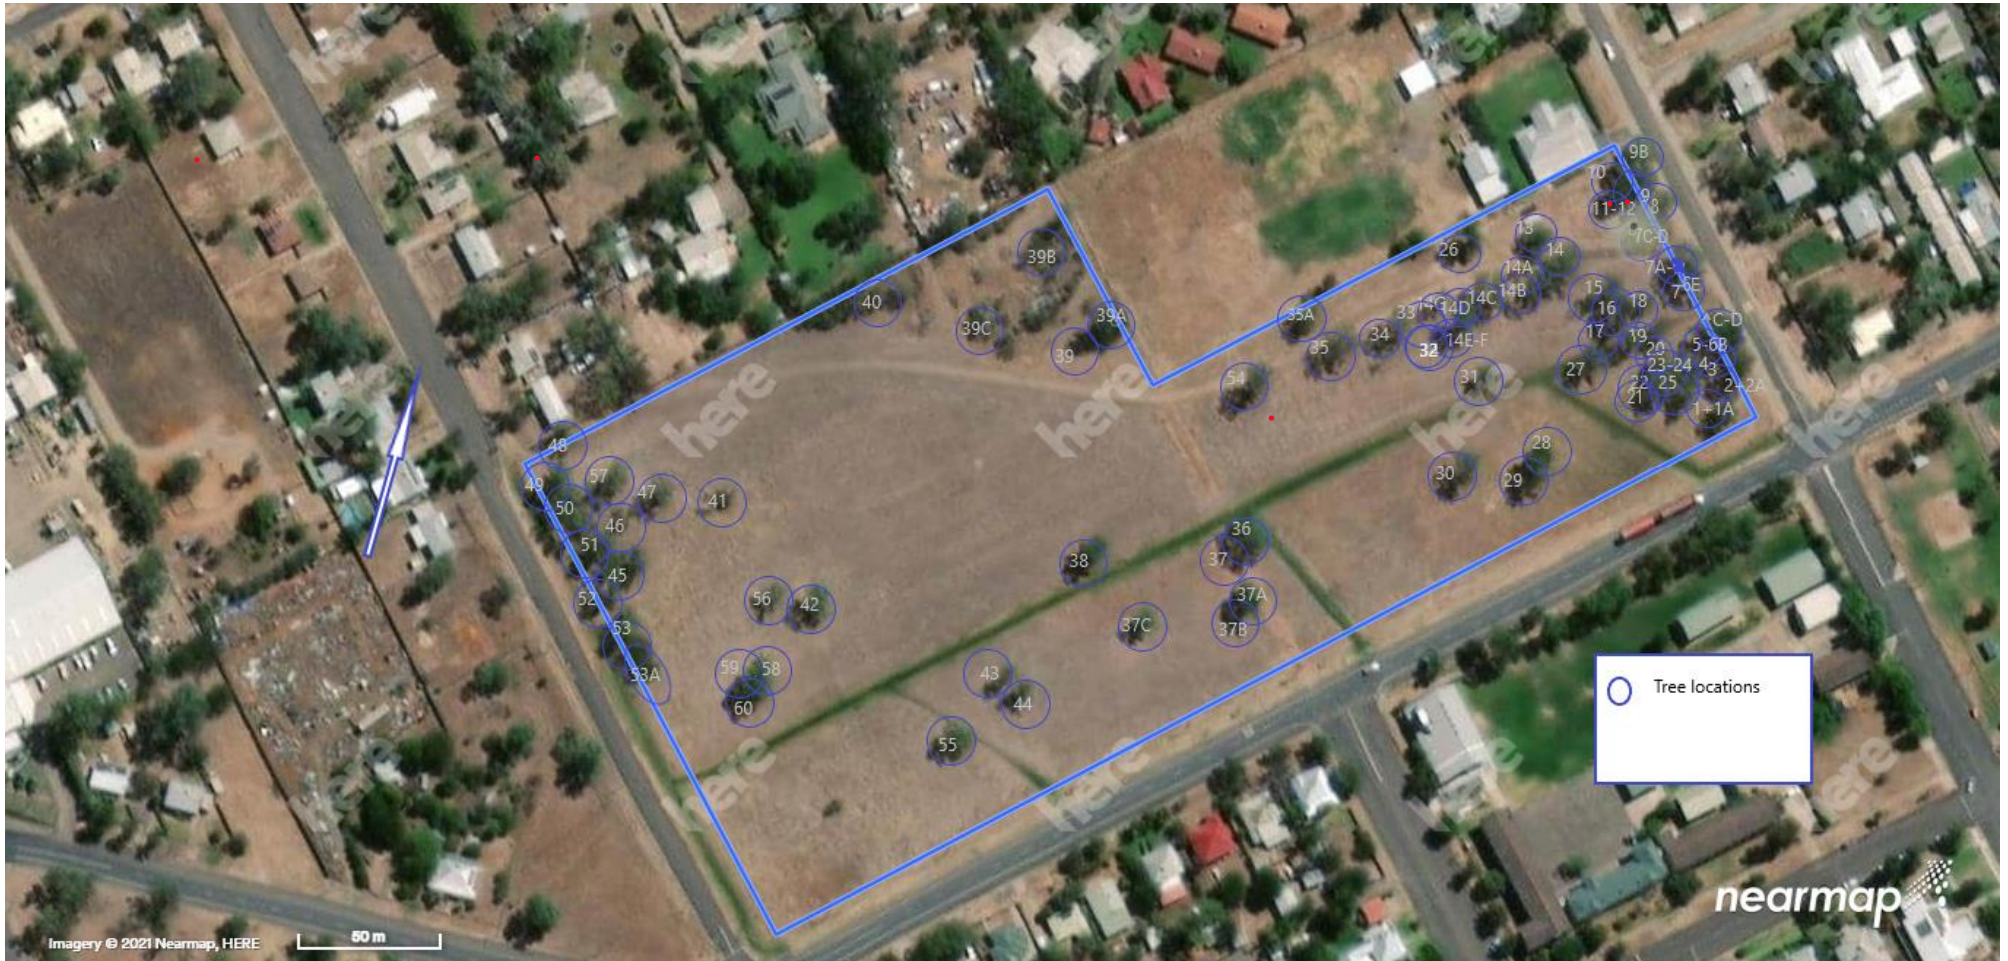
Tree Location Map: (Mark up Map 20322) (Fig 2).

All trees have been tagged and assigned a number and referenced on the Tree Location Map (Fig2) of its approximate location on the site and again referenced in the Tree Survey Table.

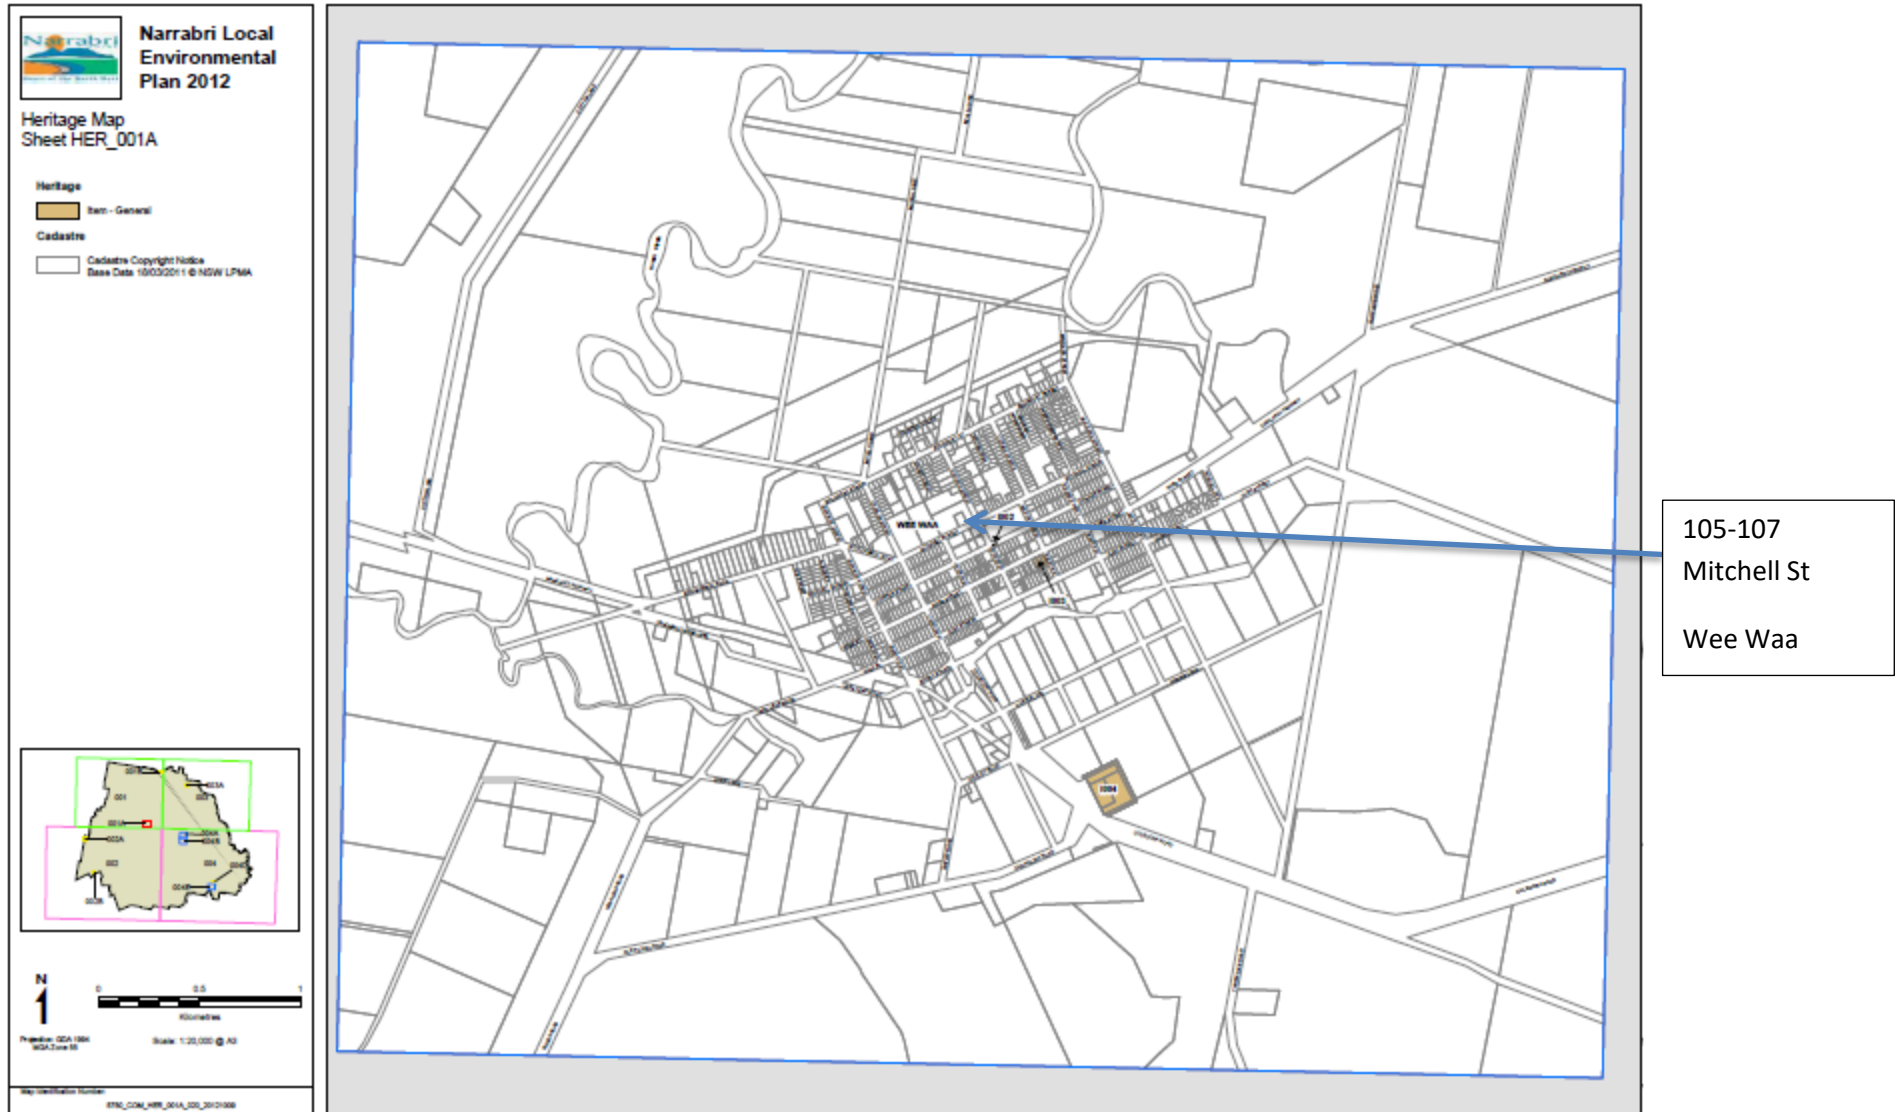
Heritage Map (Fig 4) : Narrabri Council (LEP 2012) Wee WAA Sheet HER\_001A

**5.4** Electronic search was undertaken of the Narrabri Shire Council's LEP 2012 for heritage item or Heritage Conservation area and have no related item found. (*Heritage Conservation area Map HER\_001A LEP 2012*). (*See Fig 4*).
