Microbial Testing - Willyama High School

Radium Street, Broken Hill, NSW 2880

School Infrastructure NSW Regional Office - North Western NSW

Report No.: 30158-R04

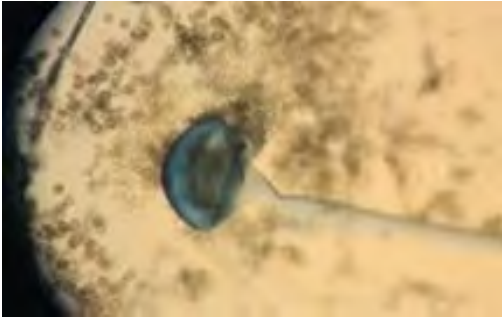
LOCATION of Surface Swabs 16 th Jan 2024	ORGANISM grown
<p>R01-30158-S01</p> <p>Room AR-ON-11, floor</p>  	<p>Growth of Cladosporium, Alternaria, Rhyzopus spp</p>

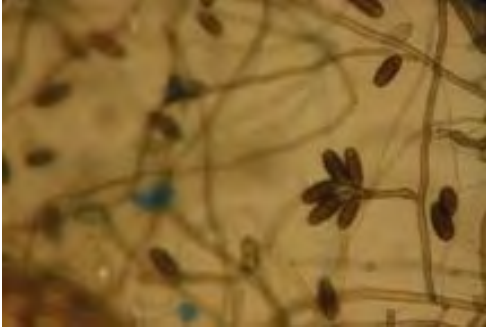
<p>Rhyzopus spp 400x magnification</p>
<p>R01-30158-S02</p> <p>Room AR-IE -26, Floor</p>    	<p>Growth of Alternaria, Bipolaris and Mucor spp, and environmental bacilli</p>

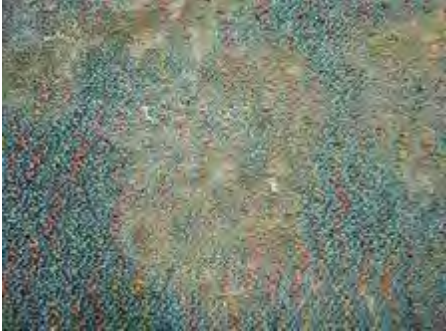
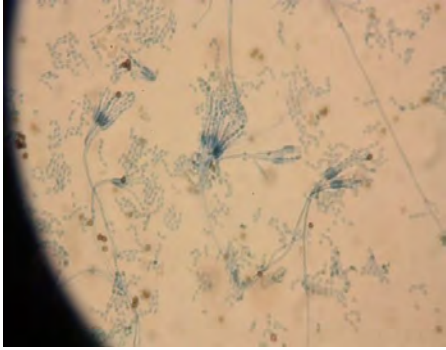
LOCATION of Bio-Tapes – 16 th Jan 2024	ORGANISM at 400x Magnification
<p>R01-30158-S03 Room AR-OW-18, floor</p>

<p>Spores of Cladosporium and Penicillium spp detected.</p>

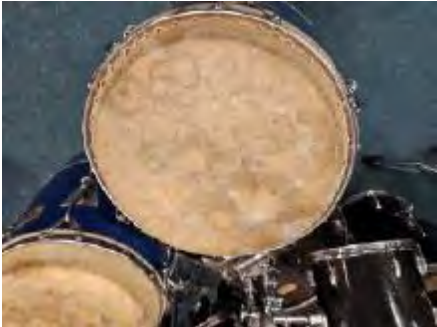
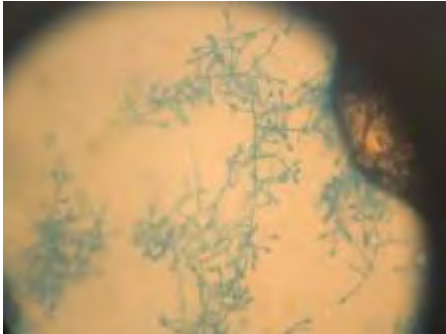
<p>Penicillium spp 400x magnification</p>
<p>R01-30158-S04 AR-ON-11, Drum kit, skin</p>

<p>Occasional spores of Cladosporium spp detected.</p>

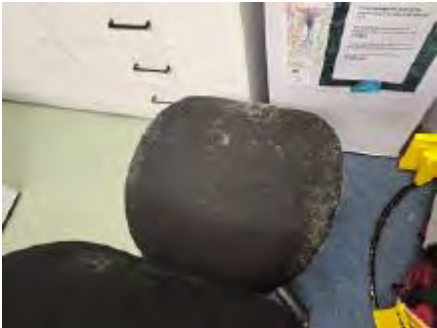
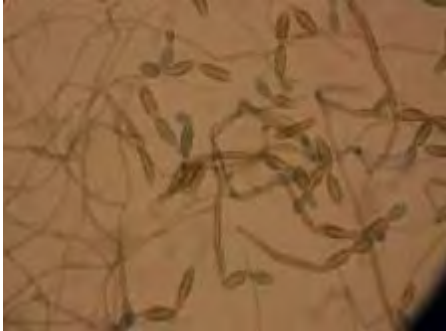
<p>Cladosporium spp 400x magnification</p>
<p>R01-30158-S05 AR-ON-08, fabric chair.</p>

<p>Spores of Aspergillus and Alternaria spp detected.</p>

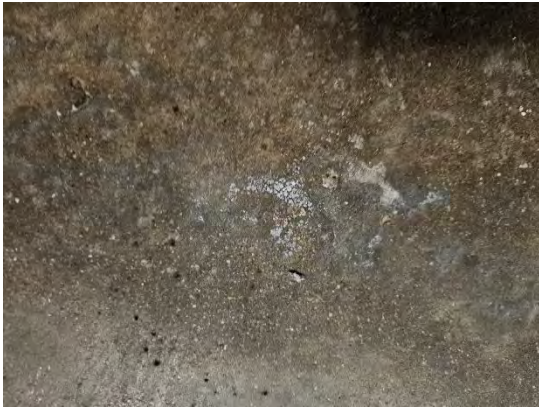
Image 1: Mould

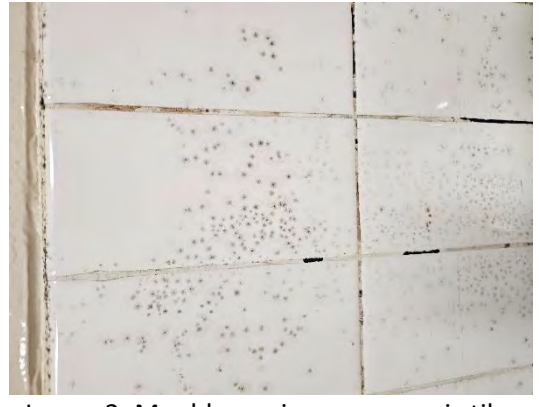
Image 2: Mould on grime on ceramic tiles

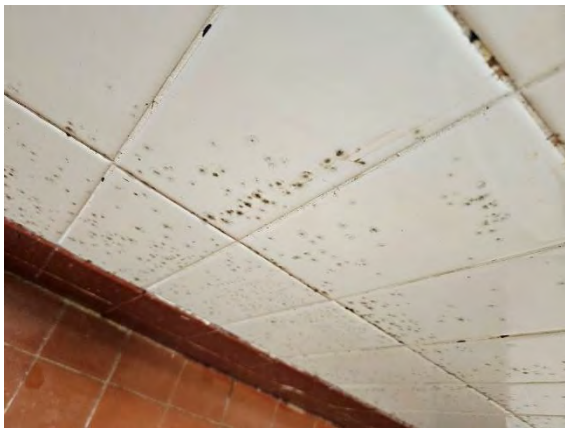
Image 3: Mould

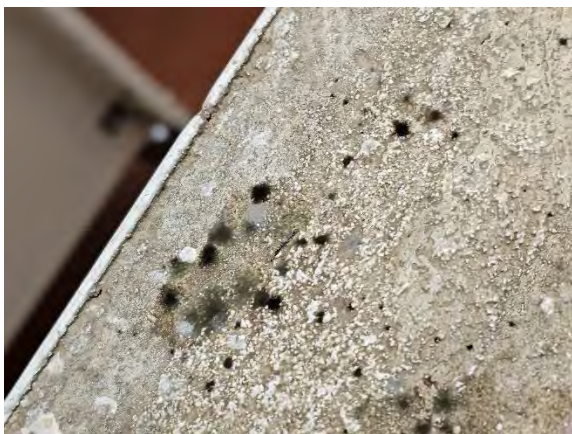
Image 5: Mould on concrete

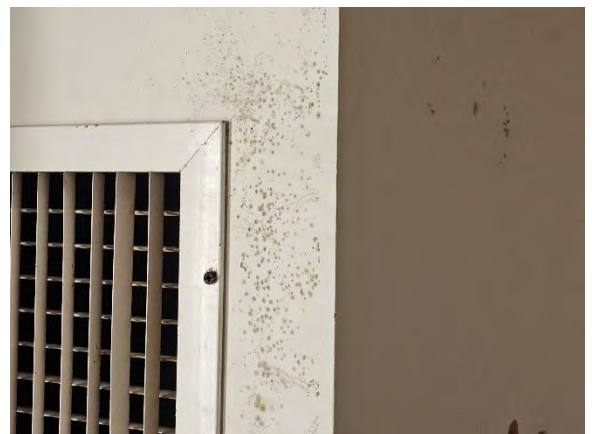
Image 6: Mould nearby air-conditioning duct

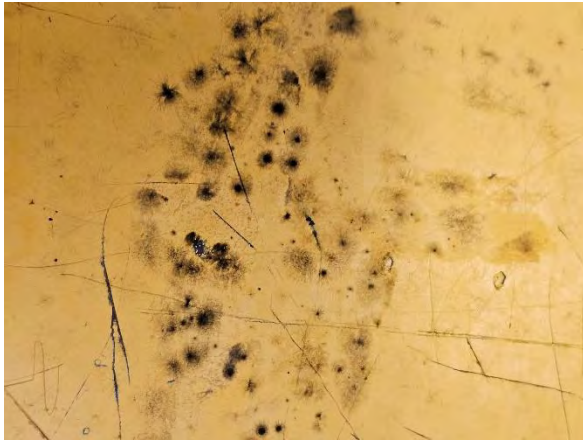
Image 7: Mould

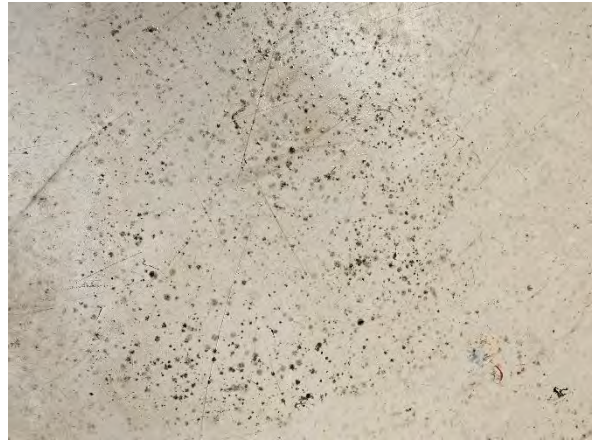
Image 8: Mould

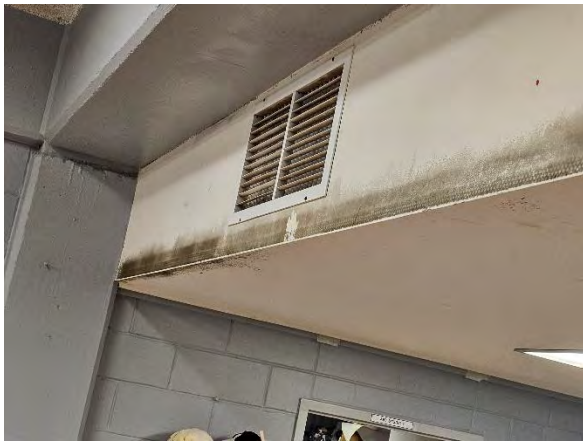
Image 9: Mould by air-conditioning duct

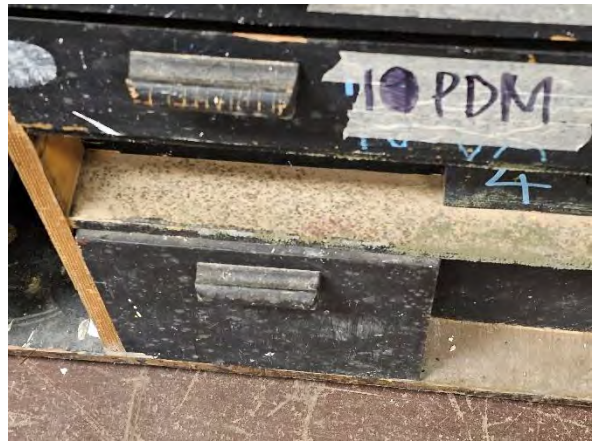
Image 10: Cabinet, infestation

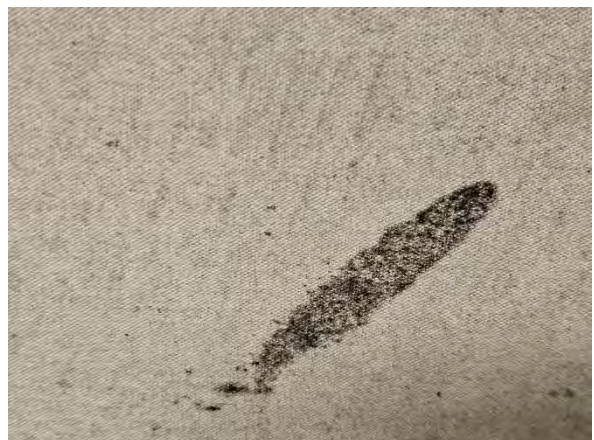
Image 12: Mould on fabric

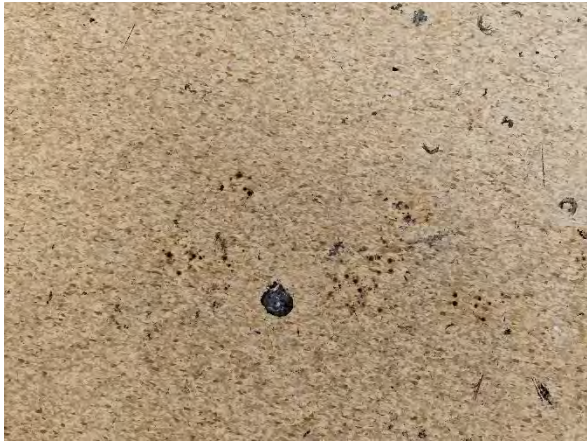
Image 13: Mould

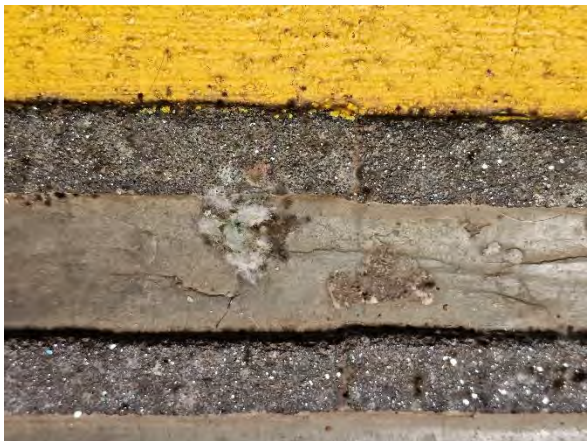
Image 15: Mould

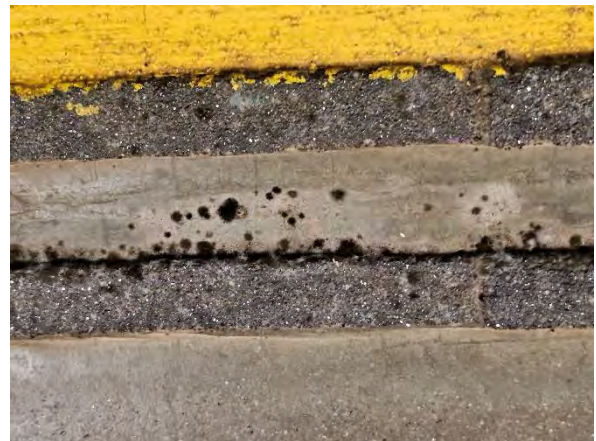
Image 16: Mould

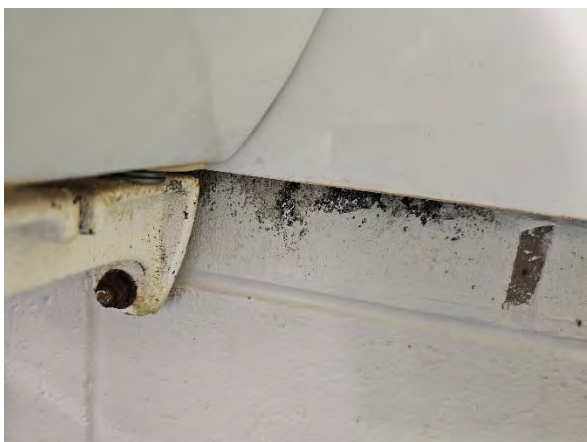
Image 17: Mould

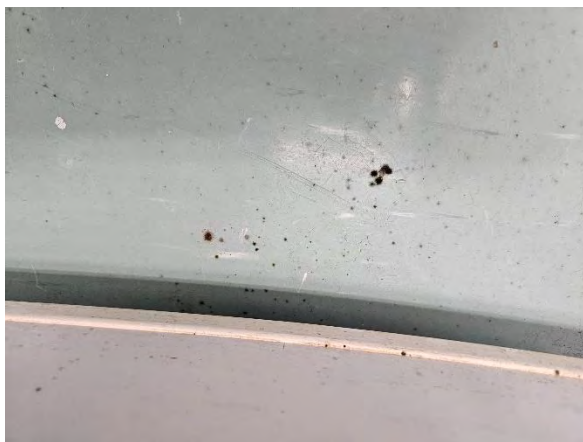
Image 21: Ceiling condensation

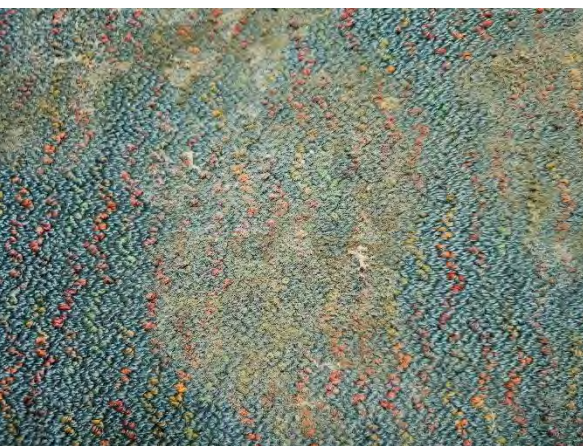
Image 23: Carpet, mould

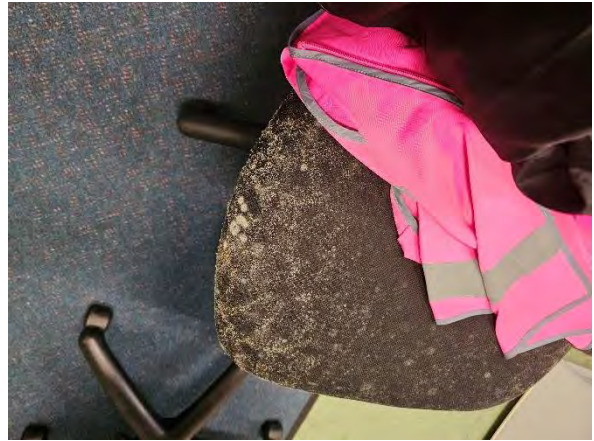
Image 26: Fabric chair, mould

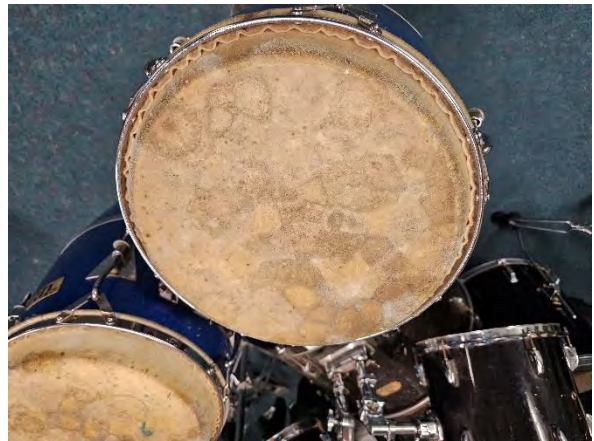
Image 28: Drum skins, mold

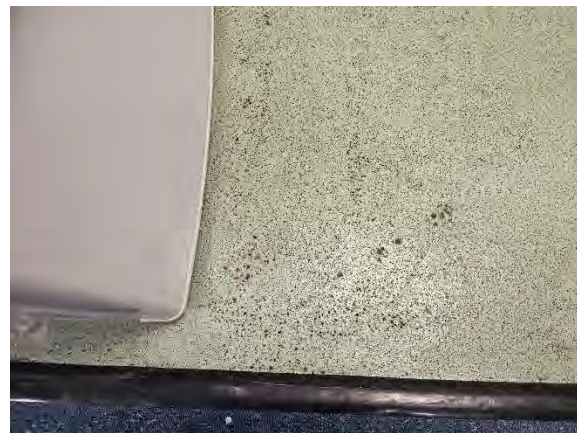
Image 29: Mould, vinyl sheet floor

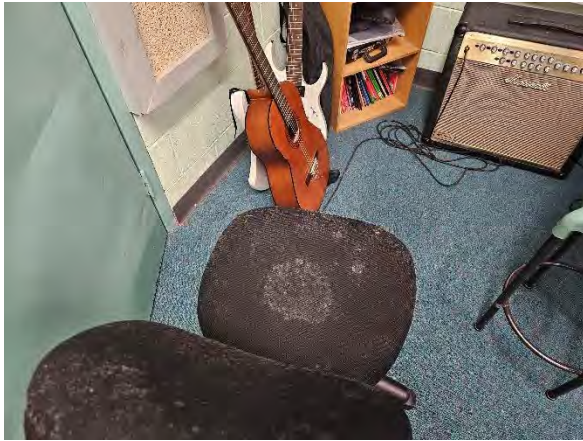
Image 32: Mould, carpet

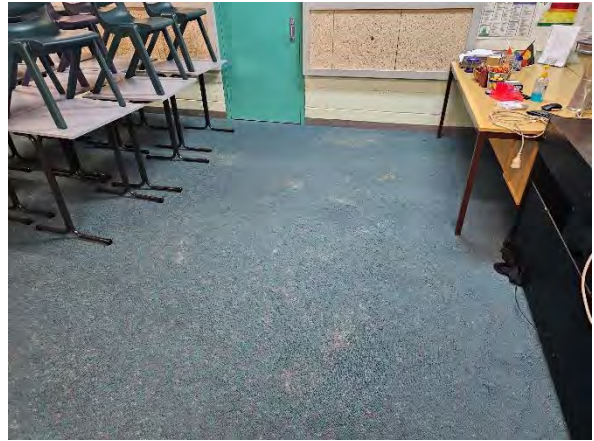
Image 33: Mould on carpet

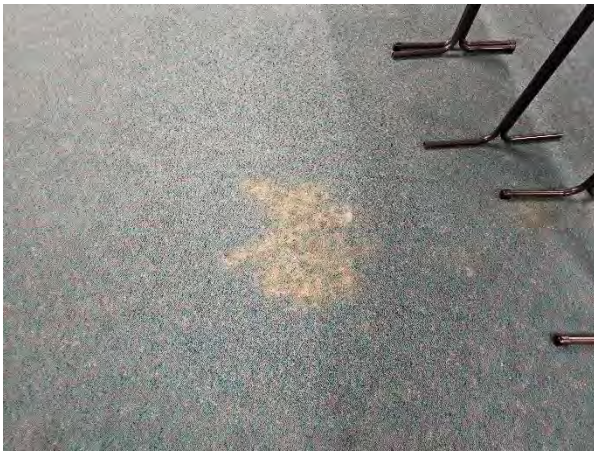
Image 34: Mould

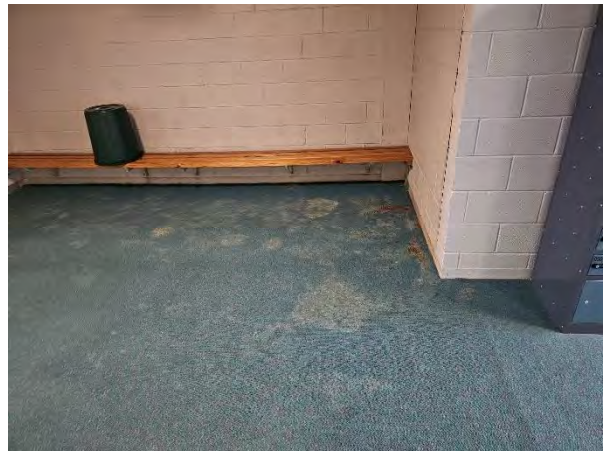
Image 35: Mould

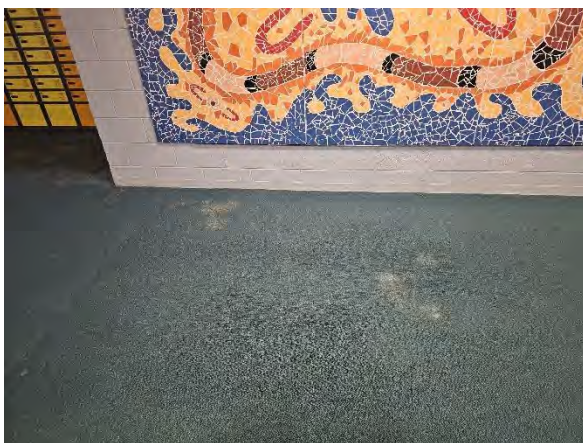
Image 36: Mould

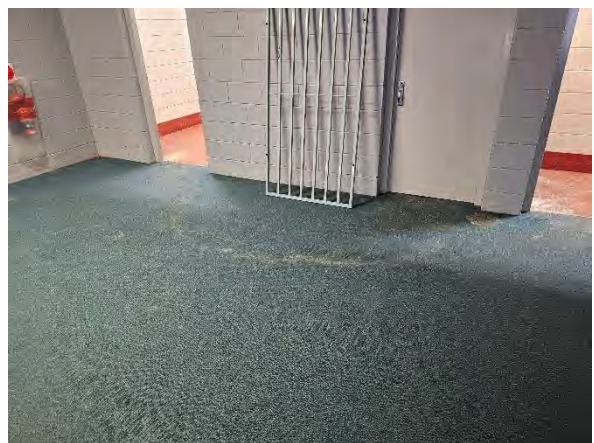
Image 37: Mould infestation

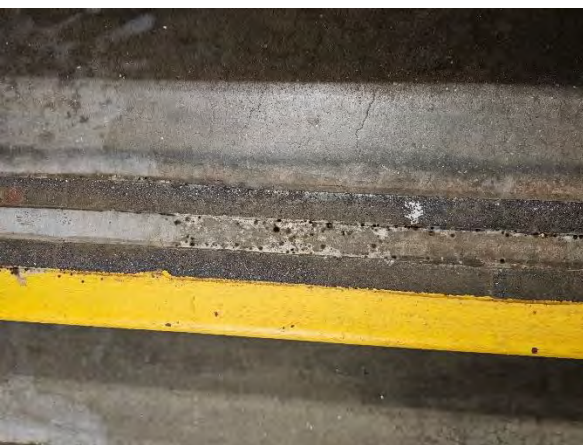
Image 42: Mould

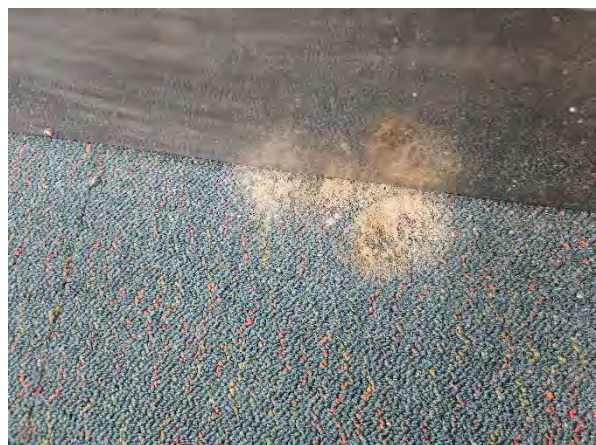
Image 43: Mould

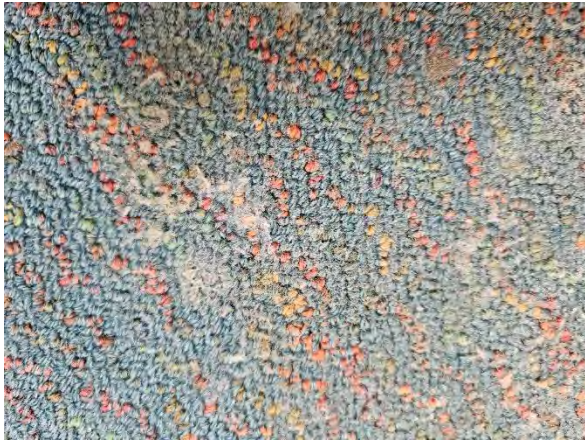
Image 44: Mould

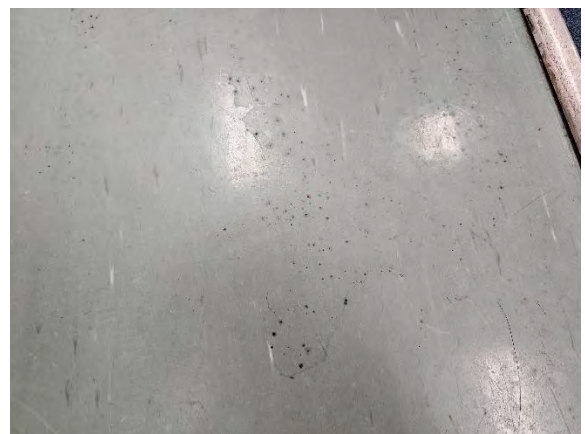
Image 47: Mould, vinyl sheet

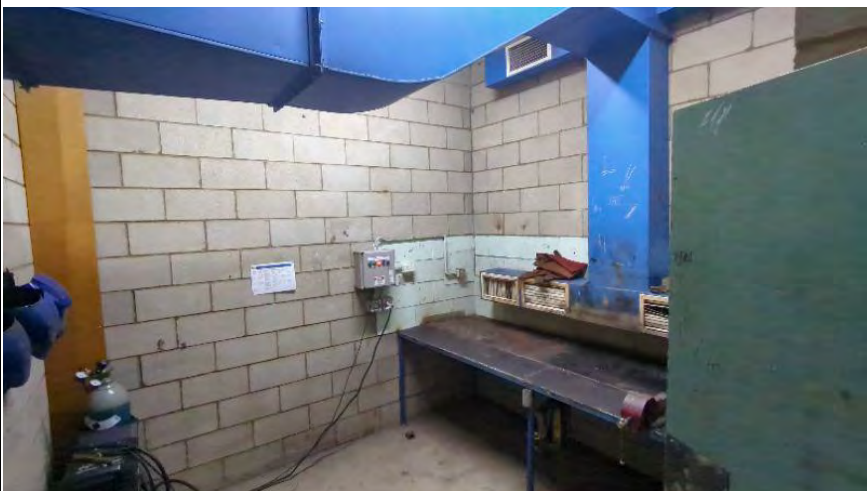
<p data-bbox="337 997 672 1029">B00A-R0E01 - Welding area</p>	<p data-bbox="946 506 1256 575">Masonry walls, concrete floor and concrete ceiling.</p>	<p data-bbox="1271 506 1563 615">No signs of visual mould growth or water damage were noted.</p> <p data-bbox="1271 632 1552 701">IICRC-520:2015 Condition 2 guidelines</p>

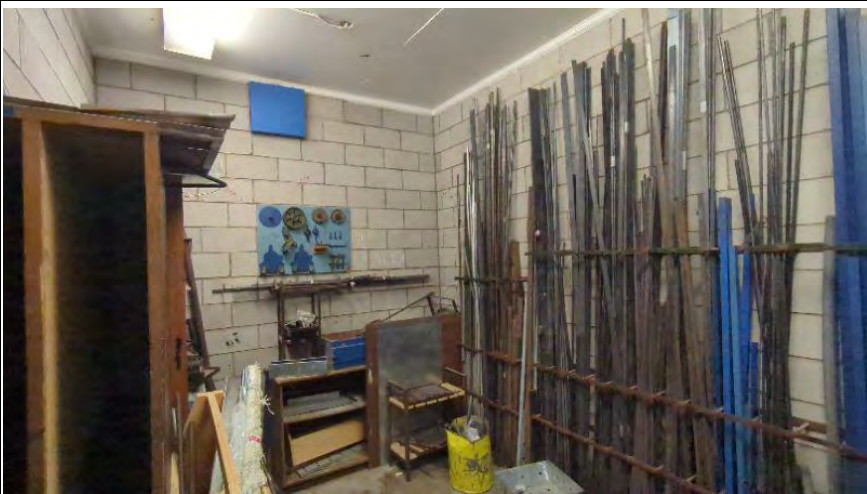
<p data-bbox="326 1549 683 1581">B00A-R0E02 - Materials Store</p>	<p data-bbox="946 1056 1256 1125">Masonry walls, concrete floor and concrete ceiling.</p>	<p data-bbox="1271 1056 1563 1165">No signs of visual mould growth or water damage were noted.</p> <p data-bbox="1271 1182 1552 1251">IICRC-520:2015 Condition 2 guidelines</p>

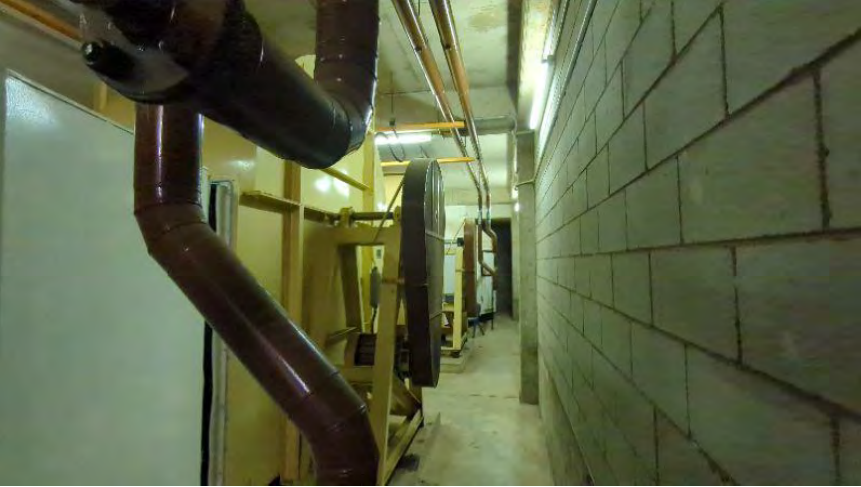
<p data-bbox="354 869 646 898">B00A-ROE03 - Plant room</p>	<p data-bbox="948 380 1243 443">Masonry walls, concrete ceiling and concrete floor.</p>	<p data-bbox="1268 380 1554 478">No signs of visual mould growth or water damage were noted.</p> <p data-bbox="1268 495 1554 558">IICRC-520:2015 Condition 2 guidelines</p>

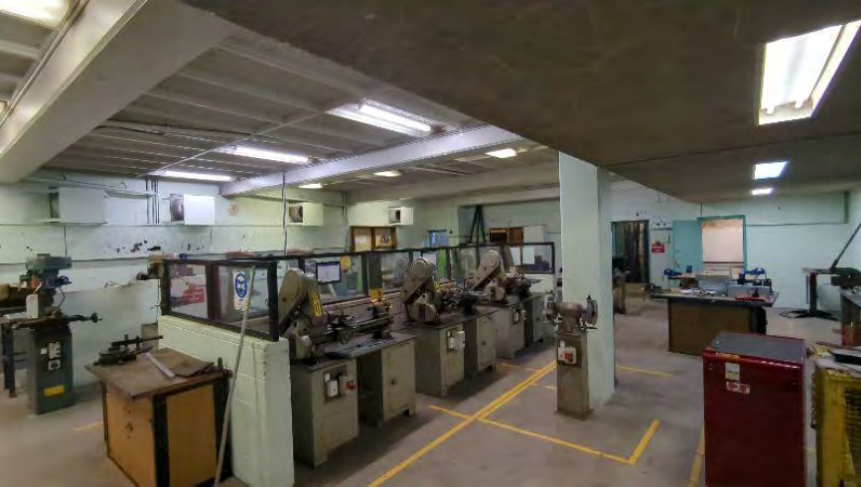
<p data-bbox="204 1421 797 1451">B00A-ROE04 - Materials Technology Learning Space</p>	<p data-bbox="948 928 1243 1104">Masonry walls, concrete floor and a mix of suspended ceiling tiles and sprayed coating (vermiculite) ceiling.</p>	<p data-bbox="1268 928 1554 1026">No signs of visual mould growth or water damage were noted.</p> <p data-bbox="1268 1043 1554 1106">IICRC-520:2015 Condition 2 guidelines</p>

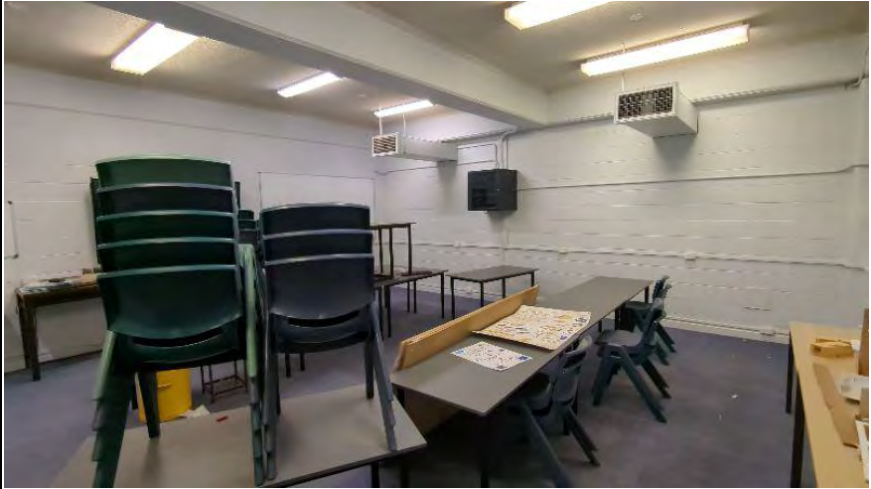
<p data-bbox="363 953 634 982">B00A-R0E07 - Design LS</p>	<p data-bbox="938 453 1255 558">Masonry walls, carpet over concrete and sprayed coating (vermiculite) ceiling</p>	<p data-bbox="1273 453 1550 594">Suspected visual mould growth was noted to carpet and hardwood cupboard.</p> <p data-bbox="1273 611 1550 642">Refer to Index photo 19.</p> <p data-bbox="1263 657 1560 720">IICRC-520:2015 Condition 3 guidelines</p>

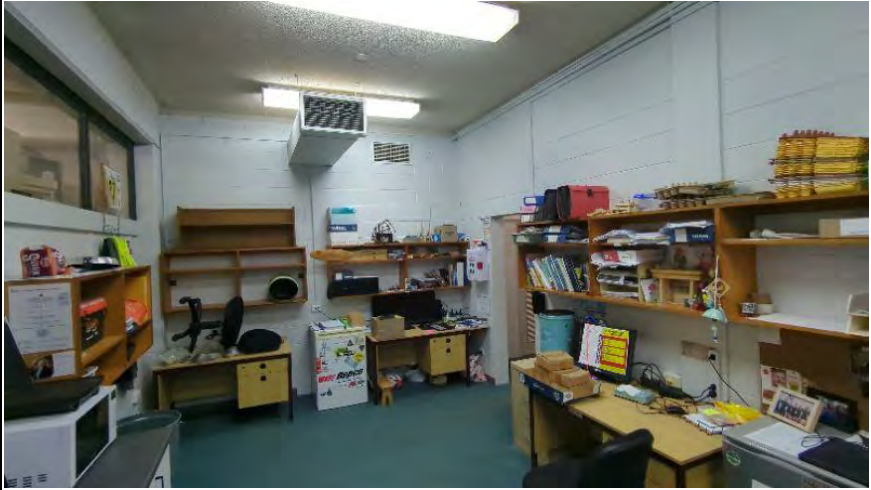
<p data-bbox="355 1512 643 1541">B00A-R0E14 - Staff Study</p>	<p data-bbox="938 1012 1255 1117">Masonry walls, carpet over concrete and sprayed coating (vermiculite) ceiling</p>	<p data-bbox="1273 1012 1550 1152">Suspected visual mould growth was noted to carpet, porous furniture and porous contents.</p> <p data-bbox="1263 1169 1560 1232">Refer to Index photos 20 - 25.</p> <p data-bbox="1263 1249 1560 1312">IICRC-520:2015 Condition 3 guidelines</p>

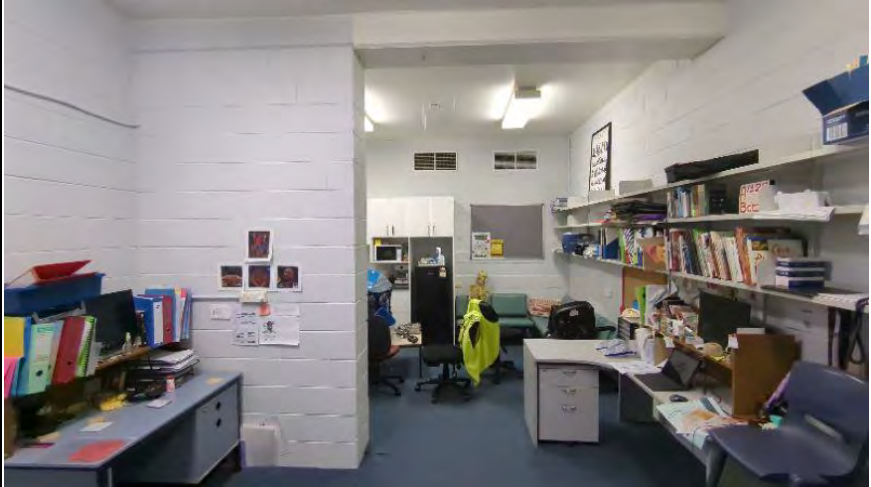
<p data-bbox="354 1583 646 1610">B00A-R0N08 - Staff Study</p>	<p data-bbox="938 1094 1253 1205">Masonry walls, carpet over concrete and sprayed coating (vermiculite) ceiling.</p>	<p data-bbox="1268 1094 1555 1241">Suspected visual mould growth was noted to carpet, all furniture and all contents.</p> <p data-bbox="1268 1257 1555 1320">Refer to Index photos 49 - 62.</p> <p data-bbox="1268 1388 1555 1451">IICRC-520:2015 Condition 3 guidelines</p>

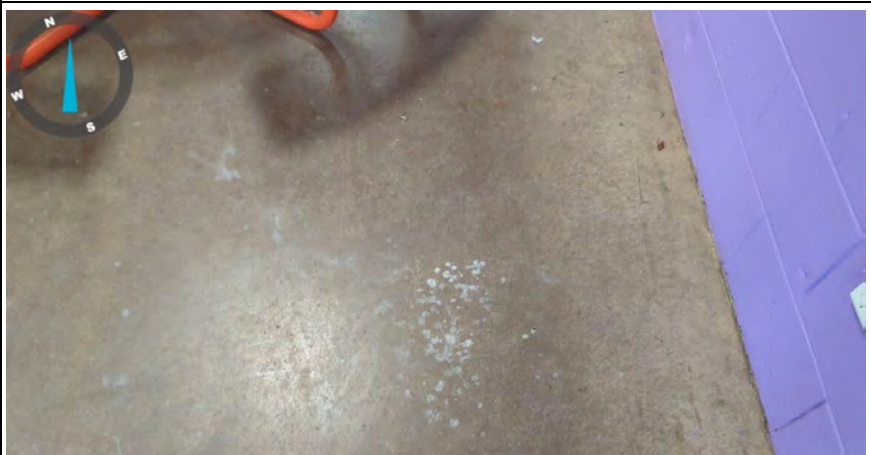
<p data-bbox="350 1503 651 1530">B00A-R0W02 - Movement</p>	<p data-bbox="951 1052 1243 1152">Concrete floor, masonry walls and sprayed coating (vermiculite) ceiling.</p>	<p data-bbox="1268 1052 1552 1430">Traces of suspected visual mould growth were noted to concrete floor, lower sections of masonry walls and art works. Refer to index photos 85 - 86. IICRC-520:2015 Condition 3 guidelines</p>

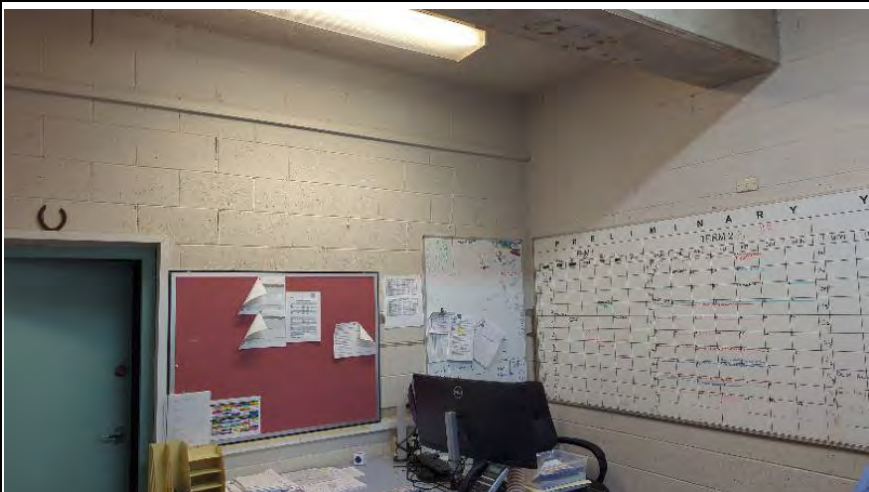
<p data-bbox="350 1688 654 1719">B00A-R0W29 - Staff Study</p>	<p data-bbox="930 1178 1260 1293">Masonry walls, carpet over concrete and concrete ceiling.</p>	<p data-bbox="1260 1178 1560 1293">Suspected visual mould growth was noted to carpet.</p> <p data-bbox="1260 1304 1560 1377">Refer to index photos 115 - 120.</p> <p data-bbox="1260 1388 1560 1461">IICRC-520:2015 Condition 3 guidelines</p>

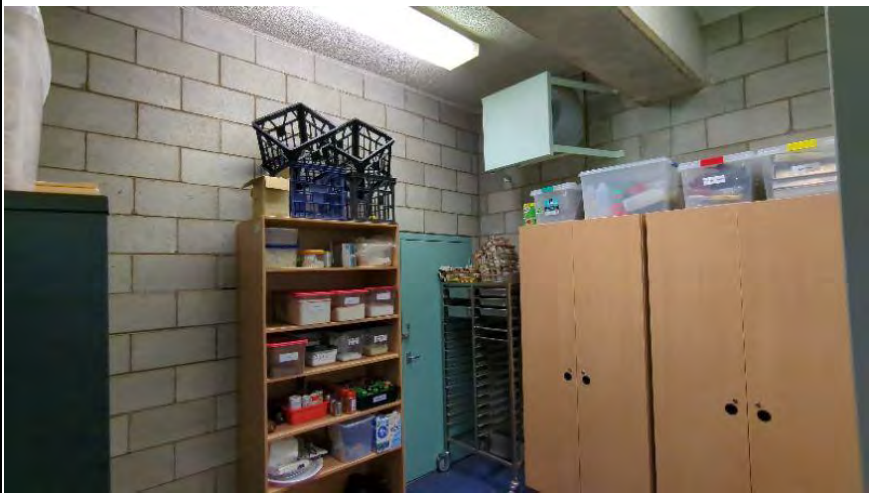
<p data-bbox="350 993 646 1020">B00A-R0W27 - Storeroom</p>	<p data-bbox="954 499 1243 604">Masonry walls, concrete floor and sprayed coating (vermiculite) ceiling</p>	<p data-bbox="1271 499 1552 768">No signs of visual mould or water damage were noted. Refer to index photos 121 - 127. IICRC-520:2015 Condition 3 guidelines</p>

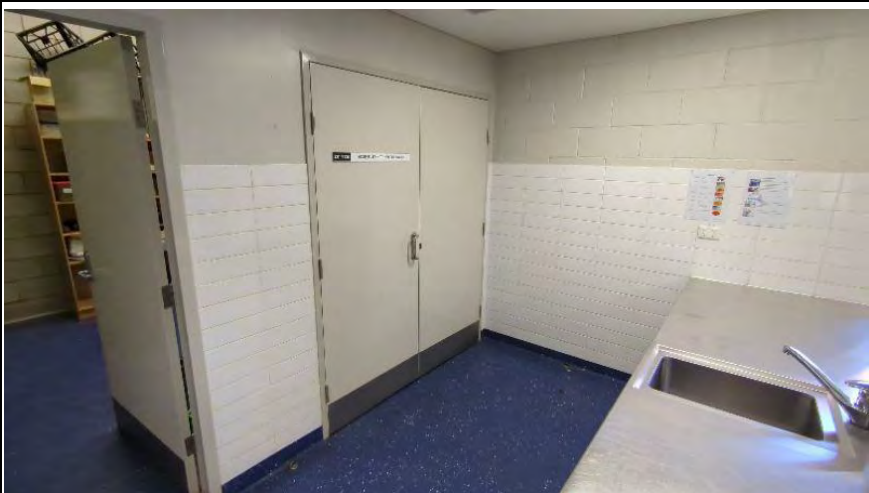
<p data-bbox="375 1539 621 1566">B00A-R0W41 - Pantry</p>		<p data-bbox="1276 1052 1547 1125">Pantry No access Assumed mould growth</p>

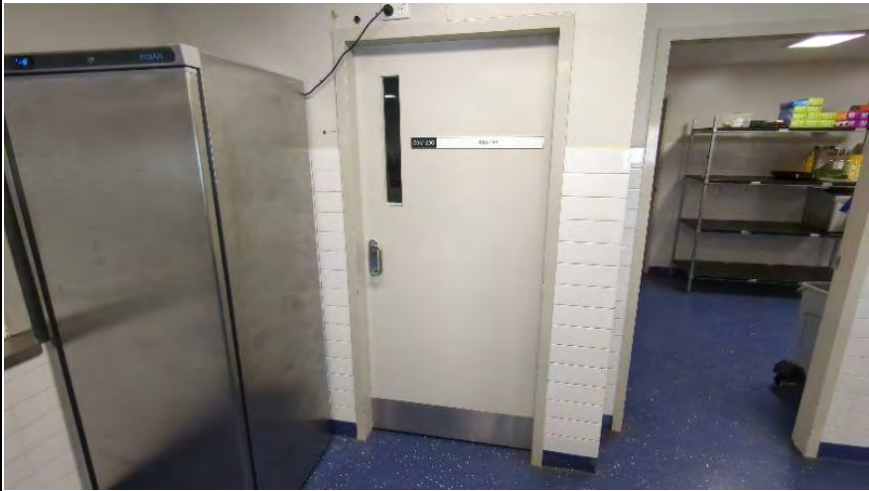
<p data-bbox="375 1539 625 1570">B00A-R0W36 - Pantry</p>		<p data-bbox="1300 1052 1523 1115">No access Assumed mould growth</p>

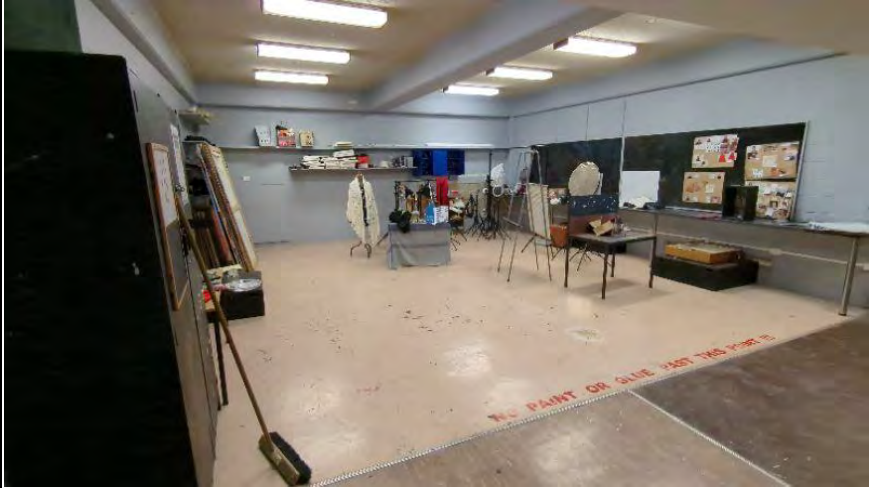
<p data-bbox="354 940 646 974">B00A-R0W16 - Workshop</p>	<p data-bbox="938 453 1253 558">Masonry walls, vinyl floor sheeting and sprayed coating (vermiculite) ceiling.</p>	<p data-bbox="1273 453 1550 758">Suspected visual mould growth noted to vinyl floor sheeting, masonry walls and all contents. Refer to B00A- R0W17 + index photo 173. IICRC-520:2015 Condition 3 guidelines</p>

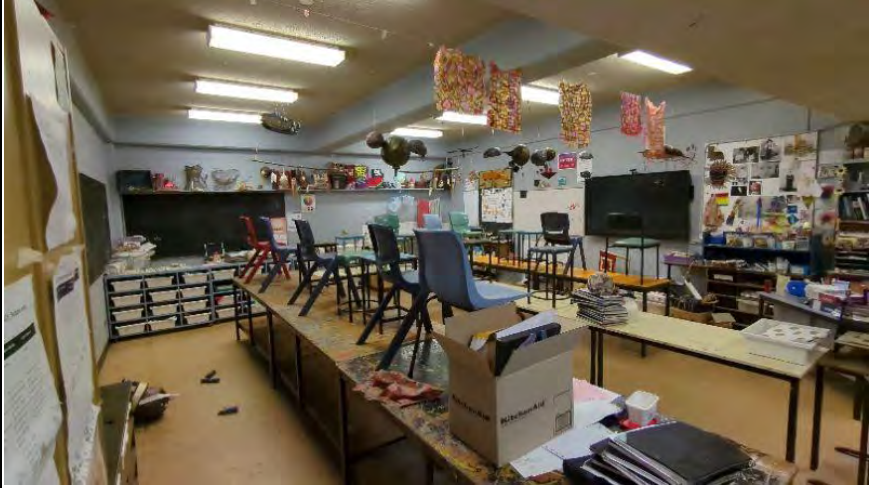
<p data-bbox="370 1493 630 1526">B00A-R0W14 - Art L. S</p>	<p data-bbox="938 1005 1253 1110">Masonry walls, vinyl floor sheeting and sprayed coating (vermiculite) ceiling.</p>	<p data-bbox="1273 1005 1550 1310">Suspected visual mould growth noted to vinyl floor sheeting, masonry walls and all contents. Refer to index photos. 171 - 175 IICRC-520:2015 Condition 3 guidelines</p>

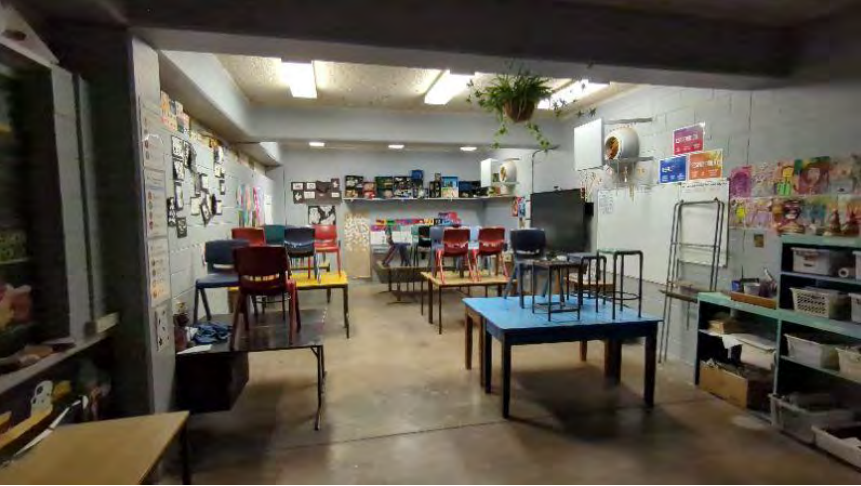
<p data-bbox="370 947 630 974">B00A-ROW12 - Art L. S</p>	<p data-bbox="938 453 1253 558">Masonry walls, vinyl floor sheeting and sprayed coating (vermiculite) ceiling.</p>	<p data-bbox="1268 453 1555 558">Traces of suspected visual mould growth was noted to porous contents.</p> <p data-bbox="1268 575 1555 646">Refer to index photos. 176 - 180</p> <p data-bbox="1268 663 1555 730">IICRC-520:2015 Condition 3 guidelines</p>

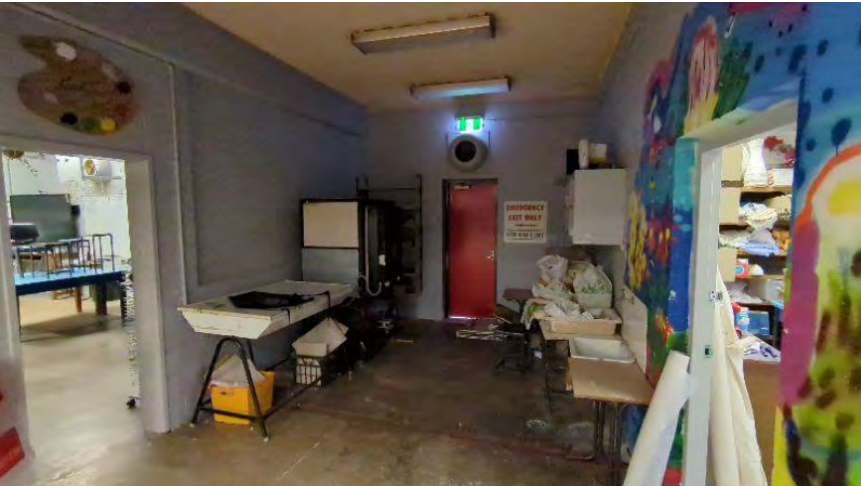
<p data-bbox="391 1493 609 1520">B00A-ROW11 - Kiln</p>	<p data-bbox="954 999 1243 1104">Masonry walls, concrete floor and sprayed coating (vermiculite) ceiling.</p>	<p data-bbox="1268 999 1555 1104">Suspected visual mould growth noted to hardwood shelving unit.</p> <p data-bbox="1268 1121 1555 1192">Refer to index photos 181 - 186.</p> <p data-bbox="1268 1209 1555 1276">IICRC-520:2015 Condition 3 guidelines</p>

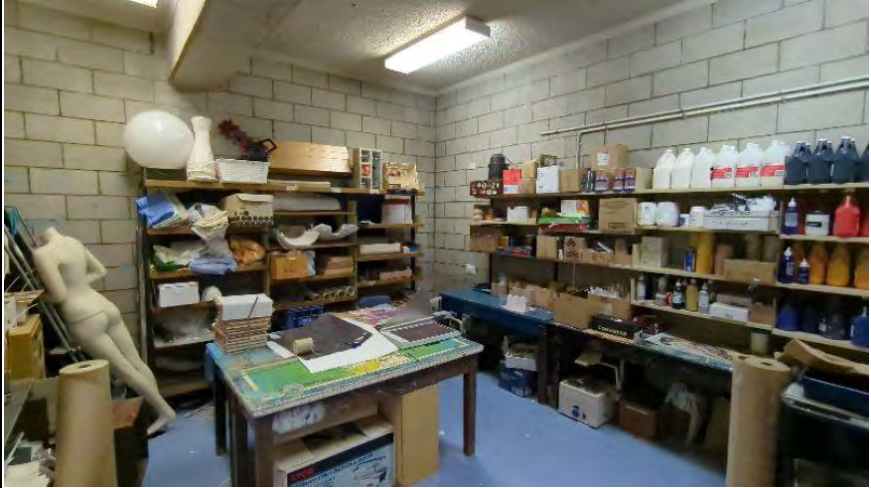
<p data-bbox="365 942 631 974">B00A-R0W09 - Printing</p>	<p data-bbox="938 453 1253 558">Masonry walls, vinyl floor sheeting and sprayed coating (vermiculite) ceiling</p>	<p data-bbox="1273 453 1550 722">Suspected visual mould growth was noted to porous contents. Refer to index photos 187. IICRC-520:2015 Condition 3 guidelines</p>

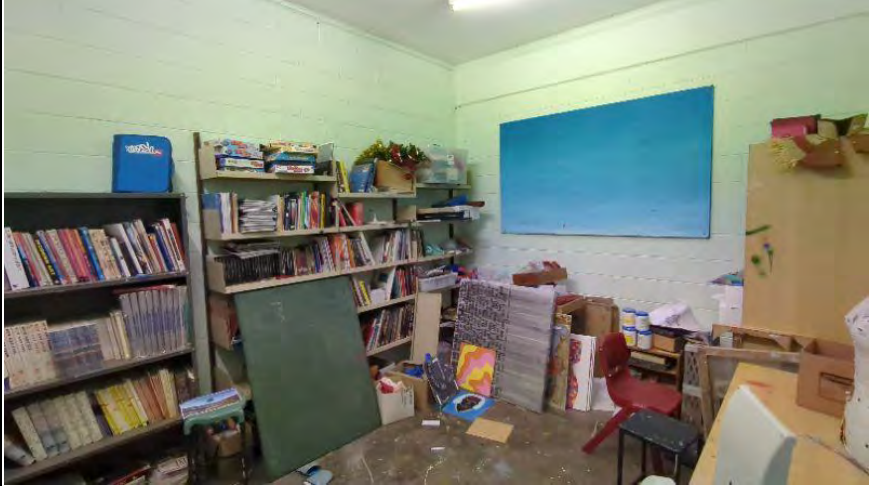
<p data-bbox="350 1493 646 1524">B00A-R0W13 - Storeroom</p>	<p data-bbox="954 1005 1237 1110">Masonry walls, concrete floor and plasterboard ceiling.</p>	<p data-bbox="1266 1005 1557 1190">No signs of visual mould growth or water damage were noted. IICRC-520:2015 Condition 3 guidelines</p>

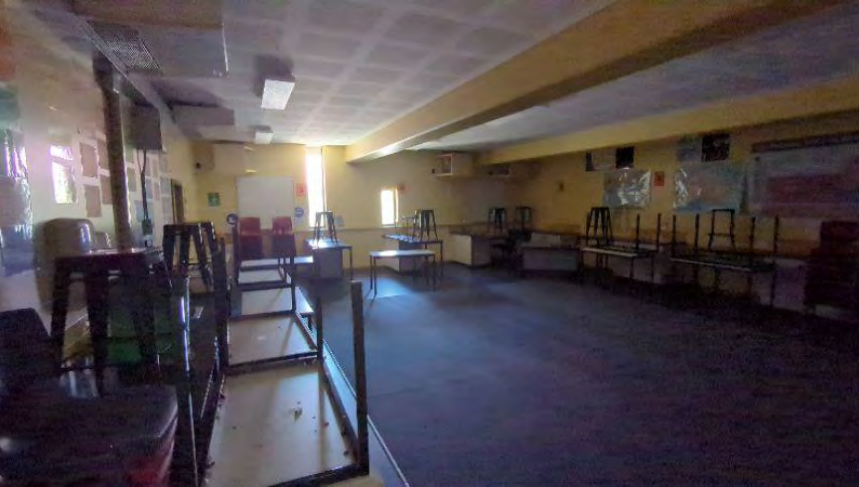
<p data-bbox="354 993 646 1020">B00A-R1E22 - Science L. S</p>	<p data-bbox="959 499 1230 638">Plasterboard walls, perforated plasterboard ceiling and carpet over concrete.</p>	<p data-bbox="1268 499 1555 684">No signs of visual mould growth or water damage were noted. IICRC-520:2015 Condition 3 guidelines</p>

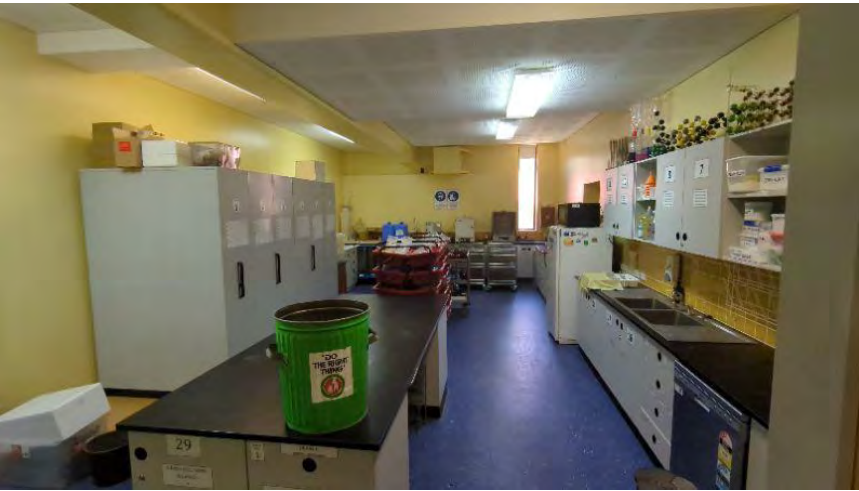
<p data-bbox="354 1541 646 1568">B00A-R1E21 - Preparation</p>	<p data-bbox="959 1052 1230 1190">Plasterboard walls, perforated plasterboard ceiling and carpet over concrete.</p>	<p data-bbox="1268 1052 1555 1392">No signs of visual mould growth were noted. Evaporative water stains were noted to vinyl floor sheeting. Refer to index photos 188-193. IICRC-520:2015 Condition 3 guidelines</p>

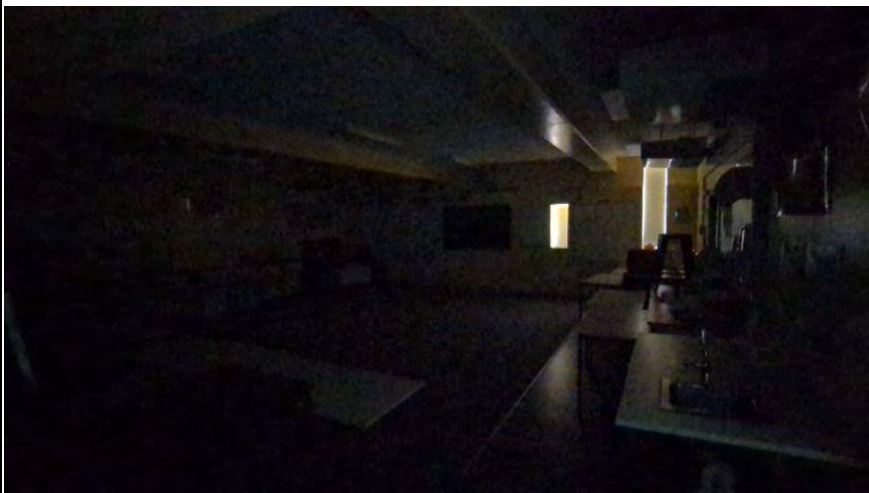
<p data-bbox="354 993 646 1020">B00A-R1E20 - Science L. S</p>	<p data-bbox="954 499 1235 638">Plasterboard walls, perforated plasterboard ceiling and carpet over concrete.</p>	<p data-bbox="1268 499 1555 768">No signs of visual mould growth were noted. Evaporative water stains were noted to tabletops. Refer to index photo 194. IICRC-520:2015 Condition 3 guidelines</p>

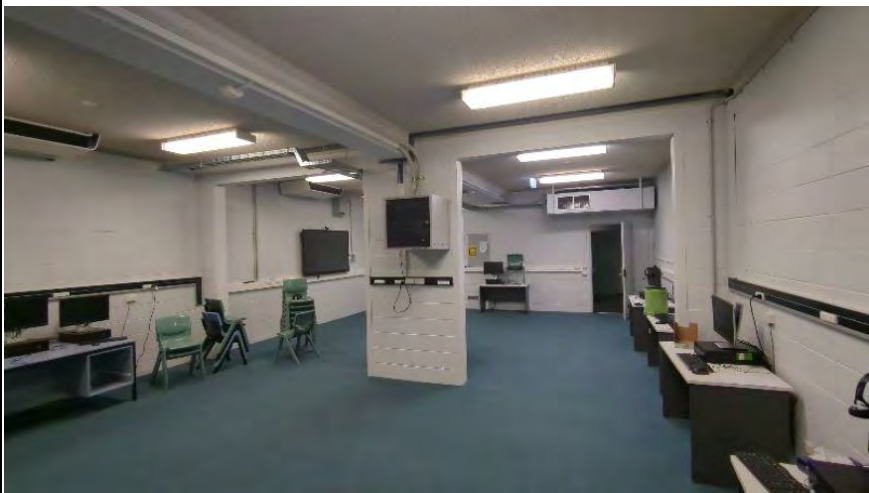
<p data-bbox="282 993 716 1024">B00A-R1E12 Computer learning space</p>	<p data-bbox="938 499 1252 604">Masonry walls, carpet over concrete and sprayed coating (vermiculite) ceiling.</p>	<p data-bbox="1268 499 1559 806">No signs of visual mould growth were noted. Water stains were noted to carpet. Refer to index photos 197 - 200. IICRC-520:2015 Condition 3 guidelines</p>

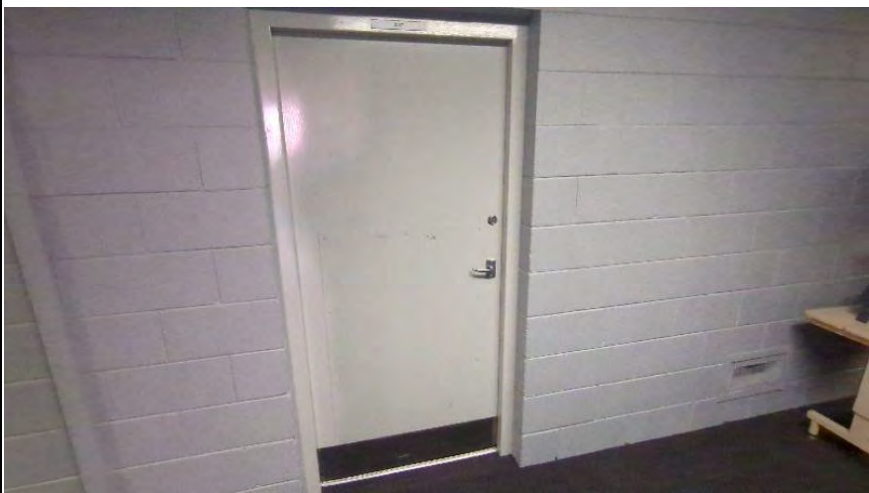
<p data-bbox="363 1541 638 1572">B00A-R1E14 General LS</p>	<p data-bbox="946 1050 1247 1150">Masonry walls, perforated plasterboard ceiling and carpet over concrete.</p>	<p data-bbox="1268 1050 1559 1234">Traces of suspected visual mould growth were noted to carpet. IICRC-520:2015 Condition 3 guidelines</p>

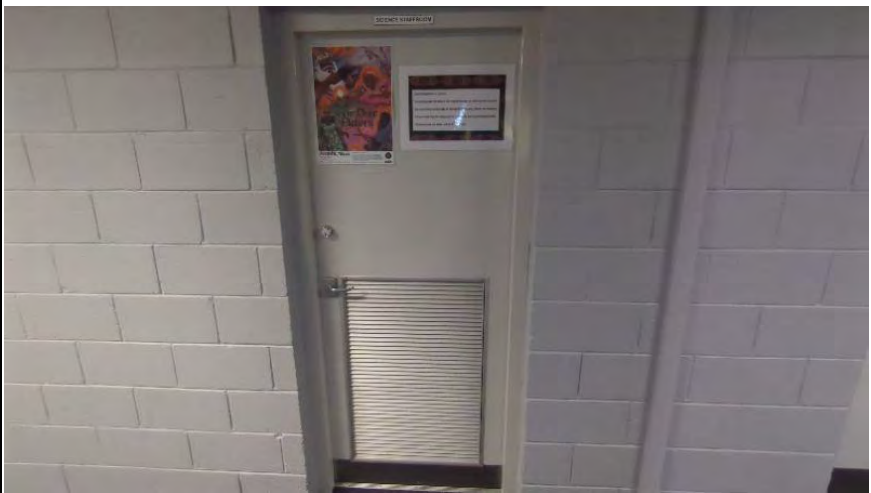
<p data-bbox="363 989 634 1020">B00A-R1E15 Staff study</p>		<p data-bbox="1297 499 1523 562">No access Assumed mould</p>
<p data-bbox="363 1045 634 1077">B00A-R1E18 Staff study</p>		<p data-bbox="1297 1045 1523 1108">No access Assumed mould</p>

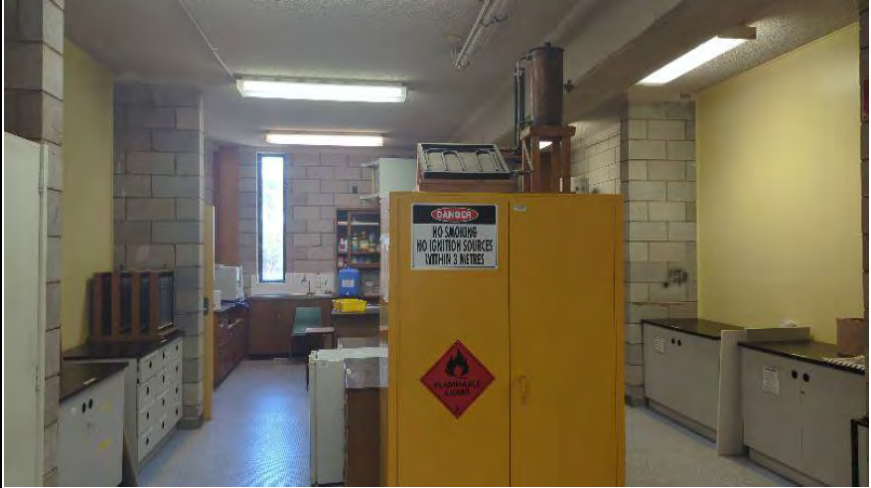
<p data-bbox="350 953 646 982">B00A-R1E02 - Preparation</p>	<p data-bbox="954 453 1239 554">Masonry walls, vinyl floor sheeting and concrete ceiling.</p>	<p data-bbox="1276 453 1555 667">No signs of visual mould growth were noted. Evaporative water staining was noted to vinyl floor sheeting and benchtops.</p> <p data-bbox="1276 684 1563 747">Refer to index photos 205 - 210.</p> <p data-bbox="1276 764 1563 827">IICRC-520:2015 Condition 3 guidelines</p>

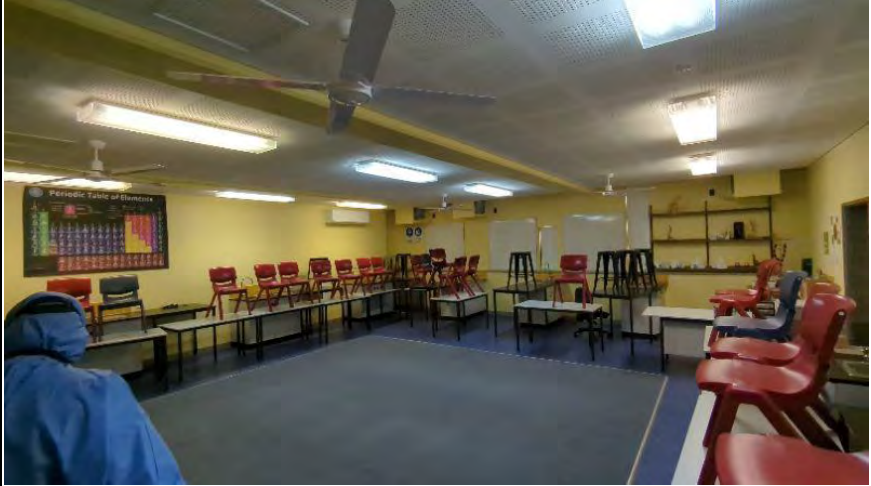
<p data-bbox="375 1518 621 1547">B00A-R1E03 - Lab L. S</p>	<p data-bbox="961 1020 1234 1155">Plasterboard walls, perforated plasterboard ceiling and carpet over concrete.</p>	<p data-bbox="1276 1020 1555 1155">No signs of visual mould growth were noted. Water stains were noted to carpet.</p> <p data-bbox="1276 1171 1563 1234">Refer to index photos 211 - 212.</p> <p data-bbox="1276 1251 1563 1314">IICRC-520:2015 Condition 3 guidelines</p>
