Microbial Testing - Willyama High School

Radium Street, Broken Hill, NSW 2880

School Infrastructure NSW Regional Office - North Western NSW

Report No.: 30158-R04

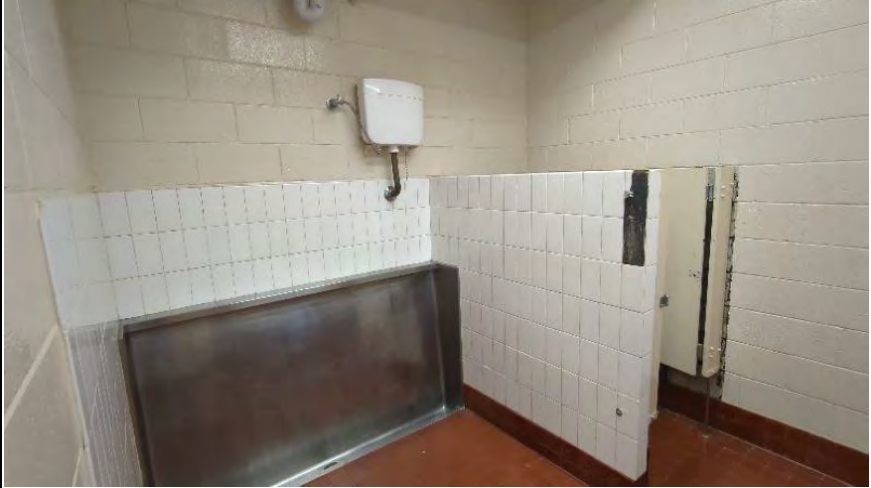
<p data-bbox="363 951 639 982">B00A-R1E07 Boys Toilet</p>	<p data-bbox="938 447 1255 552">Masonry walls, ceramic wall tiles, ceramic floor tiles and concrete ceiling.</p>	<p data-bbox="1276 447 1549 590">Suspected visual mould growth was noted to chipboard 'splashback' behind sink mirror.</p> <p data-bbox="1276 606 1560 674">Refer to index photos 213 - 216.</p> <p data-bbox="1276 690 1560 758">IICRC-520:2015 Condition 3 guidelines</p>

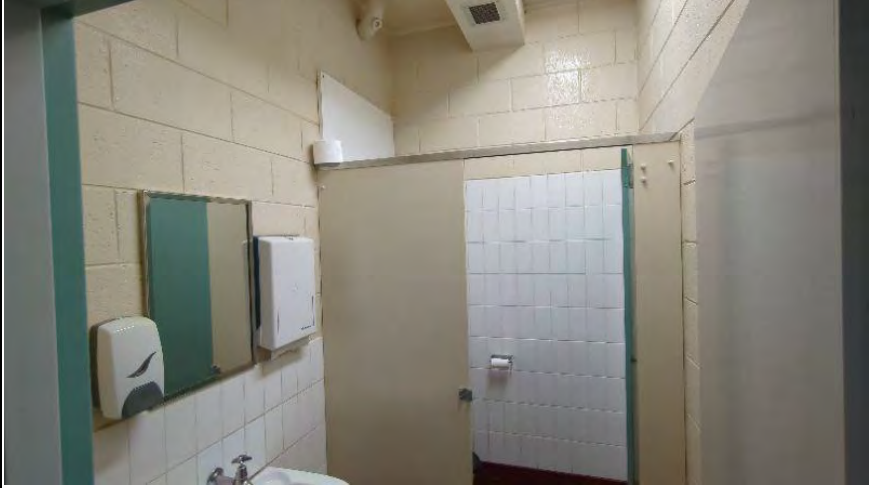
<p data-bbox="363 1518 639 1549">B00A-R1E06 Staff Toilet</p>	<p data-bbox="938 1014 1255 1119">Masonry walls, ceramic wall tiles, ceramic floor tiles and concrete ceiling.</p>	<p data-bbox="1276 1014 1549 1119">Suspected visual mould growth was noted to the toilet seat.</p> <p data-bbox="1276 1136 1560 1167">Refer to index photo 217.</p> <p data-bbox="1276 1184 1560 1251">IICRC-520:2015 Condition 3 guidelines</p>

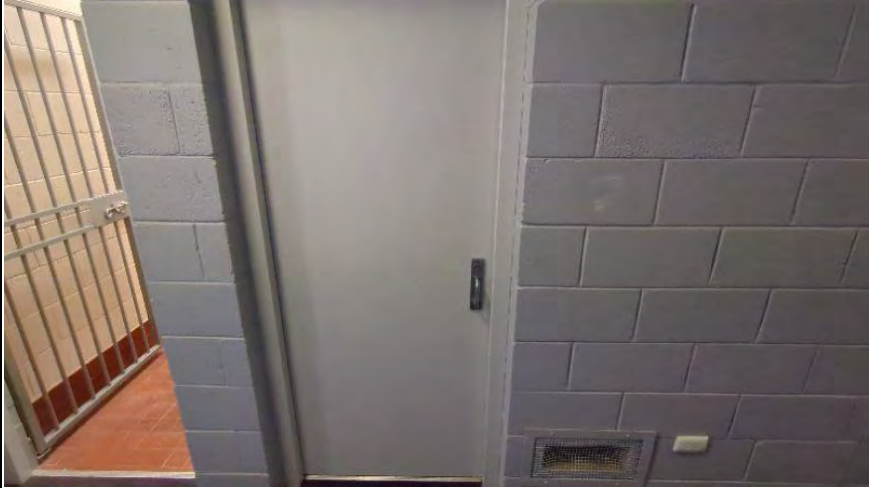
<p data-bbox="363 942 638 972">B00A-R1E05 Staff Toilet</p>		<p data-bbox="1297 453 1523 516">No access Assumed mould</p>

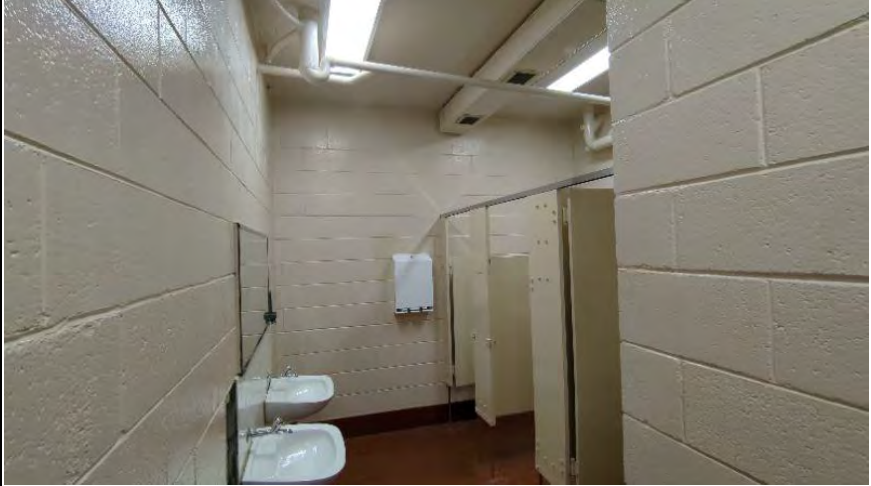
<p data-bbox="363 1493 638 1522">B00A-R1E04 Girls Toilet</p>	<p data-bbox="937 1003 1256 1104">Masonry walls, ceramic wall tiles, ceramic floor tiles and concrete ceiling.</p>	<p data-bbox="1268 1003 1554 1142">No signs of visual mould growth. Evaporative water stains were noted to ceramic floor tiles.</p> <p data-bbox="1261 1157 1560 1224">IICRC-520:2015 Condition 3 guidelines</p>

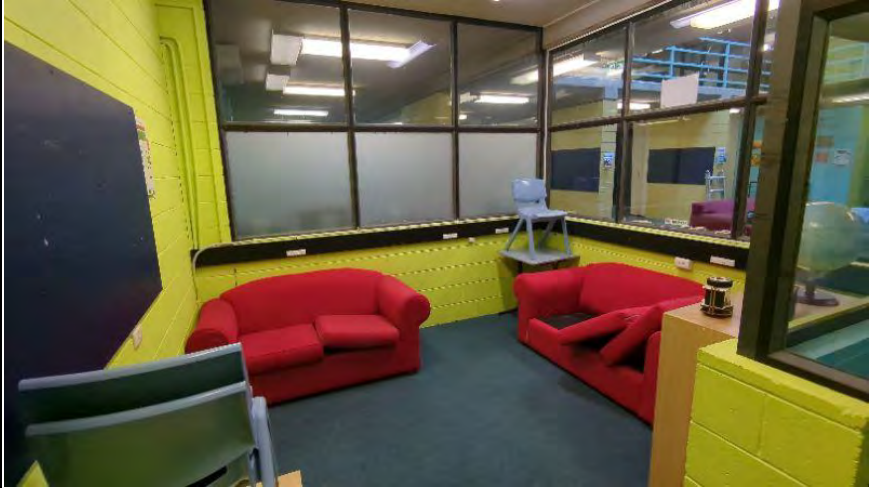
<p data-bbox="363 942 634 972">B00A-R1N09 - Librarian</p>	<p data-bbox="938 453 1253 558">Masonry walls, carpet over concrete and sprayed coating (vermiculite) ceiling.</p>	<p data-bbox="1268 453 1555 558">Suspected visual mould growth was noted on the couch.</p> <p data-bbox="1268 573 1555 636">Refer to index photos 226 - 227.</p> <p data-bbox="1268 653 1555 716">IICRC-520:2015 Condition 3 guidelines</p>

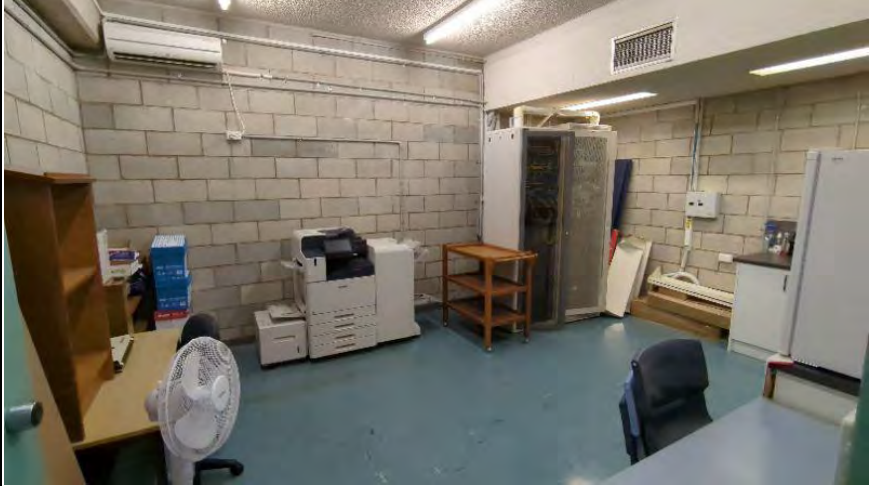
<p data-bbox="363 1493 634 1522">B00A-R108 - Storeroom</p>	<p data-bbox="938 1005 1253 1110">Masonry walls, carpet over concrete and sprayed coating (vermiculite) ceiling.</p>	<p data-bbox="1268 1005 1555 1110">Suspected visual mould growth was noted to porous contents.</p> <p data-bbox="1268 1125 1555 1146">Refer to index photo 228.</p> <p data-bbox="1268 1163 1555 1226">IICRC-520:2015 Condition 3 guidelines</p>

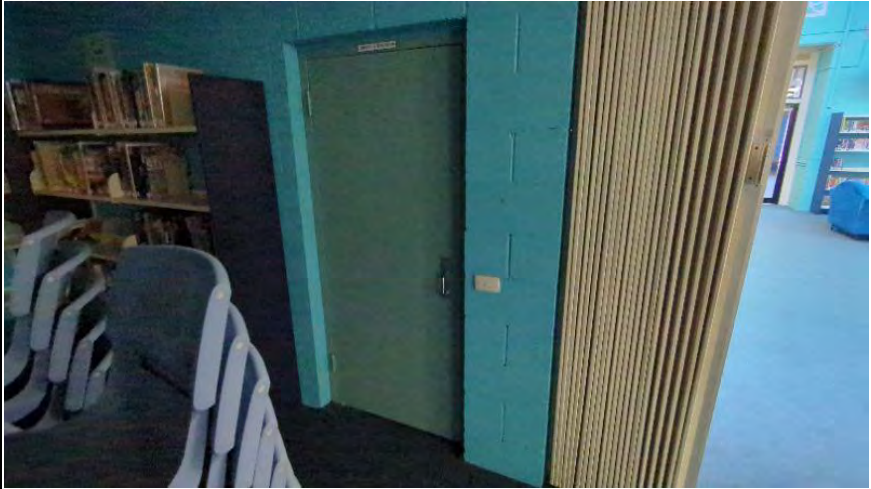
<p data-bbox="354 940 646 972">B00A-R1N04 - Storeroom</p>		<p data-bbox="1292 453 1528 527">Storeroom no access Assumed mould</p>
<p data-bbox="354 999 646 1031">B00A-R1N07 Storeroom</p>		<p data-bbox="1354 999 1468 1031">No access</p>

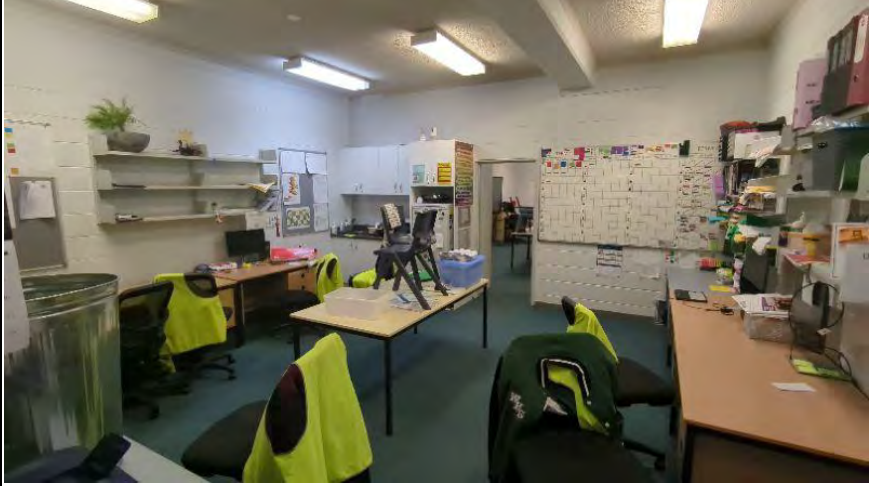
<p data-bbox="354 1549 646 1581">B00A-R1W23 - Staff Study</p>	<p data-bbox="938 1056 1255 1161">Masonry walls, carpet over concrete and sprayed coating (vermiculite) ceiling.</p>	<p data-bbox="1271 1056 1554 1360">Suspected visual mould growth was noted to the carpet floor and porous contents. Refer to index photos 230 - 238. IICRC-520:2015 Condition 3 guidelines</p>

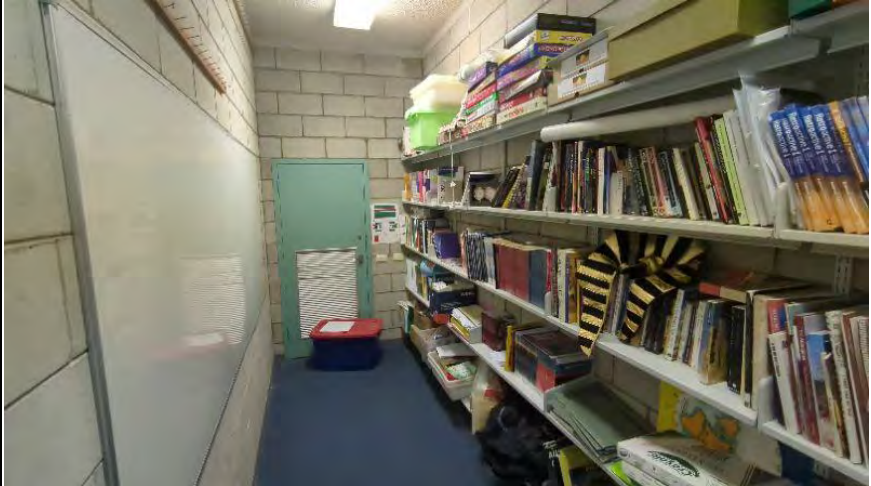
<p data-bbox="347 953 651 1035">B00A-R1W24 - Store room B00A-R1W25 - Staff study</p>	<p data-bbox="938 453 1253 558">Masonry walls, carpet over concrete and sprayed coating (vermiculite) ceiling.</p>	<p data-bbox="1273 453 1554 722">Suspected visual mould growth was noted to the carpet. Refer to index photos 239 - 240. IICRC-520:2015 Condition 3 guidelines</p> <p data-bbox="1273 1010 1554 1314">Suspected visual mould growth was noted to all building materials and contents. Refer to index photos 242 - 259. IICRC-520:2015 Condition 3 guidelines</p>

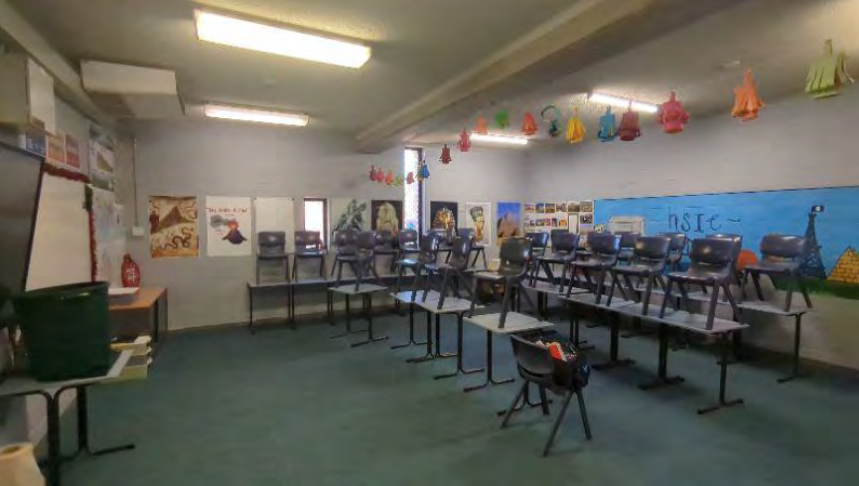
<p data-bbox="342 993 656 1020">B00A-R1W20 - General L. S</p>	<p data-bbox="938 499 1252 604">Masonry walls, carpet over concrete and sprayed coating (vermiculite) ceiling.</p>	<p data-bbox="1276 499 1544 604">Suspected visual mould growth was noted to carpet floor.</p> <p data-bbox="1276 621 1544 684">Refer to index photos 268 - 270.</p> <p data-bbox="1263 701 1560 764">IICRC-520:2015 Condition 3 guidelines</p>

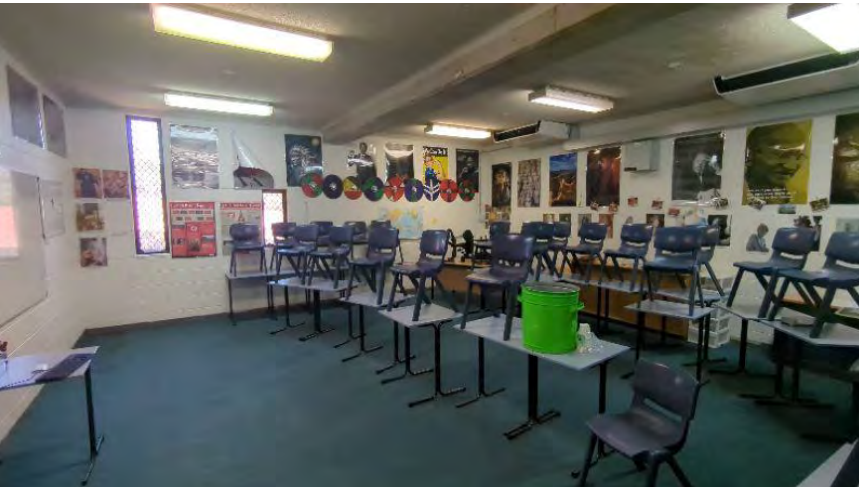
<p data-bbox="342 1545 656 1572">B00A-R1W19 - General L. S</p>	<p data-bbox="938 1045 1252 1150">Masonry walls, carpet over concrete and sprayed coating (vermiculite) ceiling.</p>	<p data-bbox="1276 1045 1544 1150">Traces of suspected visual mould growth was noted to the carpet floor.</p> <p data-bbox="1276 1167 1544 1230">Refer to index photos 271 - 275.</p> <p data-bbox="1263 1247 1560 1310">IICRC-520:2015 Condition 3 guidelines</p>

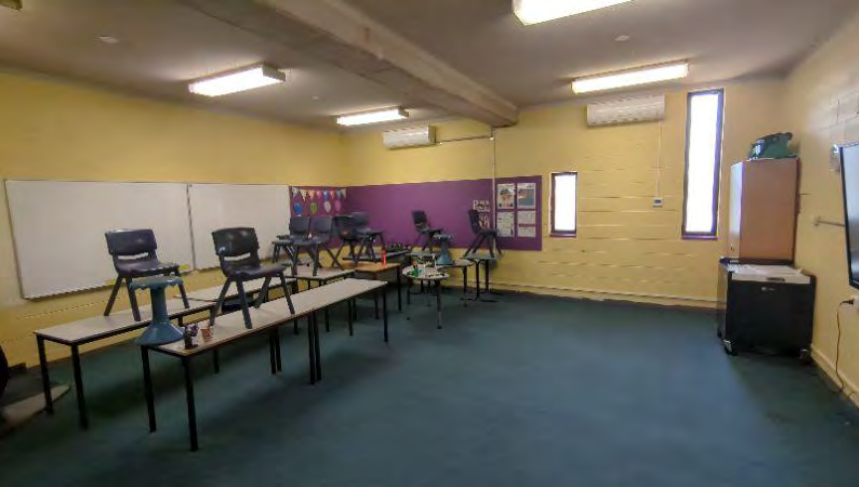
<p data-bbox="342 993 656 1020">B00A-R1W13 - General L. S</p>	<p data-bbox="938 499 1252 604">Masonry walls, carpet over concrete and sprayed coating (vermiculite) ceiling.</p>	<p data-bbox="1279 499 1547 604">Suspected visual mould growth was noted to carpet floor.</p> <p data-bbox="1279 621 1547 695">Refer to index photos. 294 - 297</p> <p data-bbox="1263 709 1559 783">IICRC-520:2015 Condition 3 guidelines</p>

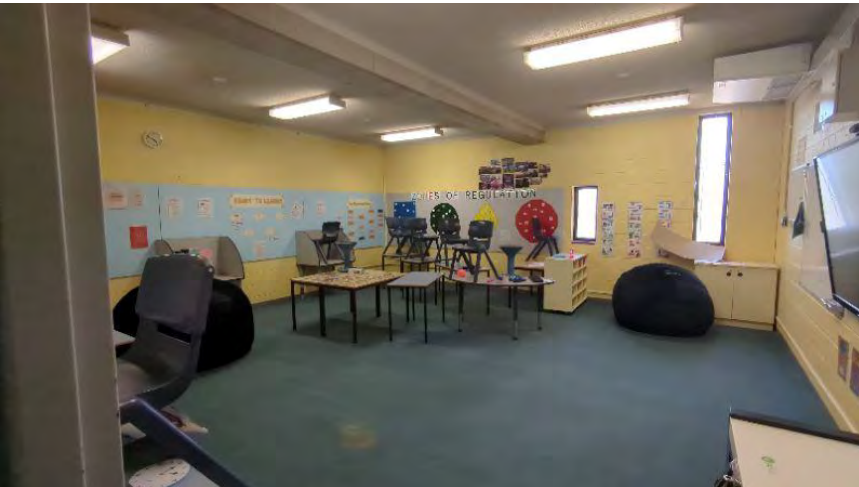
<p data-bbox="342 1545 656 1572">B00A-R1W12 - General L. S</p>	<p data-bbox="938 1045 1252 1150">Masonry walls, carpet over concrete and sprayed coating (vermiculite) ceiling.</p>	<p data-bbox="1279 1045 1547 1150">Suspected visual mould growth was noted to carpet floor.</p> <p data-bbox="1263 1167 1559 1241">Refer to index photos 298 - 304.</p> <p data-bbox="1263 1255 1559 1329">IICRC-520:2015 Condition 3 guidelines</p>

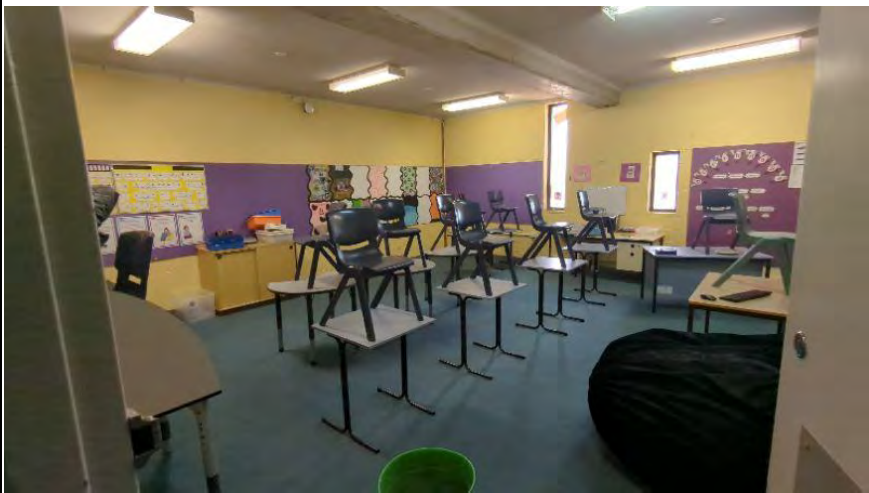
<p data-bbox="342 993 656 1024">B00A-R1W11 - General L. S</p>	<p data-bbox="938 499 1252 604">Plasterboard walls, carpet over concrete and sprayed coating (vermiculite) ceiling.</p>	<p data-bbox="1276 499 1546 678">Suspected visual mould growth was noted to carpet, benchtop cupboard and porous contents.</p> <p data-bbox="1263 695 1562 758">Refer to index photos 305 - 307.</p> <p data-bbox="1263 779 1562 842">IICRC-520:2015 Condition 3 guidelines</p>

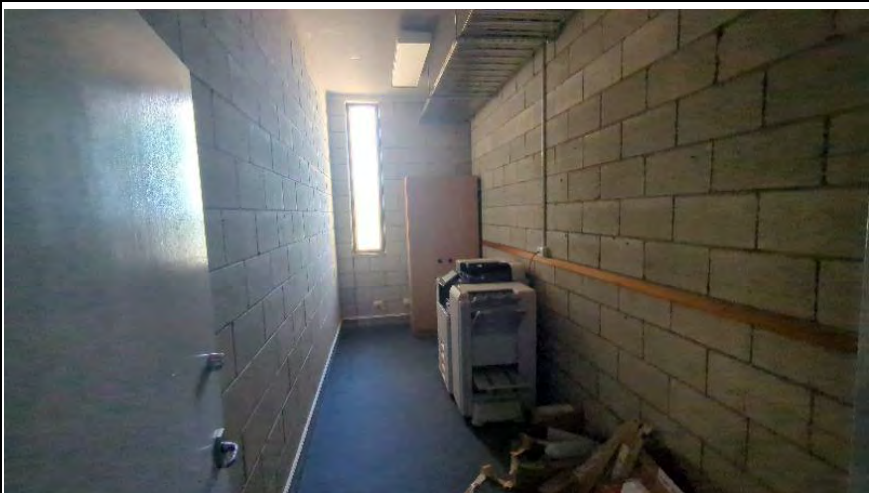
<p data-bbox="350 1539 647 1570">B00A-R1W10 - Storeroom</p>	<p data-bbox="938 1052 1252 1157">Masonry walls, carpet over concrete and sprayed coating (vermiculite) ceiling.</p>	<p data-bbox="1268 1052 1554 1157">No signs of visual mould growth or water damage were noted.</p> <p data-bbox="1263 1173 1562 1236">IICRC-520:2015 Condition 3 guidelines</p>

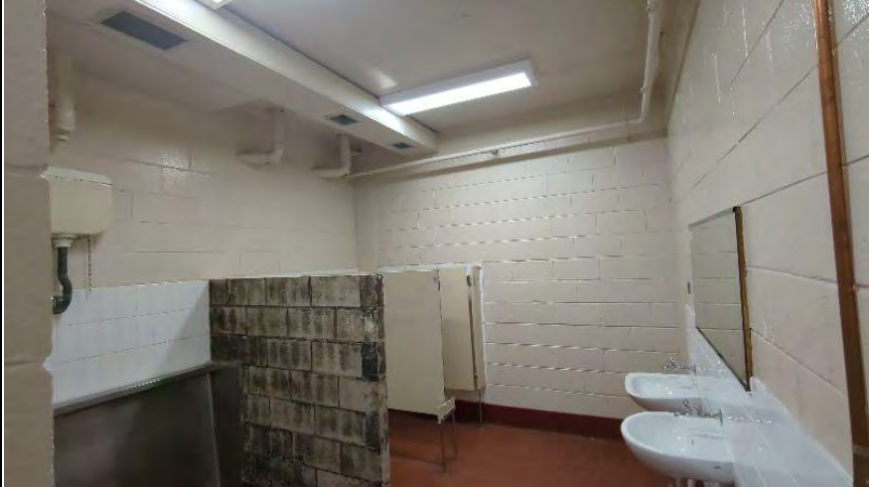
<p data-bbox="349 993 651 1024">B00A-R1W06 - Boys Toilet</p>	<p data-bbox="935 499 1255 562">Concrete ceiling, masonry walls and ceramic floor tiles.</p>	<p data-bbox="1268 499 1555 852">No signs of visible mould growth were noted. Evaporative water stains were noted to ceramic floor tiles. Refer to index photos. 310 - 311 IICRC-520:2015 Condition 3 guidelines</p>

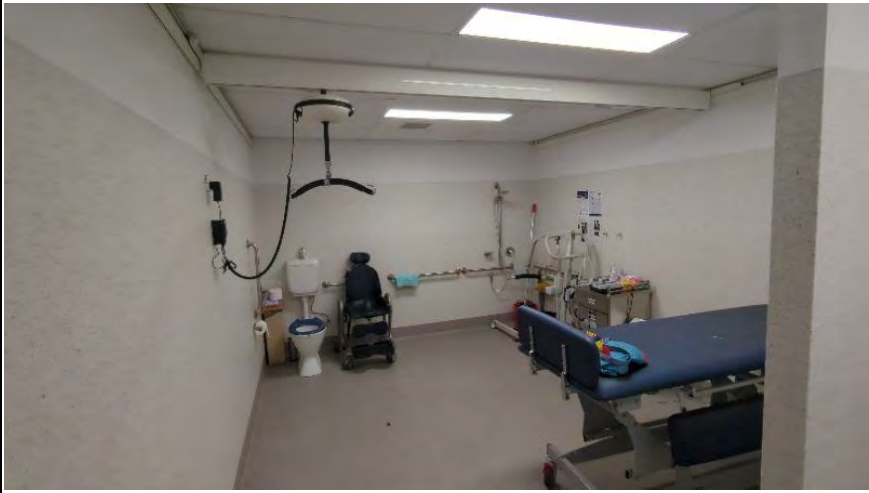
<p data-bbox="349 1541 651 1572">B00A-R1W04 - Staff Toilet</p>	<p data-bbox="943 1052 1247 1188">Plasterboard suspended ceiling tiles, plasterboard walls and vinyl floor sheeting.</p>	<p data-bbox="1268 1052 1555 1234">No signs of visual mould growth or water damage were noted. IICRC-520:2015 Condition 3 guidelines</p>

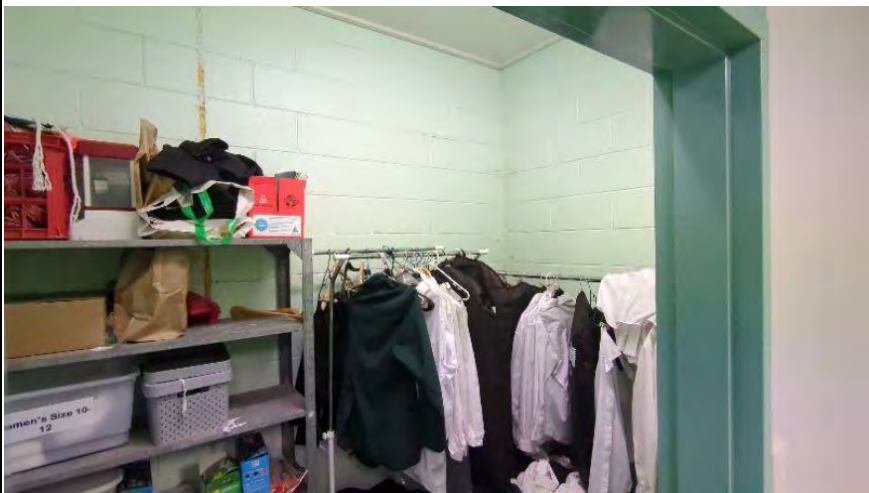
<p data-bbox="337 993 667 1024">B00A-R2N16 - Uniform Shop</p>	<p data-bbox="943 499 1250 604">Masonry walls, carpet over concrete and fibre cement ceiling.</p>	<p data-bbox="1273 499 1555 604">No signs of visual mould growth or water damage were noted.</p> <p data-bbox="1273 621 1555 688">IICRC-520:2015 Condition 3 guidelines</p>

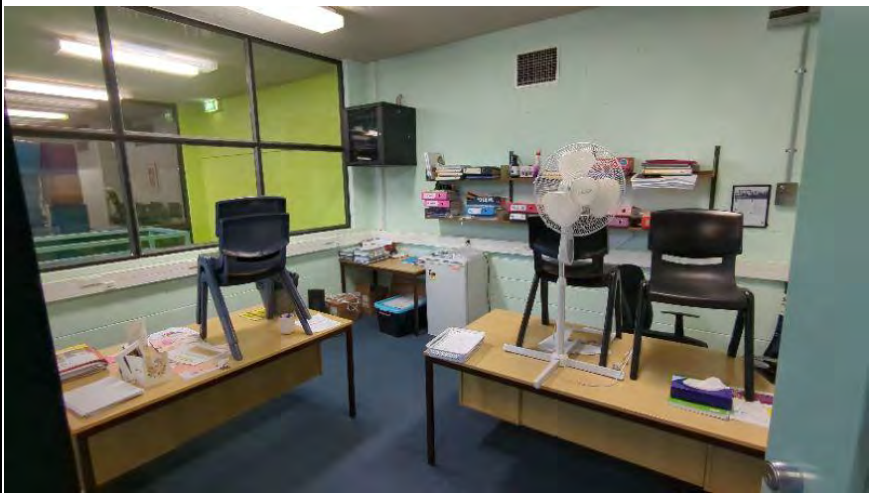
<p data-bbox="354 989 643 1024">B00A-R2N07 - Workshop</p>	<p data-bbox="935 499 1255 604">Masonry walls, carpet over concrete and sprayed coating (vermiculite) ceiling.</p>	<p data-bbox="1268 499 1554 604">No signs of visual mould or water damage were noted.</p> <p data-bbox="1268 617 1562 688">IICRC-520:2015 Condition 3 guidelines</p>

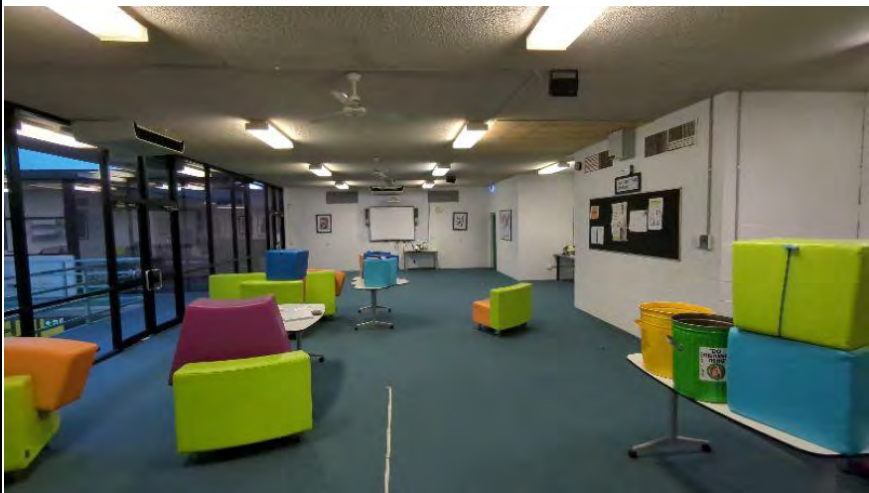
<p data-bbox="375 993 621 1024">B00A-R2N05 - Library</p>	<p data-bbox="938 499 1252 604">Plasterboard walls, carpet over concrete and sprayed coating (vermiculite) ceiling.</p>	<p data-bbox="1268 499 1554 604">No signs of visual mould growth or water damage were.</p> <p data-bbox="1268 621 1554 684">IICRC-520:2015 Condition 3 guidelines</p>

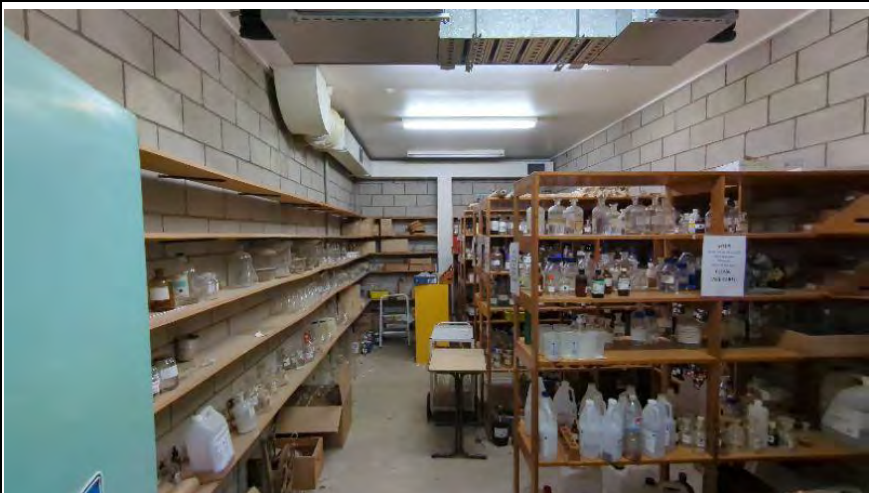
<p data-bbox="358 1539 638 1570">B00A-R2E12 - App Store</p>	<p data-bbox="954 1052 1235 1157">Masonry walls, concrete floor and fibre cement ceiling.</p>	<p data-bbox="1268 1052 1554 1157">No signs of visual mould growth or water damage were noted.</p> <p data-bbox="1268 1173 1554 1236">IICRC-520:2015 Condition 3 guidelines</p> <p data-bbox="1284 1253 1537 1316">*Hazardous Chemicals Present*</p>

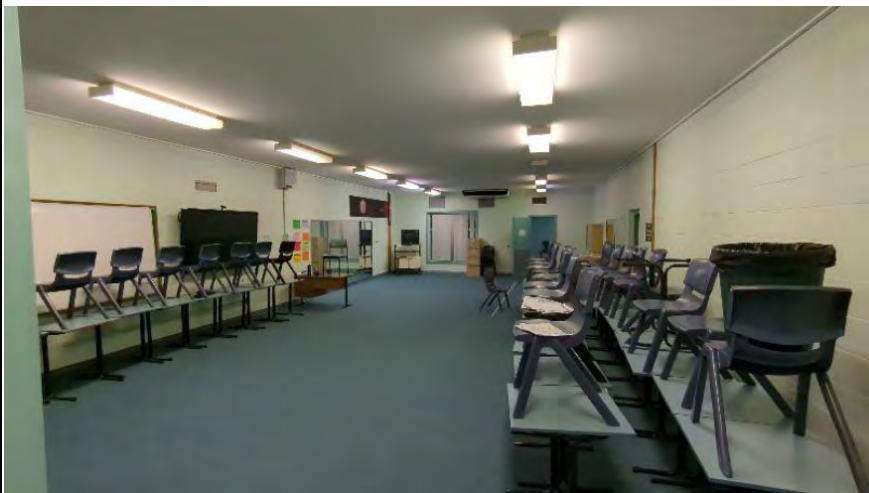
<p data-bbox="391 993 610 1020">B00A-R2E11 - Staff</p>	<p data-bbox="943 499 1252 604">Masonry walls, carpet over concrete and plasterboard ceiling.</p>	<p data-bbox="1276 499 1555 678">Suspected visual mould growth was noted to the carpet floor, hardwood desk and porous contents.</p> <p data-bbox="1268 695 1560 762">IICRC-520:2015 Condition 3 guidelines</p>

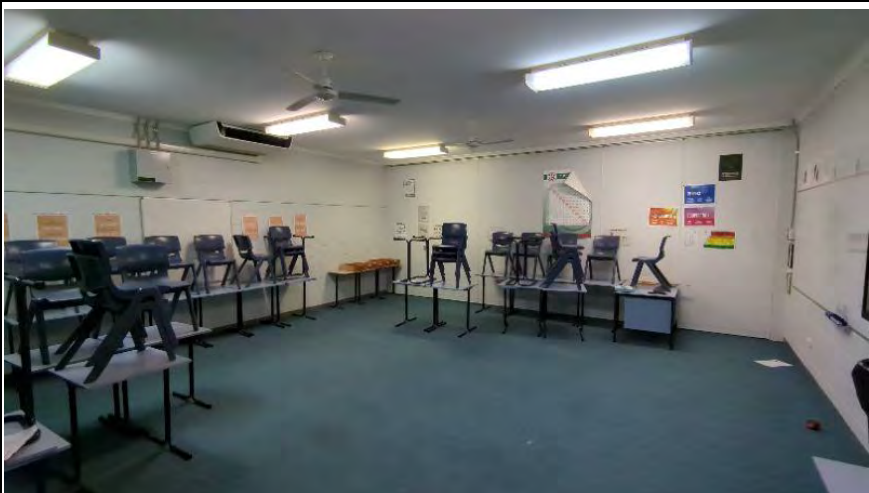
<p data-bbox="350 1539 651 1566">B00A-R2E09 - General L. S</p>	<p data-bbox="943 1052 1252 1157">Masonry walls, carpet over concrete and plasterboard ceiling.</p>	<p data-bbox="1276 1052 1555 1157">Suspected visual mould growth was noted to carpet floor.</p> <p data-bbox="1268 1173 1560 1241">IICRC-520:2015 Condition 3 guidelines</p>

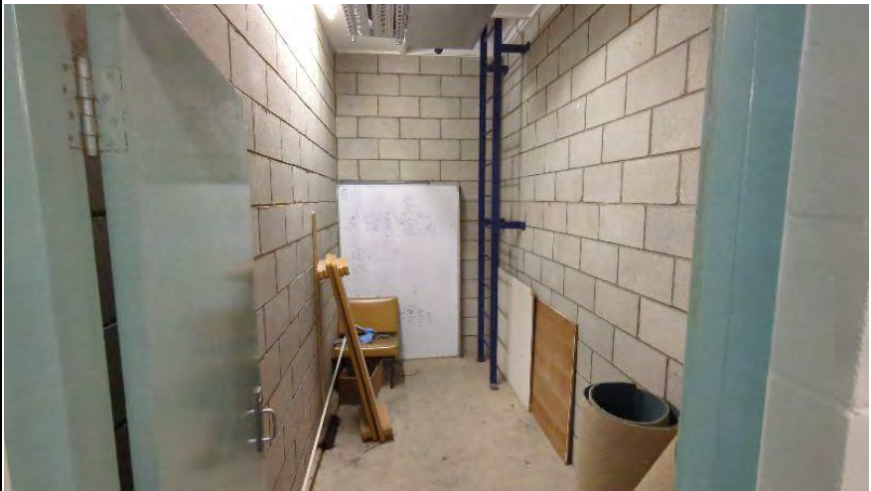
<p data-bbox="354 989 643 1020">B00A-R2E13 - Storeroom</p>	<p data-bbox="956 495 1235 600">Masonry walls, concrete floor and fibre cement ceiling.</p>	<p data-bbox="1268 495 1552 600">No signs of visual mould growth or water damage were noted.</p> <p data-bbox="1268 615 1552 684">IICRC-520:2015 Condition 3 guidelines</p>

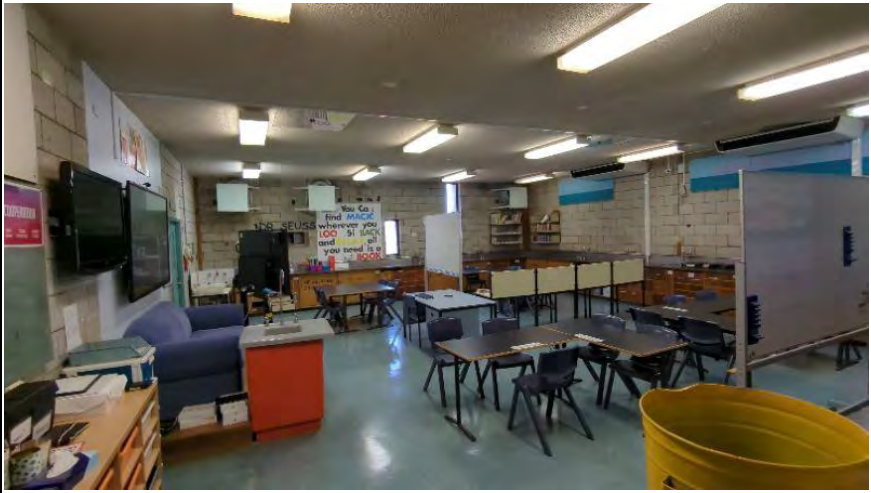
<p data-bbox="396 1541 600 1572">B00A-R2E18 - Lab</p>	<p data-bbox="935 1045 1256 1150">Masonry walls, vinyl floor sheeting and sprayed coating (vermiculite) ceiling.</p>	<p data-bbox="1268 1045 1552 1224">No signs of visual mould growth or water damage were noted. However, staining (likely grease) was present to couch.</p> <p data-bbox="1268 1239 1552 1308">Refer to index photos 330 - 331.</p> <p data-bbox="1268 1323 1552 1392">IICRC-520:2015 Condition 3 guidelines</p>

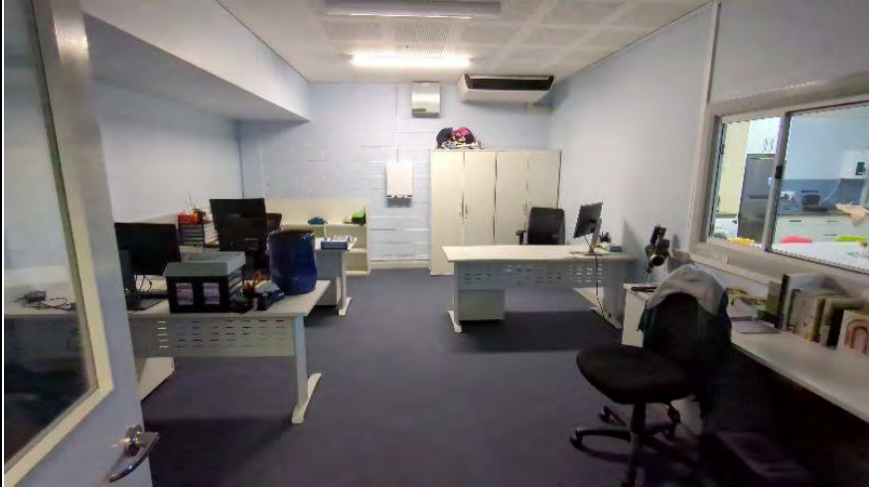
<p data-bbox="354 993 644 1024">B00A-R2E25 - Staff Study</p>	<p data-bbox="956 499 1235 638">Plasterboard walls, perforated plasterboard ceiling and carpet over concrete.</p>	<p data-bbox="1268 499 1557 686">No signs of visual mould growth or water damage were noted. IICRC-520:2015 Condition 3 guidelines</p>

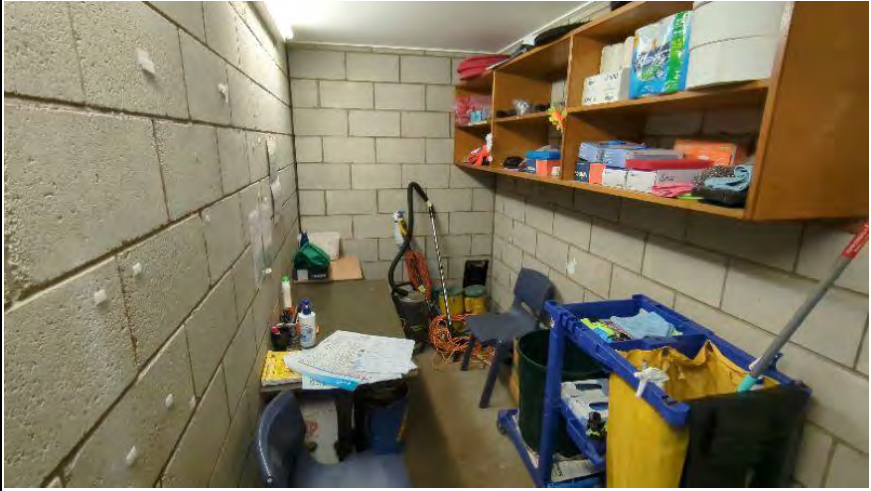
<p data-bbox="331 1541 667 1572">B00A-R2N06 - Cleaning Store</p>	<p data-bbox="943 1050 1252 1152">Masonry walls, carpet over concrete and fibre cement ceiling.</p>	<p data-bbox="1268 1050 1557 1236">No signs of visual mould growth or water damage were noted. IICRC-520:2015 Condition 3 guidelines</p>

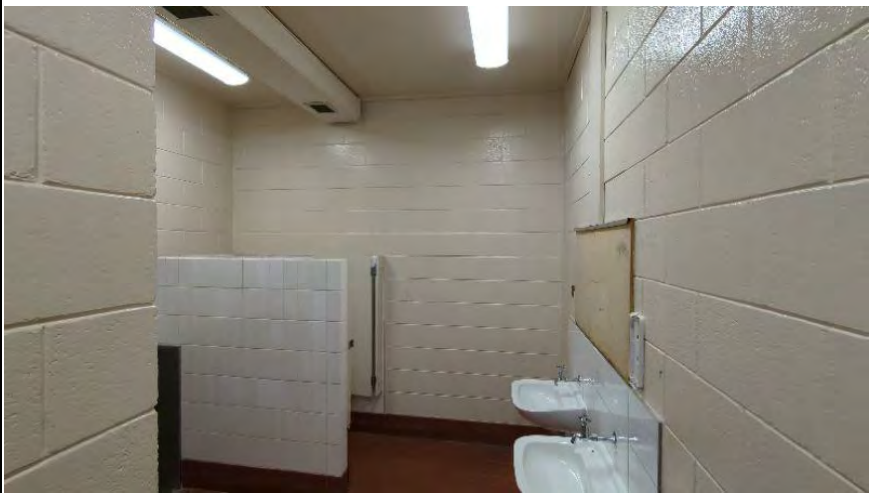
<p data-bbox="354 993 646 1024">B00A-R2E05 - Boys Toilet</p>	<p data-bbox="930 499 1260 569">Masonry walls, ceramic floor tiles and concrete ceiling,</p>	<p data-bbox="1260 499 1560 789">No signs of visual mould growth were noted. Signs of water damage were noted to plywood sheet covering mirror and evaporative water stains were noted to ceramic floor tiles.</p> <p data-bbox="1260 804 1560 873">IICRC-520:2015 Condition 3 guidelines</p>

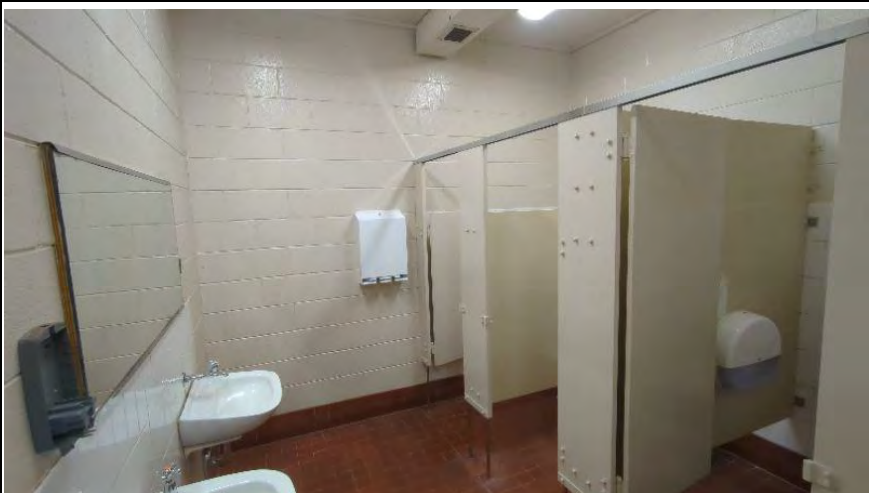
<p data-bbox="354 1539 646 1570">B00A-R2E04 - Girl's toilet</p>	<p data-bbox="930 1045 1260 1115">Masonry walls, ceramic floor tiles and concrete ceiling,</p>	<p data-bbox="1260 1045 1560 1230">No signs of visual mould growth were noted. Evaporative water stains were noted to ceramic floor tiles.</p> <p data-bbox="1260 1245 1560 1314">IICRC-520:2015 Condition 3 guidelines</p>

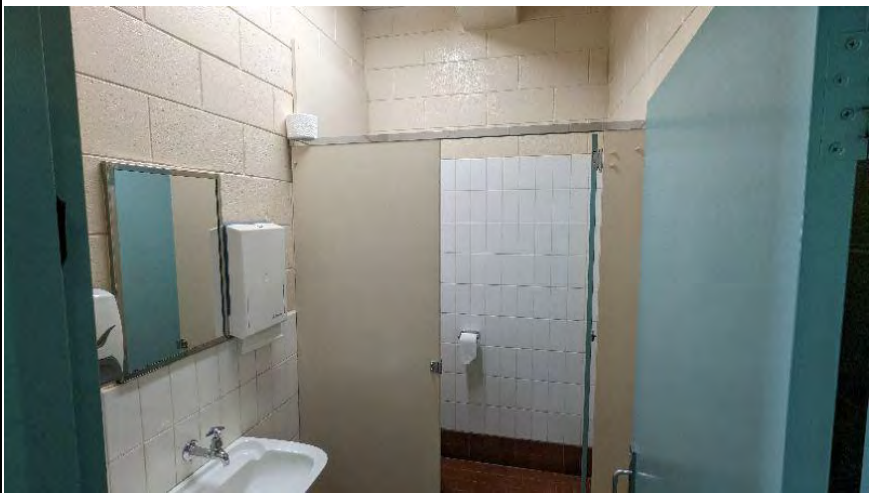
<p data-bbox="354 993 646 1020">B00A-R2E06 - Staff Toilet</p>	<p data-bbox="935 499 1255 569">Masonry walls, ceramic floor tiles and concrete ceiling,</p>	<p data-bbox="1271 499 1552 762">No signs of visual mould growth were noted. Evaporative water stains were noted to ceramic floor tiles. IICRC-520:2015 Condition 3 guidelines</p>

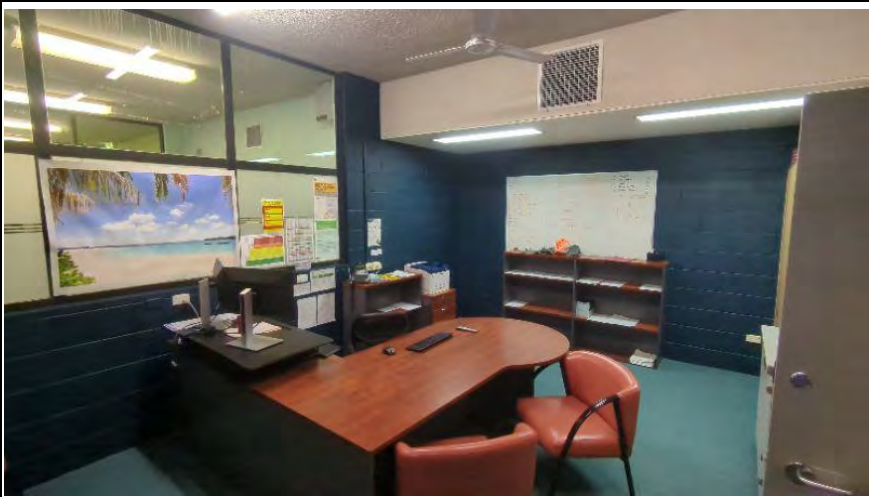
<p data-bbox="381 1541 618 1568">B00A-R2N20 - Office</p>	<p data-bbox="935 1052 1255 1152">Masonry walls, carpet over concrete and sprayed coating (vermiculite) ceiling.</p>	<p data-bbox="1271 1052 1552 1236">No signs of visual mould growth or water damage were noted. IICRC-520:2015 Condition 3 guidelines</p>

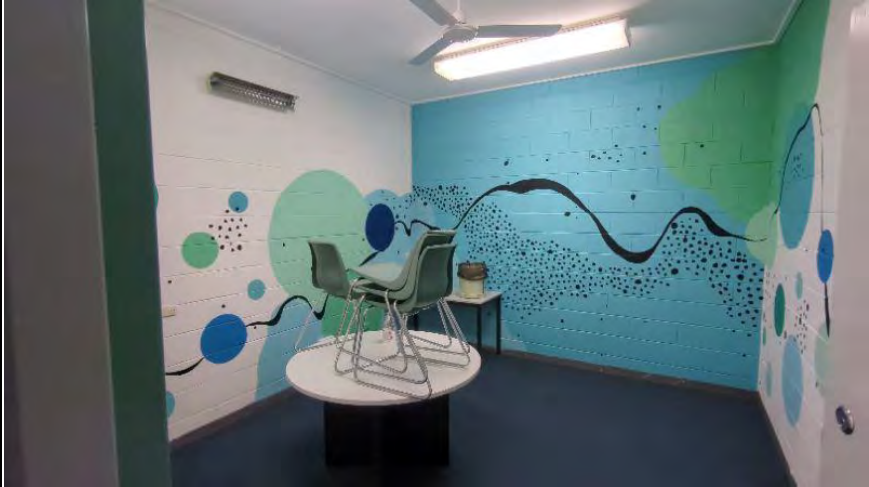
<p data-bbox="321 993 675 1024">B00A-R2N09 - Interview Room</p>	<p data-bbox="943 499 1250 604">Masonry walls, carpet over concrete and plasterboard ceiling.</p>	<p data-bbox="1273 499 1555 604">No signs of visual mould growth or water damage were noted.</p> <p data-bbox="1286 621 1542 688">Refer to index photos 333-334.</p> <p data-bbox="1263 701 1562 768">IICRC-520:2015 Condition 3 guidelines</p>

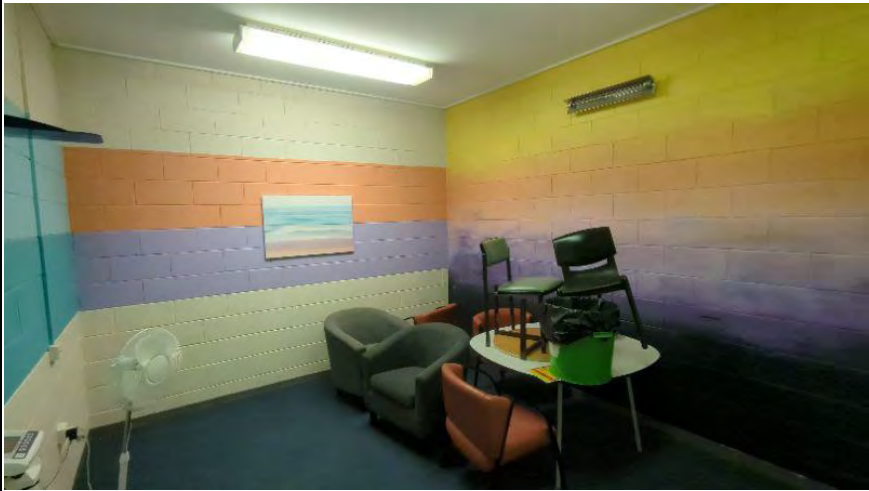
<p data-bbox="362 1541 638 1572">B00A-R2N10 - Interview</p>	<p data-bbox="943 1052 1250 1157">Masonry walls, carpet over concrete and plasterboard ceiling.</p>	<p data-bbox="1273 1052 1555 1157">No signs of visual mould growth or water damage were noted.</p> <p data-bbox="1263 1169 1562 1236">IICRC-520:2015 Condition 3 guidelines</p>

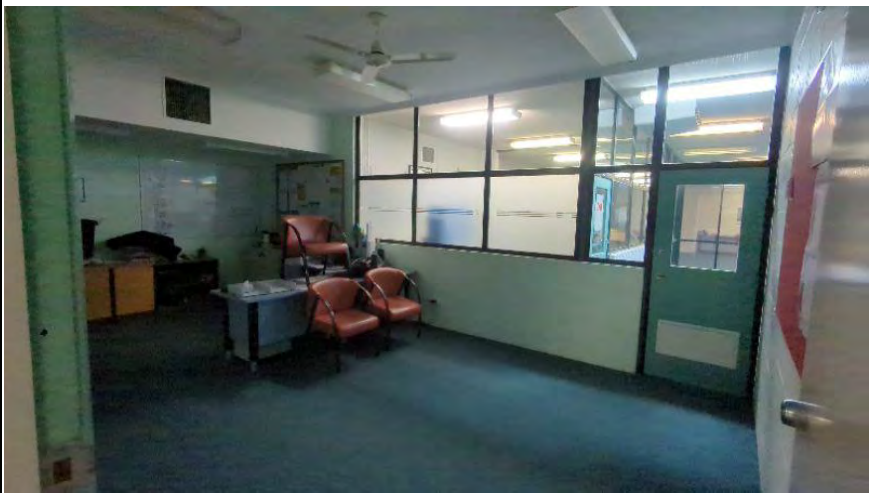
<p data-bbox="354 993 643 1020">B00A-R2N11 - Workroom</p>	<p data-bbox="938 499 1252 604">Plasterboard walls, carpet over concrete and sprayed coating (vermiculite) ceiling.</p>	<p data-bbox="1268 499 1550 678">No signs of visual mould growth were noted. Signs of water ingress (in the form of brown staining) was noted to the cornice.</p> <p data-bbox="1268 695 1550 852">Refer to index photos. 335-336 IICRC-520:2015 Condition 3 guidelines</p>

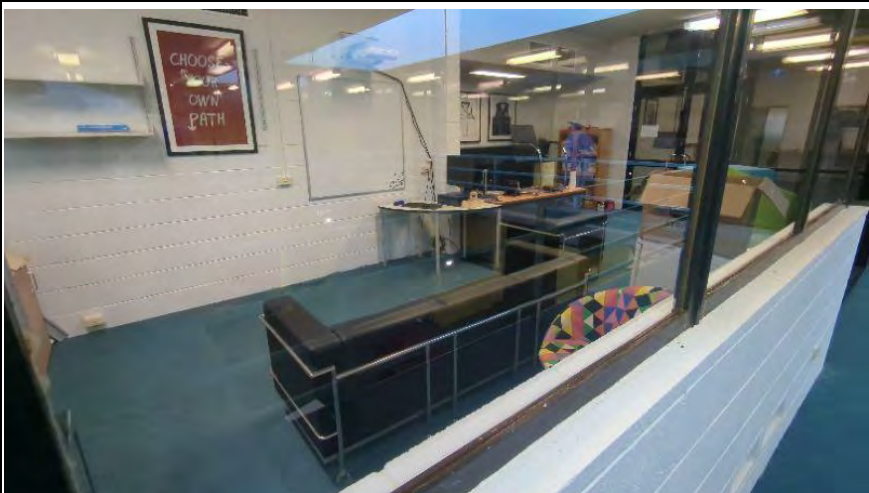
<p data-bbox="354 1539 643 1566">B00A-R2N12 - Workroom</p>	<p data-bbox="938 1045 1252 1150">Masonry walls, carpet over concrete and plasterboard ceiling.</p>	<p data-bbox="1268 1045 1550 1150">Trades of suspected visual mould growth were noted to the carpet floor.</p> <p data-bbox="1268 1167 1550 1325">Refer to index photos 338-340. IICRC-520:2015 Condition 3 guidelines</p>

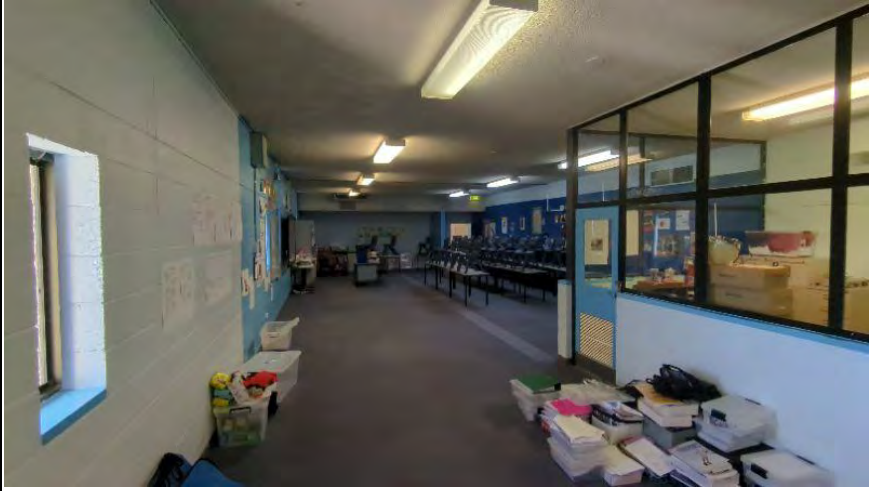
<p data-bbox="347 993 651 1024">B00A-R2N01 - General L. S</p>	<p data-bbox="938 499 1255 604">Masonry walls, carpet over concrete and sprayed coating (vermiculite) ceiling.</p>	<p data-bbox="1268 499 1557 758">No signs of visual mould growth were noted. Liquid staining was noted to carpet adjacent to western doorway. Refer to index photos 341.</p> <p data-bbox="1268 779 1557 842">IICRC-520:2015 Condition 3 guidelines</p>

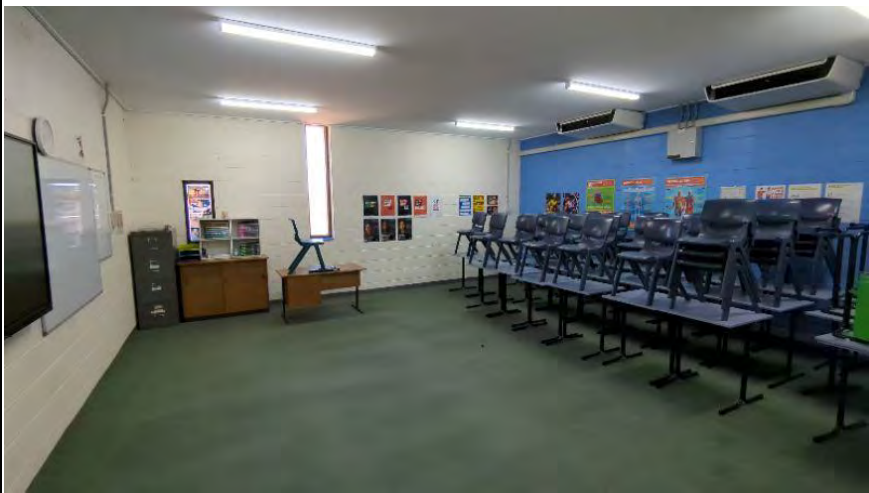
<p data-bbox="342 993 656 1020">B00A-R2W21 - General L. S</p>	<p data-bbox="943 499 1247 604">Masonry wall, carpet over concrete and plasterboard ceiling.</p>	<p data-bbox="1273 499 1555 688">No signs of visual mould growth or water damage were noted. IICRC-520:2015 Condition 3 guidelines</p>

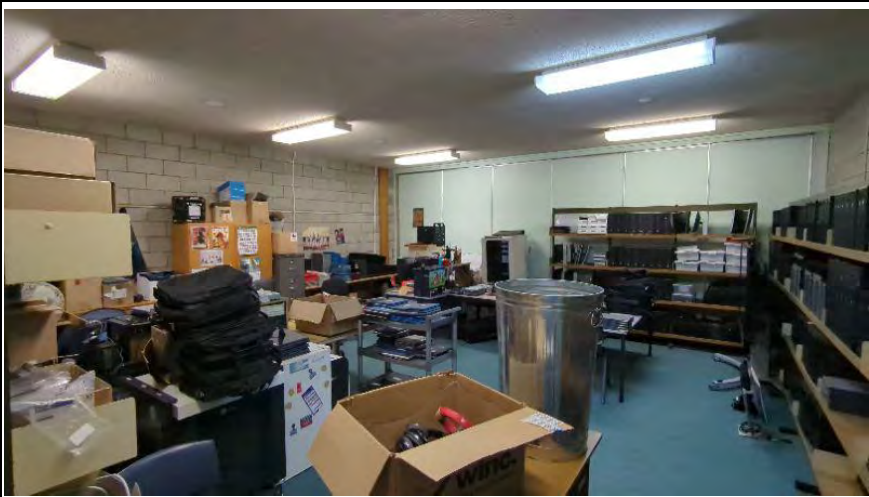
<p data-bbox="355 1541 643 1568">B00A-R2W17 - Interview</p>	<p data-bbox="938 1052 1252 1157">Masonry walls, carpet over concrete and sprayed coating (vermiculite) ceiling.</p>	<p data-bbox="1273 1052 1555 1272">No signs of visual mould growth or water damage were noted to building materials or contents. IICRC-520:2015 Condition 3 guidelines</p>

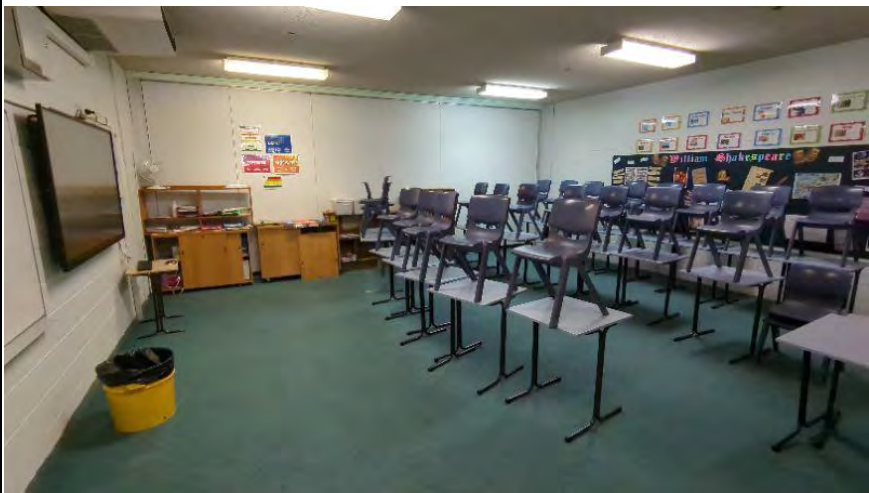
<p data-bbox="354 993 646 1020">B00A-R2W16 General L. S</p>	<p data-bbox="938 499 1252 604">Masonry walls, carpet over concrete and sprayed coating (vermiculite) ceiling.</p>	<p data-bbox="1268 499 1550 768">Traces of suspected visual mould growth were noted to carpet. Refer to index photos 344. IICRC-520:2015 Condition 3 guidelines</p>

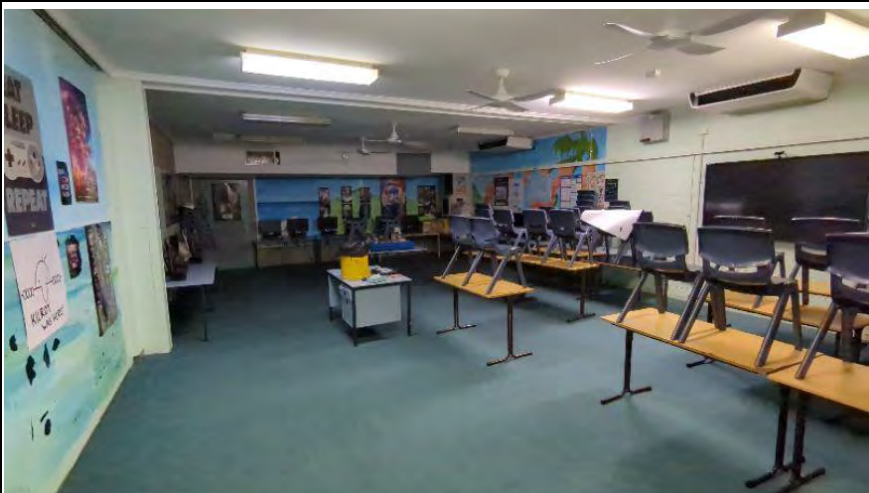
<p data-bbox="334 1539 667 1566">B00A-R2W11 - Computer L. S</p>	<p data-bbox="938 1045 1252 1150">Masonry walls, carpet over concrete and plasterboard ceiling.</p>	<p data-bbox="1268 1045 1550 1234">No signs of visual mould growth or water damage were noted. IICRC-520:2015 Condition 3 guidelines</p>

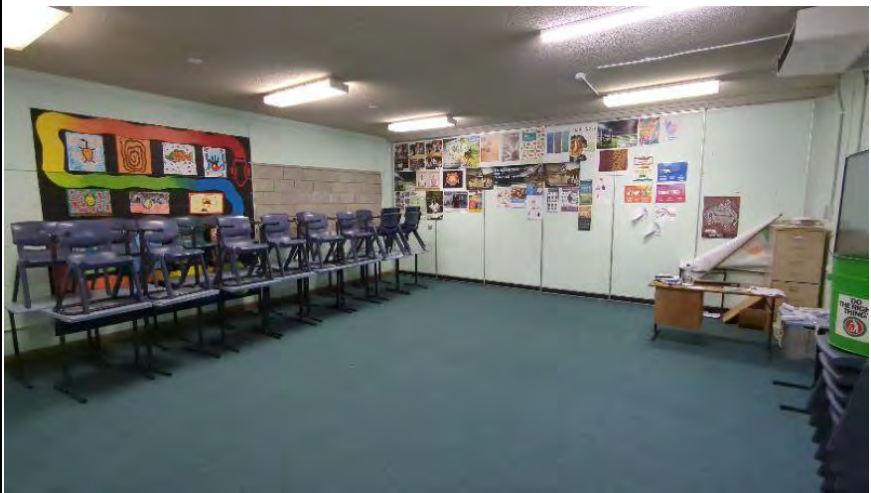
<p data-bbox="342 993 656 1020">B00A-R2W13 - General L. S</p>	<p data-bbox="938 499 1255 604">Masonry walls, carpet over concrete and sprayed coating (vermiculite) ceiling.</p>	<p data-bbox="1268 499 1557 604">No signs of visual mould growth or water damage were noted.</p> <p data-bbox="1268 621 1557 684">IICRC-520:2015 Condition 3 guidelines</p>

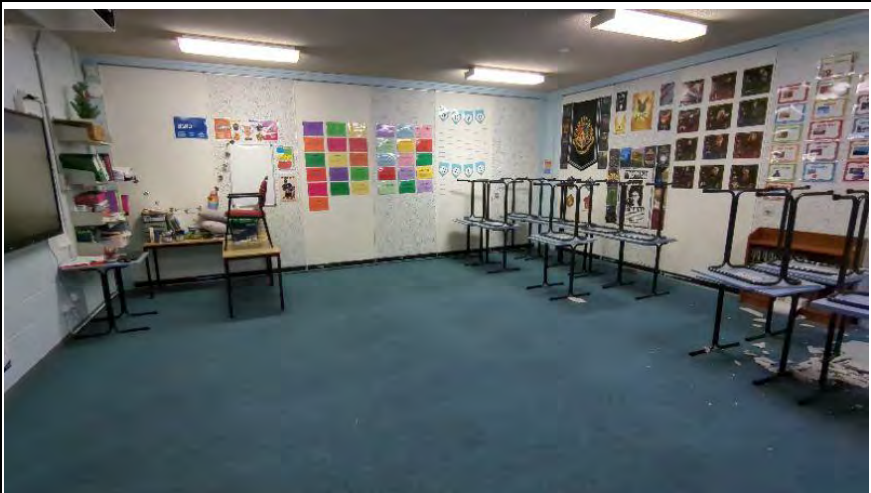
<p data-bbox="342 1539 656 1566">B00A-R2W12 - General L. S</p>	<p data-bbox="938 1045 1255 1150">Masonry walls, carpet over concrete and sprayed coating (vermiculite) ceiling.</p>	<p data-bbox="1268 1045 1557 1150">Suspected visual mould growth was noted to chair and pillow.</p> <p data-bbox="1268 1167 1557 1230">Refer to index photos 345- 346.</p> <p data-bbox="1268 1293 1557 1356">IICRC-520:2015 Condition 3 guidelines</p>
