Microbial Testing - Willyama High School

Radium Street, Broken Hill, NSW 2880

School Infrastructure NSW Regional Office - North Western NSW

Report No.: 30158-R04

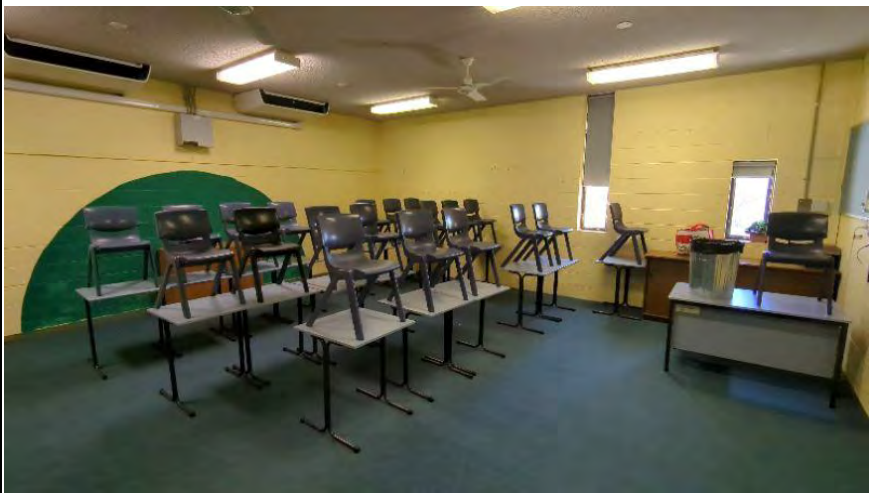
<p data-bbox="342 993 654 1020">B00A-R2W10 - General L. S</p>	<p data-bbox="938 499 1252 604">Masonry walls, carpet over concrete and sprayed coating (vermiculite) ceiling.</p>	<p data-bbox="1268 499 1554 842">No signs of visual mould growth were noted. Water damage (in the form of leaching) was noted to ceiling and upper sections of masonry wall. Refer to index photos. 347</p> <p data-bbox="1268 905 1554 968">IICRC-520:2015 Condition 3 guidelines</p>
  <p data-bbox="342 1545 654 1572">B00A-R2W09 - General L. S</p>	<p data-bbox="938 1052 1252 1157">Masonry walls, carpet over concrete and sprayed coating (vermiculite) ceiling.</p>	<p data-bbox="1268 1052 1554 1157">No signs of visual mould growth or water damage were noted.</p> <p data-bbox="1268 1167 1554 1230">IICRC-520:2015 Condition 3 guidelines</p>

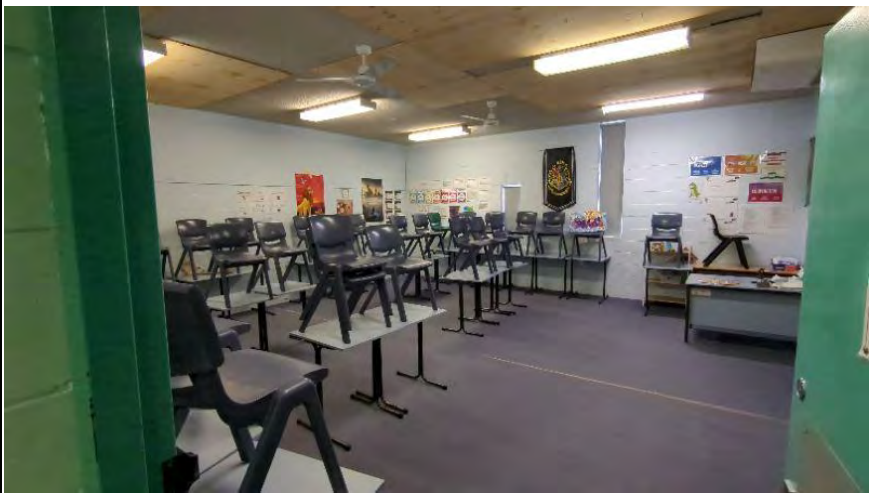
<p data-bbox="342 989 656 1020">B00A-R2W08 - General L. S</p>	<p data-bbox="938 499 1252 604">Masonry walls, carpet over concrete and sprayed coating (vermiculite) ceiling.</p>	<p data-bbox="1268 499 1552 604">No signs of visual mould growth or water damage were noted.</p> <p data-bbox="1268 615 1552 688">IICRC-520:2015 Condition 3 guidelines</p>

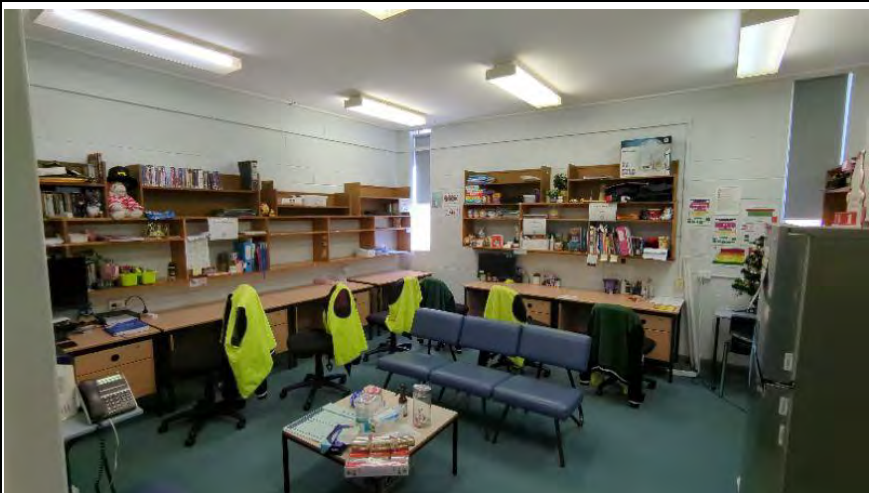
<p data-bbox="354 1535 644 1566">B00A-R2W07 Staff Study</p>	<p data-bbox="938 1045 1252 1150">Masonry walls, carpet over concrete and plasterboard ceiling.</p>	<p data-bbox="1268 1045 1552 1150">Suspected visual mould growth was noted to porous contents.</p> <p data-bbox="1268 1161 1552 1234">Refer to index photos 348 - 352.</p> <p data-bbox="1268 1245 1552 1318">IICRC-520:2015 Condition 3 guidelines</p>

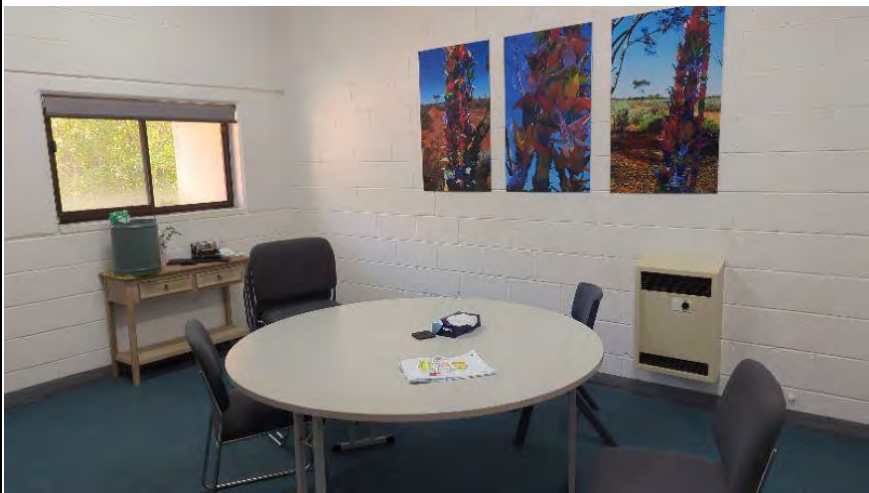
<p data-bbox="375 993 621 1024">B00A-R1S01 - Deputy</p>	<p data-bbox="938 499 1252 604">Masonry walls, carpet over concrete and plasterboard ceiling.</p>	<p data-bbox="1268 499 1554 604">No signs of visual mould growth or water damage were noted.</p> <p data-bbox="1268 621 1554 688">IICRC-520:2015 Condition 2 guidelines</p>

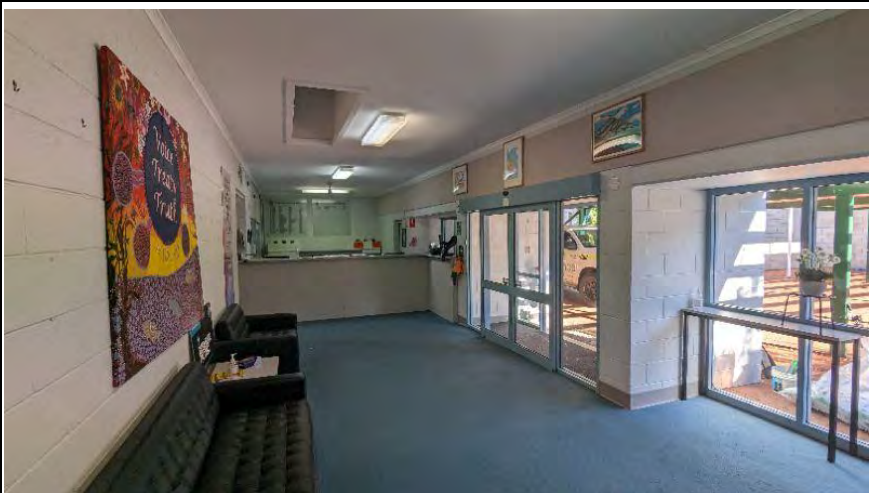
<p data-bbox="386 1539 610 1570">B00A-R1S03 - Entry</p>	<p data-bbox="938 1052 1252 1157">Masonry walls, carpet over concrete and sprayed coating (vermiculite) ceiling.</p>	<p data-bbox="1268 1052 1554 1157">No signs of visual mould growth or water damage were noted.</p> <p data-bbox="1268 1173 1554 1241">IICRC-520:2015 Condition 2 guidelines</p>

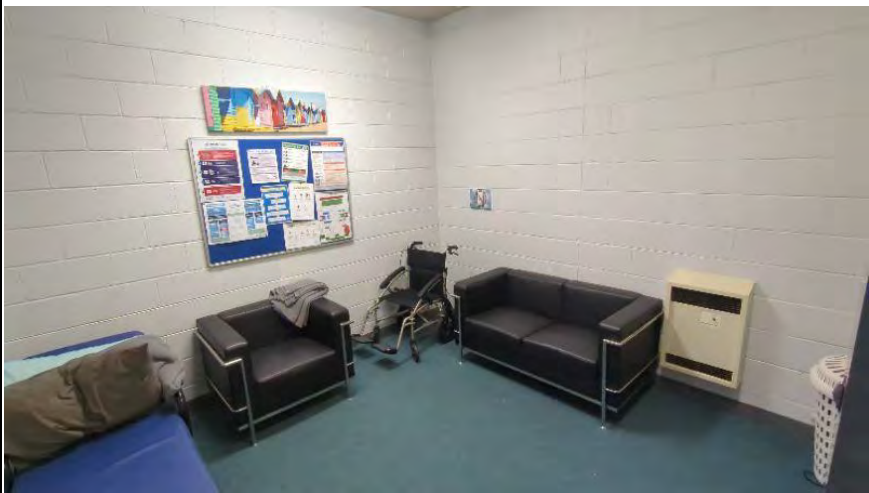
<p data-bbox="370 993 626 1024">B00A-R1S06 - Sick Bay</p>	<p data-bbox="938 499 1252 604">Masonry walls, carpet over concrete and sprayed coating (vermiculite) ceiling.</p>	<p data-bbox="1268 499 1554 688">No signs of visual mould growth or water damage were noted. IICRC-520:2015 Condition 2 guidelines</p>
  <p data-bbox="370 1539 626 1570">B00A-R1S07 - Printing</p>	<p data-bbox="938 1045 1252 1150">Masonry walls, carpet over concrete and sprayed coating (vermiculite) ceiling.</p>	<p data-bbox="1268 1045 1554 1234">No signs of visual mould growth or water damage were noted. IICRC-520:2015 Condition 2 guidelines</p>

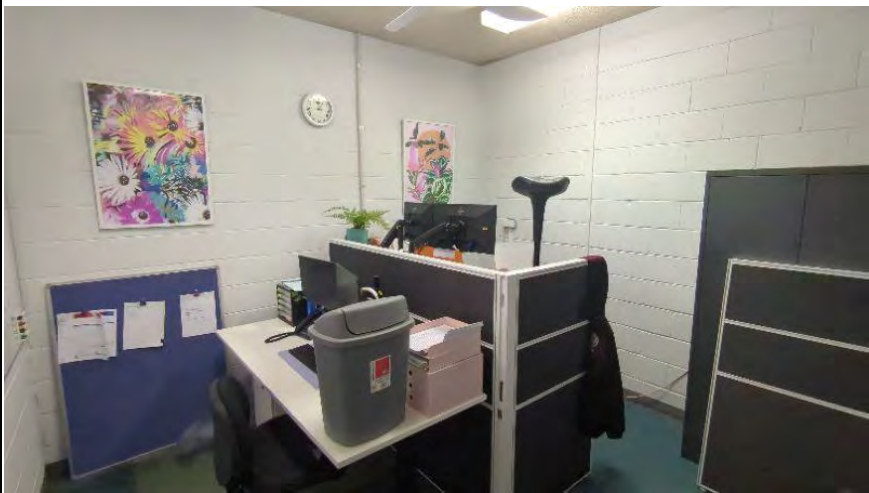
<p data-bbox="375 993 621 1020">B00A-R1S14 - Clerical</p>	<p data-bbox="938 499 1252 604">Masonry walls, carpet over concrete and sprayed coating (vermiculite) ceiling.</p>	<p data-bbox="1268 499 1559 730">*Add 'tape-lift' sample results* - Staining Present on seat Refer to index photo 353. IICRC-520:2015 Condition 2 guidelines</p>

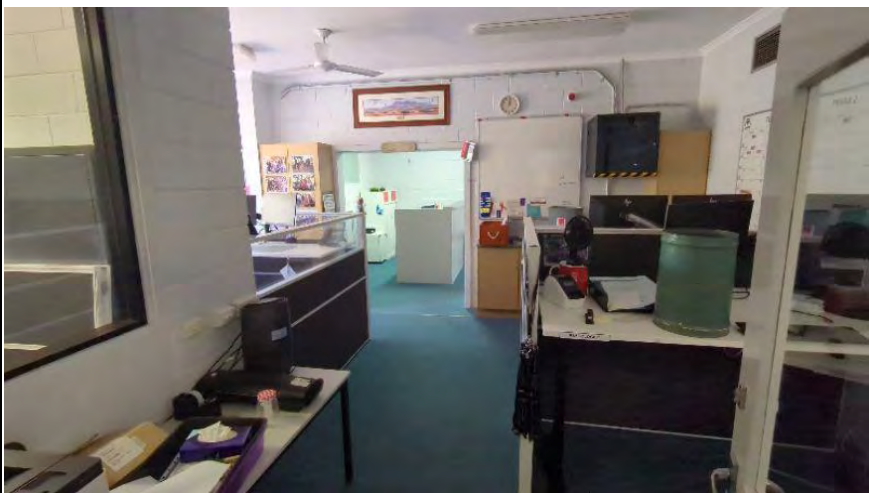
<p data-bbox="375 1541 621 1568">B00A-R1S15 - Clerical</p>	<p data-bbox="938 1050 1252 1192">Masonry walls, carpet over concrete and plasterboard ceiling lining over sprayed coating (vermiculite) ceiling.</p>	<p data-bbox="1268 1050 1559 1234">No signs of visual mould growth or water damage were noted. IICRC-520:2015 Condition 2 guidelines</p>

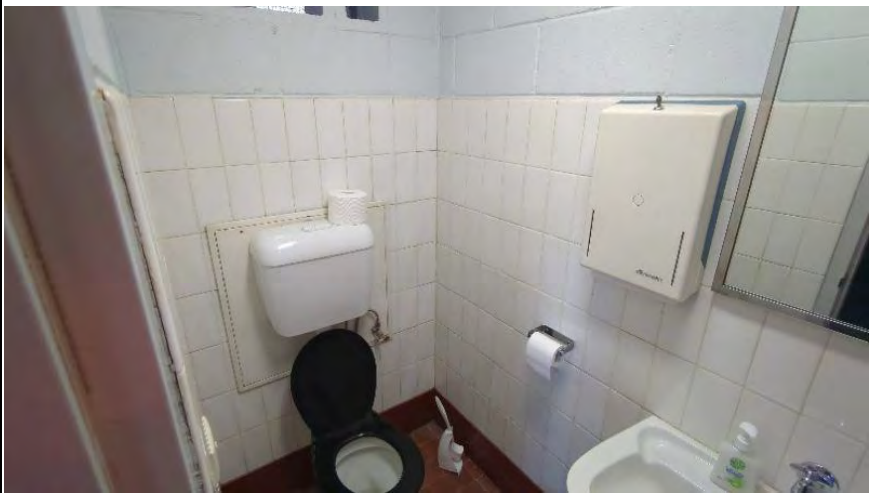
<p data-bbox="354 989 646 1020">B00A-R1S10 - Staff Toilet</p>	<p data-bbox="938 499 1253 604">Ceramic wall tiles, ceramic floor tiles and fibre cement ceiling.</p>	<p data-bbox="1266 499 1555 604">No signs of visual mould growth or water damage were noted.</p> <p data-bbox="1266 615 1555 688">IICRC-520:2015 Condition 2 guidelines</p>

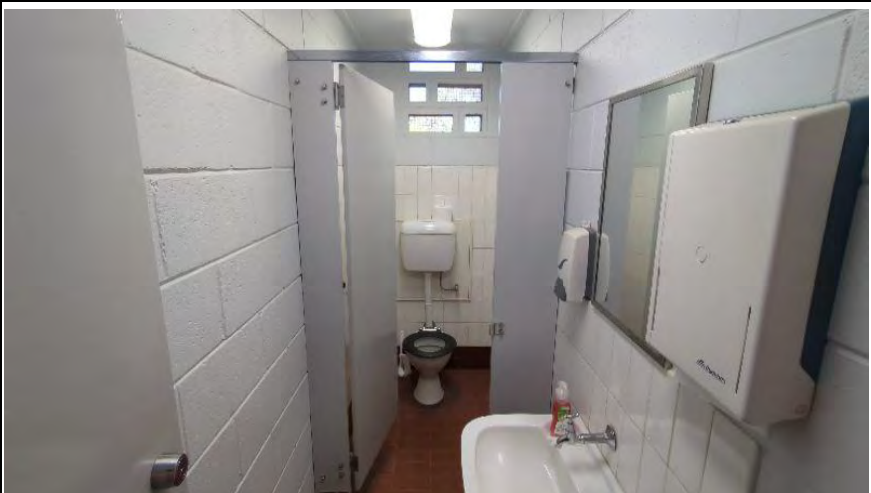
<p data-bbox="362 1539 638 1570">B00A-R1S11 Staff Toilet</p>	<p data-bbox="938 1045 1253 1150">Ceramic wall tiles, ceramic floor tiles and fibre cement ceiling.</p>	<p data-bbox="1266 1045 1555 1150">No signs of visual mould growth or water damage were noted.</p> <p data-bbox="1266 1161 1555 1234">IICRC-520:2015 Condition 2 guidelines</p>

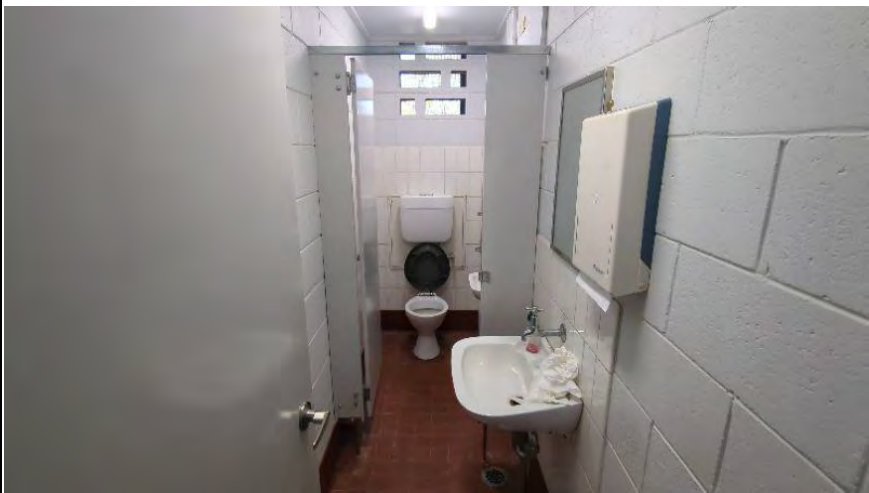
<p data-bbox="354 989 643 1020">B00A-R1S12 - Staff Toilet</p>	<p data-bbox="938 499 1252 604">Ceramic wall tiles, ceramic floor tiles and fibre cement ceiling.</p>	<p data-bbox="1268 499 1554 688">No signs of visual mould growth or water damage were noted. IICRC-520:2015 Condition 2 guidelines</p>

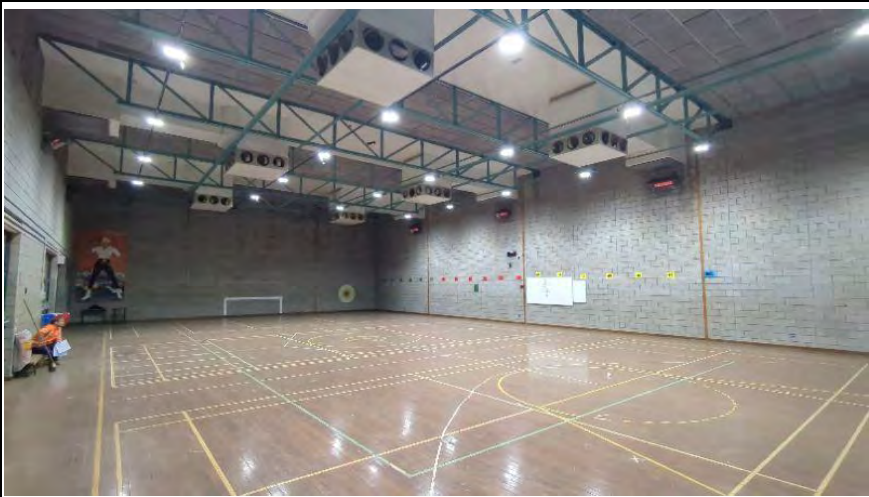
<p data-bbox="305 1539 695 1570">B00A-R0S08 - Multipurpose Space</p>	<p data-bbox="946 1052 1243 1150">Masonry walls, hardwood floor and acoustic ceiling tiles.</p>	<p data-bbox="1268 1052 1554 1241">No signs of visual mould growth or water damage were noted. IICRC-520:2015 Condition 2 guidelines</p>

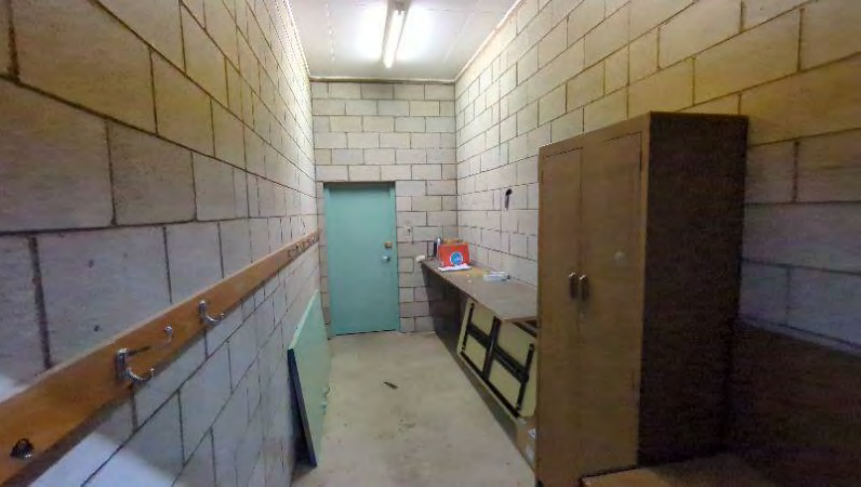
<p data-bbox="358 993 643 1020">B00A-R0S03 - Storeroom</p>	<p data-bbox="948 499 1243 569">Masonry walls, concrete floor and concrete ceiling.</p>	<p data-bbox="1268 499 1554 604">No signs of visual mould growth or water damage were noted.</p> <p data-bbox="1268 621 1554 690">IICRC-520:2015 Condition 2 guidelines</p>
<p data-bbox="371 1052 630 1079">B00A-R0S22 - Practice</p>		<p data-bbox="1268 1052 1554 1157">No signs of visual mould growth or water damage were noted.</p> <p data-bbox="1268 1173 1554 1243">Refer to index photos 354 - 356.</p> <p data-bbox="1268 1257 1554 1327">IICRC-520:2015 Condition 2 guidelines</p>

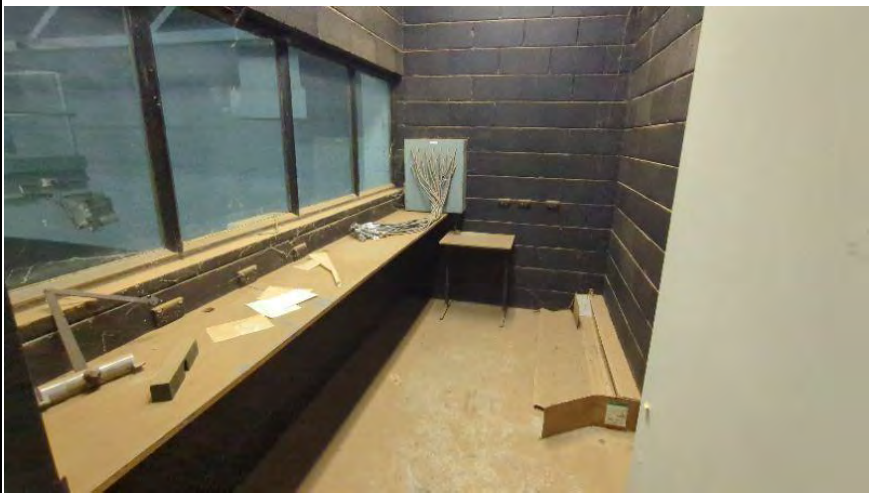
<p data-bbox="337 993 659 1020">B00A-R1S16 - Control Room</p>	<p data-bbox="946 499 1243 569">Masonry walls, concrete floor and concrete ceiling.</p>	<p data-bbox="1268 499 1554 604">No signs of visual mould growth or water damage were noted.</p> <p data-bbox="1284 621 1537 690">Refer to index photos 357, 359.</p> <p data-bbox="1260 701 1562 770">IICRC-520:2015 Condition 2 guidelines</p>

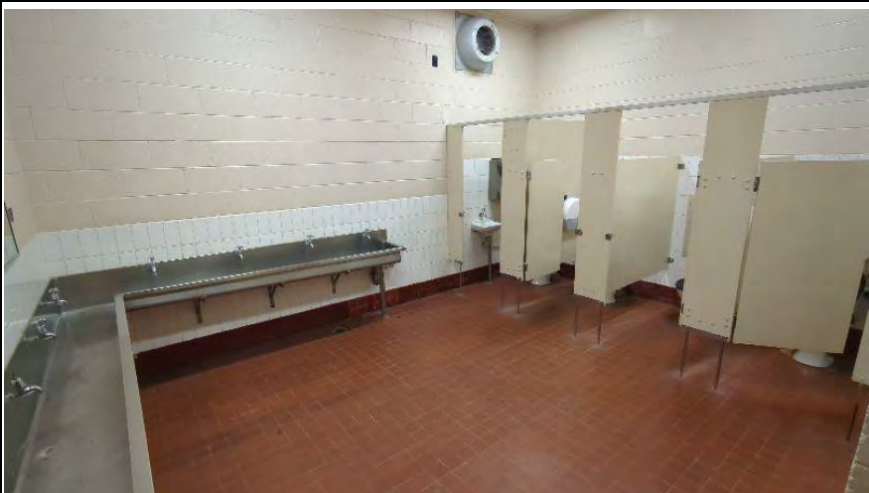
<p data-bbox="355 1539 641 1566">B00A-R0S27 - Girls Toilet</p>	<p data-bbox="938 1052 1252 1157">Masonry walls, ceramic wall tiles, ceramic floor tiles and concrete ceiling.</p>	<p data-bbox="1268 1052 1554 1157">No signs of visual mould growth or water damage were noted.</p> <p data-bbox="1260 1167 1562 1236">IICRC-520:2015 Condition 2 guidelines</p>

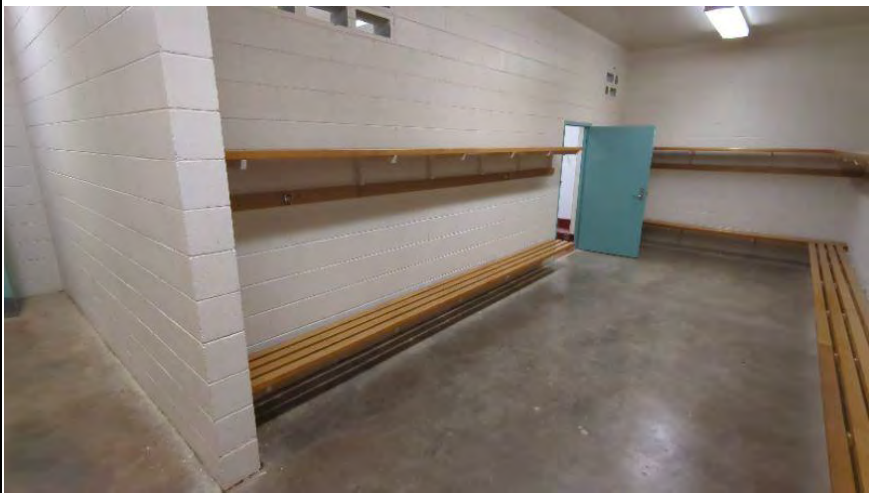
<p data-bbox="337 993 662 1024">B00A-RS024 - Change Room</p>	<p data-bbox="930 499 1260 569">Masonry walls, ceramic floor tiles and concrete ceiling.</p>	<p data-bbox="1260 499 1562 604">No signs of visual mould growth or water damage were noted.</p> <p data-bbox="1260 617 1562 686">IICRC-520:2015 Condition 2 guidelines</p>

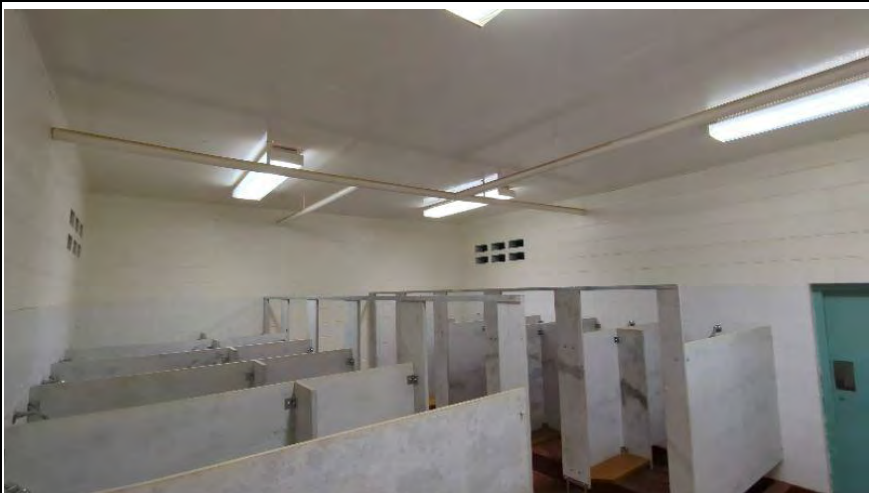
<p data-bbox="370 1541 630 1572">B00A-R0S25 - Showers</p>	<p data-bbox="930 1045 1260 1115">Masonry walls, ceramic floor tiles and concrete ceiling.</p>	<p data-bbox="1260 1045 1562 1150">No signs of visual mould growth or water damage were noted.</p> <p data-bbox="1260 1163 1562 1232">IICRC-520:2015 Condition 2 guidelines</p>

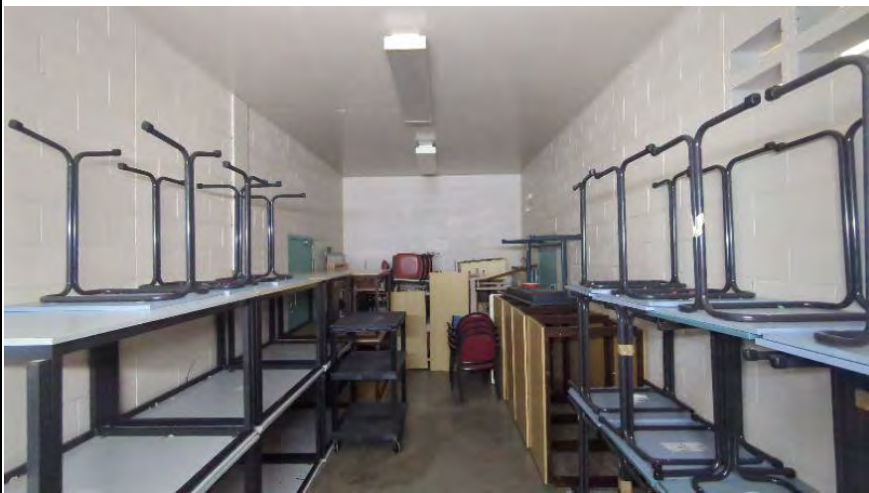
<p data-bbox="337 989 659 1020">B00A-R0S24 - Change Room</p>	<p data-bbox="930 489 1260 562">Masonry walls, ceramic floor tiles and concrete ceiling.</p>	<p data-bbox="1260 489 1560 600">No signs of visual mould growth or water damage were noted.</p> <p data-bbox="1260 611 1560 684">IICRC-520:2015 Condition 2 guidelines</p>

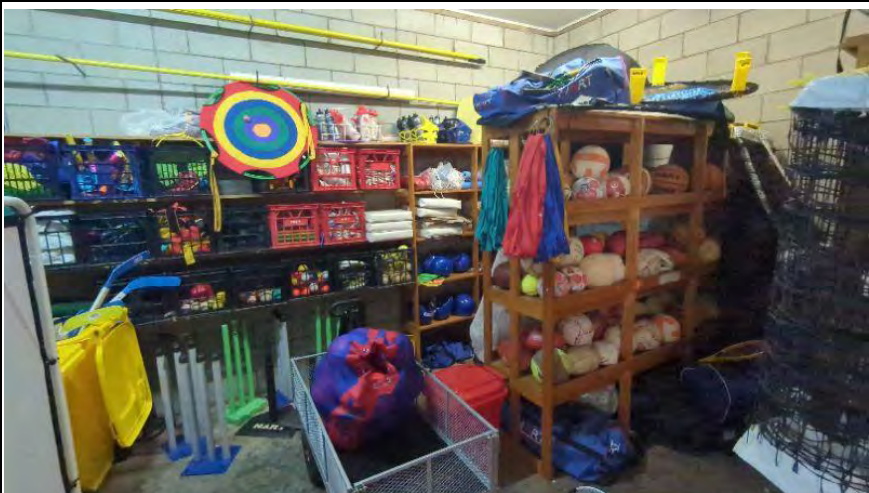
<p data-bbox="321 1535 675 1566">B00A-R0S30 - Equipment Store</p>	<p data-bbox="930 1035 1260 1108">Masonry walls, ceramic floor tiles and concrete ceiling.</p>	<p data-bbox="1260 1035 1560 1146">No signs of visual mould growth or water damage were noted.</p> <p data-bbox="1260 1157 1560 1230">IICRC-520:2015 Condition 2 guidelines</p>

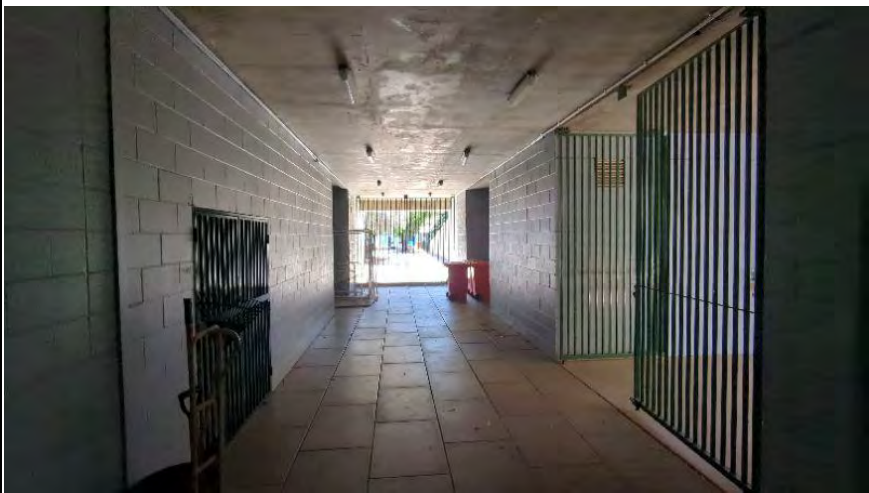
<p data-bbox="354 989 643 1020">B00A-R0S20 - Movement</p>	<p data-bbox="930 489 1260 562">Masonry walls, ceramic floor tiles and concrete ceiling.</p>	<p data-bbox="1260 489 1560 600">No signs of visual mould growth or water damage were noted.</p> <p data-bbox="1260 611 1560 684">IICRC-520:2015 Condition 2 guidelines</p>

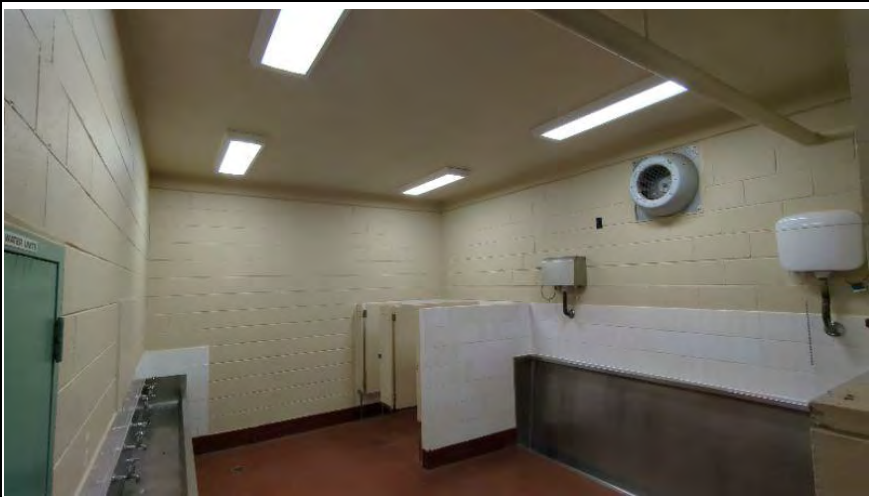
<p data-bbox="354 1539 643 1570">B00A-R0S15 - Boys Toilet</p>	<p data-bbox="930 1035 1260 1108">Masonry walls, ceramic floor tiles and concrete ceiling.</p>	<p data-bbox="1260 1035 1560 1146">No signs of visual mould growth or water damage were noted.</p> <p data-bbox="1260 1157 1560 1230">IICRC-520:2015 Condition 2 guidelines</p>

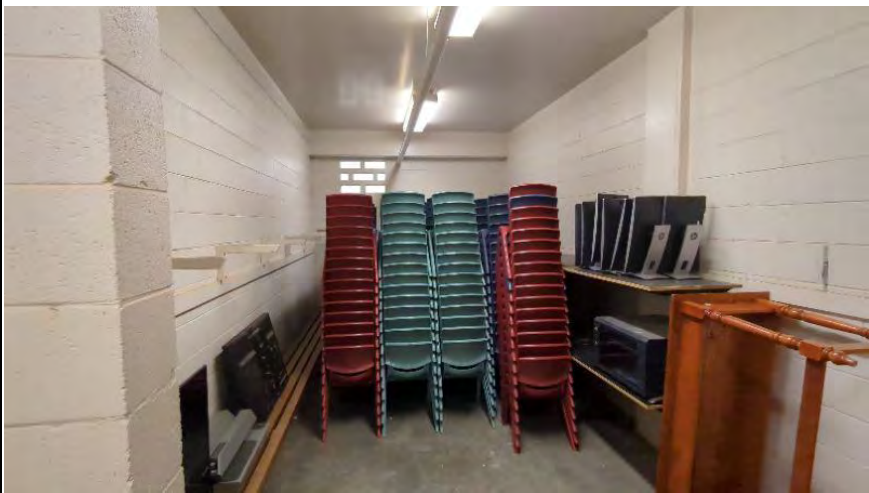
<p data-bbox="337 993 659 1024">B00A-R0S12 - Change Room</p>	<p data-bbox="930 499 1260 569">Masonry walls, ceramic floor tiles and concrete ceiling.</p>	<p data-bbox="1260 499 1562 604">No signs of visual mould growth or water damage were noted.</p> <p data-bbox="1260 617 1562 686">IICRC-520:2015 Condition 2 guidelines</p>

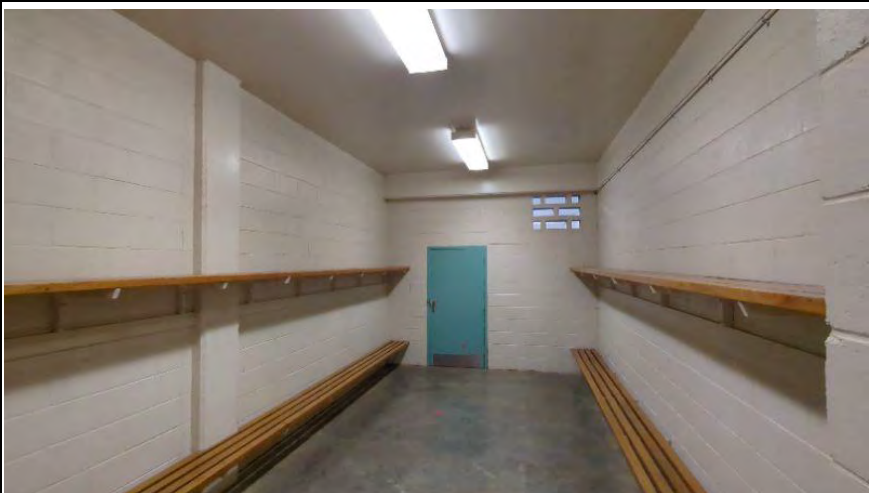
<p data-bbox="337 1539 659 1570">B00A-R0S11 - Change Room</p>	<p data-bbox="930 1045 1260 1115">Masonry walls, ceramic floor tiles and concrete ceiling.</p>	<p data-bbox="1260 1045 1562 1150">No signs of visual mould growth or water damage were noted.</p> <p data-bbox="1260 1163 1562 1232">IICRC-520:2015 Condition 2 guidelines</p>

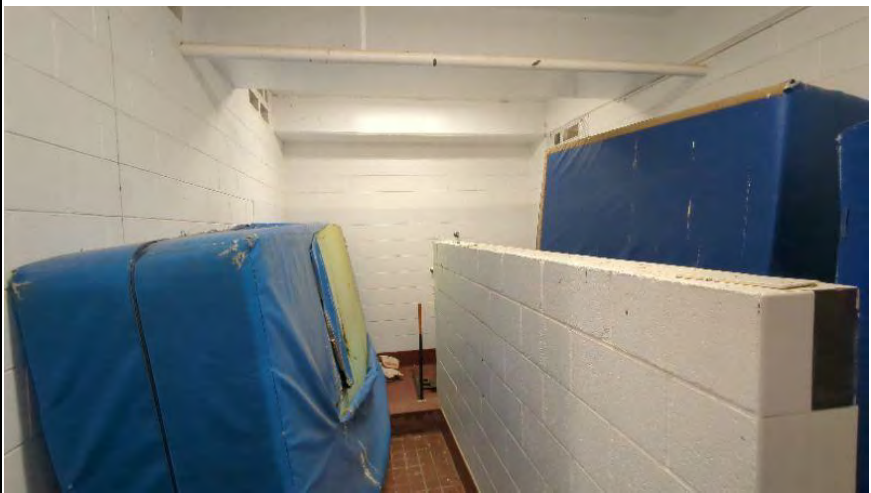
<p data-bbox="370 993 630 1020">B00A-R0S10 - Showers</p>	<p data-bbox="932 499 1260 569">Masonry walls, ceramic floor tiles and concrete ceiling.</p>	<p data-bbox="1273 499 1555 680">Suspected visual mould growth was noted to porous contents. Room was in a general state of disarray.</p> <p data-bbox="1260 695 1563 764">IICRC-520:2015 Condition 2 guidelines</p>

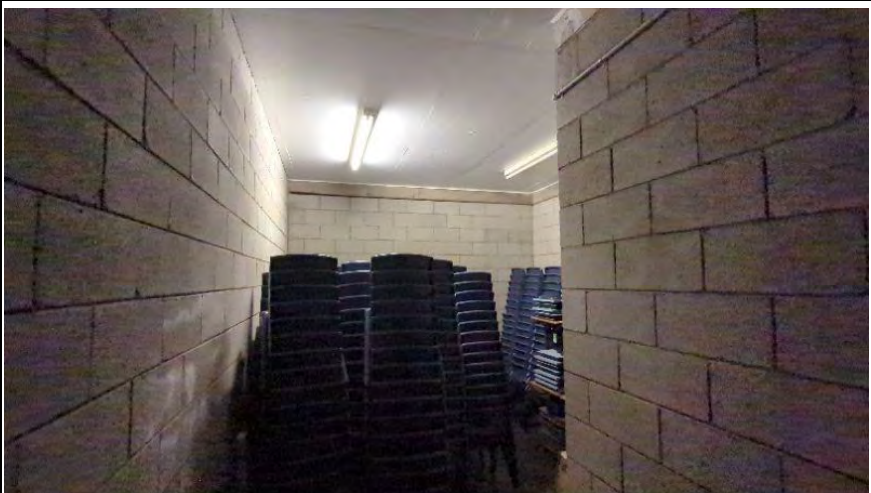
<p data-bbox="321 1541 678 1568">B00A-R0S05 - Equipment Store</p>	<p data-bbox="932 1047 1260 1117">Masonry walls, ceramic floor tiles and concrete ceiling.</p>	<p data-bbox="1260 1047 1563 1266">No signs of visual mould growth were noted. Water ingress (in the form of leaching) was noted to the upper sections of masonry walls.</p> <p data-bbox="1260 1281 1563 1350">Refer to index photos 360 - 361.</p> <p data-bbox="1260 1365 1563 1434">IICRC-520:2015 Condition 2 guidelines</p>
<p data-bbox="354 1596 646 1623">B00A-R0S04 - Chair Store</p>		<p data-bbox="1273 1596 1555 1707">No access, keys provided did not open. Assumed mould</p>

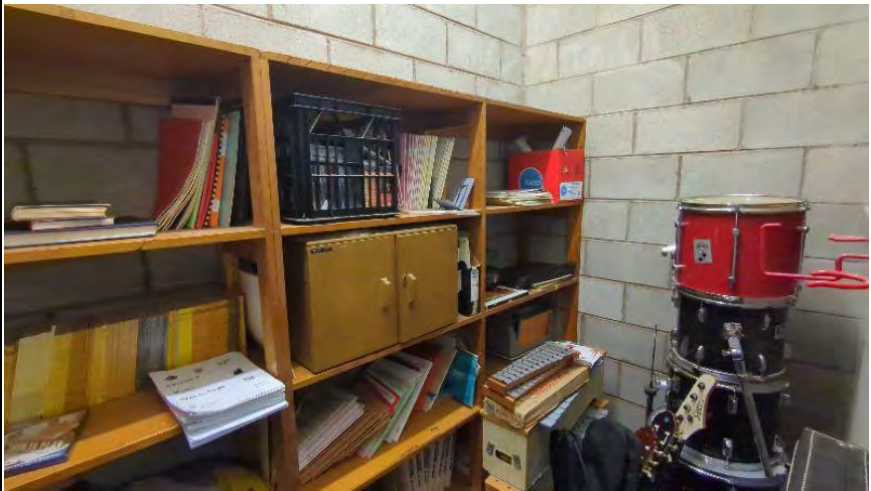
<p data-bbox="347 989 651 1020">B00A-R0N13 - Music Store</p>	<p data-bbox="943 495 1252 600">Masonry walls, carpet over concrete and concrete ceiling.</p>	<p data-bbox="1271 495 1552 768">Suspected visual mould growth was noted to the carpet and all contents. Refer to index photos 362 - 363. IICRC-520:2015 Condition 3 guidelines</p>

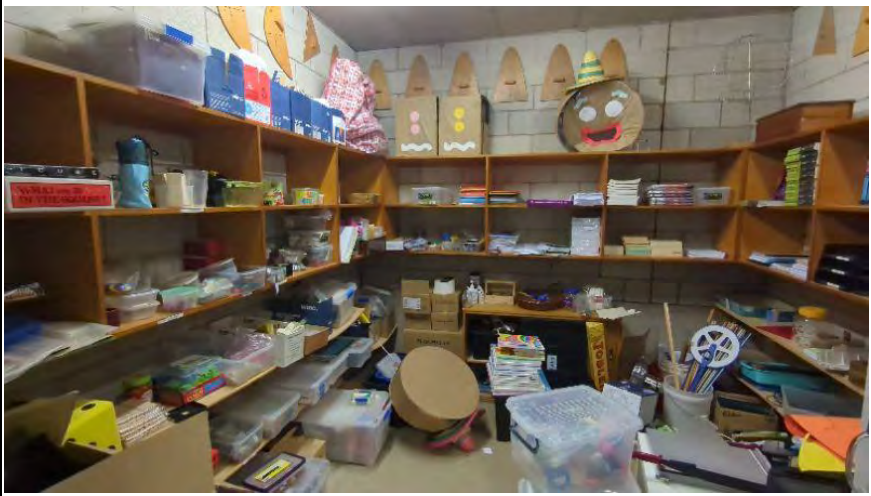
Photo	Material Type	Description
<p>B00A-R1E16 - Staff Study</p>	<p>Masonry walls, carpet over concrete and sprayed coating (vermiculite) ceiling.</p>	<p>Suspected visual mould growth was noted to carpet floor and porous contents.</p> <p>Refer to index photos 370 - 371</p> <p>IICRC-520:2015 Condition 3 guidelines</p>

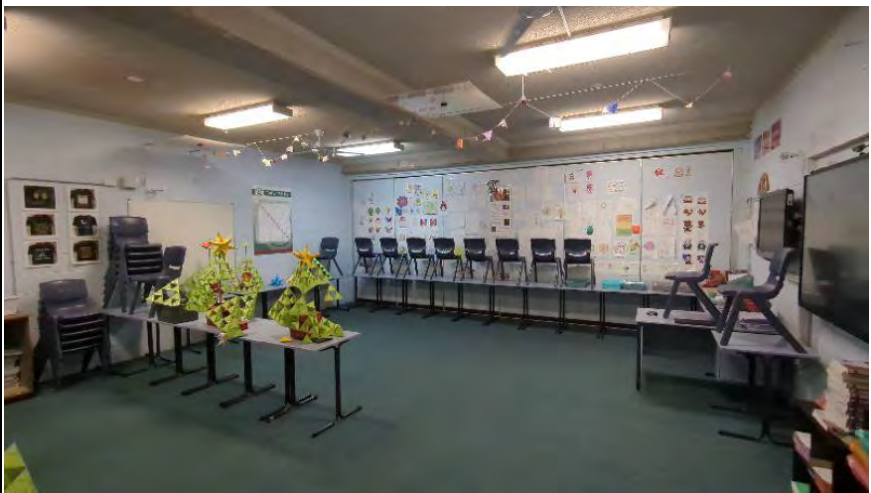
<p data-bbox="350 993 651 1020">B00A-R1E10 - General L. S</p>	<p data-bbox="938 499 1255 604">Masonry walls, carpet over concrete and sprayed coating (vermiculite) ceiling.</p>	<p data-bbox="1268 499 1554 604">Suspected visual mould growth was noted to carpet floor.</p> <p data-bbox="1268 615 1554 688">IICRC-520:2015 Condition 3 guidelines</p>
<p data-bbox="362 1045 639 1073">B00A-R2E08 - Music L. S</p>	<p data-bbox="938 1045 1255 1150">Masonry walls, carpet over concrete and sprayed coating (vermiculite) ceiling.</p>	<p data-bbox="1268 1045 1554 1150">No signs of visual mould growth or water damage were noted.</p> <p data-bbox="1268 1161 1554 1234">IICRC-520:2015 Condition 3 guidelines</p>

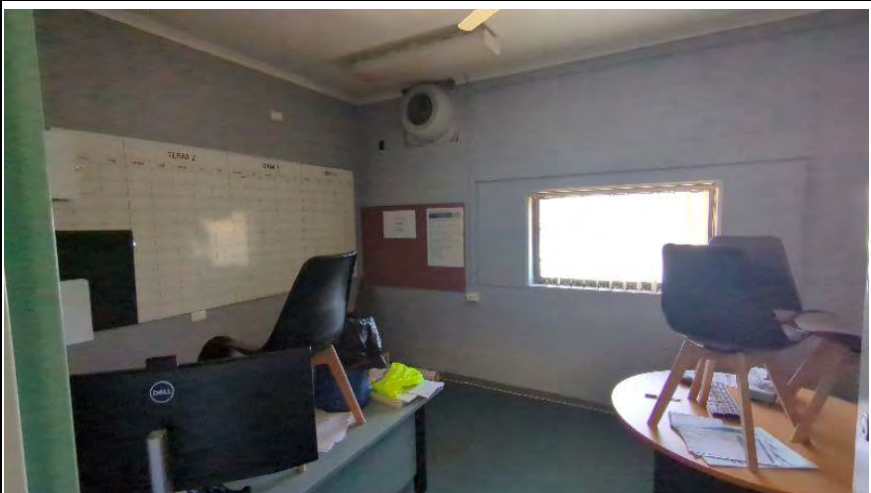
<p data-bbox="350 1770 646 1797">B00A-R2N13 - Staff Study</p>	<p data-bbox="938 1276 1255 1381">Masonry walls, carpet over concrete and sprayed coating (vermiculite) ceiling.</p>	<p data-bbox="1268 1276 1554 1381">Suspected visual mould growth was noted to linoleum skirting.</p> <p data-bbox="1268 1392 1554 1465">IICRC-520:2015 Condition 3 guidelines</p>

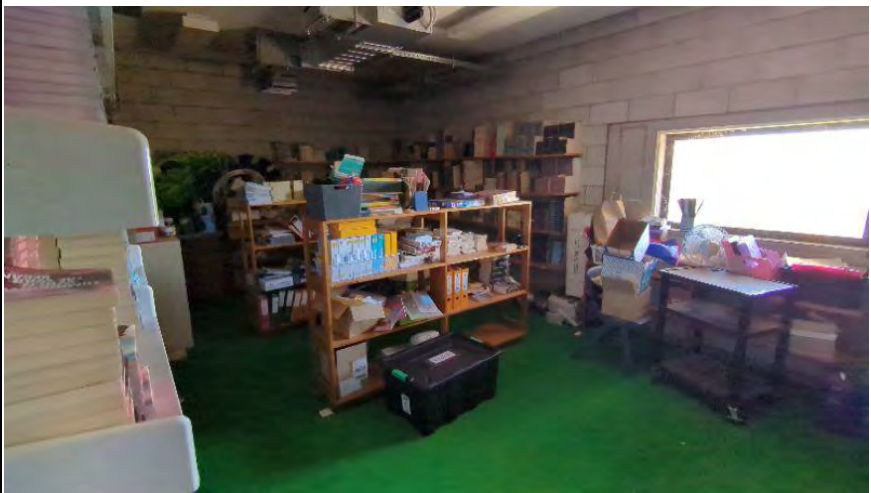
<p data-bbox="342 989 654 1020">B00A-R2W01 - Store Room</p>	<p data-bbox="937 499 1256 604">Masonry walls, carpet over concrete and sprayed coating (vermiculite) ceiling.</p>	<p data-bbox="1268 499 1554 604">No signs of visual mould growth or water damage were noted.</p> <p data-bbox="1268 615 1554 688">IICRC-520:2015 Condition 3 guidelines</p>

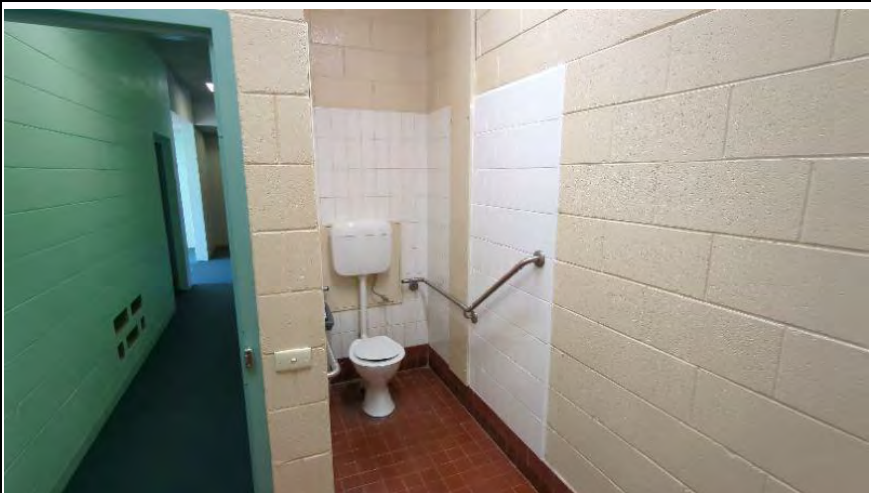
<p data-bbox="355 1535 641 1566">B00A-RW02 - Staff Toilet</p>	<p data-bbox="937 1045 1256 1108">Masonry walls, ceramic floor tiles and concrete ceiling.</p>	<p data-bbox="1268 1045 1554 1150">No signs of visual mould growth or water damage were noted.</p> <p data-bbox="1268 1161 1554 1234">IICRC-520:2015 Condition 3 guidelines</p>

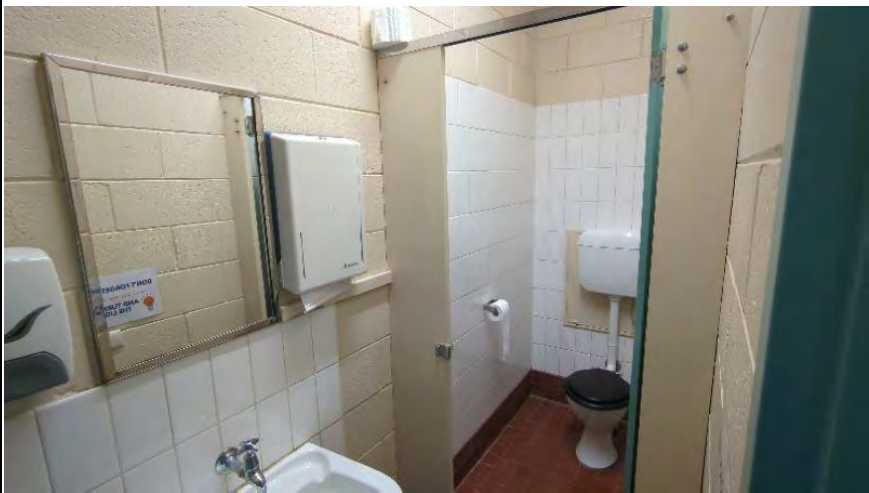
<p data-bbox="349 993 651 1020">B00A-R2W03 - Staff Toilet</p>	<p data-bbox="930 499 1260 569">Masonry walls, ceramic floor tiles and concrete ceiling.</p>	<p data-bbox="1260 499 1562 604">No signs of visual mould growth or water damage were noted.</p> <p data-bbox="1260 617 1562 686">IICRC-520:2015 Condition 3 guidelines</p>

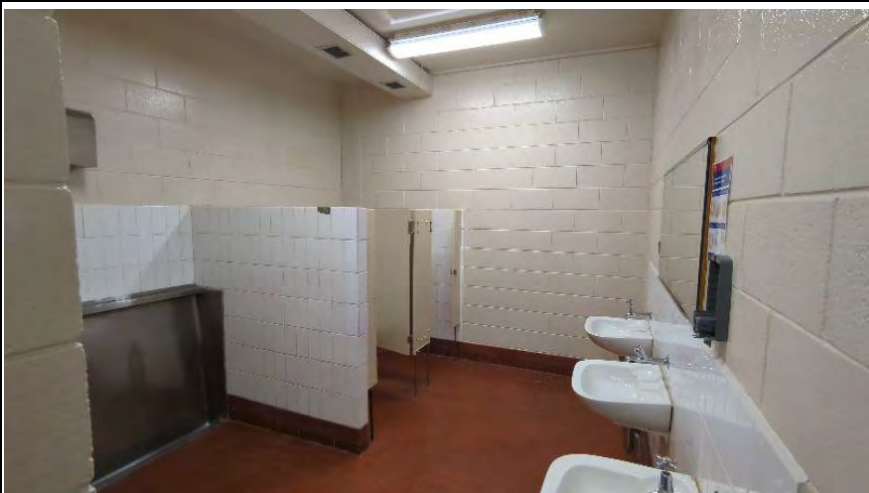
<p data-bbox="349 1539 651 1566">B00A-R2W04 - Boys Toilet</p>	<p data-bbox="930 1045 1260 1115">Masonry walls, ceramic floor tiles and concrete ceiling.</p>	<p data-bbox="1260 1045 1562 1150">No signs of visual mould growth or water damage were noted.</p> <p data-bbox="1260 1163 1562 1232">IICRC-520:2015 Condition 3 guidelines</p>

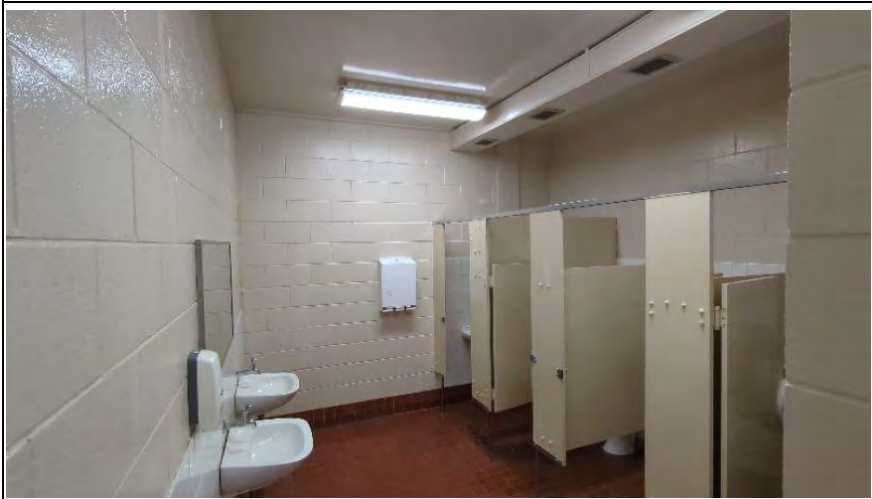
<p data-bbox="336 1081 624 1111">B00A-2W05 - Girls Toilet</p>	<p data-bbox="916 584 1251 651">Masonry walls, ceramic floor tiles and concrete ceiling.</p>	<p data-bbox="1251 584 1554 689">No signs of visual mould growth or water damage were noted.</p> <p data-bbox="1251 707 1554 775">IICRC-520:2015 Condition 3 guidelines</p>

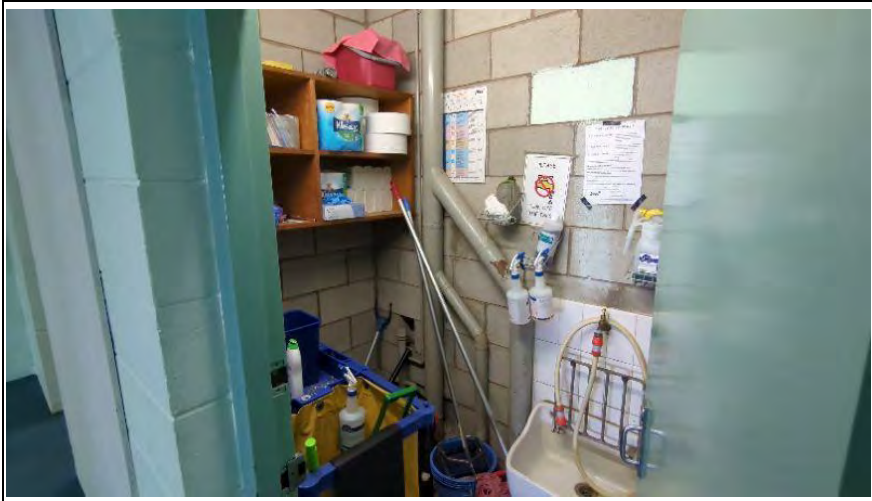
<p data-bbox="341 1632 619 1662">CS-7 Cleaning cupboard</p>	<p data-bbox="916 1137 1251 1205">Masonry walls, ceramic floor tiles and concrete ceiling.</p>	<p data-bbox="1251 1137 1554 1317">Unable to identify room from floor plan. No signs of visual mould growth or water damage were noted.</p> <p data-bbox="1251 1335 1554 1402">IICRC-520:2015 Condition 3 guidelines</p>
