Chatswood High School Redevelopment

Environmental Management Plan

Report reference number: SYDEN290382-R07

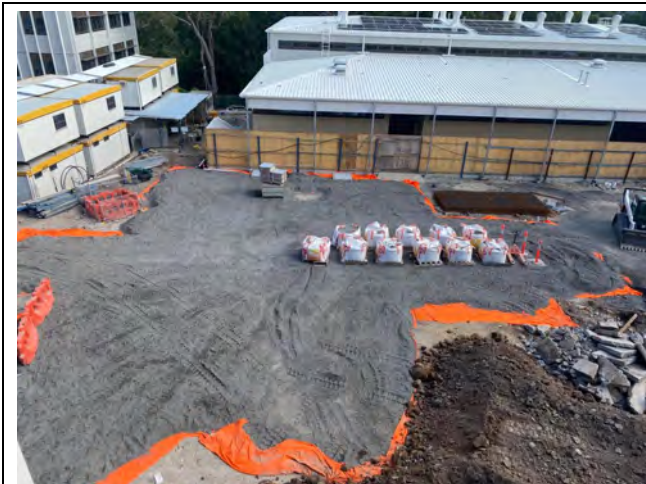
(intentionally or otherwise) when conducting future maintenance activity or construction. The photographs below illustrate the marker layer installed in different areas of the site.

Photograph 1: Elevated view of marker layer installed beneath the High School Green.

The marker layer installed within the site comprises an orange-coloured, non-degradable, non-woven geotextile fabric that was placed over historical fill material remaining within the site outside of building footprints. The purpose of the marker layer was to separate potentially contaminated fill from the capping materials above, and act as a highly visible indicator to alert workers who may disturb the capping layer

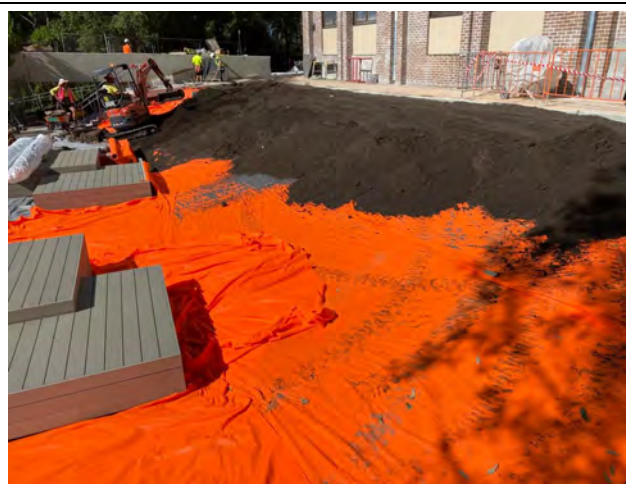
Photograph 2: Marker layer installed in landscaped area east of Building S.

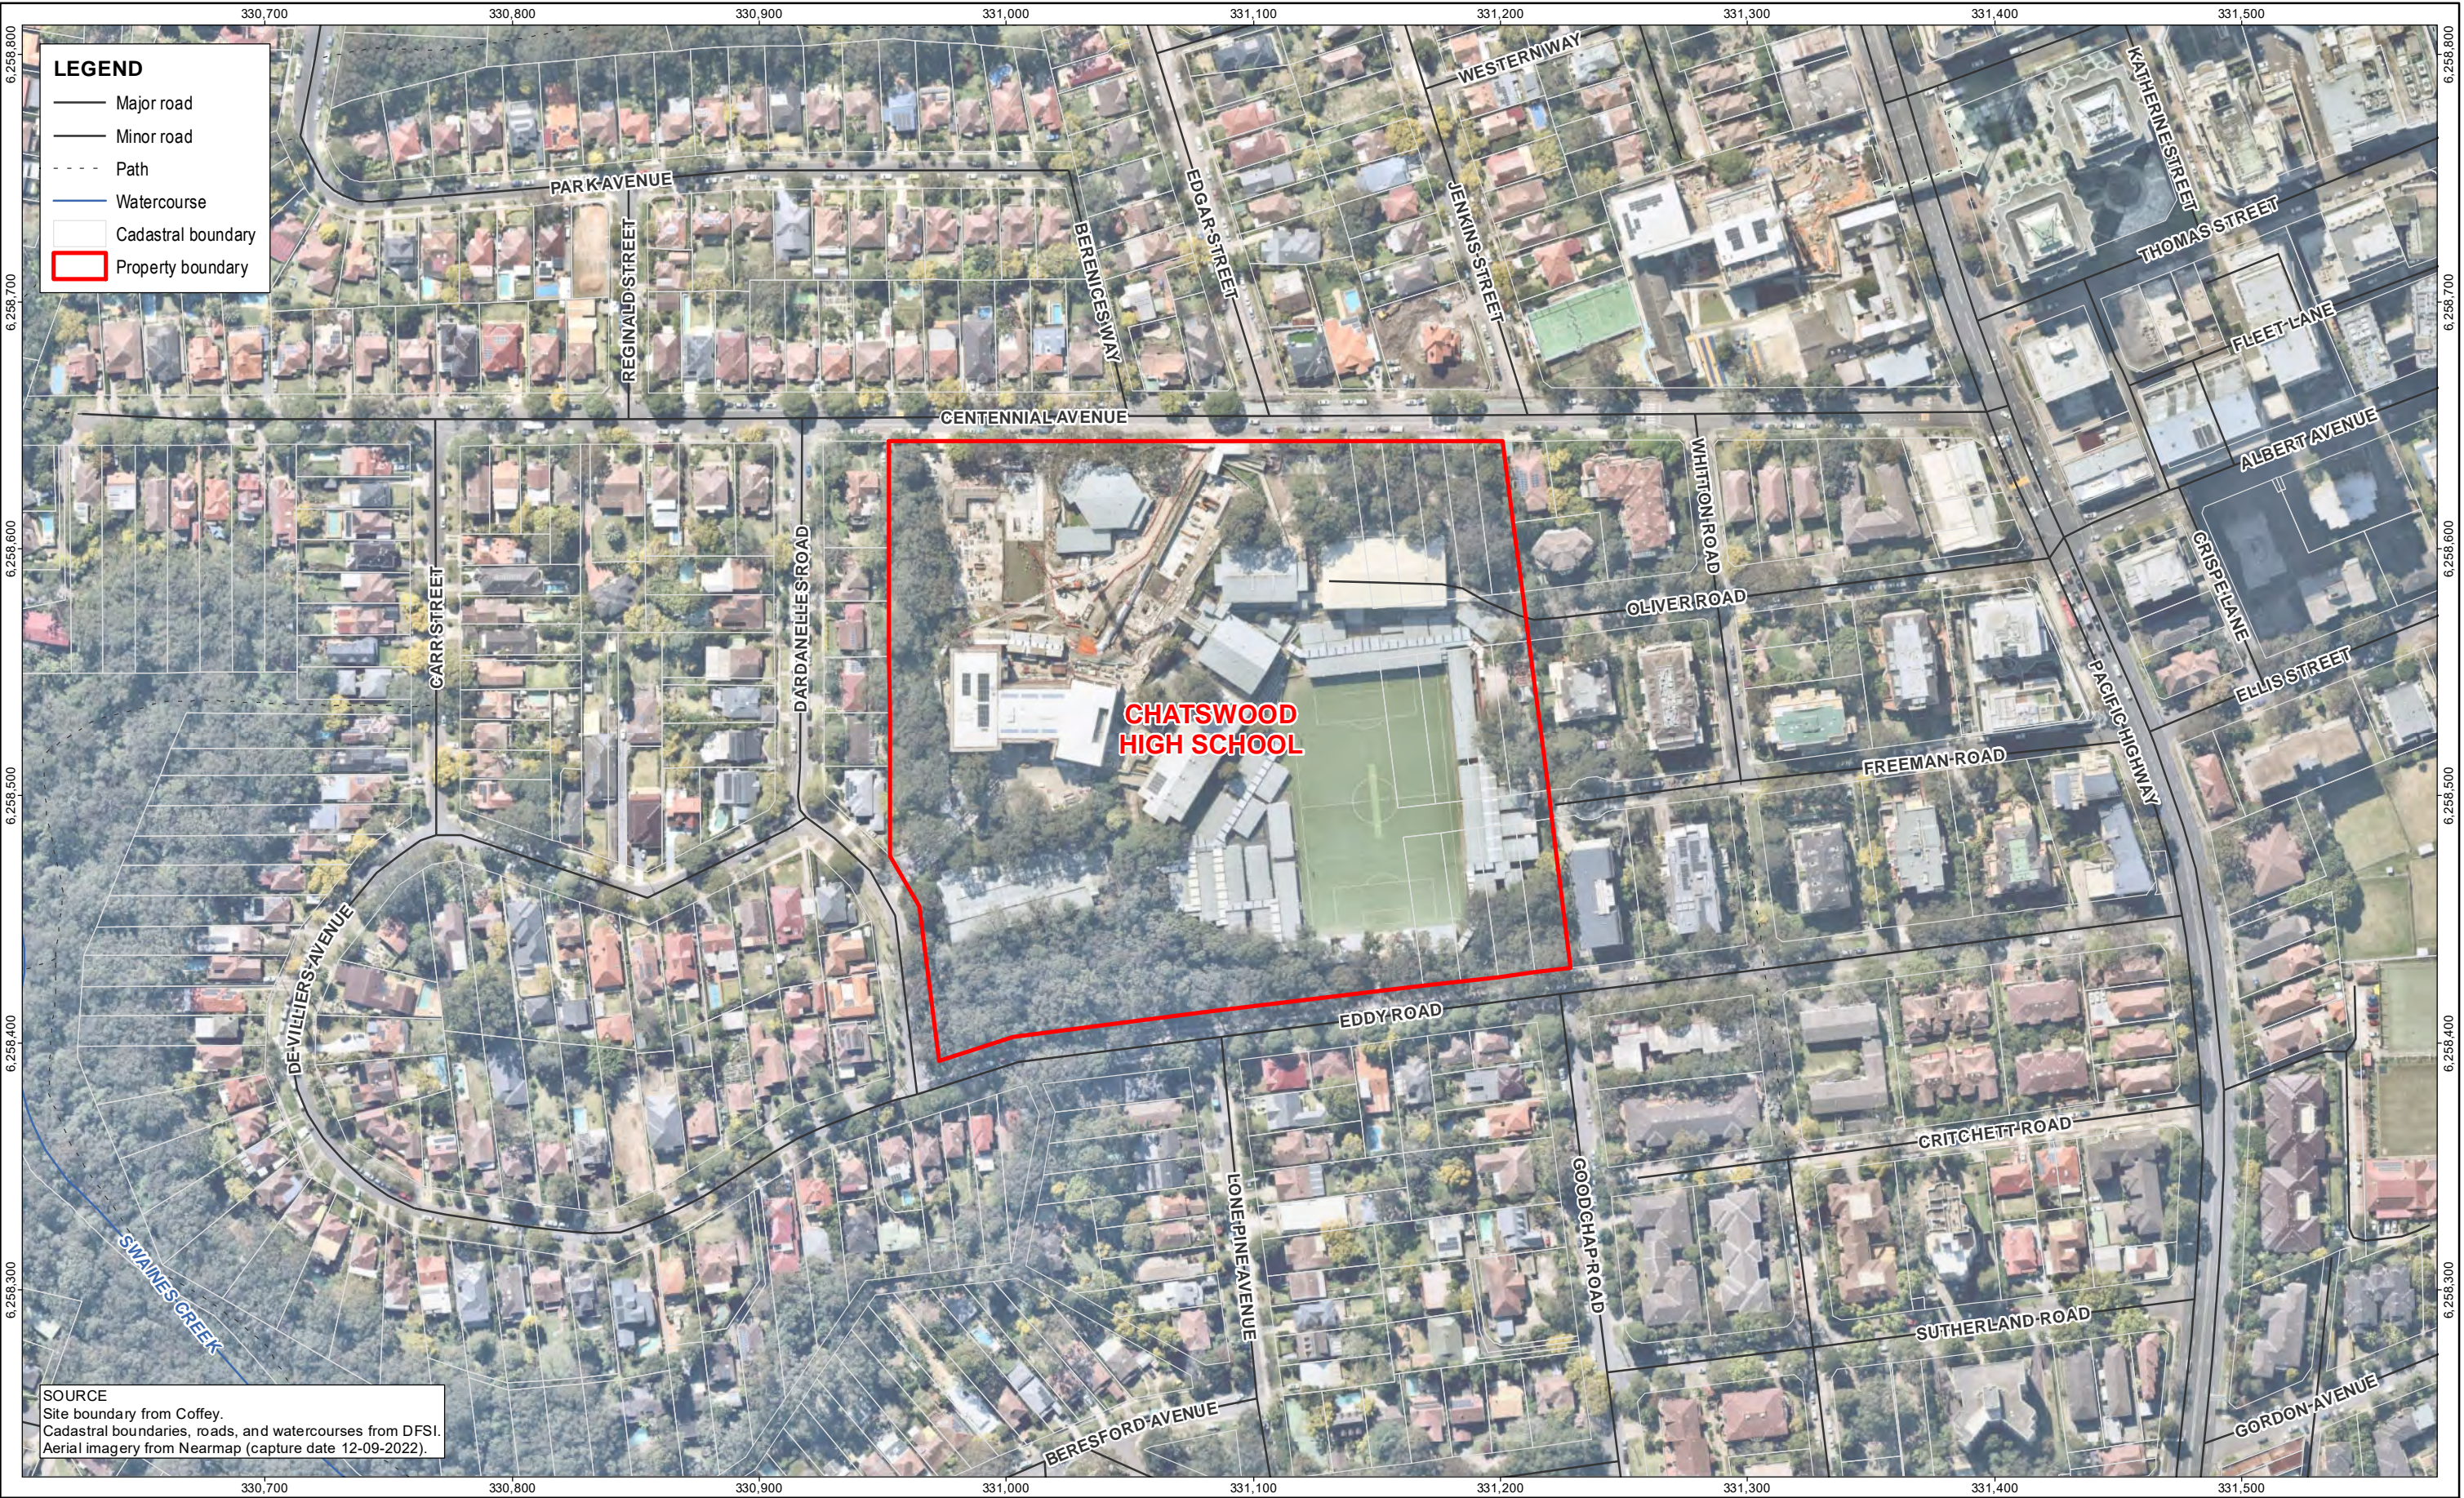
| project no: | SYDEN290382_R07 | figure no: | FIGURE 1 |

Figure 1: Property Boundary Plan

The Department of Education (DoE) has engaged Richard Crookes Constructions Pty Ltd (RCC) as Principal Contractor for redevelopment of Chatswood High School, which is located at 24 Centennial Avenue, Chatswood NSW (the 'property'). Figure 1 illustrates the location and extent of the property.

Information relating to the site affected by this EMP is summarised in Table 2.1. The location of the property and site are shown on Figure 1 and Figure 2 (Appendix A).
