Chatswood Public School Redevelopment

Environmental Management Plan

Report reference number: SYDEN290382-R02 v5 5 July 2023

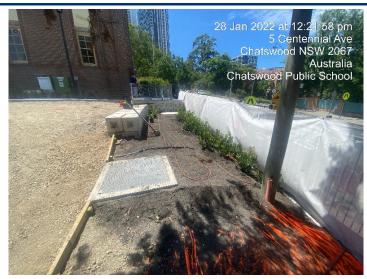
Photograph 3: Example showing site conditions where the orange-coloured marker layer was exposed beneath topsoil materials within a landscaped area in the nature play area (Stage 1 development)

Photograph 3 illustrates what the exposed marker layer could look like within gardens within the site.

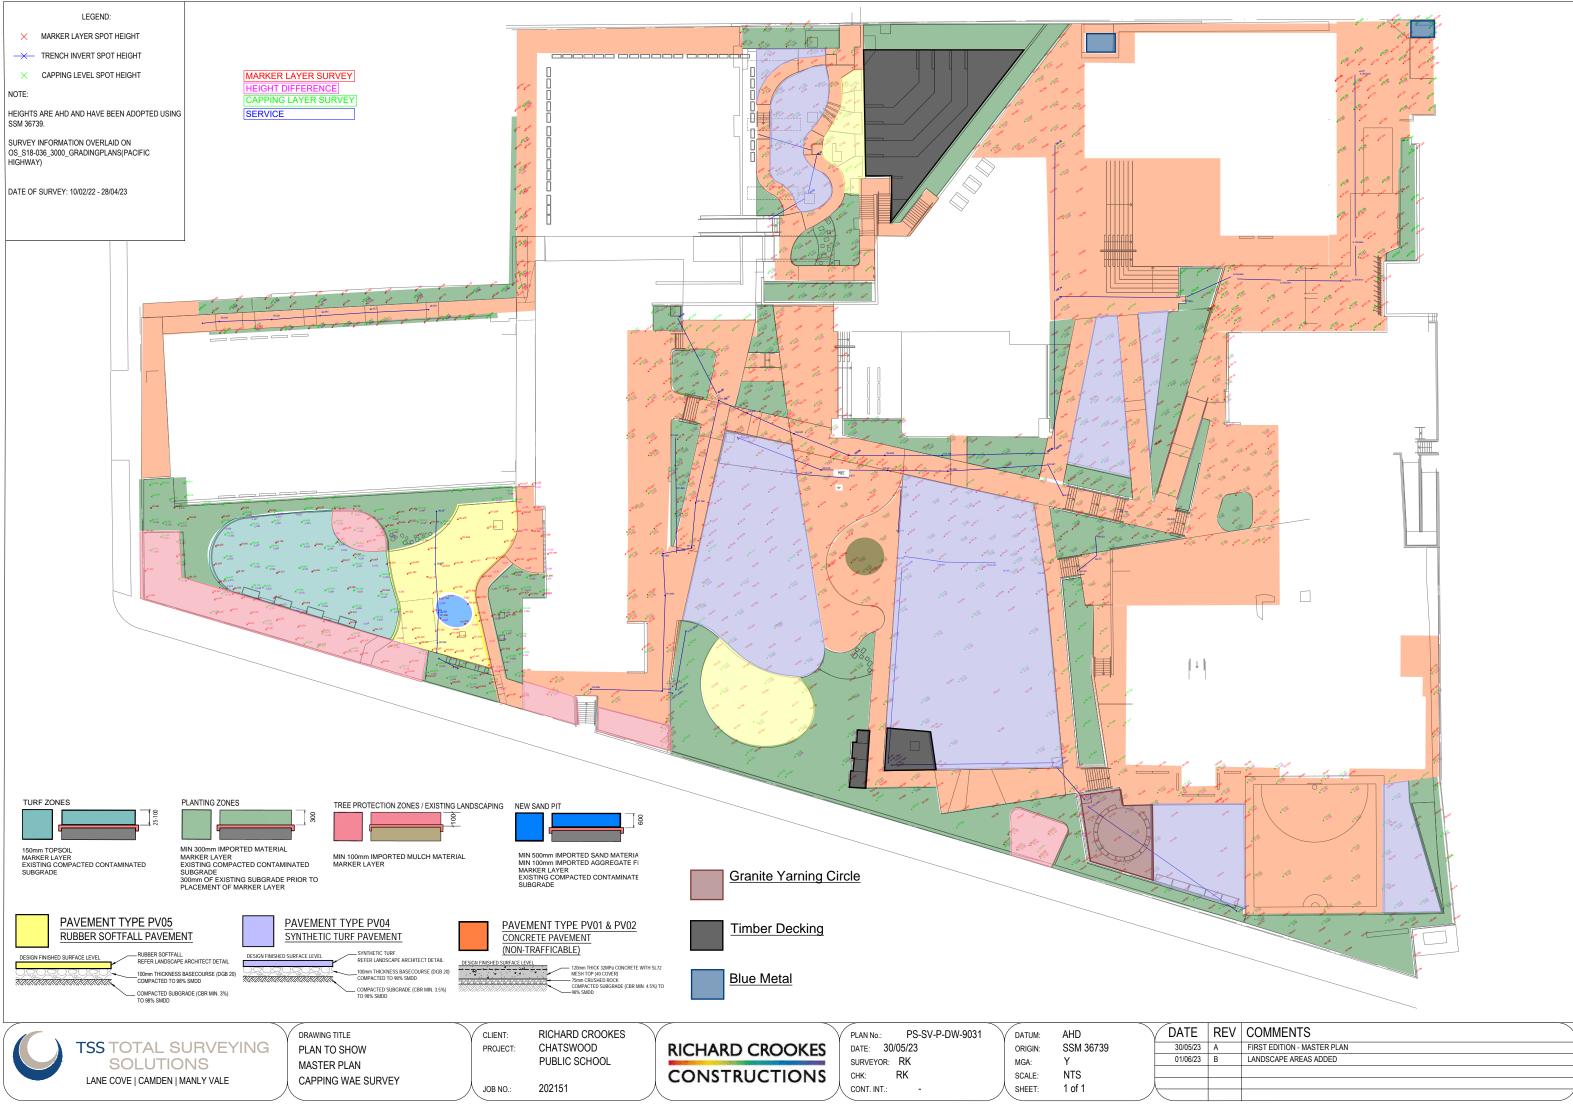
APPENDIX B: CAPPING LAYER SURVEY INFORMATION

Έ	REV	COMMENTS
5/23	A	FIRST EDITION - MASTER PLAN
6/23	В	LANDSCAPE AREAS ADDED
