Remediation Action Plan

Proposed Upgrade Works  
417 Abercrombie Street, Darlington, NSW

Prepared for  
NSW Minister of Education, Training and Youth Affairs

Project 92277.02  
August 2020

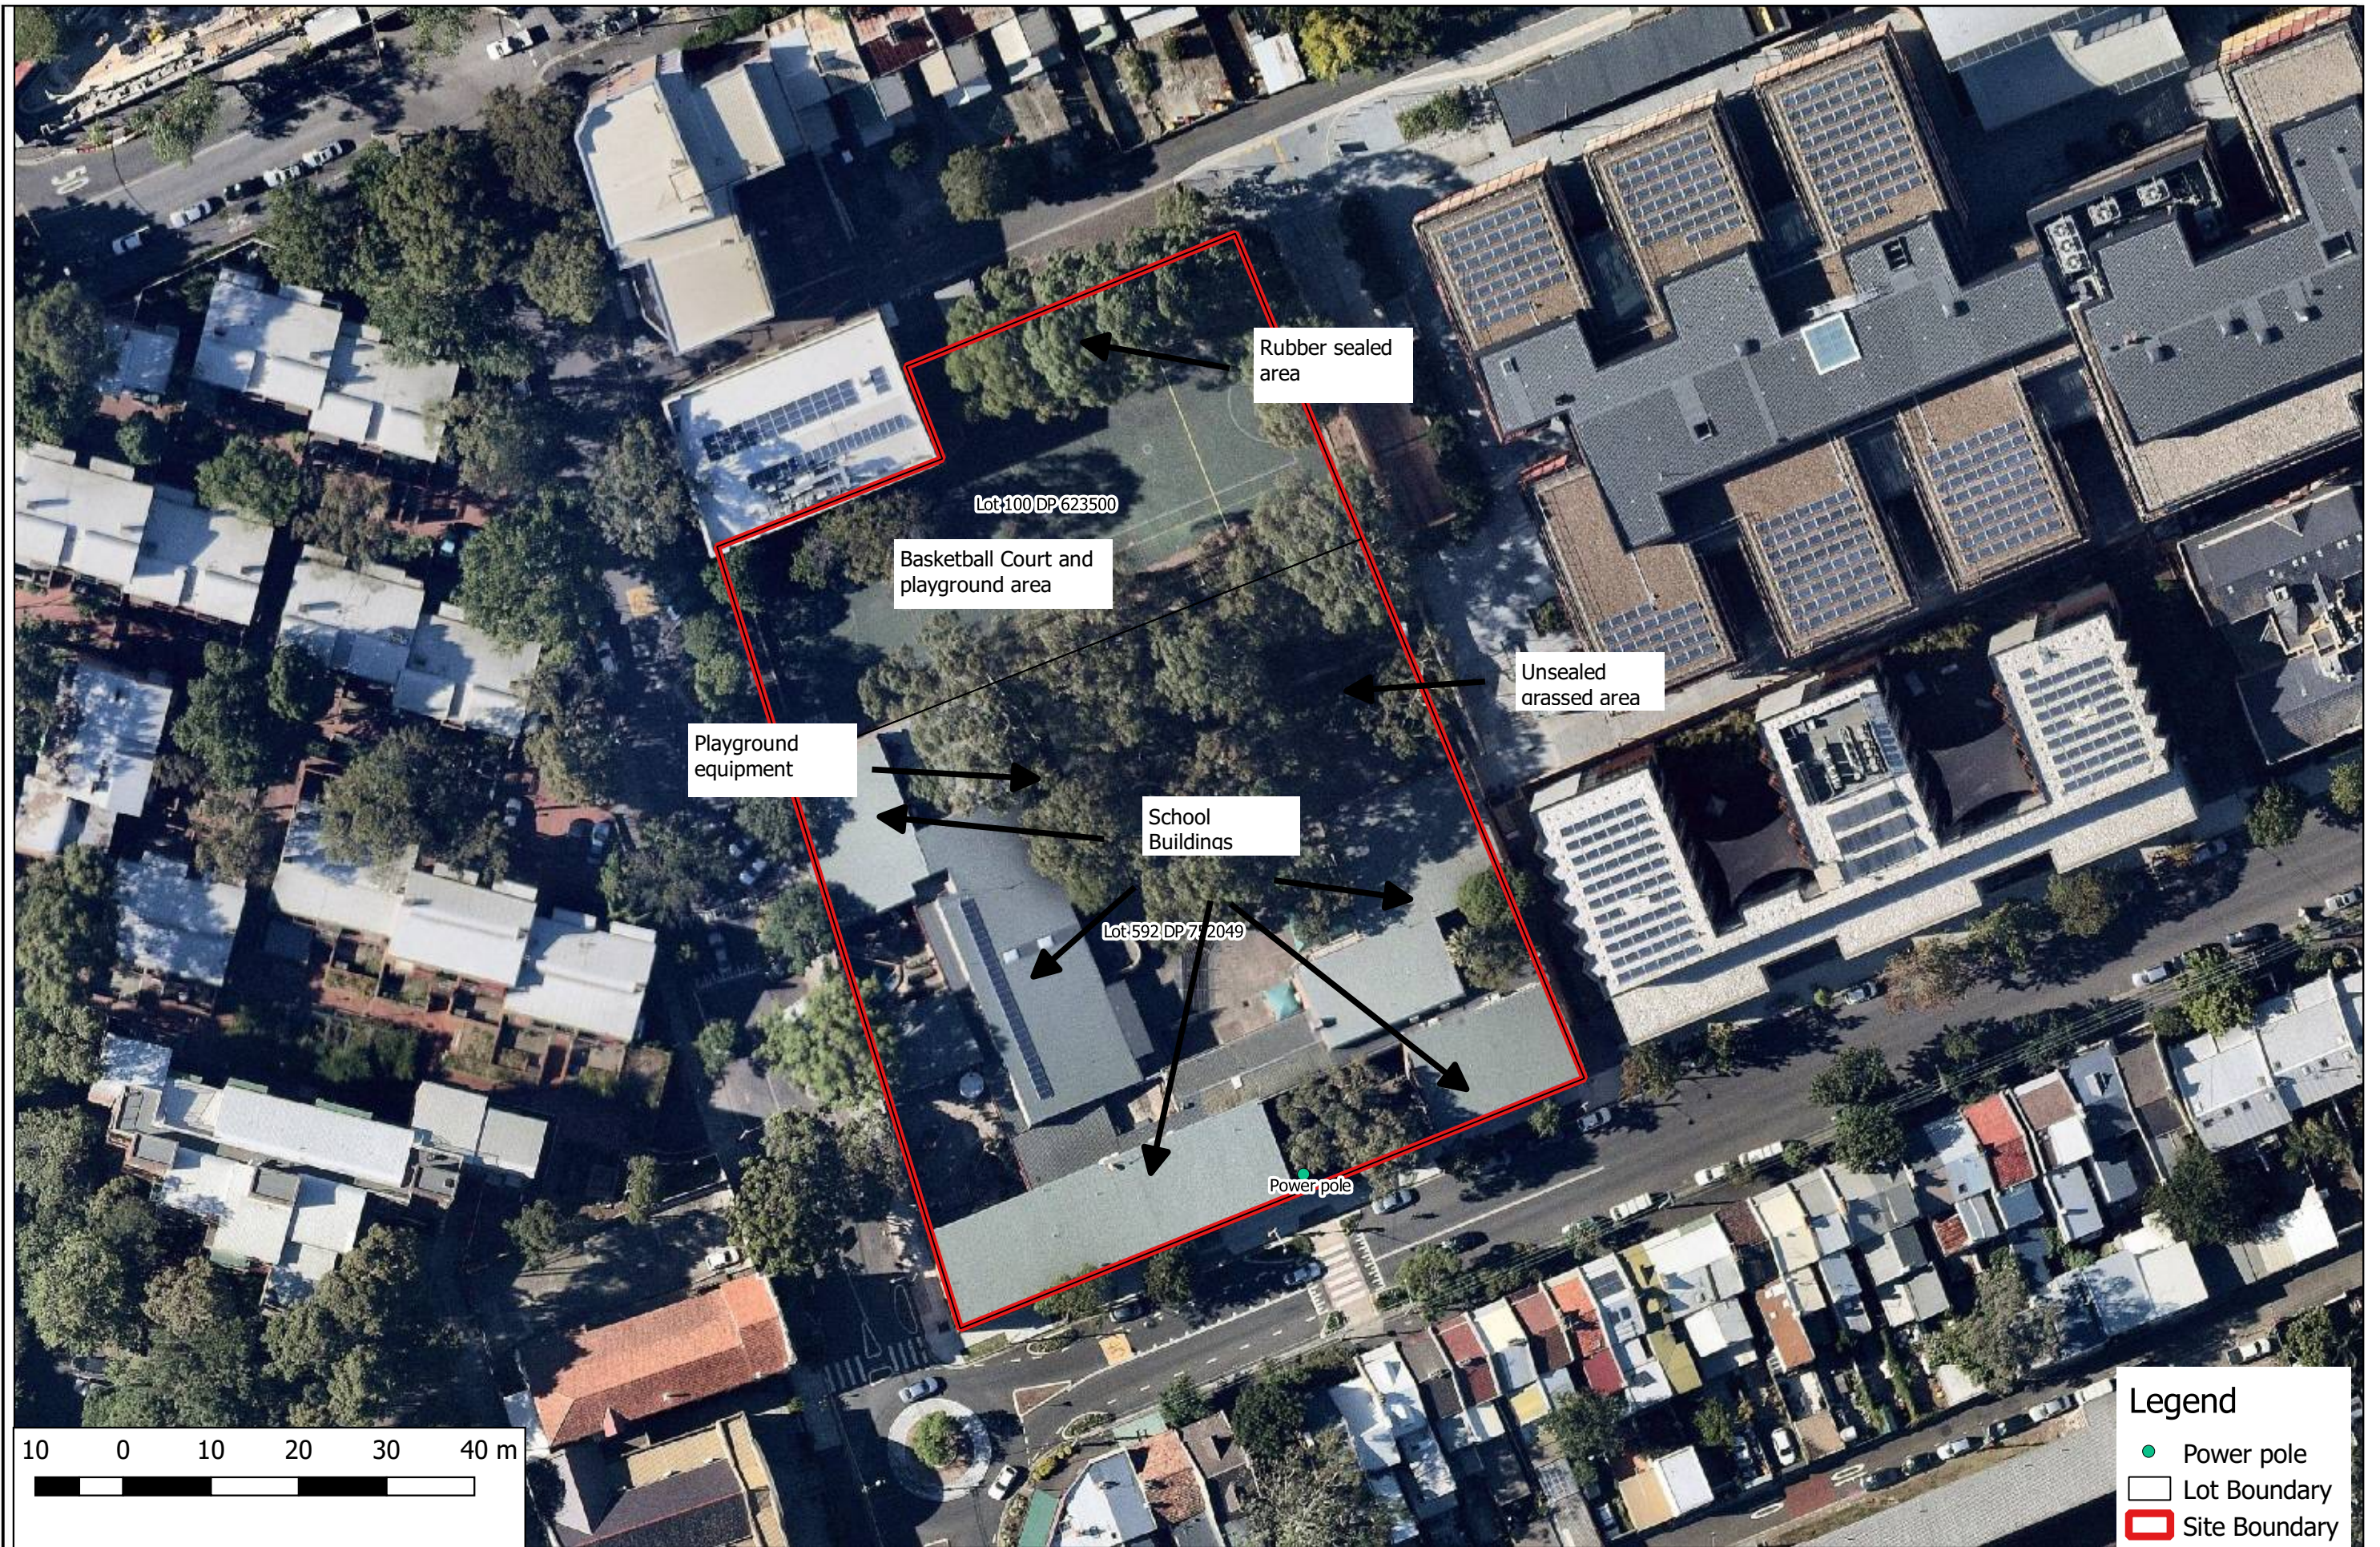
PROJECT No: 92277.02
DRAWING No: 2
REVISION: A

Legend	
	Power pole
	Lot Boundary
	Site Boundary

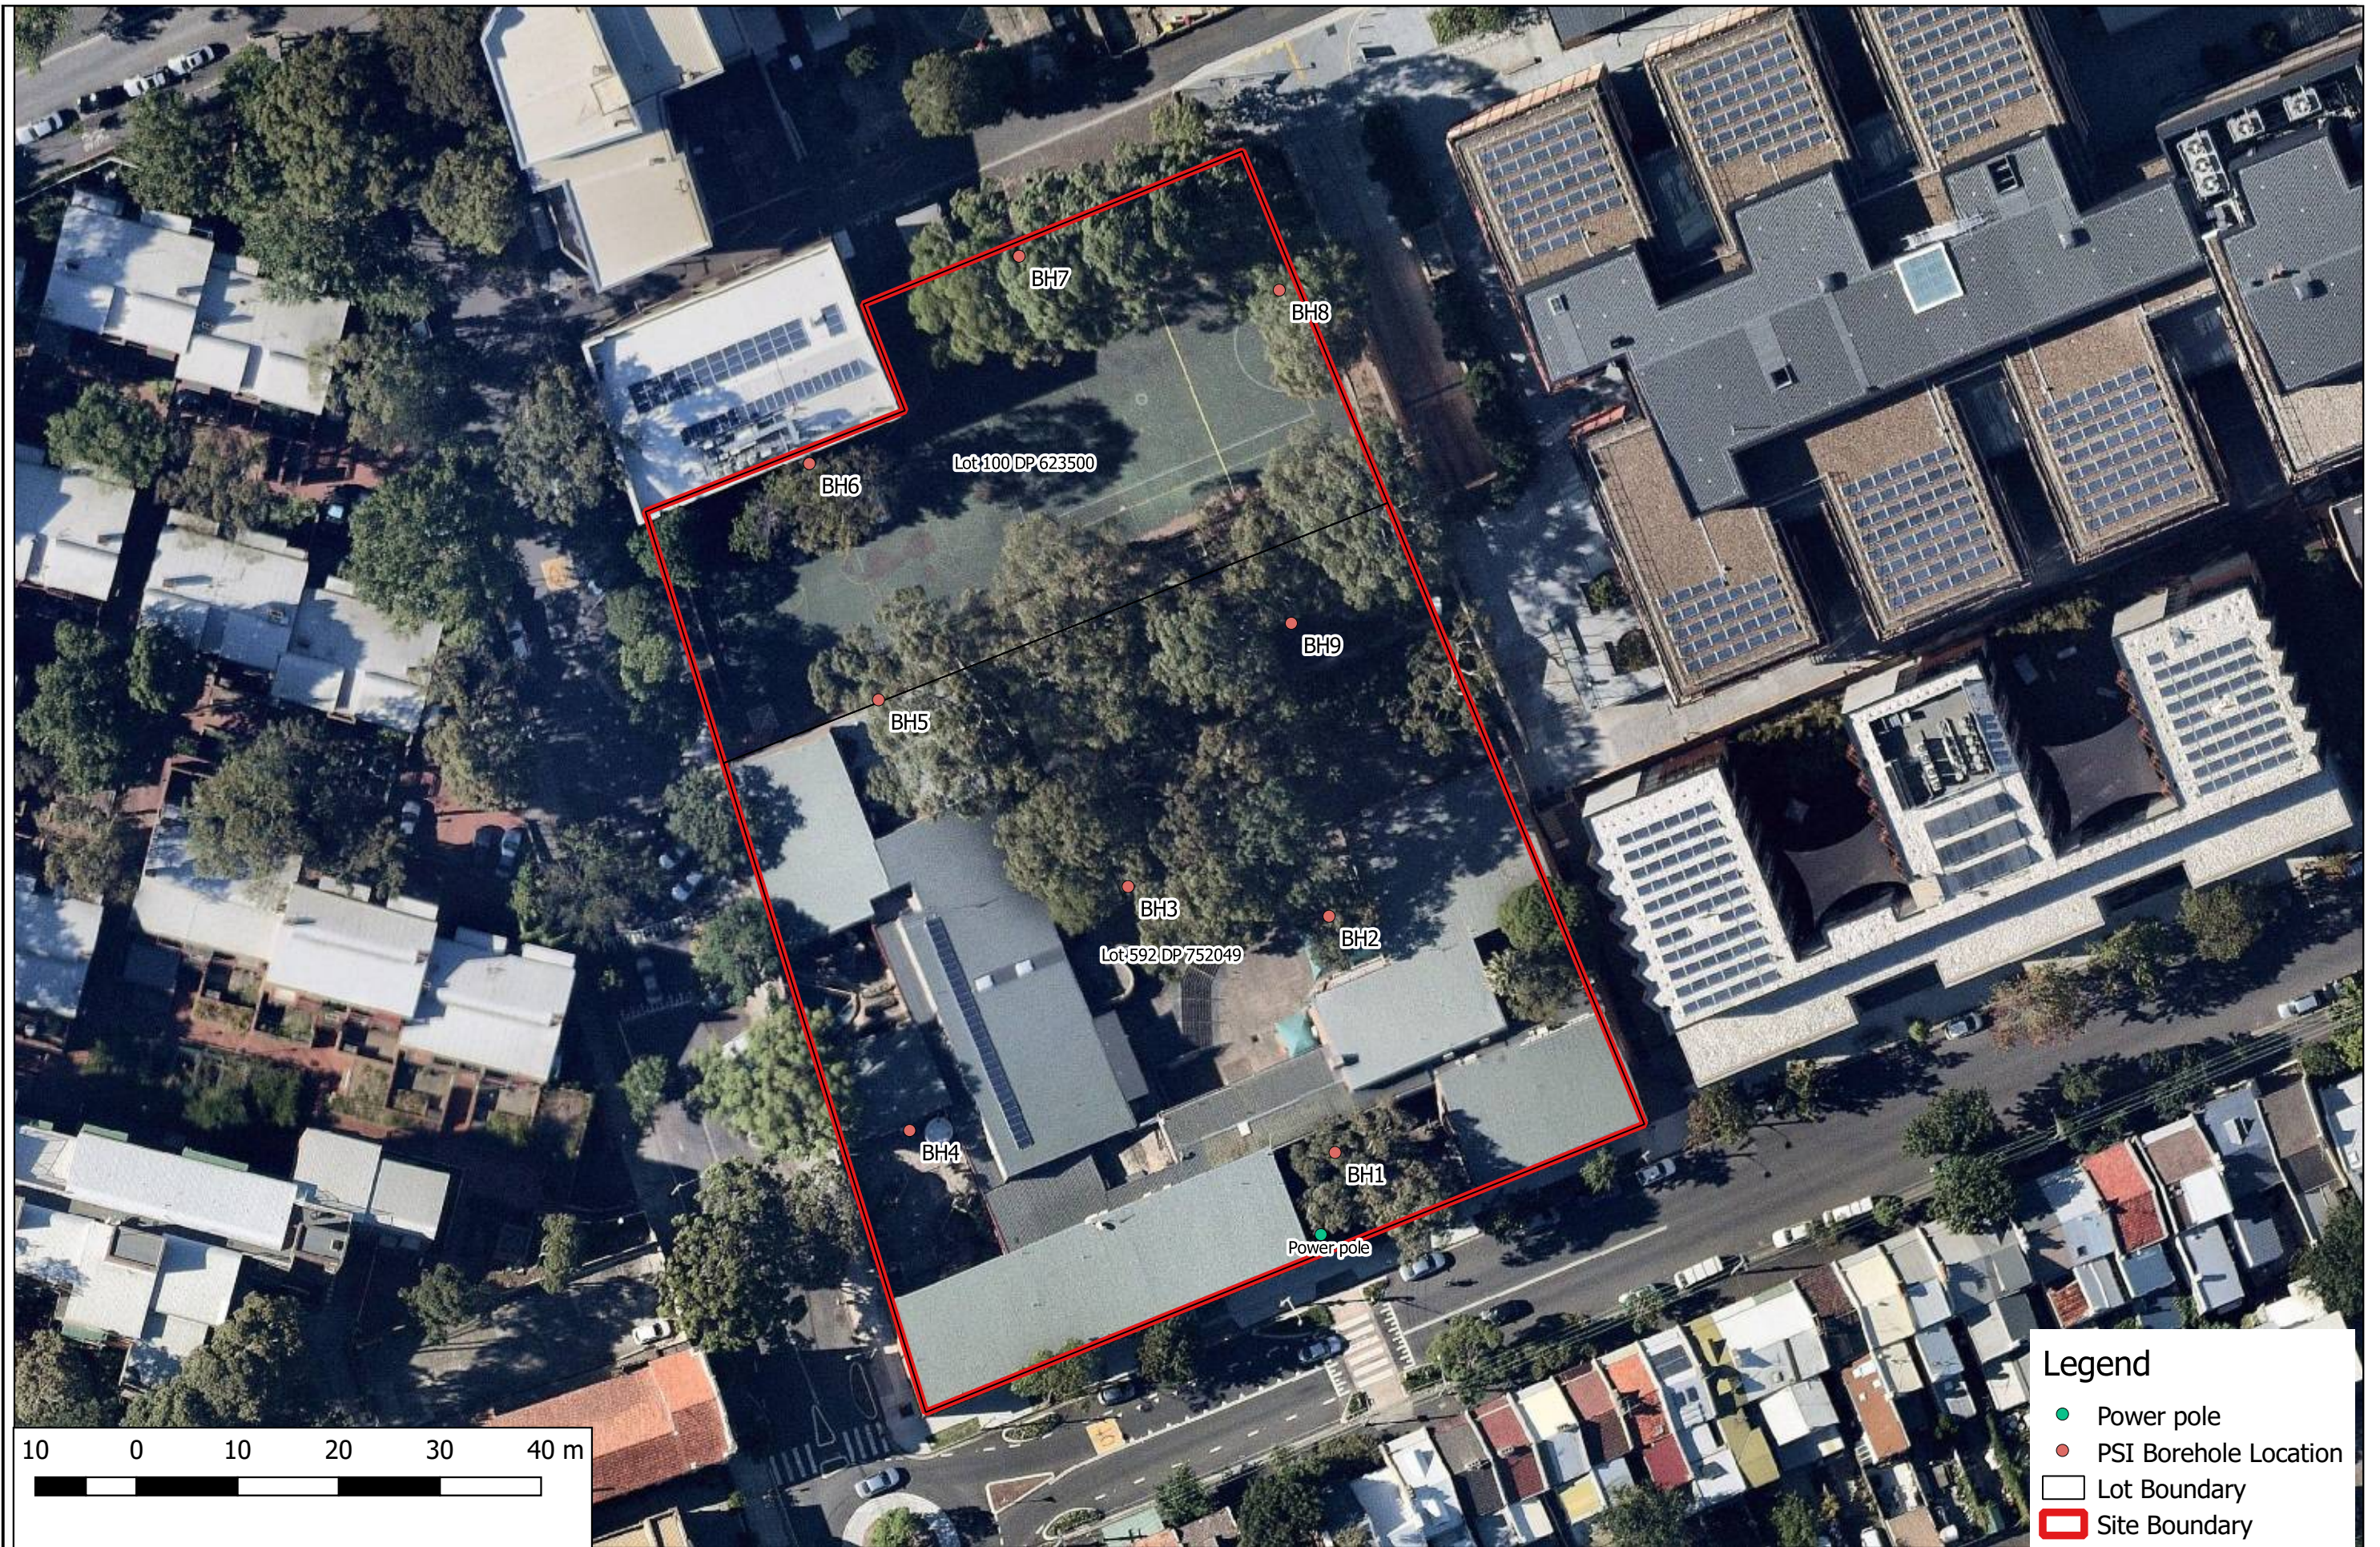
PROJECT No: 92277.02
DRAWING No:3
REVISION: A

- Power pole
- PSI Borehole Location
- Lot Boundary
- Site Boundary

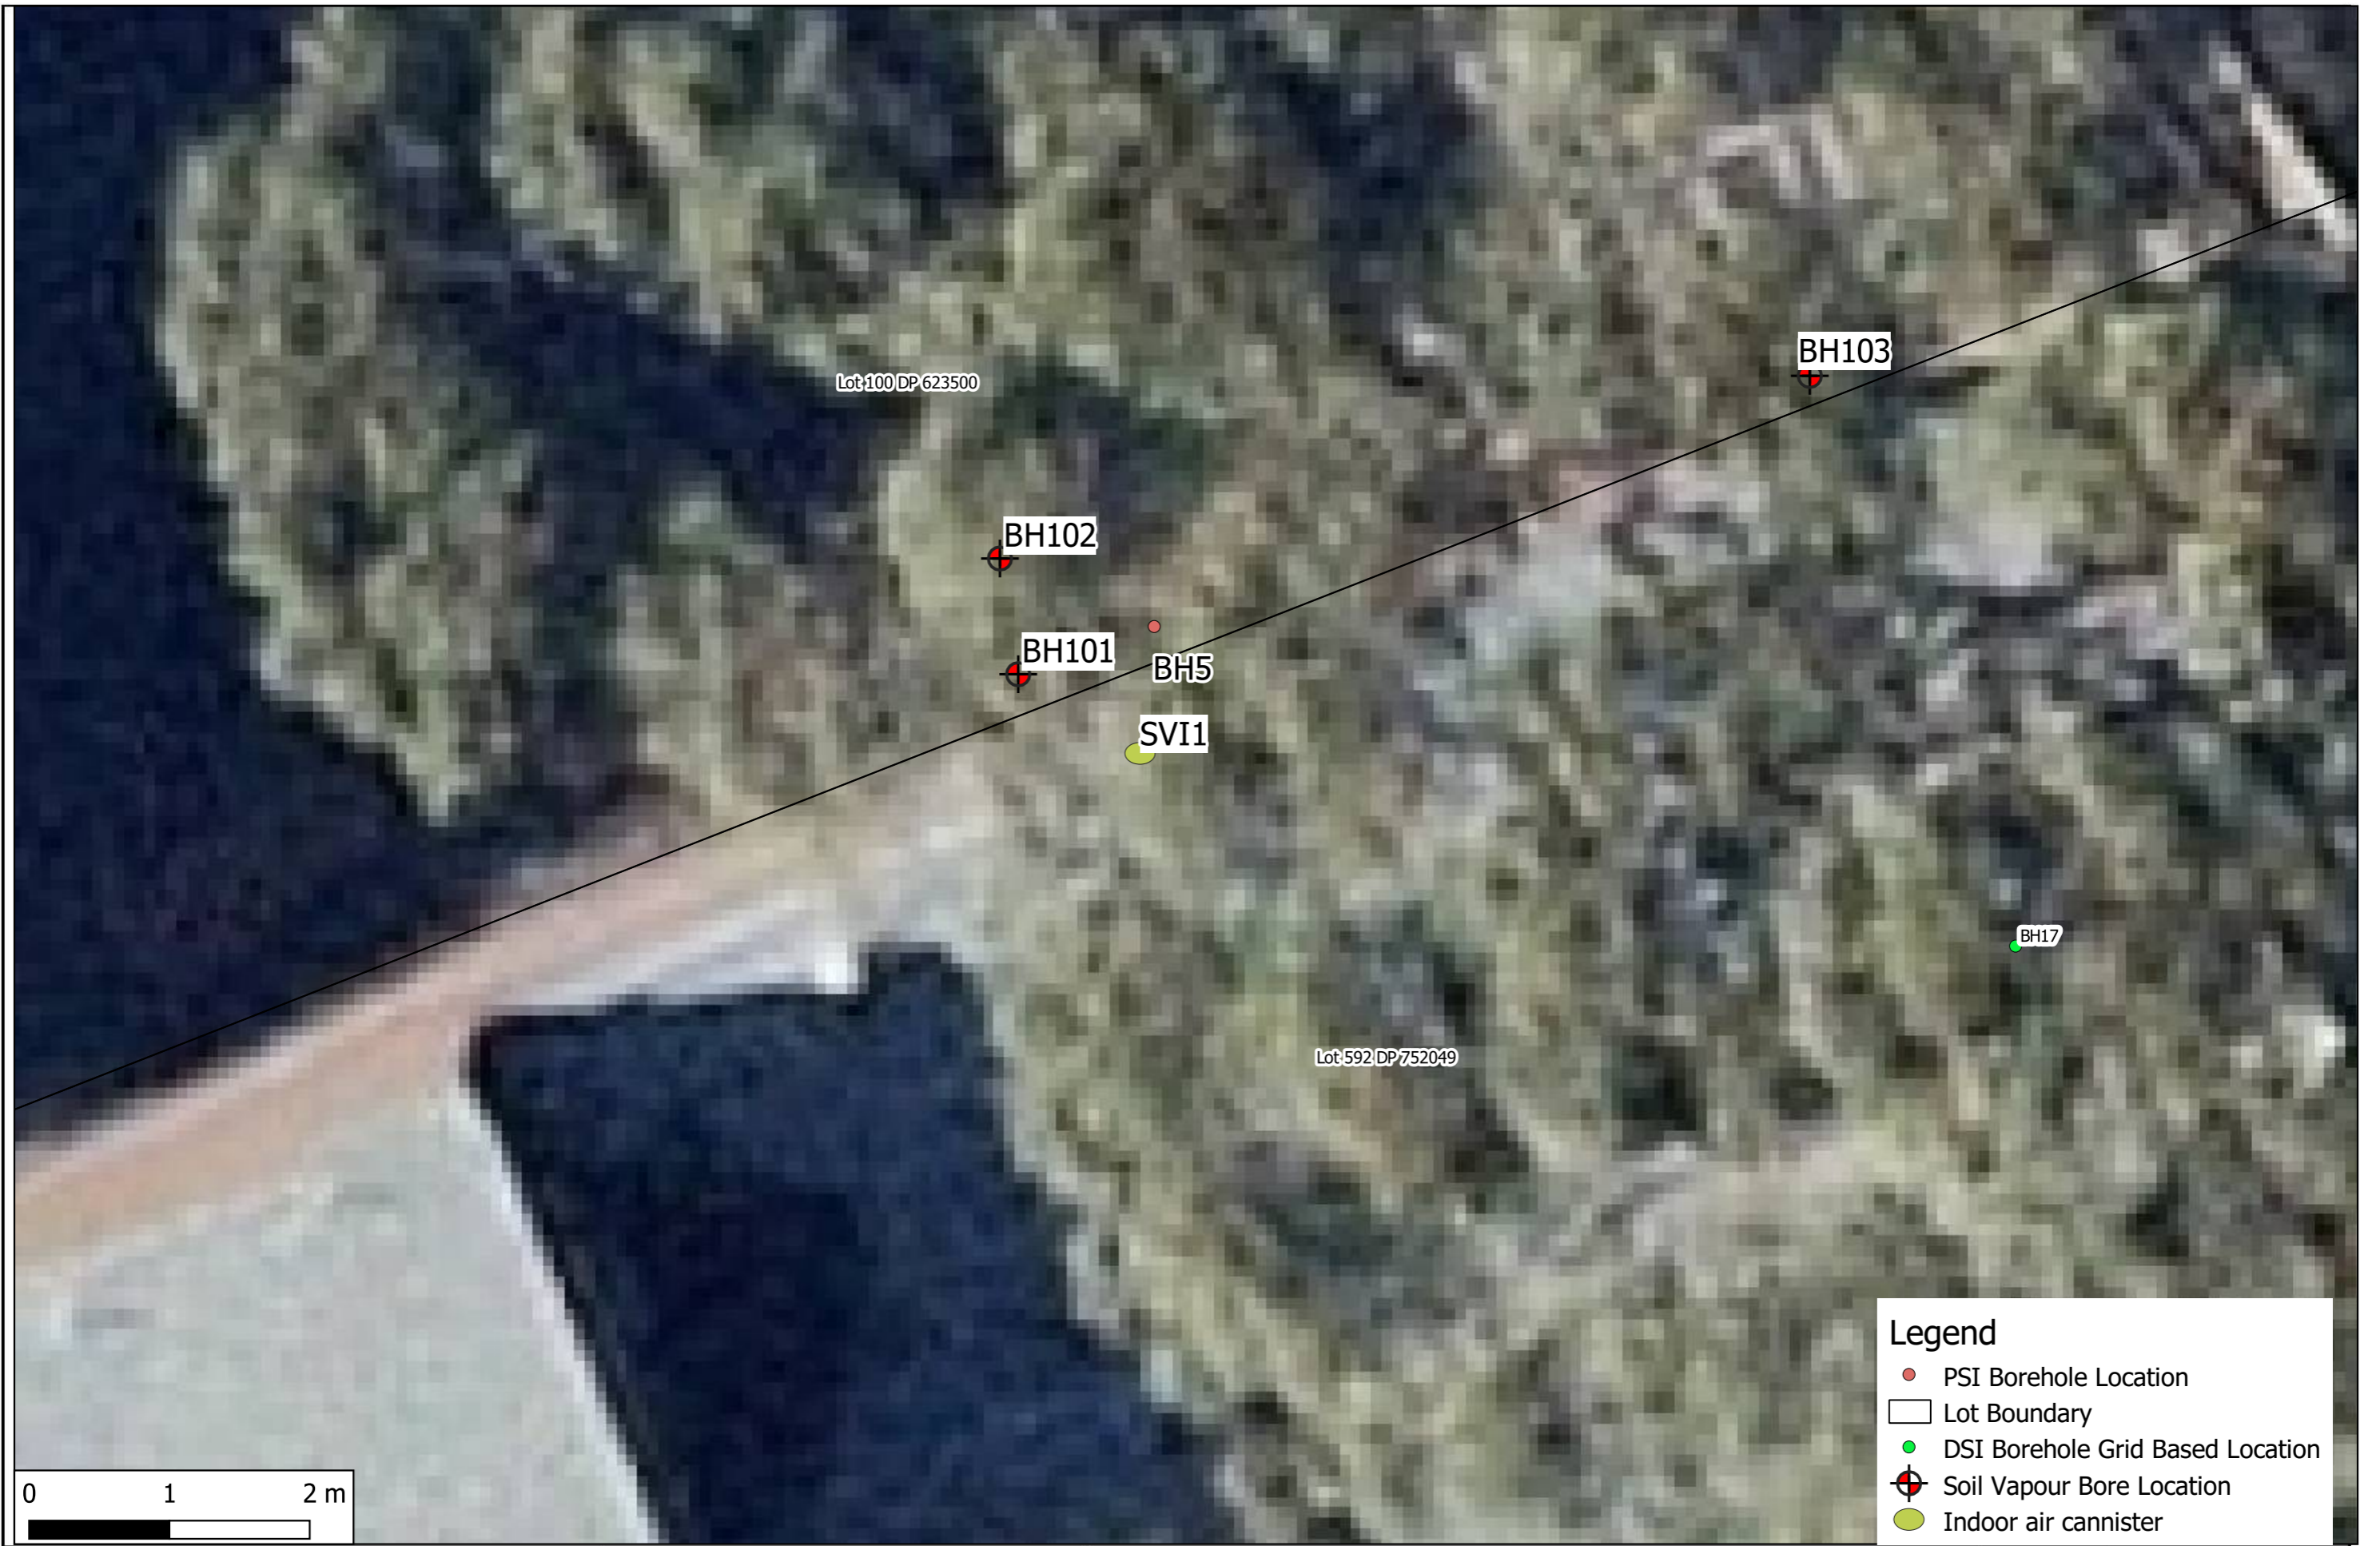
- PSI Borehole Location
- Lot Boundary
- DSI Borehole Grid Based Location
- ⊕ Soil Vapour Bore Location
- Indoor air cannister

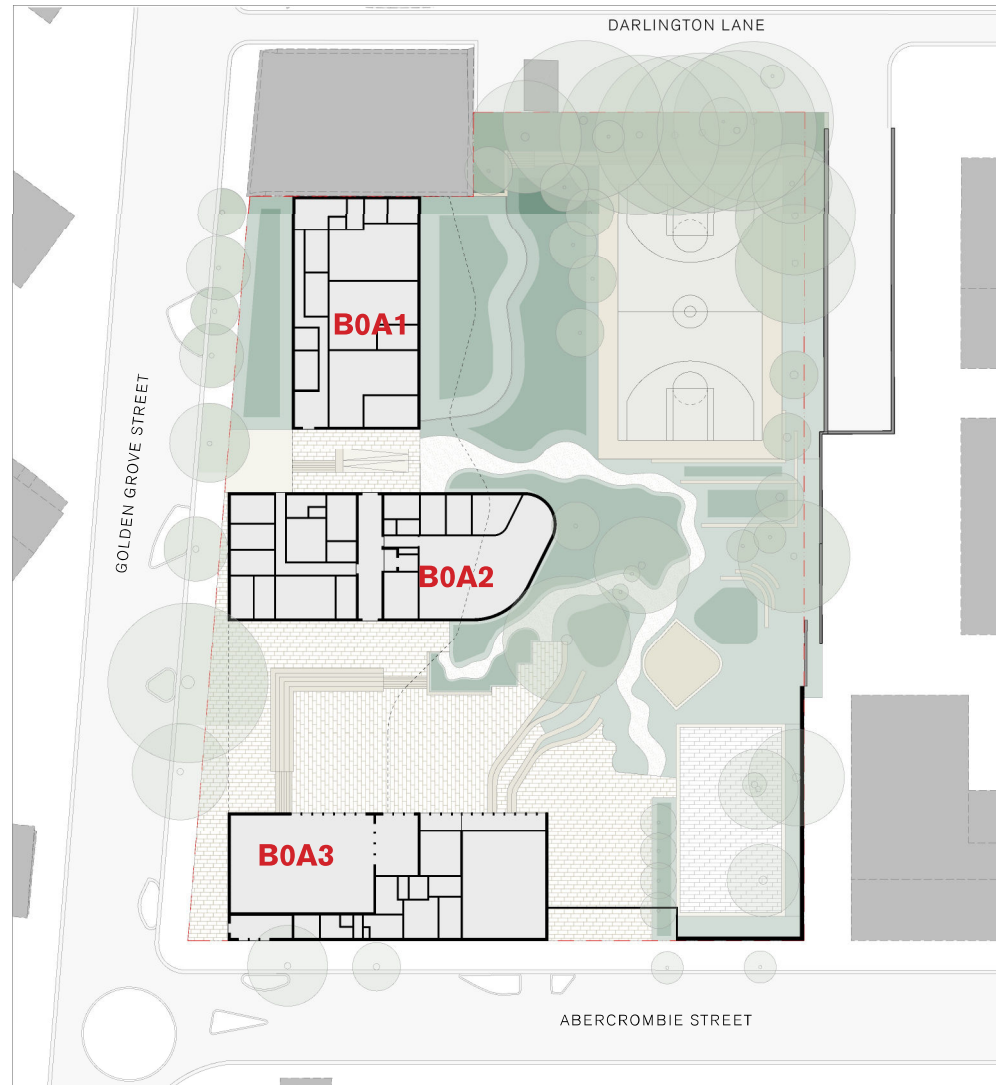
## MASTER PLAN CONCEPT

- The option that has been developed for the Master Plan, locates the main bulk of the buildings along the edge of the site following the roads and referencing the walls that currently encircle the school.
- The facade is opened up in selected places, allowing access points into the school, and making the school accessible to the community.
- The built-form along Golden Grove St is pulled back from the site boundary to expand the school drop-off areas and hold back the main volume from the road edge.
- The buildings forms an L-shape to block views in to the school site from the roads and to help enclose and secure the school without the need for extensive fencing.
- The exterior facades are very linear and aligned to a grid to reflect the urban fabric around the site, while in the inward facing facades are softer and curved to provide a gentler character to the school.
