**Project 89754.03**  
**23 April 2021**  
**89754.03.R.003.Rev3.Air Quality**  
**CB:TK:kd**

**Air Quality Assessment - Qualitative**  
**Proposed Hastings Secondary College Port Macquarie Campus Upgrade**  
**16 Owen Street, Port Macquarie**

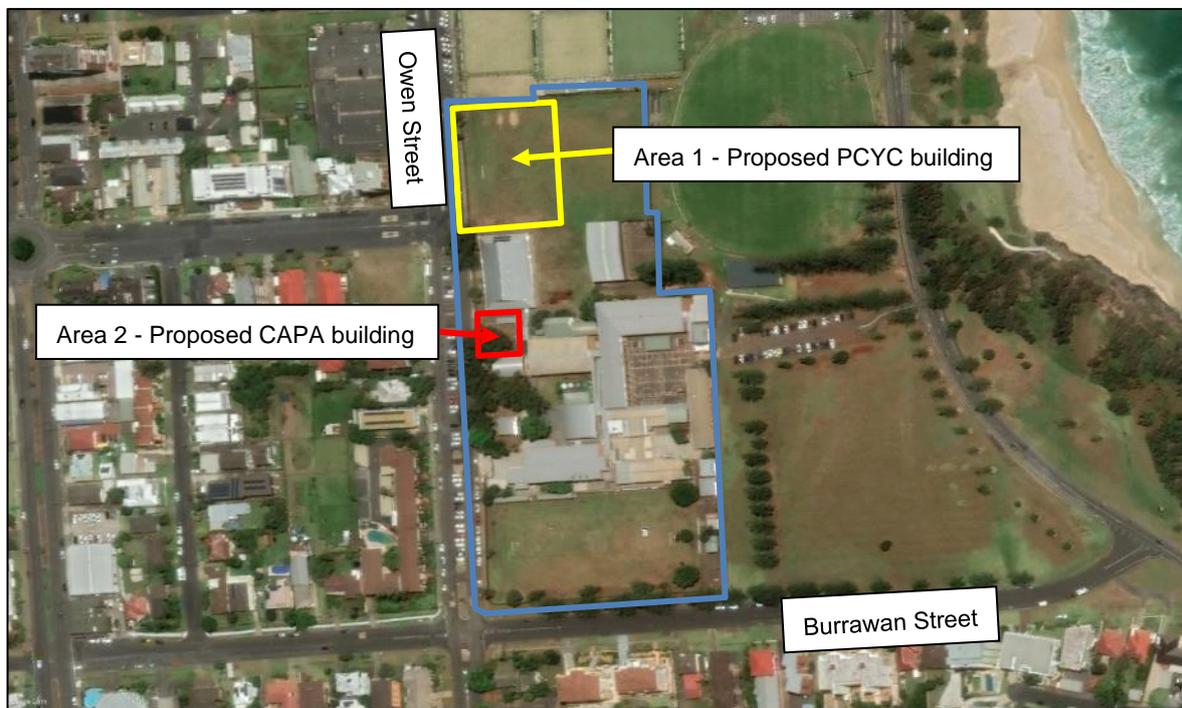
**Figure 1: Boundary of Hastings Secondary College (blue outline), proposed PCYC building extent (yellow outline) and proposed CAPA building extent (red outline) (image sourced from Google Earth, dated January 2020)**

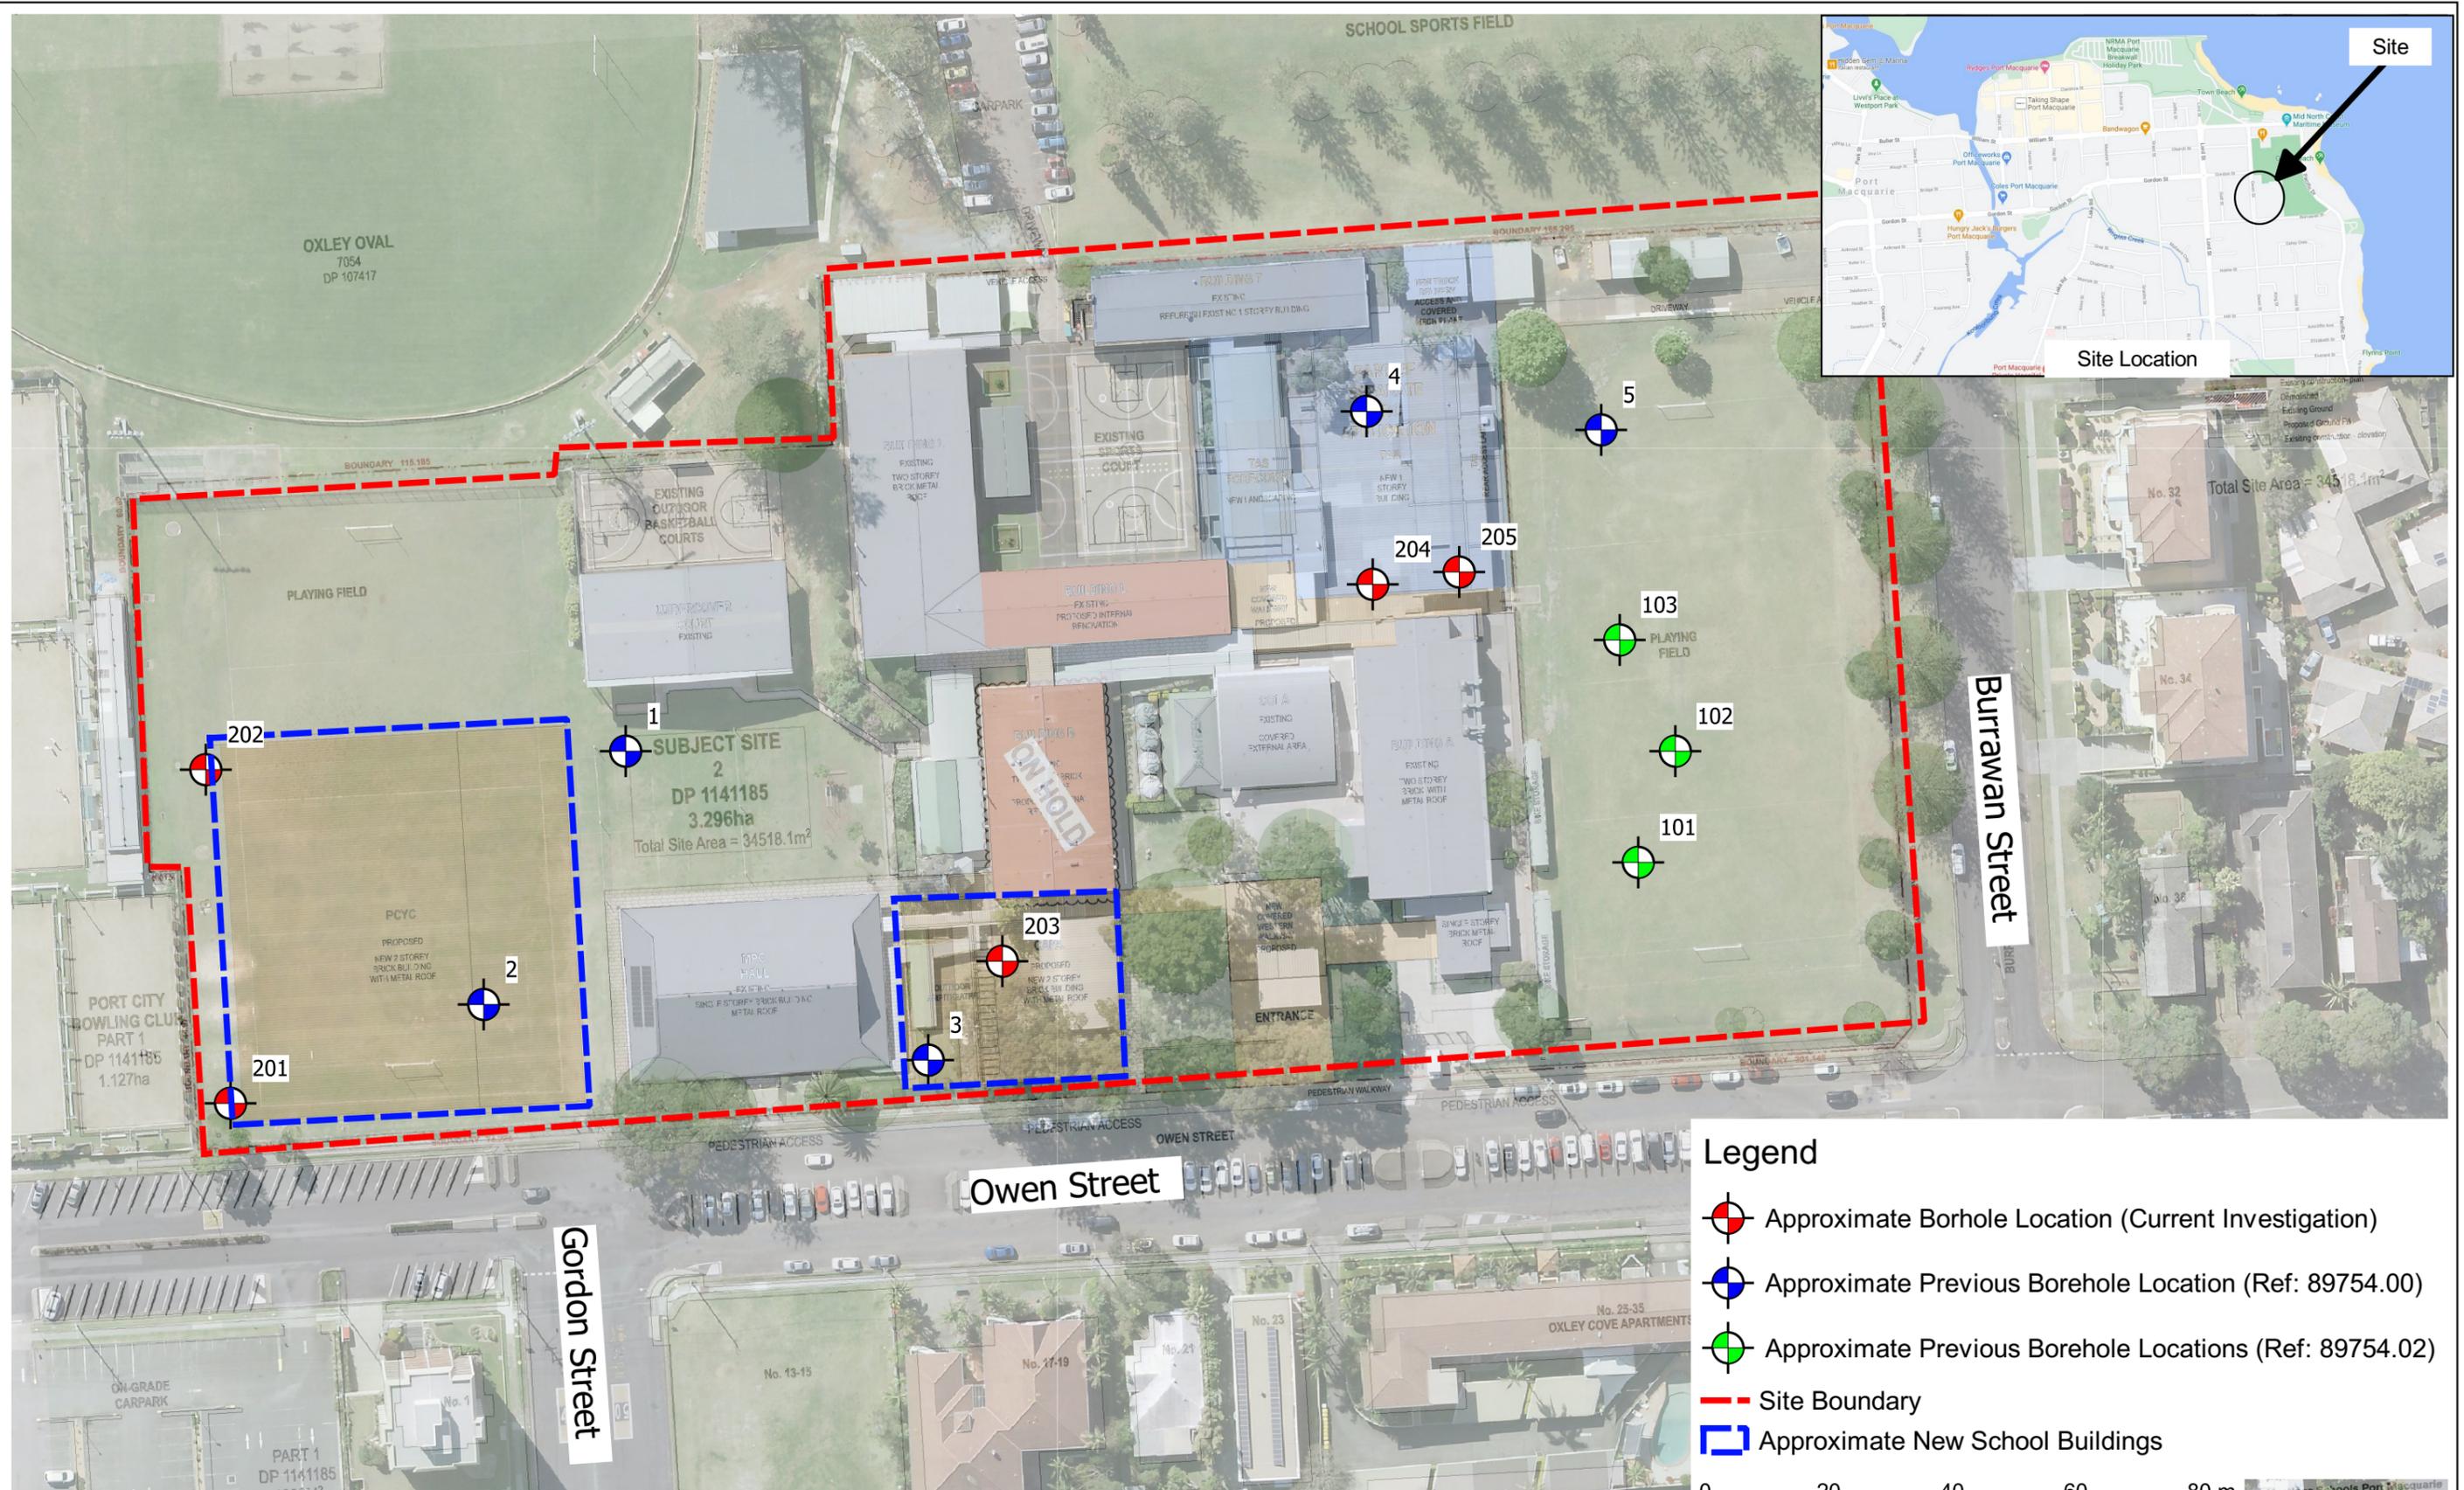
Drawing adapted from aerial imagery from Metro Map dated 17 September 2020 and Client supplied drawing titled "Site Plan - Proposed" Drawing SSSA-120010, dated 12 February 2021, Rev01, by fjmt Studio

Test locations are approximate only and were located using Handheld GPS and Measured off site features
