Environmental Management Plan

Proposed High School
Stages 1 and 2, Picton High School,
480 Argyle Street, Picton, NSW

Prepared for
Taylor Construction Group Pty Ltd

Project 92254.08
April 2021

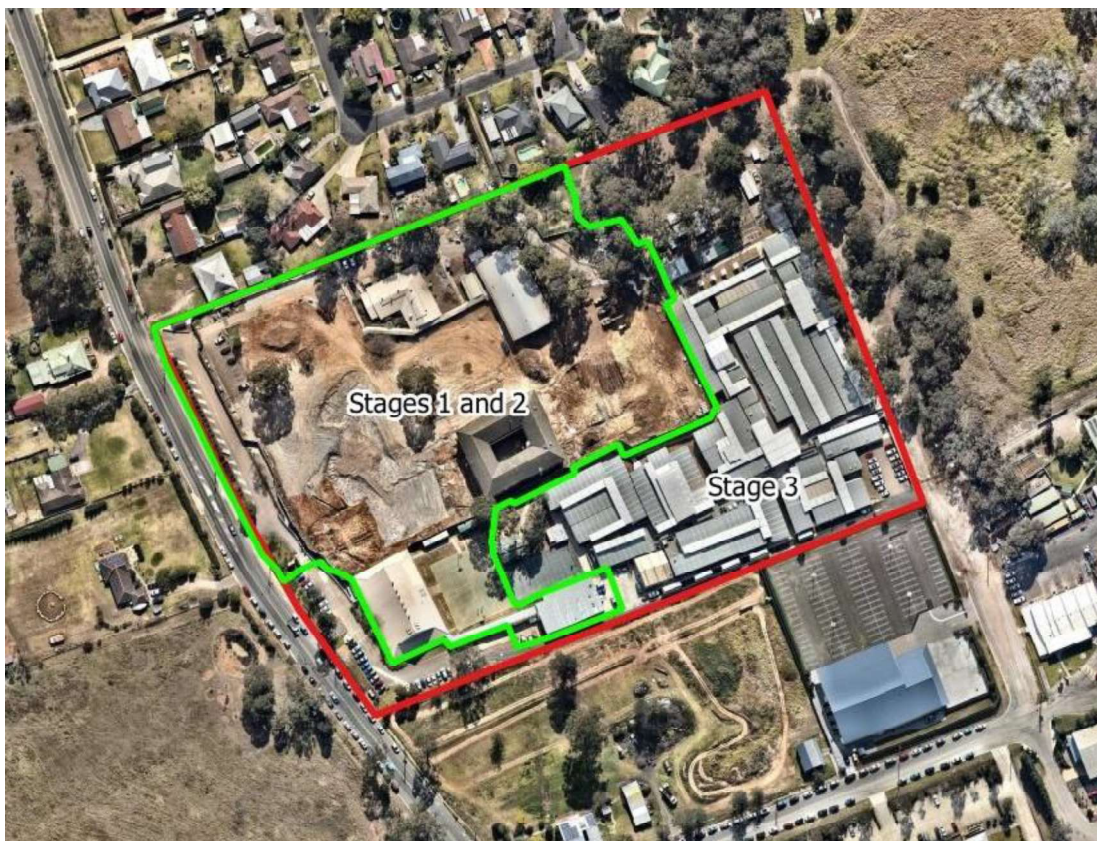
Figure 1: Site Location

The stage and site boundaries are shown on Figure 1, following page.
