SMALLS ROAD PUBLIC SCHOOL RYDE
NO:1144

CONSTRUCTION ENVIRONMENTAL MANAGEMENT PLAN (CEMP)

Client:	Richard Crookes Constructions (RCC)
Project:	Smalls Rd Public School, Ryde, NSW
Project Number:	1144
Report Title:	CEMP – Smalls Rd, Ryde, Public School
Date:	24 th May 2019
Document Name:	16145_CEMP (Rev2)
Revision Number	Revision 2
Written By: Belal Afyouni Project Manager

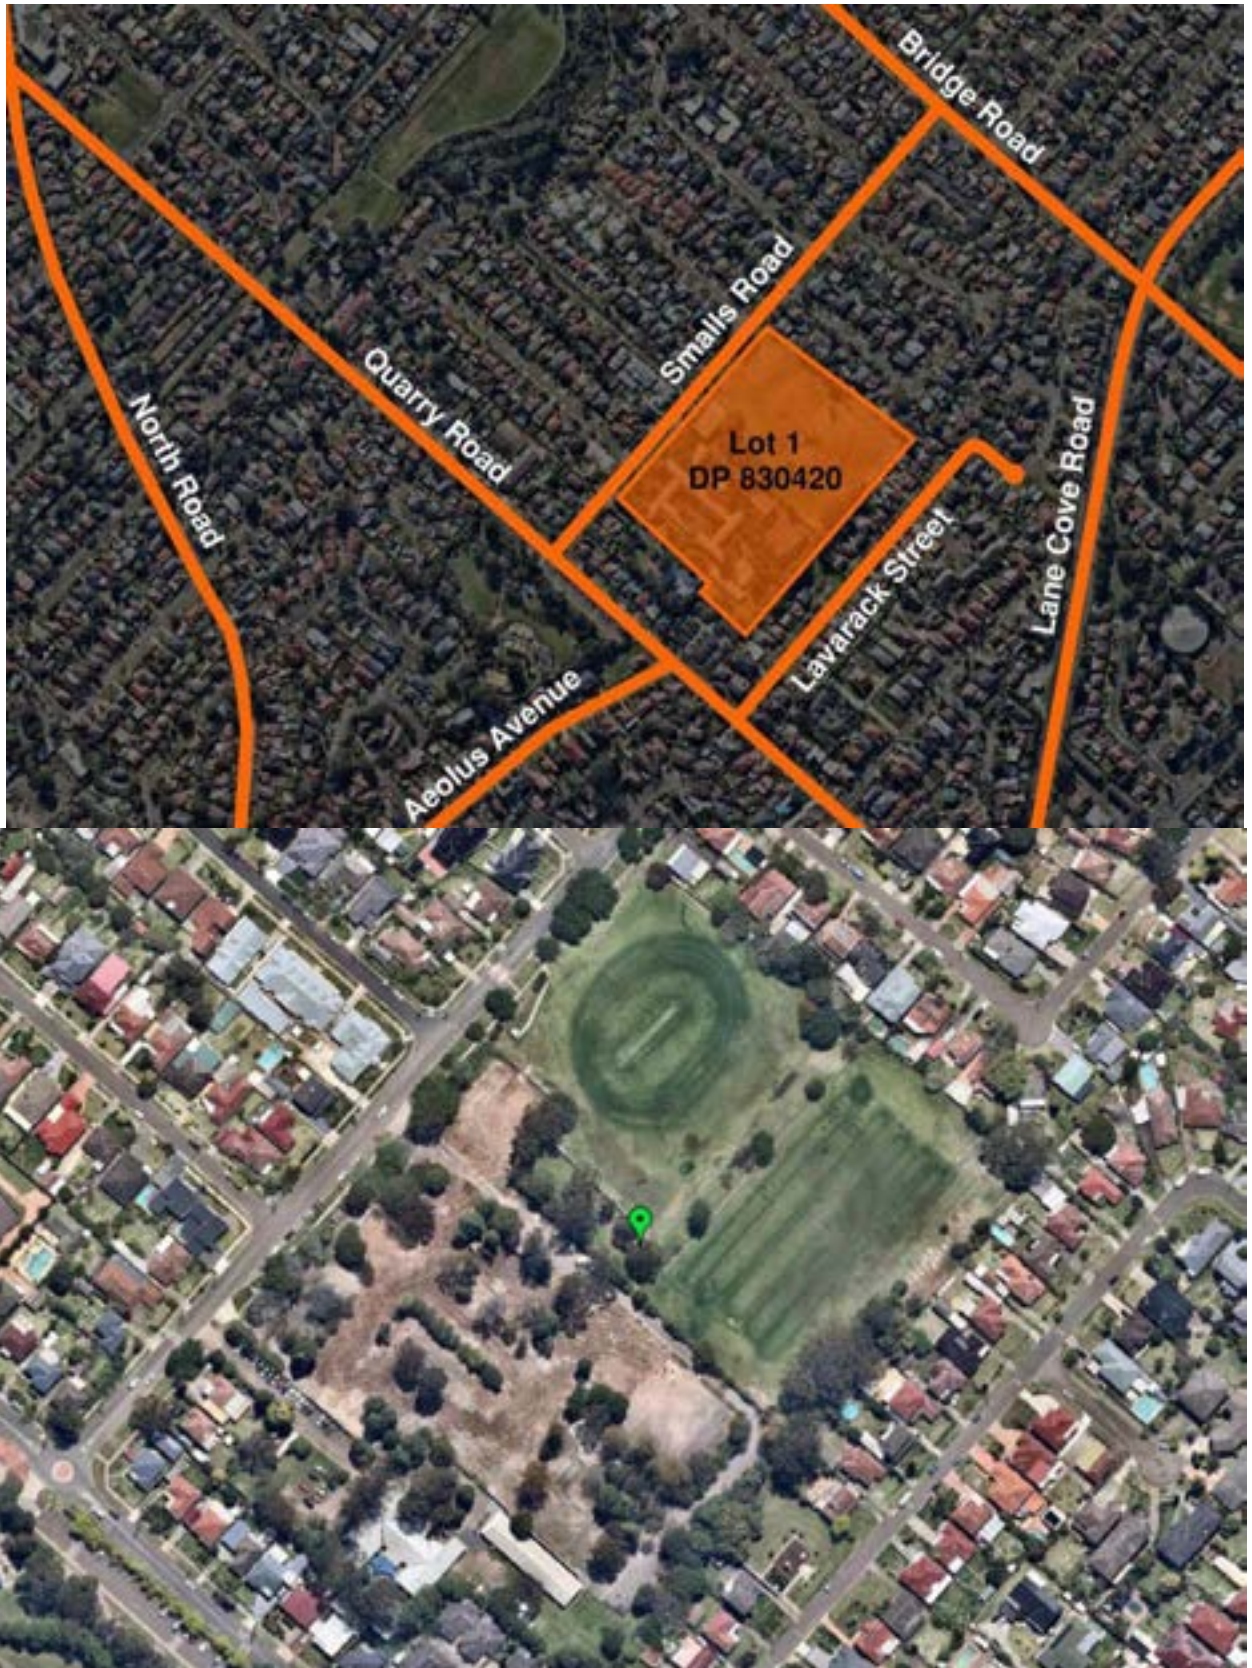
Figure 1 – Site Location

3B Smalls Road, Ryde, NSW. Lot 1 DP830420

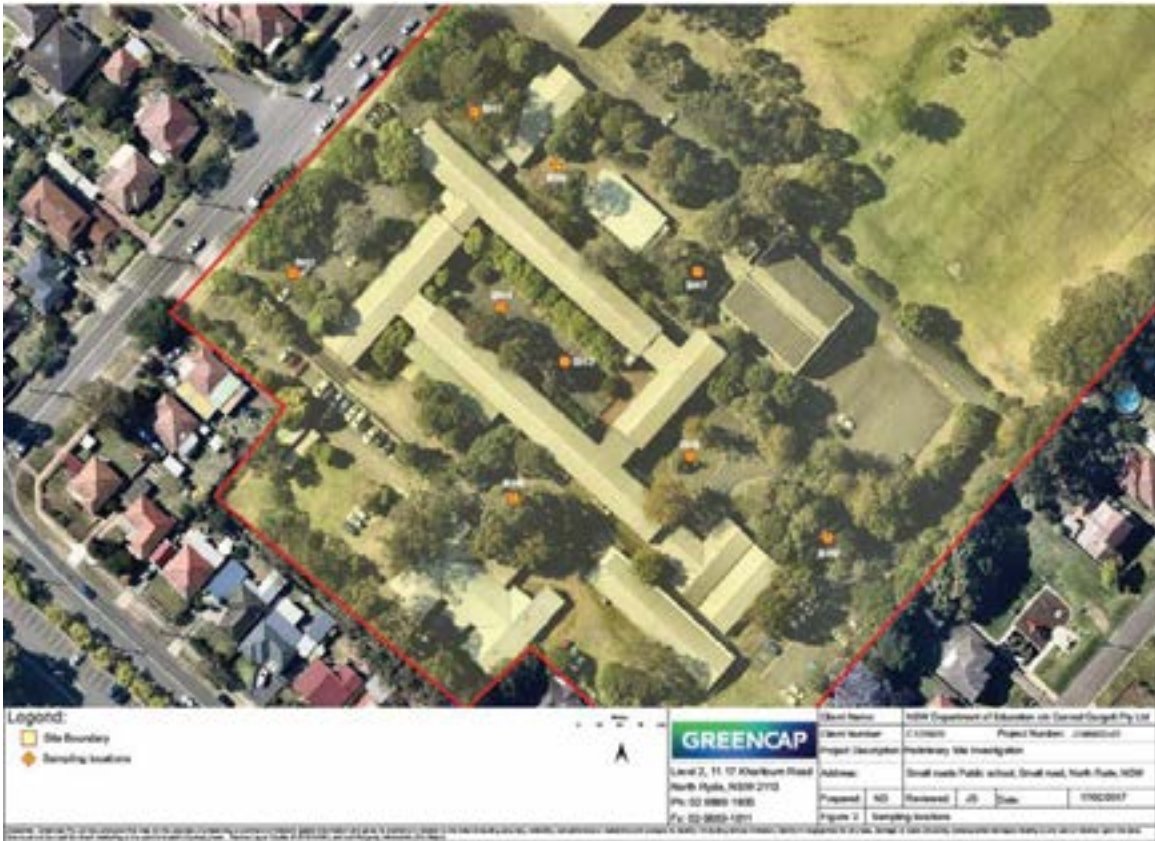
Figure 4 – Soil Sampling Locations – Findings

Soil Contamination Investigation (Greencap) : Ref J146932-01

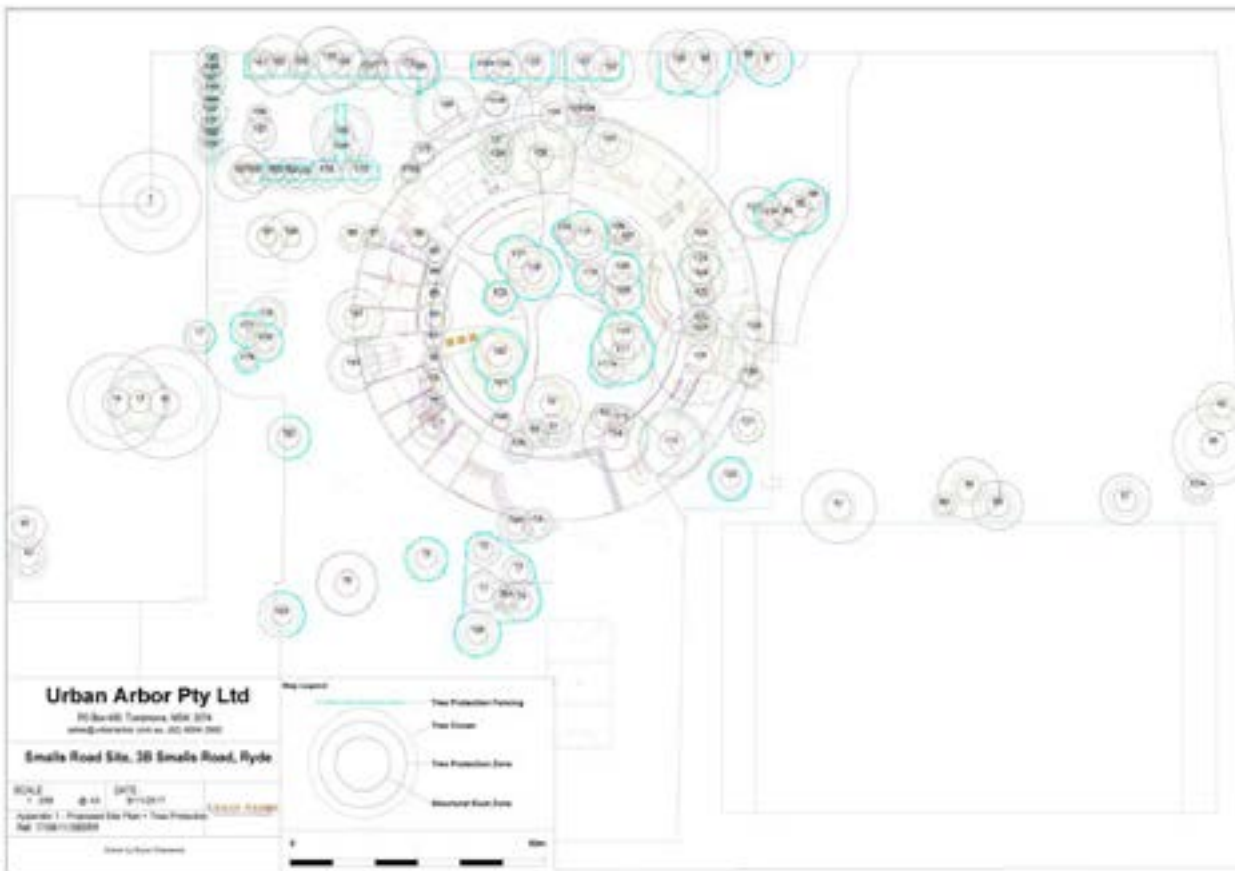
Figure 6 – Tree Protection Plan

The Arboricultural Impact Assessment Report (Priority Tree Services) : 17/08/11/3BSRR appendix 2 identifies all 150 trees onsite with a corresponding tree ID table p31 outlining recommendations . Given the AIA report was undertaken prior to demolition works a dilapidation report should be undertaken to assess the current health of trees onsite prior to RCC possession.

In total 150 trees occupy the site with 52 required to be removed for the future building, an additional 8 to be removed for landscape works and a further 6 to be removed as per Tree Hazard Assessment Report (Urban Arbor) : Rev 1 18.1.2017. All remaining trees (84 in total) must be protected for the duration of the development in accordance with AS4970-2009.

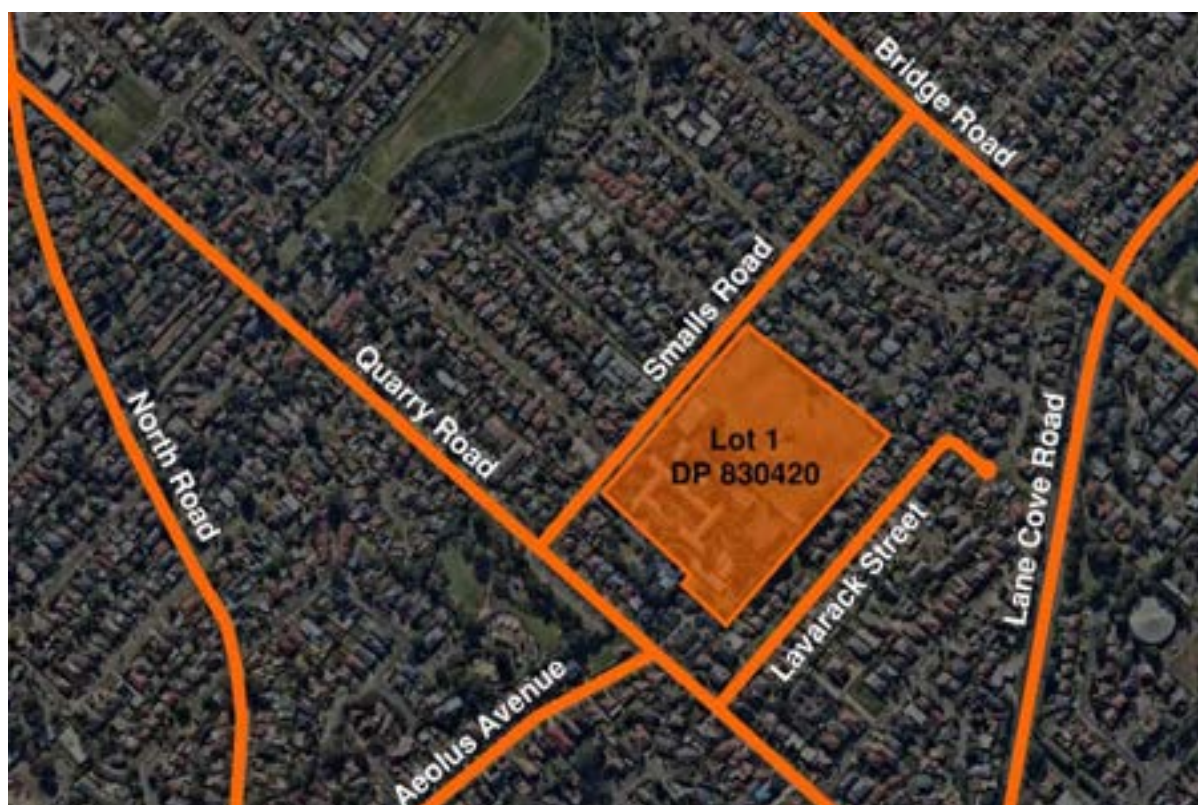
Figure 1.1: Site Location

The development site is located at 3B Smalls Road, Ryde, in the northern suburbs of Sydney. The parcel of land is designated as Lot 1 in DP 830420. The extents of this lot are illustrated in Figure 1.1 below, in the context of the local major road network.

The site is located close to the NSW state road network. Lane Cove Road is the closest state road to the site, approximately 750 metres from the site frontage on Smalls Road. Lane Cove Road is also the major regional distributor for the area, connecting to both the M2 Motorway in the north and the M4 Motorway in the south. Figure 1.1 illustrates the state and regional roads in the vicinity of the site.

Quarry Road is connected to Lane Cove Road via a four-way signalised intersection, with a slip lane provided for vehicles turning left onto Lane Cove Road from Quarry Road. Bridge Road is connected to Lane Cove Road via a four-way signalised intersection. Refer to Figure 1.1 for the site's context within the state and regional road networks.

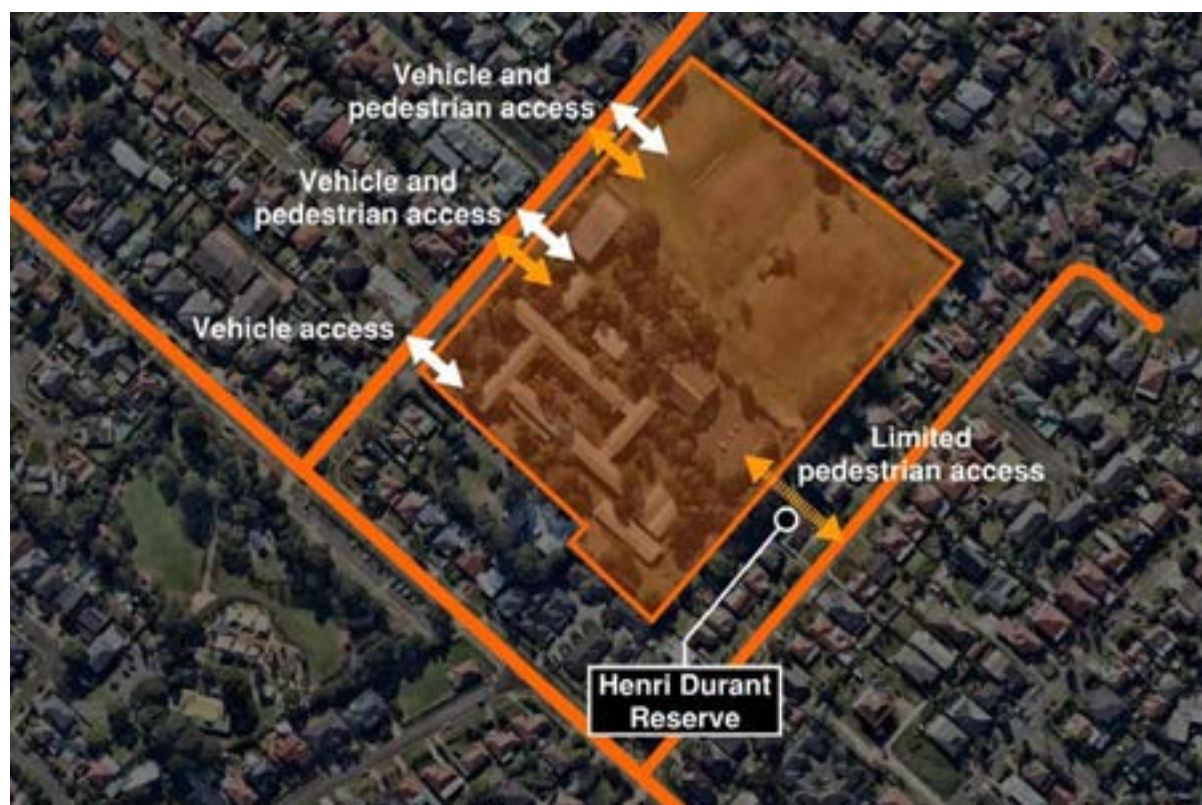
Figure 2.1: Existing Site Access

Pedestrian footpaths are provided along both sides of Smalls Road including the site's frontage. Pedestrian access to the site is also provided through Henri Durant Reserve from Lavarack Avenue. Refer to Figure 2.1 for the location of these access points.

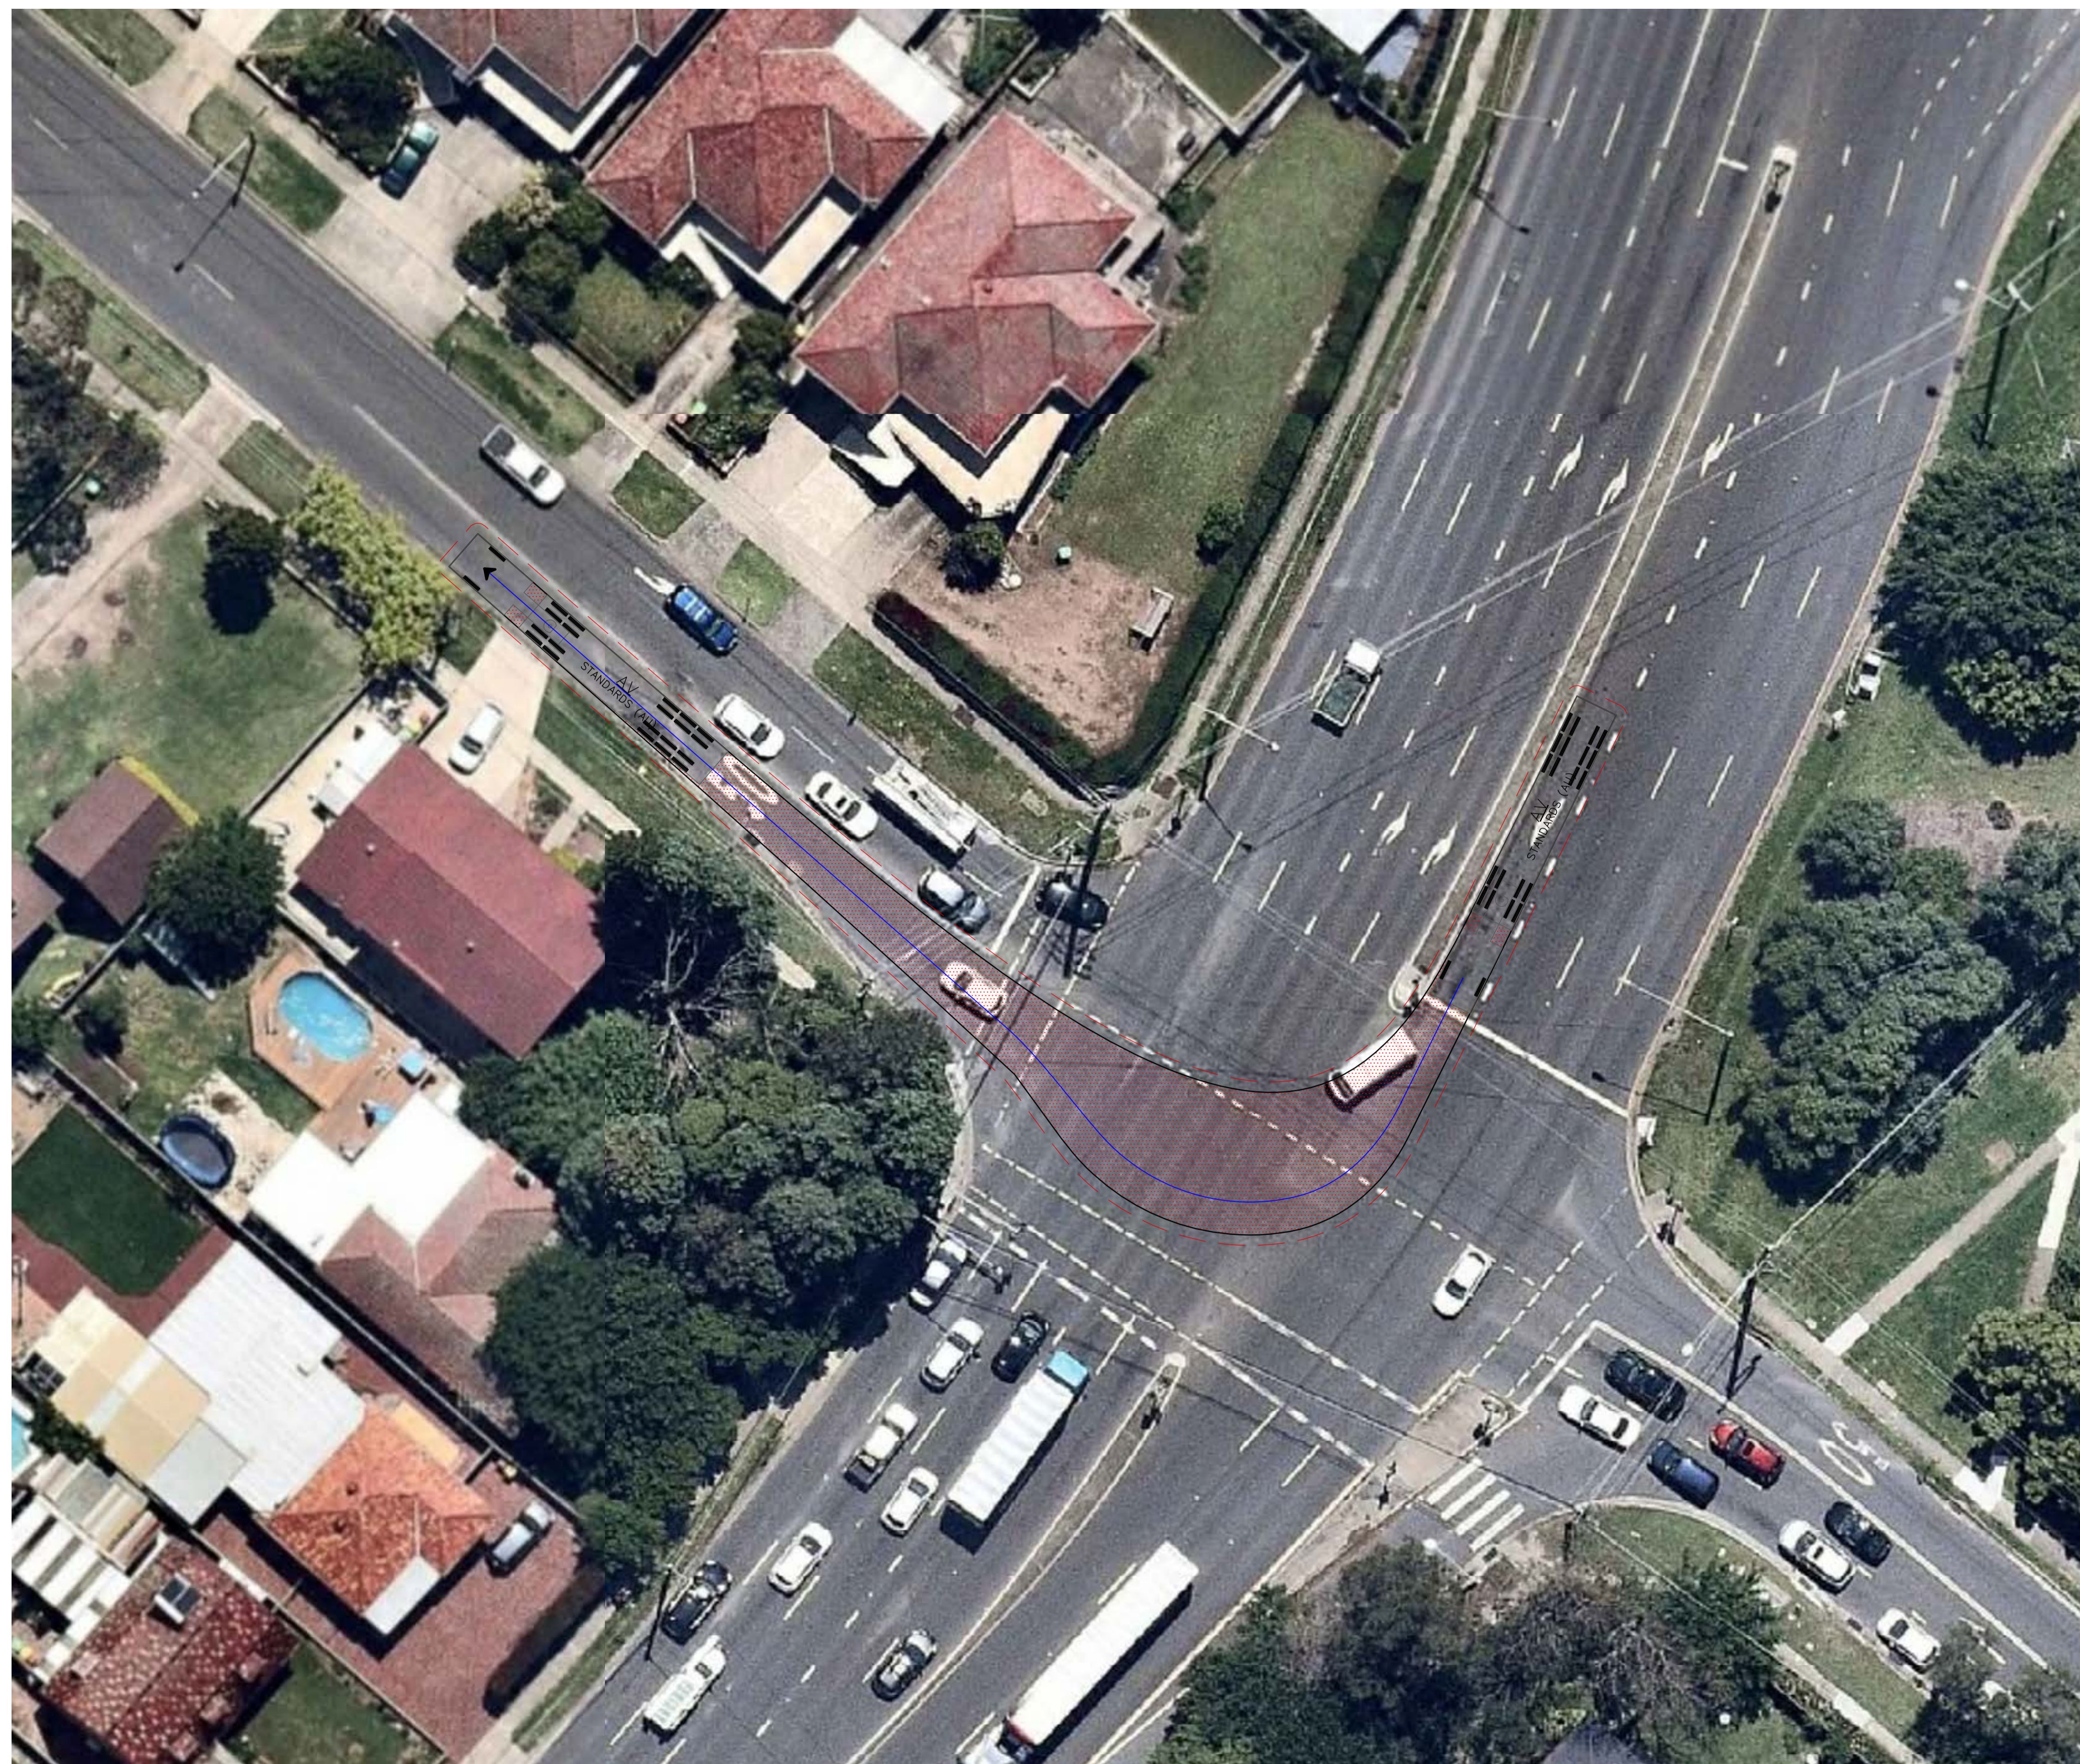
Scale : A1 1:200	Drawn KA	Authorised
Job No 161375	Drawing No T110	Revision P1
Plot File Created: Nov 06, 2018 - 11:26am

AV

Tractor Width	: 2500	Lock to Lock Time	: 6.0
Trailer Width	: 2500	Steering Angle	: 28.3
Tractor Track	: 2500	Articulating Angle	: 70.0
Trailer Track	: 2500

T100	COVER SHEET
T110	INBOUND TURNING PATH - LANE COVE RD w/ QUARRY RD INTERSECTION - SEMI-TRAILER (19m)
T120	INBOUND TURNING PATH - LANE COVE RD w/ QUARRY RD INTERSECTION - HRV (12.5m)
T210	OUTBOUND TURNING PATH - LANE COVE RD w/ BRIDGE RD INTERSECTION - SEMI-TRAILER (19m)
T220	INBOUND TURNING PATH - LANE COVE RD w/ BRIDGE RD INTERSECTION - HRV (12.5m)
T310	INBOUND TURNING PATH - QUARRY RD w/ SMALLS RD INTERSECTION - SEMI-TRAILER (19m)
T320	INBOUND TURNING PATH - QUARRY RD w/ SMALLS RD INTERSECTION - HRV (12.5m)
T410	OUTBOUND TURNING PATH - BRIDGE RD w/ SMALLS RD INTERSECTION - SEMI-TRAILER (19m)
T420	OUTBOUND TURNING PATH - BRIDGE RD w/ SMALLS RD INTERSECTION - HRV (12.5m)

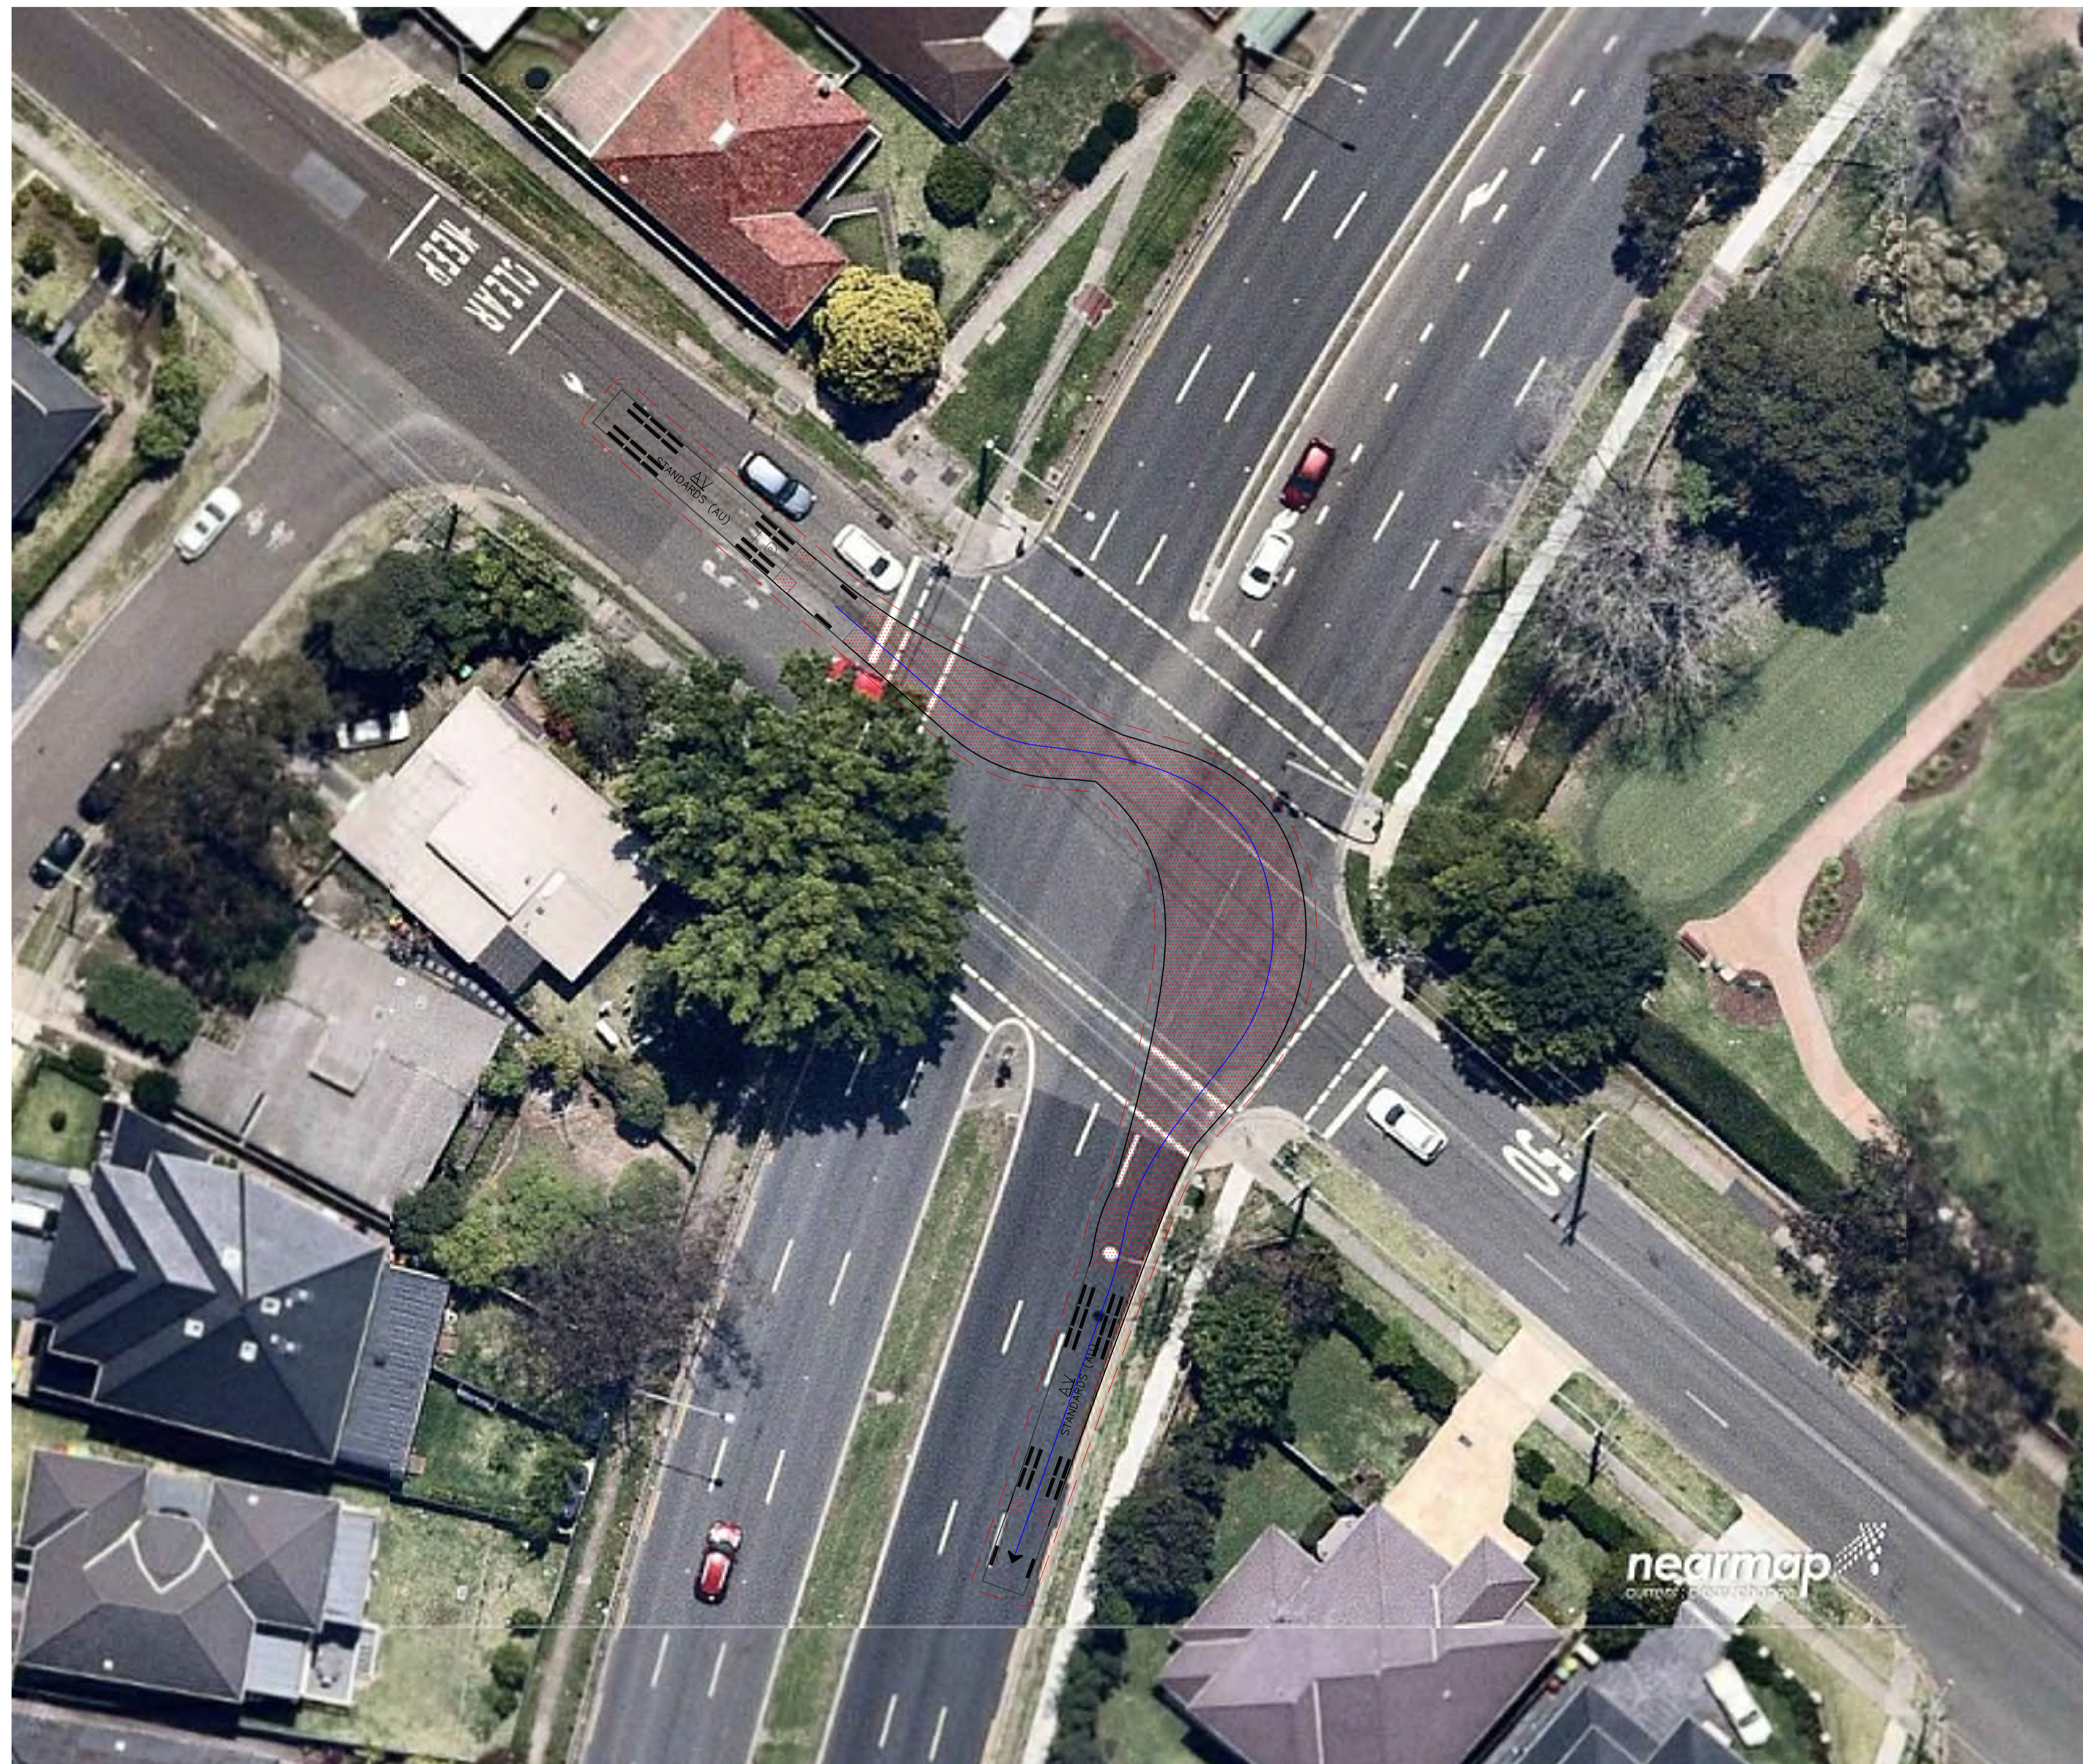
Scale : A1 1:200	Drawn KA	Authorised
Job No 161375	Drawing No T210	Revision P1
Plot File Created: Nov 06, 2018 - 11:47am

AV

Tractor Width	: 2500	Lock to Lock Time	: 6.0
Trailer Width	: 2500	Steering Angle	: 28.3
Tractor Track	: 2500	Articulating Angle	: 70.0
Trailer Track	: 2500

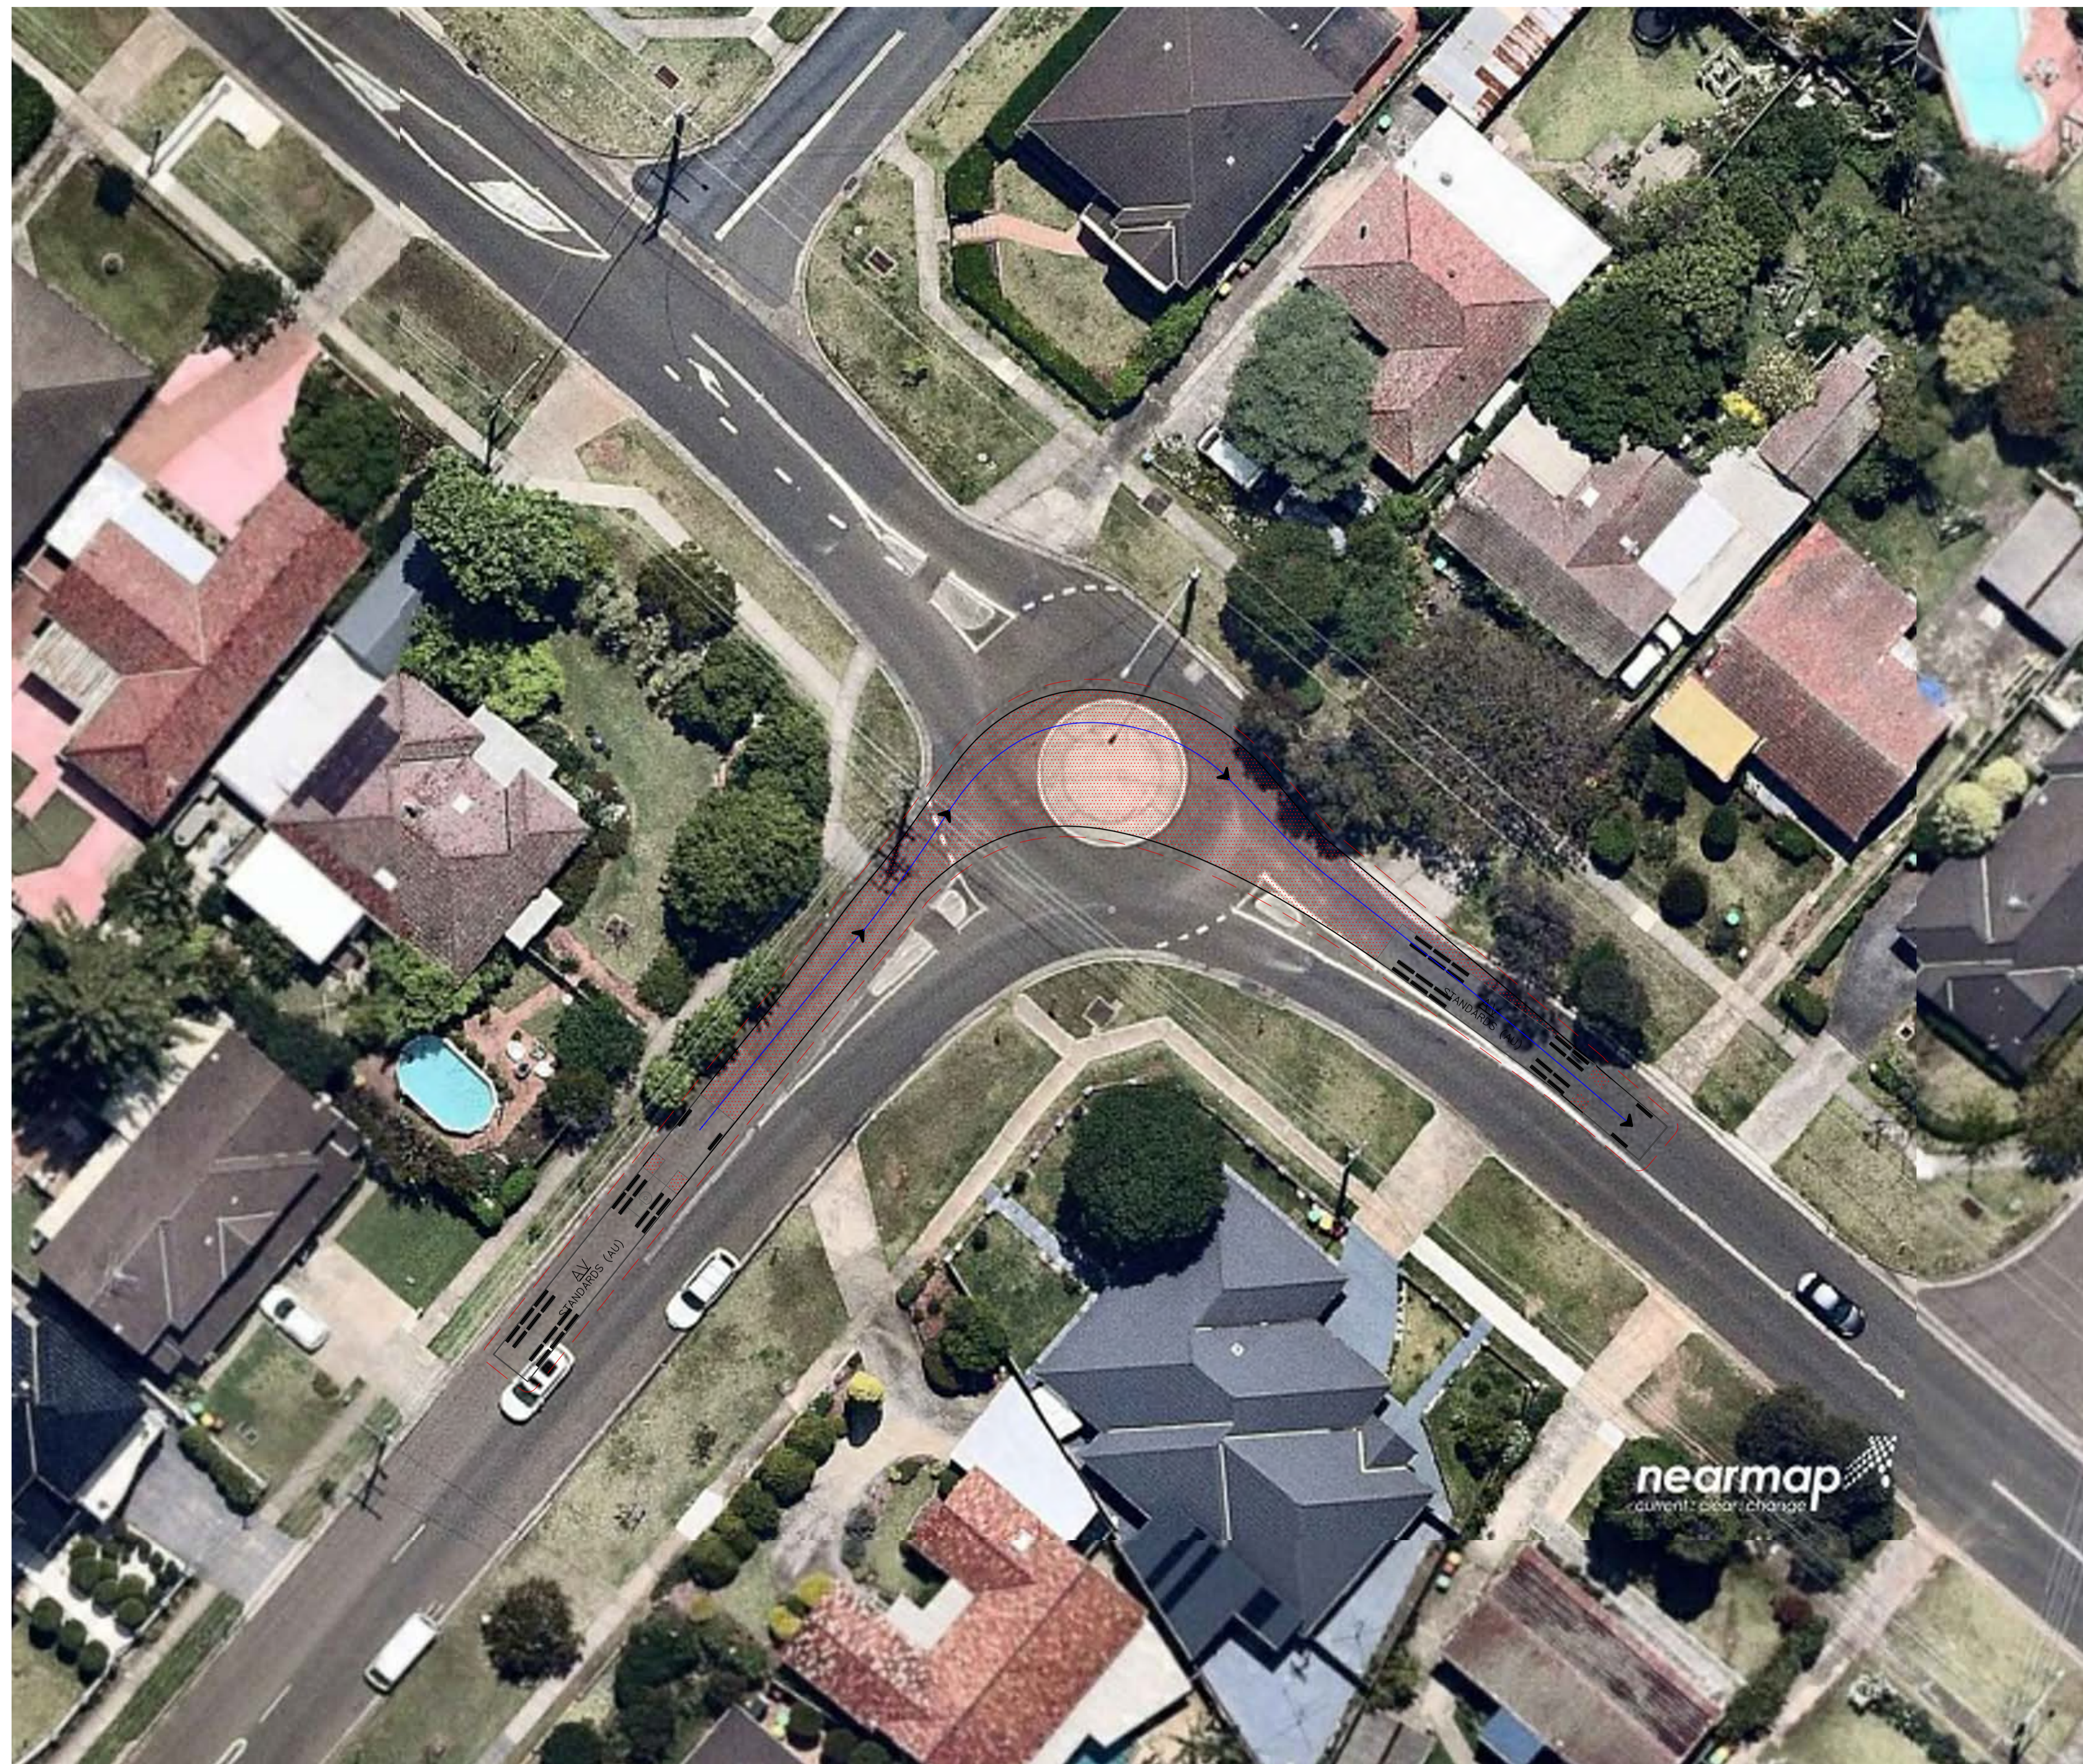
AV

Tractor Width	: 2500	Lock to Lock Time	: 6.0
Trailer Width	: 2500	Steering Angle	: 28.3
Tractor Track	: 2500	Articulating Angle	: 70.0
Trailer Track	: 2500

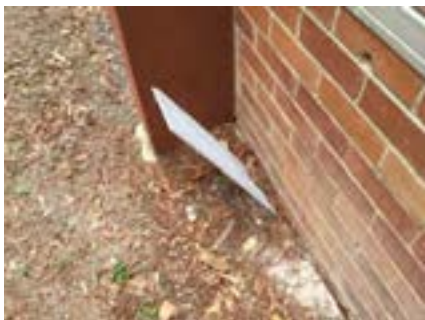
PHOTO NO.: J154351-001-PHOTO038
 RESULT: **ASBESTOS - PRESUMED POSITIVE**
 BUILDING/LEVEL: **B00A - GROUND LEVEL**
 ROOM/LOCATION: **EXTERIOR - NORTHEAST**
 FEATURE/MATERIAL: **EAVES - FIBRE CEMENT SHEETING**
 SAMPLE NO.: **SIMILAR TO: J154351-001-010**

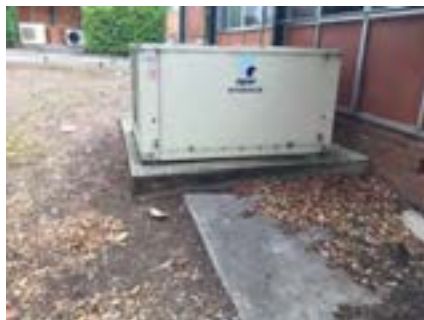
PHOTO NO.: J154351-001-PHOTO190
 RESULT: **ODS - POSITIVE**
 BUILDING/LEVEL: **B00A - GROUND LEVEL**
 ROOM/LOCATION: **EXTERIOR - SOUTHEAST**
 FEATURE/MATERIAL: **A/C UNIT - R22 - CHLORODIFLUOROMETHANE**
 SAMPLE NO.: -

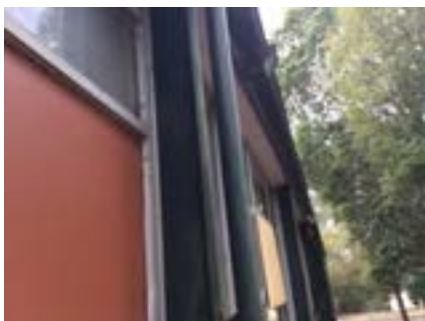
PHOTO NO.: J154351-001-PHOTO036
 RESULT: **ASBESTOS - POSITIVE**
 BUILDING/LEVEL: **B00A - GROUND LEVEL**
 ROOM/LOCATION: **EXTERIOR - VARIOUS THROUGHOUT**
 FEATURE/MATERIAL: **EAVES - FIBRE CEMENT SHEETING**
 SAMPLE NO.: **J154351-001-010**

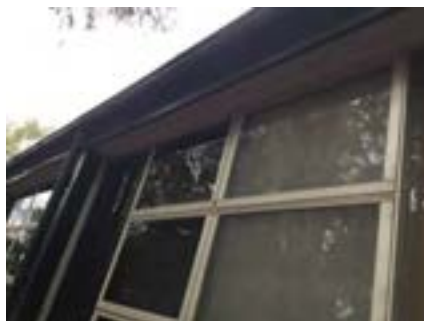
PHOTO NO.: J154351-001-PHOTO037
 RESULT: **ASBESTOS - POSITIVE**
 BUILDING/LEVEL: **B00A - GROUND LEVEL**
 ROOM/LOCATION: **EXTERIOR - VARIOUS THROUGHOUT**
 FEATURE/MATERIAL: **EAVES - FIBRE CEMENT SHEETING**
 SAMPLE NO.: **J154351-001-010**

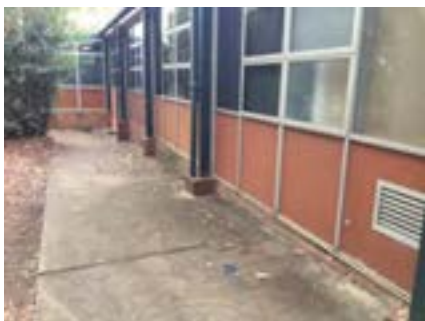
PHOTO NO.: J154351-001-PHOTO015
 RESULT: **ASBESTOS - POSITIVE**
 BUILDING/LEVEL: **B00A - GROUND LEVEL**
 ROOM/LOCATION: **EXTERIOR - VARIOUS THROUGHOUT**
 FEATURE/MATERIAL: **INFILL PANELS - COMPRESSED CEMENT SHEETING**
 SAMPLE NO.: **PREVIOUSLY SAMPLED GREENCAP J146932-02-002-024**

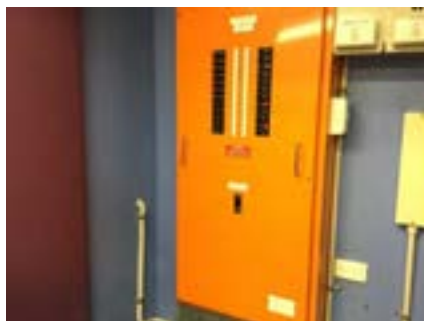
PHOTO NO.: J154351-001-PHOTO019
 RESULT: **ASBESTOS - PRESUMED POSITIVE**
 BUILDING/LEVEL: **B00A - GROUND LEVEL**
 ROOM/LOCATION: **AR0003 - ELECTRICAL CUPBOARD - SOUTH**
 FEATURE/MATERIAL: **ELECTRICAL - SWITCH BOARD - COMPRESSED BITUMINOUS ELECTRICAL PANEL**
 SAMPLE NO.: **NOT SAMPLED LIVE ELECTRICAL HAZARD**

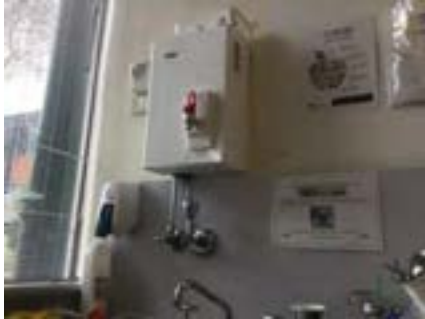
PHOTO NO.: J154351-001-PHOTO026
 RESULT: SMF - PRESUMED POSITIVE
 BUILDING/LEVEL: B00A - GROUND LEVEL
 ROOM/LOCATION: AR0005 - KITCHEN - ABOVE SINK
 FEATURE/MATERIAL: HOT WATER SERVICE INSULATION - INSULATION MATERIAL
 SAMPLE NO.: -

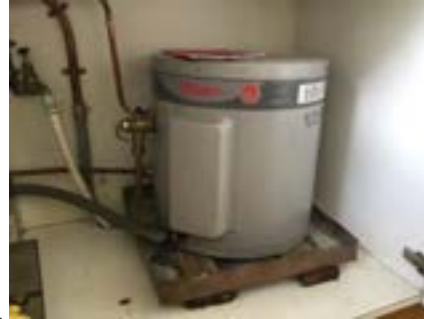
PHOTO NO.: J154351-001-PHOTO025
 RESULT: SMF - PRESUMED POSITIVE
 BUILDING/LEVEL: B00A - GROUND LEVEL
 ROOM/LOCATION: AR0005 - KITCHEN - BELOW SINK
 FEATURE/MATERIAL: HOT WATER SERVICE INSULATION - INSULATION MATERIAL
 SAMPLE NO.: -

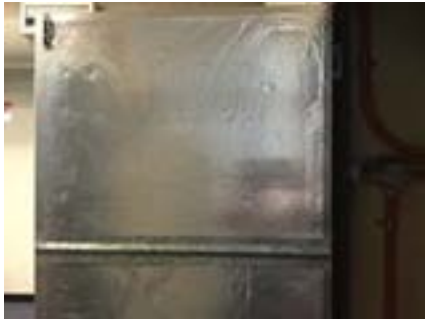
PHOTO NO.: J154351-001-PHOTO034
 RESULT: SMF - POSITIVE
 BUILDING/LEVEL: B00A - GROUND LEVEL
 ROOM/LOCATION: AR0009 - PLANT ROOM - EAST
 FEATURE/MATERIAL: INSULATION - INSULATION MATERIAL
 SAMPLE NO.: -

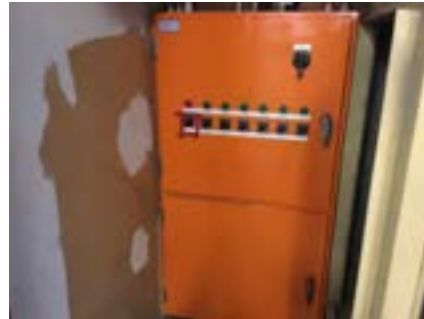
PHOTO NO.: J154351-001-PHOTO030
 RESULT: ASBESTOS - PRESUMED POSITIVE
 BUILDING/LEVEL: B00A - GROUND LEVEL
 ROOM/LOCATION: AR0009 - PLANT ROOM - WEST
 FEATURE/MATERIAL: ELECTRICAL - SWITCH BOARD - COMPRESSED BITUMINOUS ELECTRICAL PANEL
 SAMPLE NO.: NOT SAMPLED LIVE ELECTRICAL HAZARD

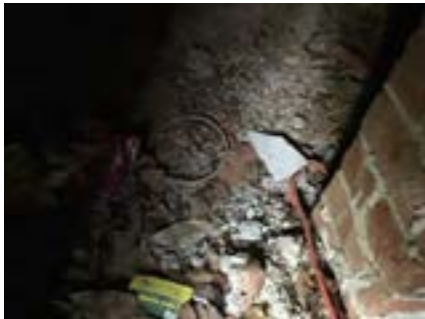
PHOTO NO.: J154351-001-PHOTO048
 RESULT: ASBESTOS - POSITIVE
 BUILDING/LEVEL: B00A - SUB-FLOOR
 ROOM/LOCATION: ALL AREAS - VARIOUS THROUGHOUT
 FEATURE/MATERIAL: DEBRIS - FIBRE CEMENT SHEETING
 SAMPLE NO.: J154351-001-015

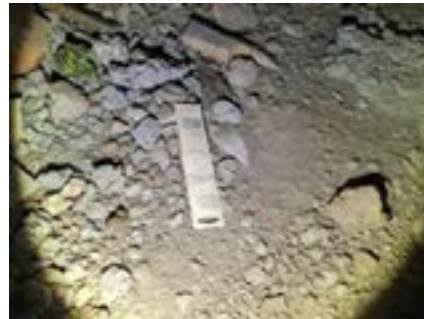
PHOTO NO.: J154351-001-PHOTO051
 RESULT: ASBESTOS - POSITIVE
 BUILDING/LEVEL: B00A - SUB-FLOOR
 ROOM/LOCATION: ALL AREAS - VARIOUS THROUGHOUT
 FEATURE/MATERIAL: DEBRIS - FIBRE CEMENT SHEETING
 SAMPLE NO.: J154351-001-017

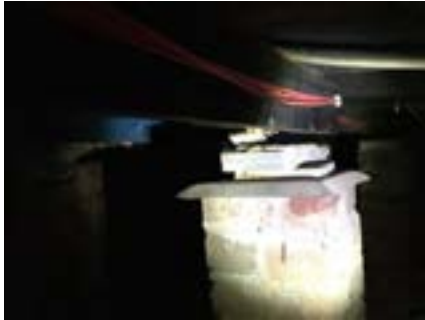
PHOTO NO.: J154351-001-PHOTO047
 RESULT: **ASBESTOS - POSITIVE**
 BUILDING/LEVEL: **B00A - SUB-FLOOR**
 ROOM/LOCATION: **ALL AREAS - VARIOUS THROUGHOUT**
 FEATURE/MATERIAL: **PACKER - FIBRE CEMENT SHEETING**
 SAMPLE NO.: J154351-001-014

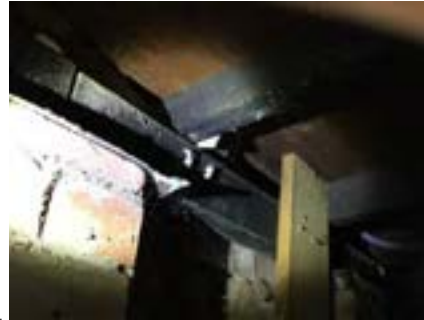
PHOTO NO.: J154351-001-PHOTO046
 RESULT: **ASBESTOS - POSITIVE**
 BUILDING/LEVEL: **B00A - SUB-FLOOR**
 ROOM/LOCATION: **ALL AREAS - VARIOUS THROUGHOUT**
 FEATURE/MATERIAL: **PACKER - FIBRE CEMENT SHEETING**
 SAMPLE NO.: J154351-001-014

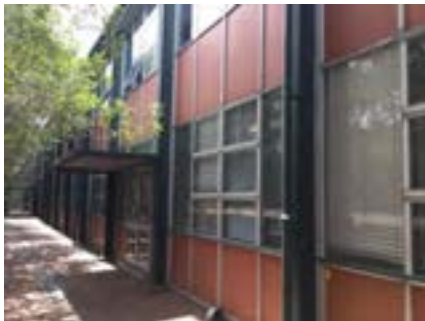
PHOTO NO.: J154351-001-PHOTO131
 RESULT: **ASBESTOS - POSITIVE**
 BUILDING/LEVEL: **B00B - ALL LEVELS**
 ROOM/LOCATION: **ALL AREAS - VARIOUS THROUGHOUT**
 FEATURE/MATERIAL: **INFILL PANELS - COMPRESSED CEMENT SHEETING**
 SAMPLE NO.: PREVIOUSLY SAMPLED GREENCAP J146932-02-002-024

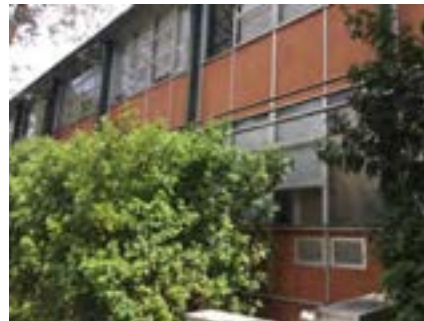
PHOTO NO.: J154351-001-PHOTO129
 RESULT: **ASBESTOS - POSITIVE**
 BUILDING/LEVEL: **B00B - ALL LEVELS**
 ROOM/LOCATION: **ALL AREAS - VARIOUS THROUGHOUT**
 FEATURE/MATERIAL: **INFILL PANELS - COMPRESSED CEMENT SHEETING**
 SAMPLE NO.: PREVIOUSLY SAMPLED GREENCAP J146932-02-002-024

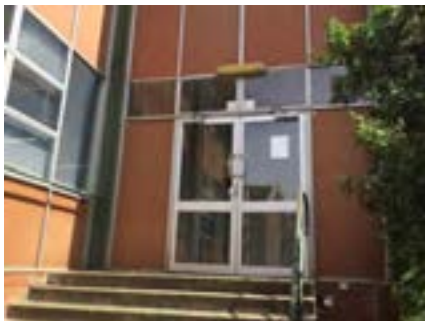
PHOTO NO.: J154351-001-PHOTO130
 RESULT: **ASBESTOS - POSITIVE**
 BUILDING/LEVEL: **B00B - ALL LEVELS**
 ROOM/LOCATION: **ALL AREAS - VARIOUS THROUGHOUT**
 FEATURE/MATERIAL: **INFILL PANELS - COMPRESSED CEMENT SHEETING**
 SAMPLE NO.: PREVIOUSLY SAMPLED GREENCAP J146932-02-002-024

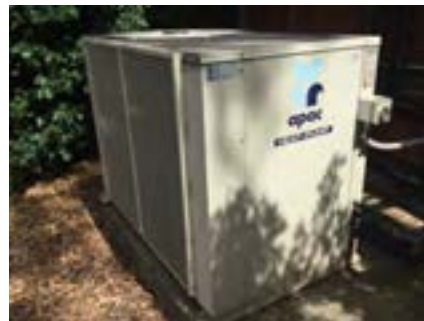
PHOTO NO.: J154351-001-PHOTO128
 RESULT: **ODS - POSITIVE**
 BUILDING/LEVEL: **B00B - GROUND LEVEL**
 ROOM/LOCATION: **EXTERIOR - VARIOUS THROUGHOUT**
 FEATURE/MATERIAL: **A/C UNIT - R22 - CHLORODIFLUOROMETHANE**
 SAMPLE NO.: -

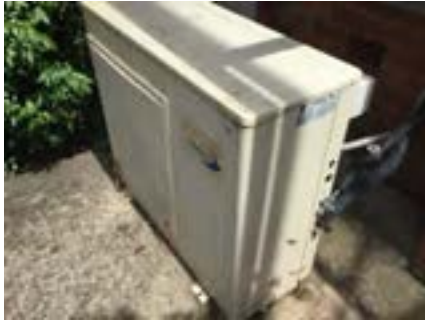
PHOTO NO.: J154351-001-PHOTO126
 RESULT: ODS - POSITIVE
 BUILDING/LEVEL: B00B - GROUND LEVEL
 ROOM/LOCATION: EXTERIOR - VARIOUS THROUGHOUT
 FEATURE/MATERIAL: A/C UNIT - R22 - CHLORODIFLUOROMETHANE
 SAMPLE NO.: -

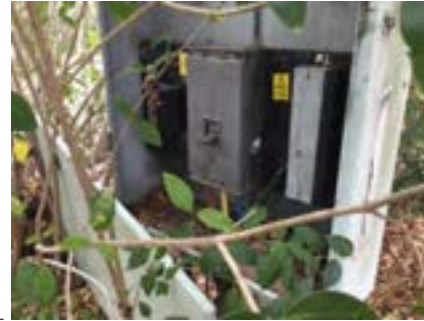
PHOTO NO.: J154351-001-PHOTO189
 RESULT: ASBESTOS - PRESUMED POSITIVE
 BUILDING/LEVEL: B00B - GROUND LEVEL
 ROOM/LOCATION: EXTERIOR - WEST
 FEATURE/MATERIAL: ELECTRICAL - SWITCH BOARD - COMPRESSED BITUMINOUS ELECTRICAL PANEL
 SAMPLE NO.: NOT SAMPLED LIVE ELECTRICAL HAZARD

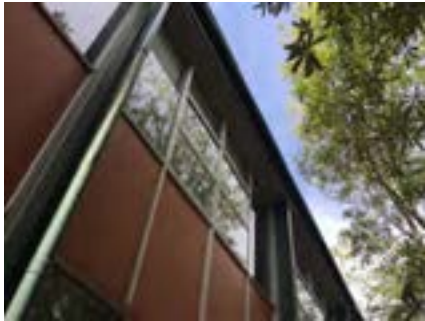
PHOTO NO.: J154351-001-PHOTO132
 RESULT: ASBESTOS - PRESUMED POSITIVE
 BUILDING/LEVEL: B00B - LEVEL ONE
 ROOM/LOCATION: EXTERIOR - VARIOUS THROUGHOUT
 FEATURE/MATERIAL: EAVES - FIBRE CEMENT SHEETING
 SAMPLE NO.: NOT SAMPLED HEIGHT RESTRICTED

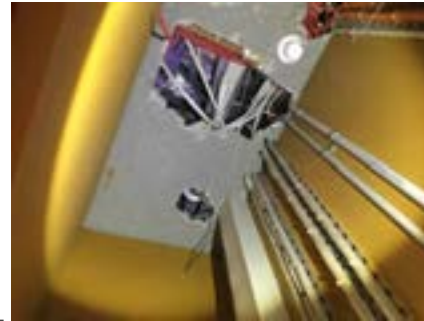
PHOTO NO.: J154351-001-PHOTO118
 RESULT: SMF - POSITIVE
 BUILDING/LEVEL: B00B - LEVEL ONE
 ROOM/LOCATION: ALL ROOMS - ABOVE CEILING
 FEATURE/MATERIAL: INSULATION - SARKING INSULATION
 SAMPLE NO.: -

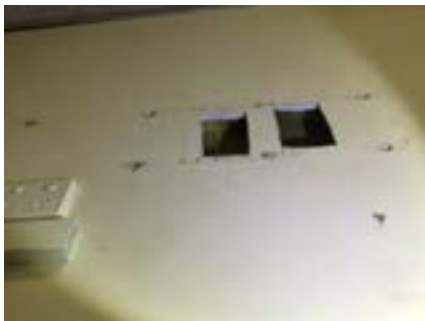
PHOTO NO.: J154351-001-PHOTO117
 RESULT: SMF - POSITIVE
 BUILDING/LEVEL: B00B - LEVEL ONE
 ROOM/LOCATION: ALL ROOMS - VARIOUS THROUGHOUT
 FEATURE/MATERIAL: INSULATION - INSULATION MATERIAL
 SAMPLE NO.: -
