SMALLS ROAD PUBLIC SCHOOL RYDE
NO:1144

CONSTRUCTION ENVIRONMENTAL MANAGEMENT PLAN (CEMP)

Client:	Richard Crookes Constructions (RCC)
Project:	Smalls Rd Public School, Ryde, NSW
Project Number:	1144
Report Title:	CEMP – Smalls Rd, Ryde, Public School
Date:	24 th May 2019
Document Name:	16145_CEMP (Rev2)
Revision Number	Revision 2
Written By: Belal Afyouni Project Manager

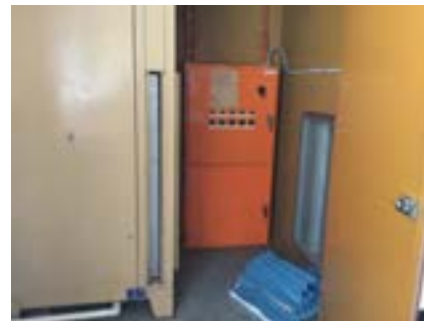
PHOTO NO.: J154351-001-PHOTO120
 RESULT: ASBESTOS - PRESUMED POSITIVE
 BUILDING/LEVEL: B00B - LEVEL ONE
 ROOM/LOCATION: BR1003 - PLANT ROOM - EAST
 FEATURE/MATERIAL: ELECTRICAL - SWITCH BOARD - COMPRESSED BITUMINOUS ELECTRICAL PANEL
 SAMPLE NO.: NOT SAMPLED LIVE ELECTRICAL HAZARD

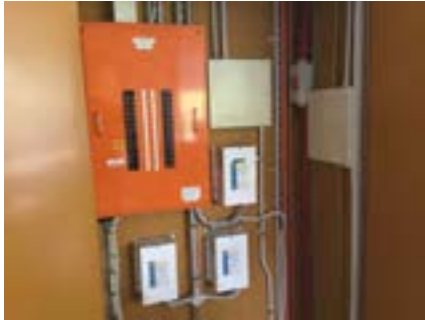
PHOTO NO.: J154351-001-PHOTO119
 RESULT: ASBESTOS - PRESUMED POSITIVE
 BUILDING/LEVEL: B00B - LEVEL ONE
 ROOM/LOCATION: BR1004 - ELECTRICAL CUPBOARD - NORTH
 FEATURE/MATERIAL: ELECTRICAL - SWITCH BOARD - COMPRESSED BITUMINOUS ELECTRICAL PANEL
 SAMPLE NO.: NOT SAMPLED LIVE ELECTRICAL HAZARD

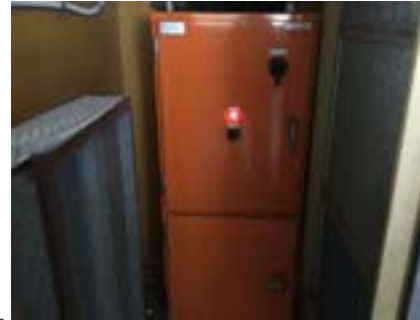
PHOTO NO.: J154351-001-PHOTO123
 RESULT: ASBESTOS - PRESUMED POSITIVE
 BUILDING/LEVEL: B00B - LEVEL ONE
 ROOM/LOCATION: BR1014 - PLANT ROOM - WEST
 FEATURE/MATERIAL: ELECTRICAL - SWITCH BOARD - COMPRESSED BITUMINOUS ELECTRICAL PANEL
 SAMPLE NO.: NOT SAMPLED LIVE ELECTRICAL HAZARD

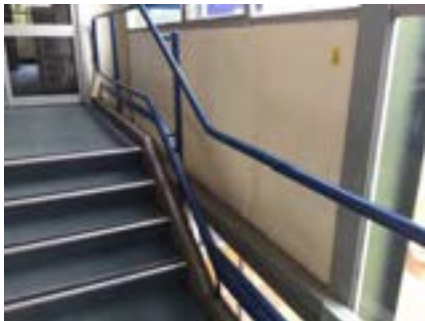
PHOTO NO.: J154351-001-PHOTO114
 RESULT: ASBESTOS - POSITIVE
 BUILDING/LEVEL: B00B - LEVEL ONE
 ROOM/LOCATION: BR1019 - COVERD WALKWAY (CONNECTING BUILDING E & B) - SOUTH
 FEATURE/MATERIAL: INFILL PANELS - COMPRESSED CEMENT SHEETING
 SAMPLE NO.: PREVIOUSLY SAMPLED GREENCAP J146932-02-002-024

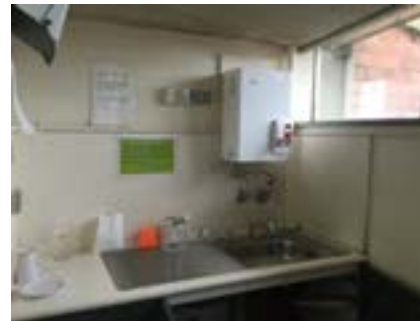
PHOTO NO.: J154351-001-PHOTO105
 RESULT: SMF - PRESUMED POSITIVE
 BUILDING/LEVEL: B00B - LEVEL ONE
 ROOM/LOCATION: BR1020 - KITCHEN - ABOVE SINK
 FEATURE/MATERIAL: HOT WATER SERVICE INSULATION - INSULATION MATERIAL
 SAMPLE NO.: -

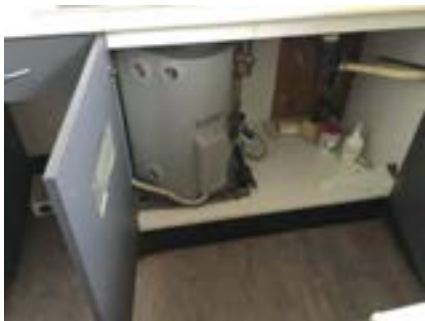
PHOTO NO.: J154351-001-PHOTO106
 RESULT: SMF - PRESUMED POSITIVE
 BUILDING/LEVEL: B00B - LEVEL ONE
 ROOM/LOCATION: BR1020 - KITCHEN - BELOW SINK
 FEATURE/MATERIAL: HOT WATER SERVICE INSULATION - INSULATION MATERIAL
 SAMPLE NO.: -

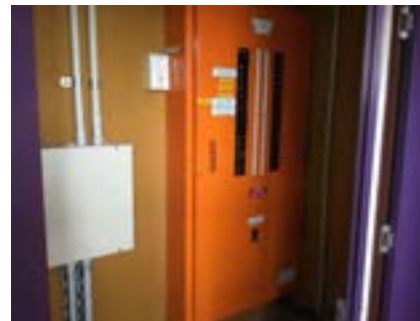
PHOTO NO.: J154351-001-PHOTO107
 RESULT: ASBESTOS - PRESUMED POSITIVE
 BUILDING/LEVEL: B00B - LEVEL ONE
 ROOM/LOCATION: BR1021 - ELECTRICAL CUPBOARD(WITHIN KITCHEN) - SOUTH
 FEATURE/MATERIAL: ELECTRICAL - SWITCH BOARD - COMPRESSED BITUMINOUS ELECTRICAL PANEL
 SAMPLE NO.: NOT SAMPLED LIVE ELECTRICAL HAZARD

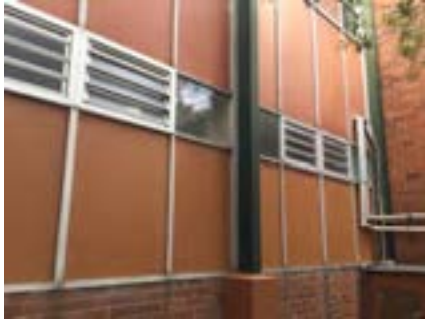
PHOTO NO.: J154351-001-PHOTO185
 RESULT: **ASBESTOS - POSITIVE**
 BUILDING/LEVEL: **B00D - ALL LEVELS**
 ROOM/LOCATION: **ALL AREAS - VARIOUS THROUGHOUT**
 FEATURE/MATERIAL: **INFILL PANELS - COMPRESSED CEMENT SHEETING**
 SAMPLE NO.: **PREVIOUSLY SAMPLED GREENCAP J146932-02-002-024**

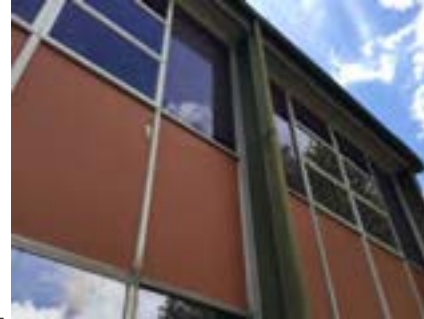
PHOTO NO.: J154351-001-PHOTO186
 RESULT: **ASBESTOS - POSITIVE**
 BUILDING/LEVEL: **B00D - ALL LEVELS**
 ROOM/LOCATION: **ALL AREAS - VARIOUS THROUGHOUT**
 FEATURE/MATERIAL: **INFILL PANELS - COMPRESSED CEMENT SHEETING**
 SAMPLE NO.: **PREVIOUSLY SAMPLED GREENCAP J146932-02-002-024**

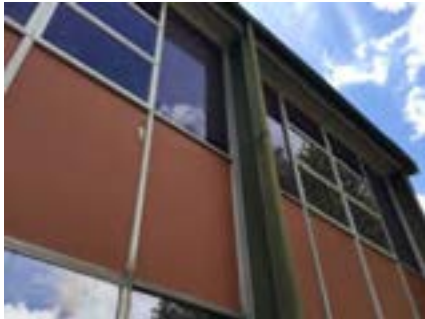
PHOTO NO.: J154351-001-PHOTO186
 RESULT: **ASBESTOS - POSITIVE**
 BUILDING/LEVEL: **B00D - ALL LEVELS**
 ROOM/LOCATION: **ALL AREAS - VARIOUS THROUGHOUT**
 FEATURE/MATERIAL: **INFILL PANELS - COMPRESSED CEMENT SHEETING**
 SAMPLE NO.: **PREVIOUSLY SAMPLED GREENCAP J146932-02-002-024**

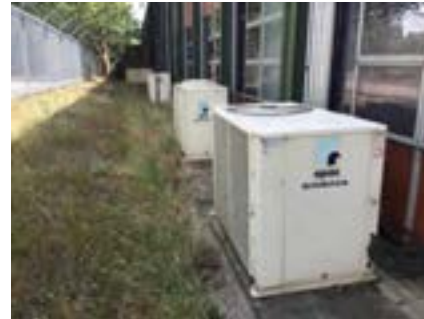
PHOTO NO.: J154351-001-PHOTO192
 RESULT: **ODS - POSITIVE**
 BUILDING/LEVEL: **B00D - GROUND LEVEL**
 ROOM/LOCATION: **EXTERIOR - VARIOUS THROUGHOUT**
 FEATURE/MATERIAL: **A/C UNIT - R22 - CHLORODIFLUOROMETHANE**
 SAMPLE NO.: -

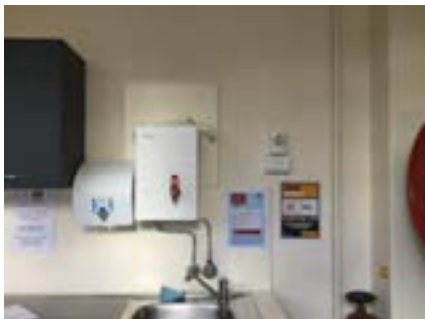
PHOTO NO.: J154351-001-PHOTO164
 RESULT: **SMF - PRESUMED POSITIVE**
 BUILDING/LEVEL: **B00D - GROUND LEVEL**
 ROOM/LOCATION: **DR0001 - KITCHEN - ABOVE SINK**
 FEATURE/MATERIAL: **HOT WATER SERVICE INSULATION - INSULATION MATERIAL**
 SAMPLE NO.: -

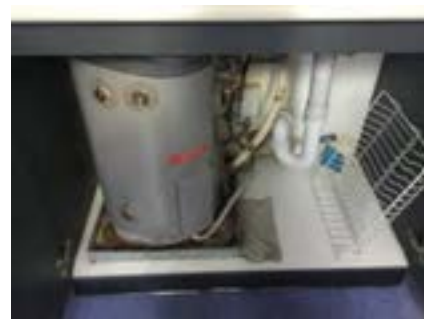
PHOTO NO.: J154351-001-PHOTO163
 RESULT: **SMF - PRESUMED POSITIVE**
 BUILDING/LEVEL: **B00D - GROUND LEVEL**
 ROOM/LOCATION: **DR0001 - KITCHEN - BELOW SINK**
 FEATURE/MATERIAL: **HOT WATER SERVICE INSULATION - INSULATION MATERIAL**
 SAMPLE NO.: -

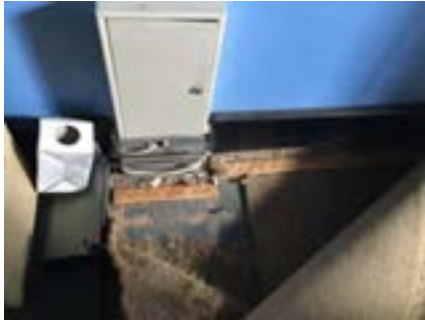
PHOTO NO.: J154351-001-PHOTO157
 RESULT: **ASBESTOS - POSITIVE**
 BUILDING/LEVEL: **B00D - GROUND LEVEL**
 ROOM/LOCATION: **DR0007 - SCANN/RECORDS STORAGE - THROUGHOUT**
 FEATURE/MATERIAL: **FLOOR COVERING - VINYL TILES & ADHESIVE**
 SAMPLE NO.: **J154351-001-049**

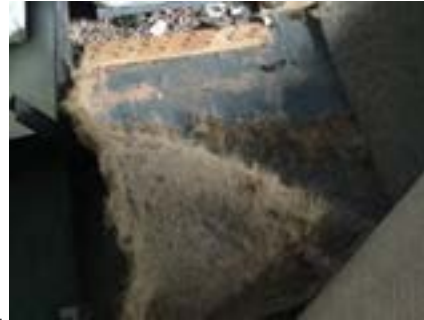
PHOTO NO.: J154351-001-PHOTO158
 RESULT: **ASBESTOS - POSITIVE**
 BUILDING/LEVEL: **B00D - GROUND LEVEL**
 ROOM/LOCATION: **DR0007 - SCANN/RECORDS STORAGE - THROUGHOUT**
 FEATURE/MATERIAL: **FLOOR COVERING - VINYL TILES & ADHESIVE**
 SAMPLE NO.: **J154351-001-049**

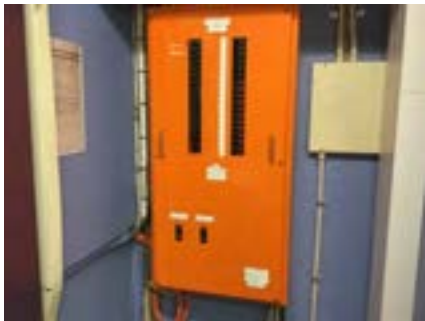
PHOTO NO.: J154351-001-PHOTO171
 RESULT: **ASBESTOS - PRESUMED POSITIVE**
 BUILDING/LEVEL: **B00D - GROUND LEVEL**
 ROOM/LOCATION: **DR0014 - ELECTRICAL CUPBOARD - WEST**
 FEATURE/MATERIAL: **ELECTRICAL - SWITCH BOARD - COMPRESSED BITUMINOUS ELECTRICAL PANEL**
 SAMPLE NO.: **NOT SAMPLED LIVE ELECTRICAL HAZARD**

Location - Item Description	Hazard Type	Sample No.	Item Status	Photo No.	Est. Extent	Condition	Friability	Dist. Potential	Risk Rating	Current Label	Reinspect Date	Control Priority	Control Recommendation	Record of Works Undertaken
DR0014 - Electrical Cupboard - Throughout Floor Covering - Sheet Vinyl & Adhesive - Green colour.	Asbestos	Similar To: J154351-001-050	Presumed Negative											
DR0014 - Electrical Cupboard - West Electrical - Switch Board - Compressed Bituminous Electrical Panel - Lining within orange colour electrical metal cabinet.	Asbestos	Not Sampled Live Electrical Hazard	Presumed Positive	J154351-001-Photo171	1 Unit/s	Good	Non Friable	Low	Low	Not Labelled	21/02/2023	P4	Confirm status, remove under controlled conditions by an appropriately licensed asbestos contractor prior to refurbishment/demolition.	
DR0016 - Electrical Cupboard - South Electrical - Switch Board - Compressed Bituminous Electrical Panel - Lining within orange colour electrical metal cabinet.	Asbestos	Not Sampled Live Electrical Hazard	Presumed Positive	J154351-001-Photo170	1 Unit/s	Good	Non Friable	Low	Low	Not Labelled	21/02/2023	P4	Confirm status, remove under controlled conditions by an appropriately licensed asbestos contractor prior to refurbishment/demolition.

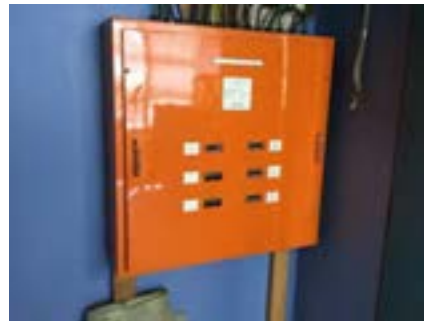
PHOTO NO.: J154351-001-PHOTO170
 RESULT: **ASBESTOS - PRESUMED POSITIVE**
 BUILDING/LEVEL: **B00D - GROUND LEVEL**
 ROOM/LOCATION: **DR0016 - ELECTRICAL CUPBOARD - SOUTH**
 FEATURE/MATERIAL: **ELECTRICAL - SWITCH BOARD - COMPRESSED BITUMINOUS ELECTRICAL PANEL**
 SAMPLE NO.: **NOT SAMPLED LIVE ELECTRICAL HAZARD**

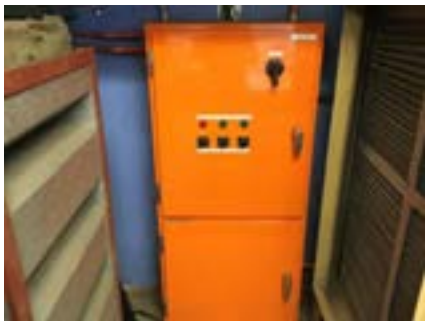
PHOTO NO.: J154351-001-PHOTO169
 RESULT: **ASBESTOS - PRESUMED POSITIVE**
 BUILDING/LEVEL: **B00D - GROUND LEVEL**
 ROOM/LOCATION: **DR0017 - PLANT ROOM - EAST**
 FEATURE/MATERIAL: **ELECTRICAL - SWITCH BOARD - COMPRESSED BITUMINOUS ELECTRICAL PANEL**
 SAMPLE NO.: **NOT SAMPLED LIVE ELECTRICAL HAZARD**

DR0017 - Plant Room - East Electrical - Switch Board - Compressed Bituminous Electrical Panel - Lining within orange colour electrical metal cabinet.	Asbestos	Not Sampled Live Electrical Hazard	Presumed Positive	J154351-001-Photo169 J154351-001-Photo168	1 Unit/s	Good	Non Friable	Low	Low	Not Labelled	21/02/2023	P4	Confirm status, remove under controlled conditions by an appropriately licensed asbestos contractor prior to refurbishment/demolition.	
DR0017 - Plant Room - Various Throughout Air Conditioning Ductwork - Mastic Sealant - Grey colour.	Asbestos	Similar To: J154351-001-045	Presumed Negative											
DR0017 - Plant Room - Various Throughout Insulation - Insulation Material - Yellow colour batts to doors and on top of duct works.	SMF		Positive	J154351-001-Photo166 J154351-001-Photo167	15 m ²	Fair	Bonded (SMF)						Repair/ seal exposed surfaces, remove by an appropriately experienced contractor under controlled conditions and using correct PPE prior to refurbishment/demolition.

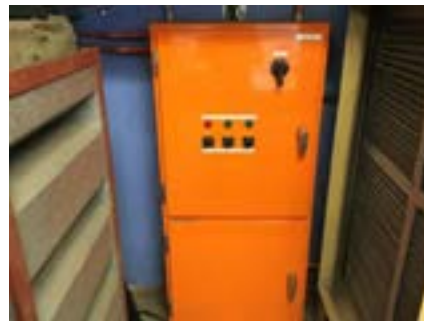
PHOTO NO.: J154351-001-PHOTO168
 RESULT: **ASBESTOS - PRESUMED POSITIVE**
 BUILDING/LEVEL: **B00D - GROUND LEVEL**
 ROOM/LOCATION: **DR0017 - PLANT ROOM - EAST**
 FEATURE/MATERIAL: **ELECTRICAL - SWITCH BOARD - COMPRESSED BITUMINOUS ELECTRICAL PANEL**
 SAMPLE NO.: **NOT SAMPLED LIVE ELECTRICAL HAZARD**

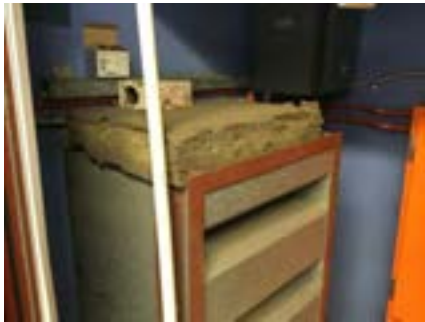
PHOTO NO.: J154351-001-PHOTO166
 RESULT: **SMF - POSITIVE**
 BUILDING/LEVEL: **B00D - GROUND LEVEL**
 ROOM/LOCATION: **DR0017 - PLANT ROOM - VARIOUS THROUGHOUT**
 FEATURE/MATERIAL: **INSULATION - INSULATION MATERIAL**
 SAMPLE NO.: -

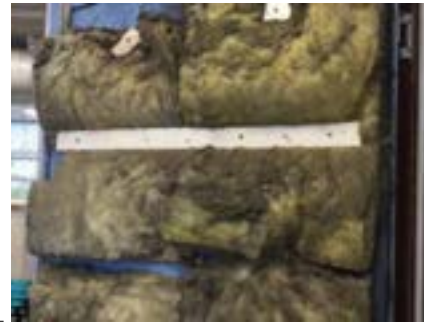
PHOTO NO.: J154351-001-PHOTO167
 RESULT: **SMF - POSITIVE**
 BUILDING/LEVEL: **B00D - GROUND LEVEL**
 ROOM/LOCATION: **DR0017 - PLANT ROOM - VARIOUS THROUGHOUT**
 FEATURE/MATERIAL: **INSULATION - INSULATION MATERIAL**
 SAMPLE NO.: -

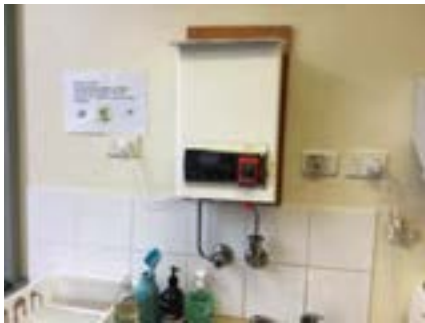
PHOTO NO.: J154351-001-PHOTO174
 RESULT: **SMF - PRESUMED POSITIVE**
 BUILDING/LEVEL: **B00D - GROUND LEVEL**
 ROOM/LOCATION: **DR0019 - STAFF KITCHEN/LUNCH ROOM - ABOVE SINK**
 FEATURE/MATERIAL: **HOT WATER SERVICE INSULATION - INSULATION MATERIAL**
 SAMPLE NO.: -

DR0019 - Staff Kitchen/Lunch Room - Above sink Hot Water Service Insulation - Insulation Material - Lining within Zip boiling water unit.	SMF		Presumed Positive	J154351-001-Photo174	1 Unit/s	Good	Bonded (SMF)						Remove by an appropriately experienced contractor under controlled conditions and using correct PPE if this material will be impacted by refurbishment/demolition works.	
DR0019 - Staff Kitchen/Lunch Room - Below sink Hot Water Service Insulation - Insulation Material - Lining within Rheem hot water unit.	SMF		Presumed Positive	J154351-001-Photo173	1 Unit/s	Good	Bonded (SMF)						Remove by an appropriately experienced contractor under controlled conditions and using correct PPE if this material will be impacted by refurbishment/demolition works.	
DR0022 - Plant Room - South Ductwork Insulation - Insulation Material - Lining within metal duct work.	SMF		Positive	J154351-001-Photo177	5 m ²	Good	Bonded (SMF)						Remove by an appropriately experienced contractor under controlled conditions and using correct PPE if this material will be impacted by refurbishment/demolition works.

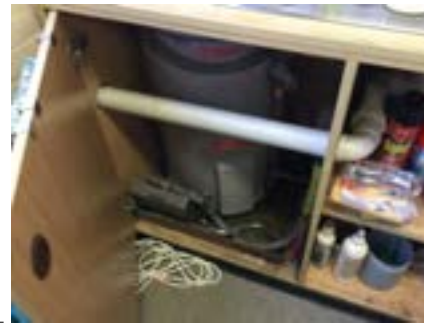
PHOTO NO.: J154351-001-PHOTO173
 RESULT: **SMF - PRESUMED POSITIVE**
 BUILDING/LEVEL: **B00D - GROUND LEVEL**
 ROOM/LOCATION: **DR0019 - STAFF KITCHEN/LUNCH ROOM - BELOW SINK**
 FEATURE/MATERIAL: **HOT WATER SERVICE INSULATION - INSULATION MATERIAL**
 SAMPLE NO.: -

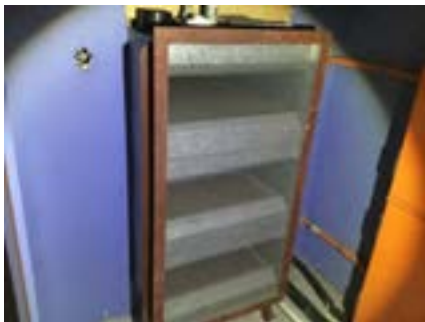
PHOTO NO.: J154351-001-PHOTO177
 RESULT: **SMF - POSITIVE**
 BUILDING/LEVEL: **B00D - GROUND LEVEL**
 ROOM/LOCATION: **DR0022 - PLANT ROOM - SOUTH**
 FEATURE/MATERIAL: **DUCTWORK INSULATION - INSULATION MATERIAL**
 SAMPLE NO.: -

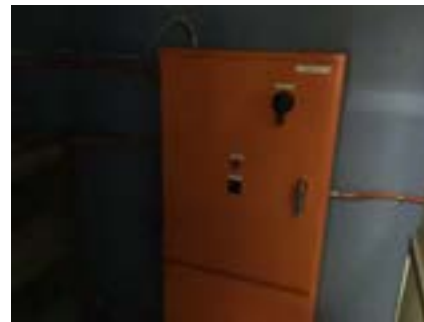
PHOTO NO.: J154351-001-PHOTO176
 RESULT: **ASBESTOS - PRESUMED POSITIVE**
 BUILDING/LEVEL: **B00D - GROUND LEVEL**
 ROOM/LOCATION: **DR0022 - PLANT ROOM - WEST**
 FEATURE/MATERIAL: **ELECTRICAL - SWITCH BOARD - COMPRESSED BITUMINOUS ELECTRICAL PANEL**
 SAMPLE NO.: **NOT SAMPLED HEIGHT RESTRICTED**

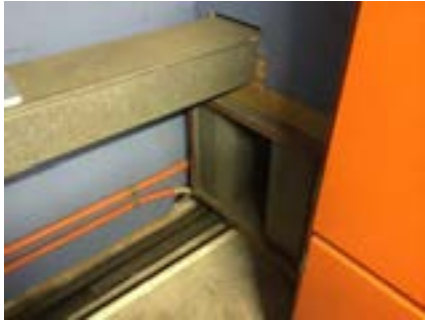
PHOTO NO.: J154351-001-PHOTO180
 RESULT: SMF - POSITIVE
 BUILDING/LEVEL: B00D - GROUND LEVEL
 ROOM/LOCATION: DR0023 - PLANT ROOM - NORTH
 FEATURE/MATERIAL: DUCTWORK INSULATION - INSULATION MATERIAL
 SAMPLE NO.: -

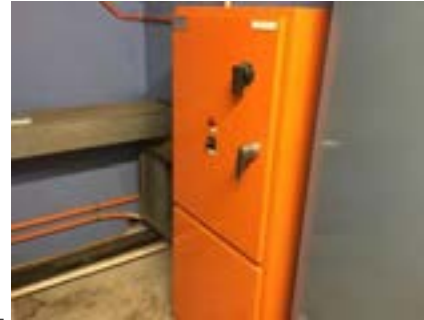
PHOTO NO.: J154351-001-PHOTO179
 RESULT: ASBESTOS - PRESUMED POSITIVE
 BUILDING/LEVEL: B00D - GROUND LEVEL
 ROOM/LOCATION: DR0023 - PLANT ROOM - NORTH
 FEATURE/MATERIAL: ELECTRICAL - SWITCH BOARD - COMPRESSED BITUMINOUS ELECTRICAL PANEL
 SAMPLE NO.: NOT SAMPLED HEIGHT RESTRICTED

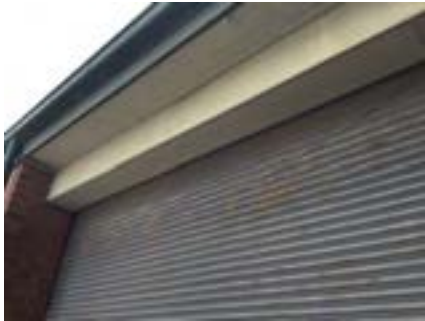
PHOTO NO.: J154351-001-PHOTO187
 RESULT: ASBESTOS - PRESUMED POSITIVE
 BUILDING/LEVEL: B00D - LEVEL ONE
 ROOM/LOCATION: ALL AREAS - VARIOUS THROUGHOUT
 FEATURE/MATERIAL: EAVES - FIBRE CEMENT SHEETING
 SAMPLE NO.: NOT SAMPLED HEIGHT RESTRICTED

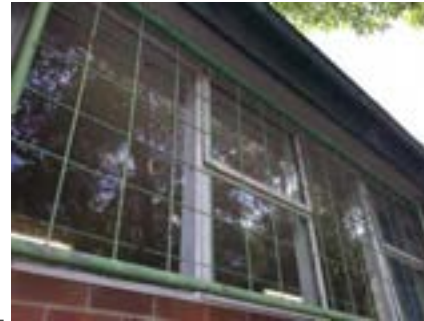
PHOTO NO.: J154351-001-PHOTO188
 RESULT: ASBESTOS - PRESUMED POSITIVE
 BUILDING/LEVEL: B00D - LEVEL ONE
 ROOM/LOCATION: ALL AREAS - VARIOUS THROUGHOUT
 FEATURE/MATERIAL: EAVES - FIBRE CEMENT SHEETING
 SAMPLE NO.: NOT SAMPLED HEIGHT RESTRICTED

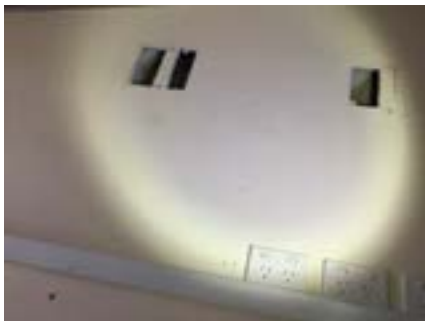
PHOTO NO.: J154351-001-PHOTO146
 RESULT: SMF - POSITIVE
 BUILDING/LEVEL: B00D - LEVEL ONE
 ROOM/LOCATION: ALL ROOMS - VARIOUS THROUGHOUT
 FEATURE/MATERIAL: INSULATION - INSULATION MATERIAL
 SAMPLE NO.: -

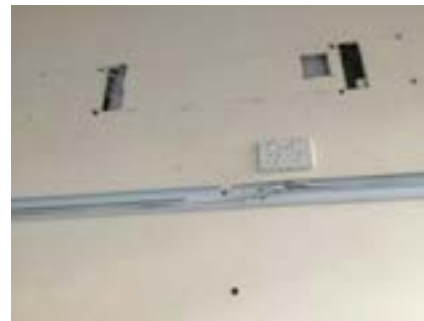
PHOTO NO.: J154351-001-PHOTO151
 RESULT: SMF - POSITIVE
 BUILDING/LEVEL: B00D - LEVEL ONE
 ROOM/LOCATION: ALL ROOMS - VARIOUS THROUGHOUT
 FEATURE/MATERIAL: INSULATION - INSULATION MATERIAL
 SAMPLE NO.: -

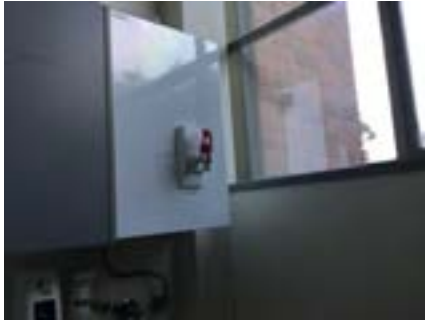
PHOTO NO.: J154351-001-PHOTO156
 RESULT: SMF - PRESUMED POSITIVE
 BUILDING/LEVEL: B00D - LEVEL ONE
 ROOM/LOCATION: DR1002 - KITCHEN - ABOVE SINK
 FEATURE/MATERIAL: HOT WATER SERVICE INSULATION - INSULATION MATERIAL
 SAMPLE NO.: -

Location - Item Description	Hazard Type	Sample No.	Item Status	Photo No.	Est. Extent	Condition	Friability	Dist. Potential	Risk Rating	Current Label	Reinspect Date	Control Priority	Control Recommendation	Record of Works Undertaken
DR1002 - Kitchen - Below sink Hot Water Service Insulation - Insulation Material - Lining within Rheem hot water unit.	SMF		Presumed Positive	J154351-001-Photo155	1 Unit/s	Good	Bonded (SMF)						Remove by an appropriately experienced contractor under controlled conditions and using correct PPE if this material will be impacted by refurbishment/ demolition works.	
DR1002 - Kitchen - Throughout Floor Covering - Sheet Vinyl & Adhesive - Grey and blue spec sheeting.	Asbestos	J154351-001-047	Negative											
DR1003 - Cleaners - Throughout Floor Covering - Sheet Vinyl & Adhesive - Greenish blue sheeting.	Asbestos	J154351-001-048	Negative											
DR1009 - Plant Room - North Ductwork Insulation - Insulation Material - Lining within metal duct work.	SMF		Positive	J154351-001-Photo141	5 m ²	Good	Bonded (SMF)						Remove by an appropriately experienced contractor under controlled conditions and using correct PPE if this material will be impacted by refurbishment/ demolition works.

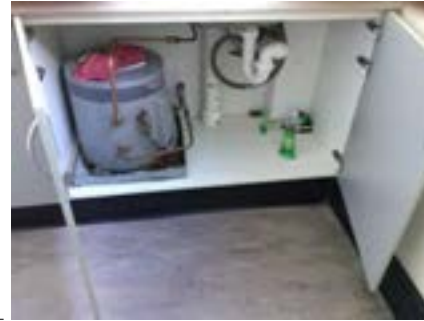
PHOTO NO.: J154351-001-PHOTO155
 RESULT: SMF - PRESUMED POSITIVE
 BUILDING/LEVEL: B00D - LEVEL ONE
 ROOM/LOCATION: DR1002 - KITCHEN - BELOW SINK
 FEATURE/MATERIAL: HOT WATER SERVICE INSULATION - INSULATION MATERIAL
 SAMPLE NO.: -

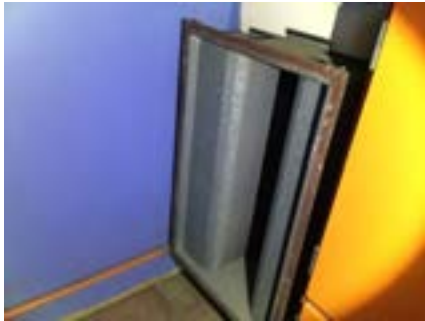
PHOTO NO.: J154351-001-PHOTO141
 RESULT: SMF - POSITIVE
 BUILDING/LEVEL: B00D - LEVEL ONE
 ROOM/LOCATION: DR1009 - PLANT ROOM - NORTH
 FEATURE/MATERIAL: DUCTWORK INSULATION - INSULATION MATERIAL
 SAMPLE NO.: -

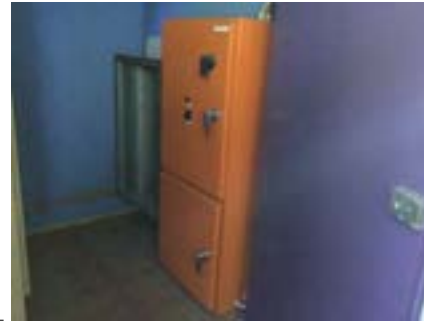
PHOTO NO.: J154351-001-PHOTO139
 RESULT: ASBESTOS - PRESUMED POSITIVE
 BUILDING/LEVEL: B00D - LEVEL ONE
 ROOM/LOCATION: DR1009 - PLANT ROOM - NORTH
 FEATURE/MATERIAL: ELECTRICAL - SWITCH BOARD - COMPRESSED BITUMINOUS ELECTRICAL PANEL
 SAMPLE NO.: NOT SAMPLED HEIGHT RESTRICTED

DR1009 - Plant Room - North Electrical - Switch Board - Compressed Bituminous Electrical Panel - Lining within orange colour electrical metal cabinet.	Asbestos	Not Sampled Height Restricted	Presumed Positive	J154351-001-Photo139	1 Unit/s	Good	Non Friable	Low	Low	Not Labelled	21/02/2023	P4	Confirm status, remove under controlled conditions by an appropriately licensed asbestos contractor prior to refurbishment/demolition.	
DR1009 - Plant Room - Throughout Floor Covering - Vinyl Tiles & Adhesive - Brown colour designer tiles.	Asbestos	J154351-001-043	Negative											
DR1009 - Plant Room - Various Throughout Air Conditioning Ductwork - Mastic Sealant - Grey colour.	Asbestos	J154351-001-045	Negative											
DR1014 - Electrical Cupboard - Various Throughout Floor Covering - Vinyl Tiles & Adhesive - With fibrous backing underneath.	Asbestos	J154351-001-046	Negative											
DR1014 - Electrical Cupboard - West Electrical - Switch Board - Compressed Bituminous Electrical Panel - Lining within orange colour electrical metal cabinet.	Asbestos	Not Sampled Live Electrical Hazard	Presumed Positive	J154351-001-Photo144	1 Unit/s	Good	Non Friable	Low	Low	Not Labelled	21/02/2023	P4	Confirm status, remove under controlled conditions by an appropriately licensed asbestos contractor prior to refurbishment/demolition.

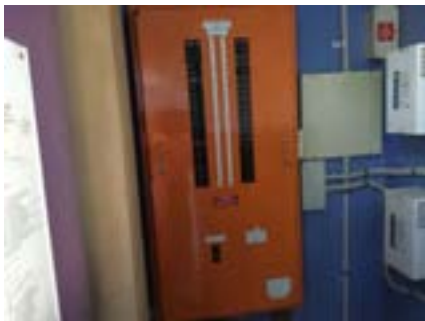
PHOTO NO.: J154351-001-PHOTO144
 RESULT: ASBESTOS - PRESUMED POSITIVE
 BUILDING/LEVEL: B00D - LEVEL ONE
 ROOM/LOCATION: DR1014 - ELECTRICAL CUPBOARD - WEST
 FEATURE/MATERIAL: ELECTRICAL - SWITCH BOARD - COMPRESSED BITUMINOUS ELECTRICAL PANEL
 SAMPLE NO.: NOT SAMPLED LIVE ELECTRICAL HAZARD

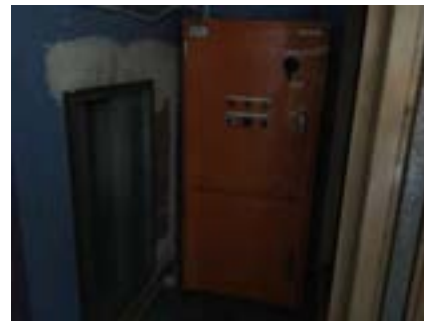
PHOTO NO.: J154351-001-PHOTO148
 RESULT: ASBESTOS - PRESUMED POSITIVE
 BUILDING/LEVEL: B00D - LEVEL ONE
 ROOM/LOCATION: DR1019 - PLANT ROOM - EAST
 FEATURE/MATERIAL: ELECTRICAL - SWITCH BOARD - COMPRESSED BITUMINOUS ELECTRICAL PANEL
 SAMPLE NO.: NOT SAMPLED HEIGHT RESTRICTED

DR1019 - Plant Room - East Electrical - Switch Board - Compressed Bituminous Electrical Panel - Lining within orange colour electrical metal cabinet.	Asbestos	Not Sampled Height Restricted	Presumed Positive	J154351-001-Photo148	1 Unit/s	Good	Non Friable	Low	Low	Not Labelled	21/02/2023	P4	Confirm status, remove under controlled conditions by an appropriately licensed asbestos contractor prior to refurbishment/demolition.	
DR1019 - Plant Room - North Ductwork Insulation - Insulation Material - Lining within metal duct work.	SMF		Positive	J154351-001-Photo149	5 m ²	Good	Bonded (SMF)						Remove by an appropriately experienced contractor under controlled conditions and using correct PPE if this material will be impacted by refurbishment/ demolition works.

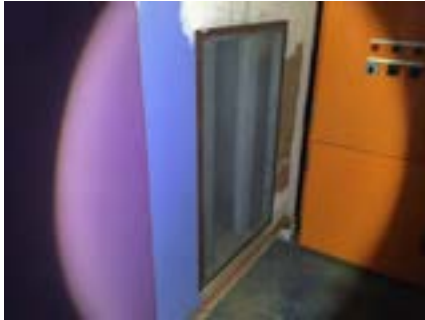
PHOTO NO.: J154351-001-PHOTO149
 RESULT: SMF - POSITIVE
 BUILDING/LEVEL: B00D - LEVEL ONE
 ROOM/LOCATION: DR1019 - PLANT ROOM - NORTH
 FEATURE/MATERIAL: DUCTWORK INSULATION - INSULATION MATERIAL
 SAMPLE NO.: -

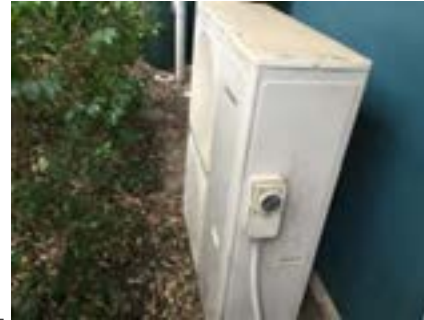
PHOTO NO.: J154351-001-PHOTO191
 RESULT: ODS - POSITIVE
 BUILDING/LEVEL: B00K - GROUND LEVEL
 ROOM/LOCATION: EXTERIOR - SOUTH
 FEATURE/MATERIAL: A/C UNIT - R22 - CHLORODIFLUOROMETHANE
 SAMPLE NO.: -

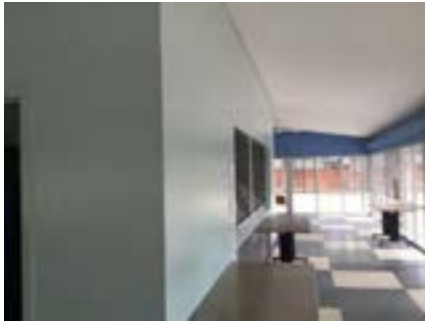
PHOTO NO.: J154351-001-PHOTO009
 RESULT: SMF - POSITIVE
 BUILDING/LEVEL: B00K - GROUND LEVEL
 ROOM/LOCATION: KR0001 - ADMIN - VARIOUS THROUGHOUT
 FEATURE/MATERIAL: INSULATION - INSULATION MATERIAL
 SAMPLE NO.: -

KR0001 - Admin - Throughout Floor Covering - Sheet Vinyl & Adhesive - Cream colour.	Asbestos	J154351-001-001	Negative											
KR0001 - Admin - Various Throughout Insulation - Insulation Material - Between Walls.	SMF		Positive	J154351-001-Photo009	100 m ²	Good	Bonded (SMF)						Remove by an appropriately experienced contractor under controlled conditions and using correct PPE if this material will be impacted by refurbishment/ demolition works.	
KR0003 - Female Toilet/Shower/Locker - Various Throughout Insulation - Insulation Material - Behind ceramic tiles and walls.	SMF		Positive	J154351-001-Photo008	45 m ²	Good	Bonded (SMF)						Remove by an appropriately experienced contractor under controlled conditions and using correct PPE if this material will be impacted by refurbishment/ demolition works.	
KR0004 - Cleaners Store - Various Throughout Insulation - Insulation Material - Behind ceramic tiles and walls.	SMF		Positive	J154351-001-Photo010	15 m ²	Good	Bonded (SMF)						Remove by an appropriately experienced contractor under controlled conditions and using correct PPE if this material will be impacted by refurbishment/ demolition works.

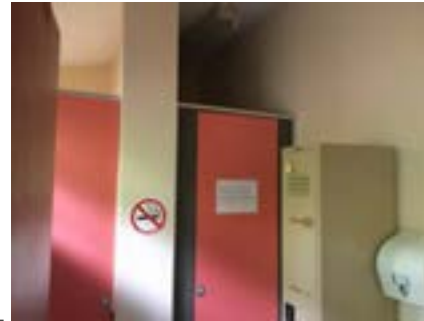
PHOTO NO.: J154351-001-PHOTO008
 RESULT: SMF - POSITIVE
 BUILDING/LEVEL: B00K - GROUND LEVEL
 ROOM/LOCATION: KR0003 - FEMALE TOILET/SHOWER/LOCKER - VARIOUS THROUGHOUT
 FEATURE/MATERIAL: INSULATION - INSULATION MATERIAL
 SAMPLE NO.: -

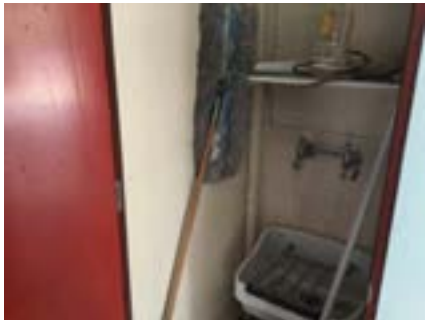
PHOTO NO.: J154351-001-PHOTO010
 RESULT: SMF - POSITIVE
 BUILDING/LEVEL: B00K - GROUND LEVEL
 ROOM/LOCATION: KR0004 - CLEANERS STORE - VARIOUS THROUGHOUT
 FEATURE/MATERIAL: INSULATION - INSULATION MATERIAL
 SAMPLE NO.: -

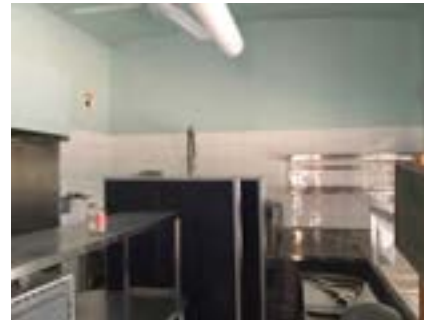
PHOTO NO.: J154351-001-PHOTO011
 RESULT: SMF - POSITIVE
 BUILDING/LEVEL: B00K - GROUND LEVEL
 ROOM/LOCATION: KR0005 - KITCHEN - VARIOUS THROUGHOUT
 FEATURE/MATERIAL: INSULATION - INSULATION MATERIAL
 SAMPLE NO.: -

KR0005 - Kitchen - Various Throughout Insulation - Insulation Material - Behind ceramic tiles and walls.	SMF		Positive	J154351-001-Photo011	50 m ²	Good	Bonded (SMF)						Remove by an appropriately experienced contractor under controlled conditions and using correct PPE if this material will be impacted by refurbishment/ demolition works.	
KR0007 - Service Area - Central Hot Water Service Insulation - Insulation Material - Lining material within Rheem hot water unit.	SMF		Presumed Positive	J154351-001-Photo007	1 Unit/s	Good	Bonded (SMF)						Remove by an appropriately experienced contractor under controlled conditions and using correct PPE if this material will be impacted by refurbishment/ demolition works.

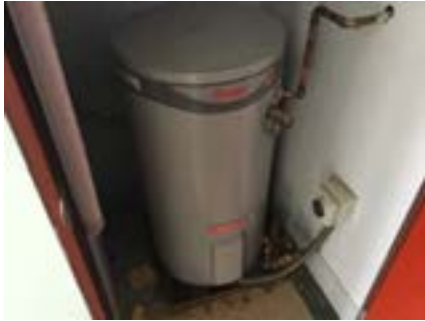
PHOTO NO.: J154351-001-PHOTO007
 RESULT: SMF - PRESUMED POSITIVE
 BUILDING/LEVEL: B00K - GROUND LEVEL
 ROOM/LOCATION: KR0007 - SERVICE AREA - CENTRAL
 FEATURE/MATERIAL: HOT WATER SERVICE INSULATION - INSULATION MATERIAL
 SAMPLE NO.: -

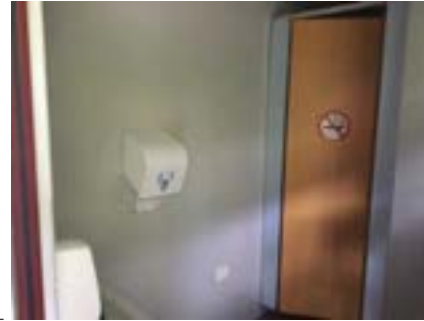
PHOTO NO.: J154351-001-PHOTO006
 RESULT: SMF - POSITIVE
 BUILDING/LEVEL: B00K - GROUND LEVEL
 ROOM/LOCATION: KR0008 - MENS LOCKER/AIRLOCK AREA - VARIOUS THROUGHOUT
 FEATURE/MATERIAL: INSULATION - INSULATION MATERIAL
 SAMPLE NO.: -

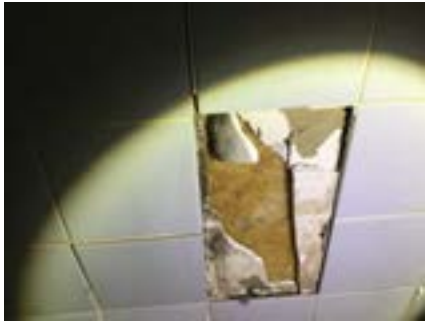
PHOTO NO.: J154351-001-PHOTO004
 RESULT: SMF - POSITIVE
 BUILDING/LEVEL: B00K - GROUND LEVEL
 ROOM/LOCATION: KR0008 - MENS SHOWER - VARIOUS THROUGHOUT
 FEATURE/MATERIAL: INSULATION - INSULATION MATERIAL
 SAMPLE NO.: -

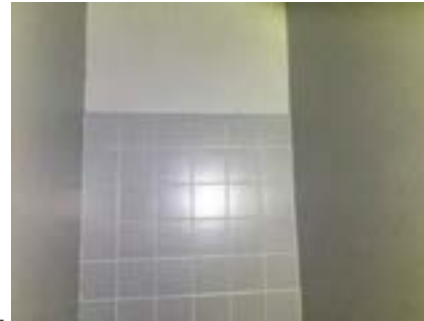
PHOTO NO.: J154351-001-PHOTO005
 RESULT: SMF - POSITIVE
 BUILDING/LEVEL: B00K - GROUND LEVEL
 ROOM/LOCATION: KR0008 - MENS TOILET - VARIOUS THROUGHOUT
 FEATURE/MATERIAL: INSULATION - INSULATION MATERIAL
 SAMPLE NO.: -

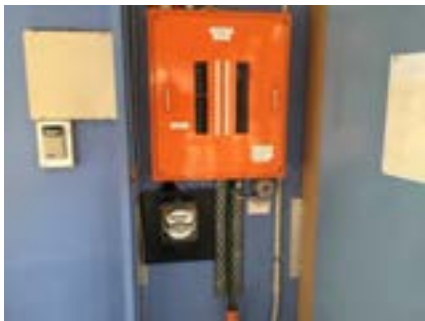
PHOTO NO.: J154351-001-PHOTO001
 RESULT: ASBESTOS - PRESUMED POSITIVE
 BUILDING/LEVEL: B00K - GROUND LEVEL
 ROOM/LOCATION: KR0009 - ELECTRICAL CUPBOARD - EAST
 FEATURE/MATERIAL: ELECTRICAL - SWITCH BOARD - COMPRESSED BITUMINOUS ELECTRICAL PANEL
 SAMPLE NO.: NOT SAMPLED LIVE ELECTRICAL HAZARD

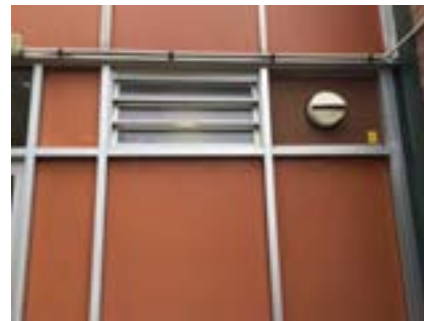
PHOTO NO.: J154351-001-PHOTO096
 RESULT: ASBESTOS - POSITIVE
 BUILDING/LEVEL: B00E - ALL LEVELS
 ROOM/LOCATION: ALL AREAS - VARIOUS THROUGHOUT
 FEATURE/MATERIAL: INFILL PANELS - COMPRESSED CEMENT SHEETING
 SAMPLE NO.: PREVIOUSLY SAMPLED GREENCAP J146932-02-002-024

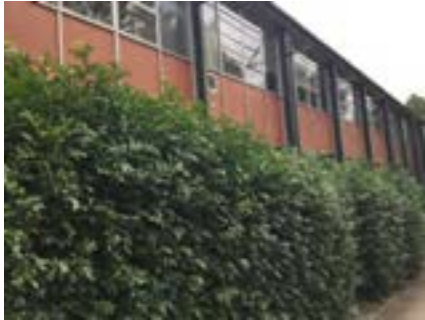
PHOTO NO.: J154351-001-PHOTO097
 RESULT: ASBESTOS - POSITIVE
 BUILDING/LEVEL: B00E - ALL LEVELS
 ROOM/LOCATION: ALL AREAS - VARIOUS THROUGHOUT
 FEATURE/MATERIAL: INFILL PANELS - COMPRESSED CEMENT SHEETING
 SAMPLE NO.: PREVIOUSLY SAMPLED GREENCAP J146932-02-002-024

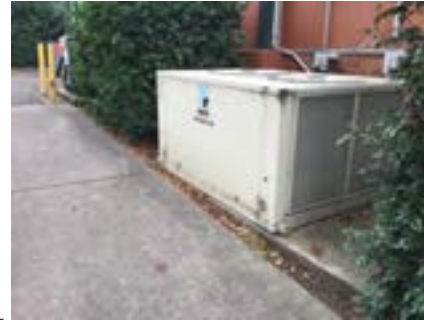
PHOTO NO.: J154351-001-PHOTO193
 RESULT: ODS - POSITIVE
 BUILDING/LEVEL: B00E - GROUND LEVEL
 ROOM/LOCATION: EXTERIOR - VARIOUS THROUGHOUT
 FEATURE/MATERIAL: A/C UNIT - R22 - CHLORODIFLUOROMETHANE
 SAMPLE NO.: -

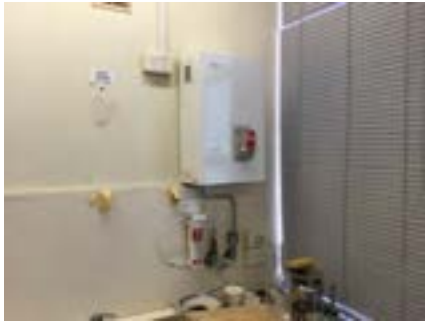
PHOTO NO.: J154351-001-PHOTO065
 RESULT: SMF - PRESUMED POSITIVE
 BUILDING/LEVEL: B00E - GROUND LEVEL
 ROOM/LOCATION: ER0001 - OPEN OFFICE - ABOVE SINK
 FEATURE/MATERIAL: HOT WATER SERVICE INSULATION - INSULATION MATERIAL
 SAMPLE NO.: -

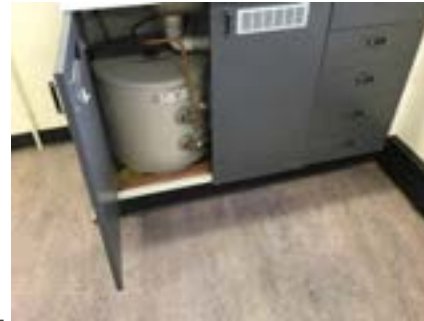
PHOTO NO.: J154351-001-PHOTO064
 RESULT: SMF - PRESUMED POSITIVE
 BUILDING/LEVEL: B00E - GROUND LEVEL
 ROOM/LOCATION: ER0001 - OPEN OFFICE - BELOW SINK
 FEATURE/MATERIAL: HOT WATER SERVICE INSULATION - INSULATION MATERIAL
 SAMPLE NO.: -

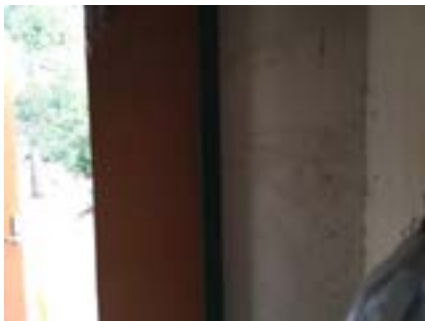
PHOTO NO.: J154351-001-PHOTO067
 RESULT: ASBESTOS - POSITIVE
 BUILDING/LEVEL: B00E - GROUND LEVEL
 ROOM/LOCATION: ER0002 - PLANT ROOM - SOUTH
 FEATURE/MATERIAL: WALL LINING - FIBRE CEMENT SHEETING
 SAMPLE NO.: PREVIOUSLY SAMPLED GREENCAP J146932-02-002-024

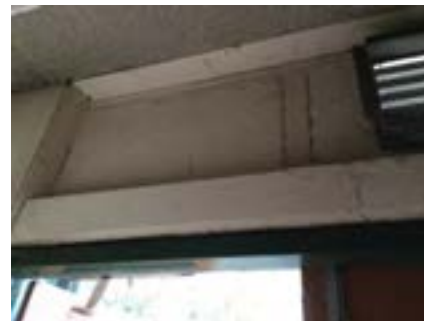
PHOTO NO.: J154351-001-PHOTO068
 RESULT: ASBESTOS - POSITIVE
 BUILDING/LEVEL: B00E - GROUND LEVEL
 ROOM/LOCATION: ER0002 - PLANT ROOM - SOUTH
 FEATURE/MATERIAL: WALL LINING - FIBRE CEMENT SHEETING
 SAMPLE NO.: PREVIOUSLY SAMPLED GREENCAP J146932-02-002-024

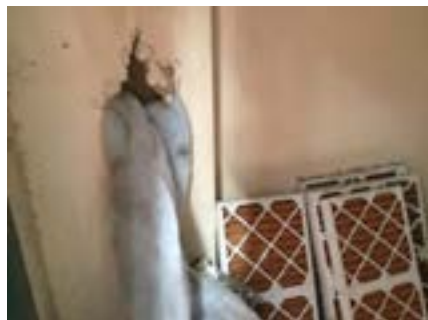
PHOTO NO.: J154351-001-PHOTO066
 RESULT: **SMF - POSITIVE**
 BUILDING/LEVEL: **B00E - GROUND LEVEL**
 ROOM/LOCATION: **ER0002 - PLANT ROOM - THROUGHOUT**
 FEATURE/MATERIAL: **INSULATION - INSULATION MATERIAL**
 SAMPLE NO.: -

B00E - Interior - Level One														
All rooms - Throughout Ceiling Lining - Vermiculite	Asbestos	Similar To: J154351-001-019	Presumed Negative											
All rooms - Various Throughout Insulation - Insulation Material - Between plaster walls.	SMF		Positive	J154351-001-Photo081 J154351-001-Photo080 J154351-001-Photo082	500 m ²	Good	Bonded (SMF)						Remove by an appropriately experienced contractor under controlled conditions and using correct PPE if this material will be impacted by refurbishment/demolition works.	
All rooms - Various Throughout Window Frames - Putty - Between glass and aluminium frames.	Asbestos	Similar To: J154351-001-021	Presumed Negative											
ER1004 - Plant Room - Central Air Conditioning Ductwork - Mastic Sealant - Grey colour material to duct works.	Asbestos	Similar To: J154351-001-026	Presumed Negative											
ER1004 - Plant Room - East Electrical - Switch Board - Compressed Bituminous Electrical Panel - Lining within the orange colour metal electrical cabinet.	Asbestos	Not Sampled Live Electrical Hazard	Presumed Positive	J154351-001-Photo103	1 Unit/s	Good	Non Friable	Low	Low	Not Labelled	21/02/2023	P4	Confirm status, remove under controlled conditions by an appropriately licensed asbestos contractor prior to refurbishment/demolition.

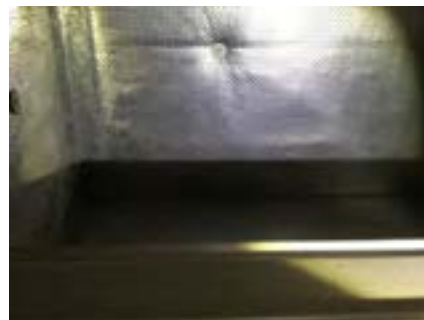
PHOTO NO.: J154351-001-PHOTO072
 RESULT: **SMF - POSITIVE**
 BUILDING/LEVEL: **B00E - GROUND LEVEL**
 ROOM/LOCATION: **ER0002 - PLANT ROOM - VARIOUS THROUGHOUT**
 FEATURE/MATERIAL: **DUCTWORK INSULATION - INSULATION MATERIAL**
 SAMPLE NO.: -

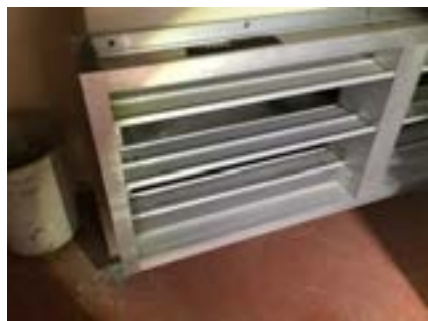
PHOTO NO.: J154351-001-PHOTO073
 RESULT: **SMF - POSITIVE**
 BUILDING/LEVEL: **B00E - GROUND LEVEL**
 ROOM/LOCATION: **ER0002 - PLANT ROOM - VARIOUS THROUGHOUT**
 FEATURE/MATERIAL: **DUCTWORK INSULATION - INSULATION MATERIAL**
 SAMPLE NO.: -

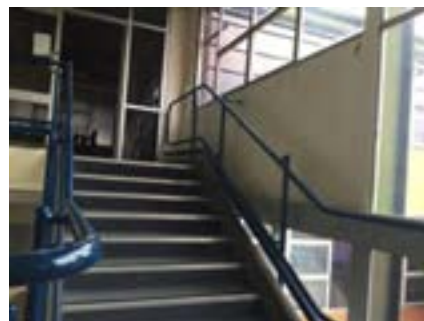
PHOTO NO.: J154351-001-PHOTO095
 RESULT: **ASBESTOS - POSITIVE**
 BUILDING/LEVEL: **B00E - GROUND LEVEL**
 ROOM/LOCATION: **ER1014 - STAIRWELL - WEST**
 FEATURE/MATERIAL: **INFILL PANELS - COMPRESSED CEMENT SHEETING**
 SAMPLE NO.: PREVIOUSLY SAMPLED GREENCAP J146932-02-002-024

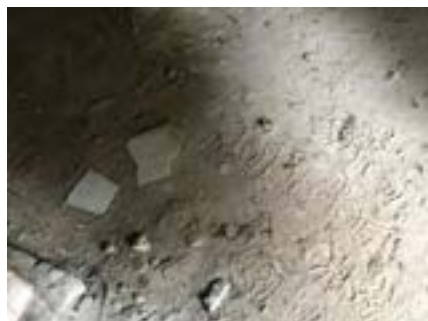
PHOTO NO.: J154351-001-PHOTO104
 RESULT: **ASBESTOS - PRESUMED POSITIVE**
 BUILDING/LEVEL: **B00E - SUB-FLOOR**
 ROOM/LOCATION: **ALL AREAS - VARIOUS THROUGHOUT**
 FEATURE/MATERIAL: **DEBRIS - FIBRE CEMENT SHEETING**
 SAMPLE NO.: **SIMILAR TO: J154351-001-032**

All areas - Various Throughout Debris - Fibre Cement Sheeting - On ground surfaces.	Asbestos	Similar To: J154351-001-032	Presumed Positive	J154351-001-Photo104	10 m ²	Poor	Non Friable	Low	Low	Not Labelled	21/02/2019	P3	Restrict access, remove under controlled conditions by an appropriately licensed asbestos contractor prior to refurbishment/demolition.	
All areas - Various Throughout Packer - Fibre Cement Sheeting - Between timber surfaces and brick stumps.	Asbestos	J154351-001-032	Positive	J154351-001-Photo102	20 m ²	Poor	Non Friable	Low	Low	Not Labelled	21/02/2019	P3	Restrict access, remove under controlled conditions by an appropriately licensed asbestos contractor prior to refurbishment/demolition.	
B00E - Exterior - Level One														
All areas - Various Throughout Eaves - Fibre Cement Sheeting - Require EWP access to sample and test.	Asbestos	Not Sampled Height Restricted	Presumed Positive	J154351-001-Photo116	50 m ²	Good	Non Friable	Low	Low	Not Labelled	21/02/2023	P4	Confirm status, remove under controlled conditions by an appropriately licensed asbestos contractor prior to refurbishment/demolition.

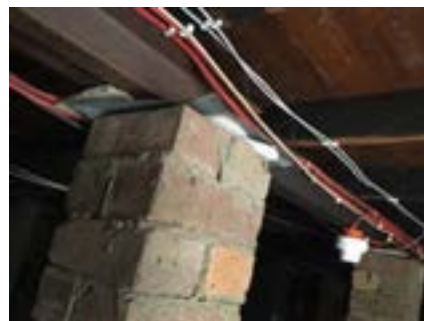
PHOTO NO.: J154351-001-PHOTO102
 RESULT: **ASBESTOS - POSITIVE**
 BUILDING/LEVEL: **B00E - SUB-FLOOR**
 ROOM/LOCATION: **ALL AREAS - VARIOUS THROUGHOUT**
 FEATURE/MATERIAL: **PACKER - FIBRE CEMENT SHEETING**
 SAMPLE NO.: **J154351-001-032**

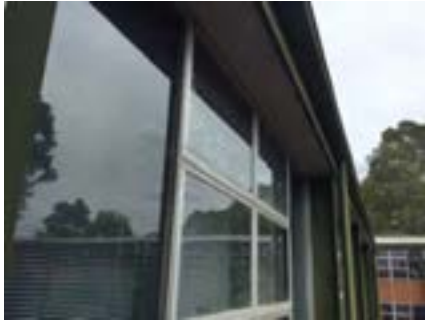
PHOTO NO.: J154351-001-PHOTO116
 RESULT: ASBESTOS - PRESUMED POSITIVE
 BUILDING/LEVEL: B00E - LEVEL ONE
 ROOM/LOCATION: ALL AREAS - VARIOUS THROUGHOUT
 FEATURE/MATERIAL: EAVES - FIBRE CEMENT SHEETING
 SAMPLE NO.: NOT SAMPLED HEIGHT RESTRICTED

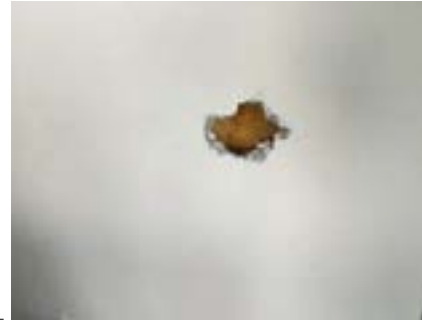
PHOTO NO.: J154351-001-PHOTO081
 RESULT: SMF - POSITIVE
 BUILDING/LEVEL: B00E - LEVEL ONE
 ROOM/LOCATION: ALL ROOMS - VARIOUS THROUGHOUT
 FEATURE/MATERIAL: INSULATION - INSULATION MATERIAL
 SAMPLE NO.: -

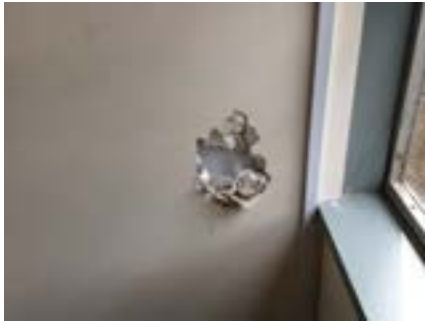
PHOTO NO.: J154351-001-PHOTO080
 RESULT: SMF - POSITIVE
 BUILDING/LEVEL: B00E - LEVEL ONE
 ROOM/LOCATION: ALL ROOMS - VARIOUS THROUGHOUT
 FEATURE/MATERIAL: INSULATION - INSULATION MATERIAL
 SAMPLE NO.: -

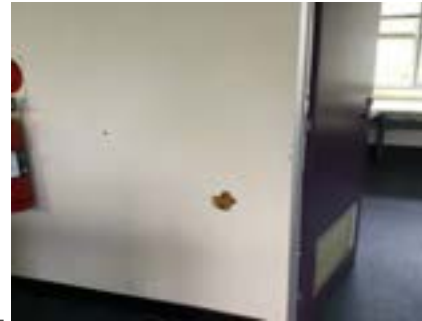
PHOTO NO.: J154351-001-PHOTO082
 RESULT: SMF - POSITIVE
 BUILDING/LEVEL: B00E - LEVEL ONE
 ROOM/LOCATION: ALL ROOMS - VARIOUS THROUGHOUT
 FEATURE/MATERIAL: INSULATION - INSULATION MATERIAL
 SAMPLE NO.: -

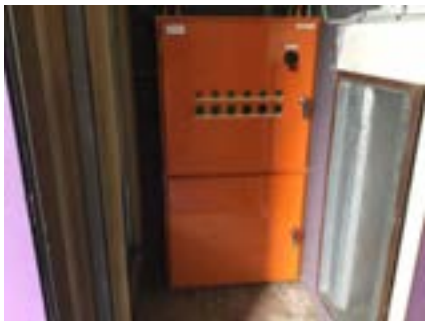
PHOTO NO.: J154351-001-PHOTO103
 RESULT: ASBESTOS - PRESUMED POSITIVE
 BUILDING/LEVEL: B00E - LEVEL ONE
 ROOM/LOCATION: ER1004 - PLANT ROOM - EAST
 FEATURE/MATERIAL: ELECTRICAL - SWITCH BOARD - COMPRESSED BITUMINOUS ELECTRICAL PANEL
 SAMPLE NO.: NOT SAMPLED LIVE ELECTRICAL HAZARD

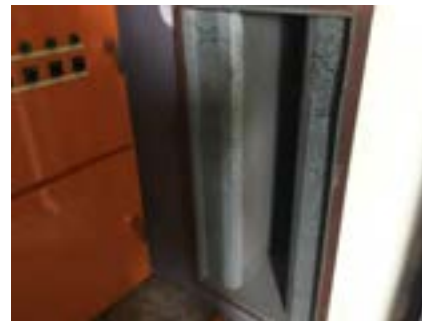
PHOTO NO.: J154351-001-PHOTO087
 RESULT: SMF - POSITIVE
 BUILDING/LEVEL: B00E - LEVEL ONE
 ROOM/LOCATION: ER1004 - PLANT ROOM - VARIOUS THROUGHOUT
 FEATURE/MATERIAL: DUCTWORK INSULATION - INSULATION MATERIAL
 SAMPLE NO.: -

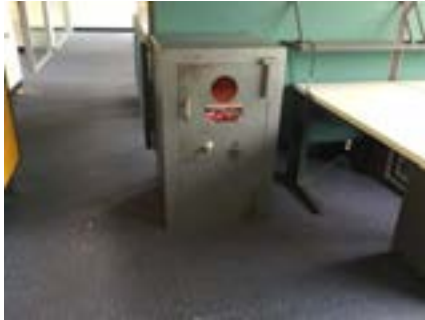
PHOTO NO.: J154351-001-PHOTO077
 RESULT: ASBESTOS - PRESUMED POSITIVE
 BUILDING/LEVEL: B00E - LEVEL ONE
 ROOM/LOCATION: ER1008 - OPEN OFFICE - CENTRAL
 FEATURE/MATERIAL: SAFE - INSULATION
 SAMPLE NO.: NOT SAMPLED RESTRICTED ACCESS

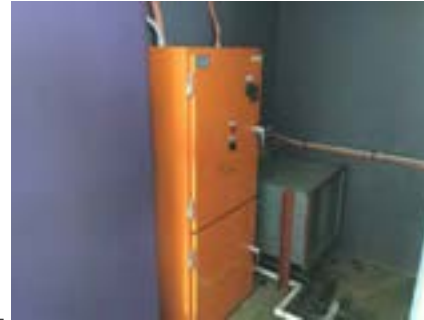
PHOTO NO.: J154351-001-PHOTO084
 RESULT: ASBESTOS - PRESUMED POSITIVE
 BUILDING/LEVEL: B00E - LEVEL ONE
 ROOM/LOCATION: ER1009 - PLANT ROOM - EAST
 FEATURE/MATERIAL: ELECTRICAL - SWITCH BOARD - COMPRESSED BITUMINOUS ELECTRICAL PANEL
 SAMPLE NO.: NOT SAMPLED LIVE ELECTRICAL HAZARD

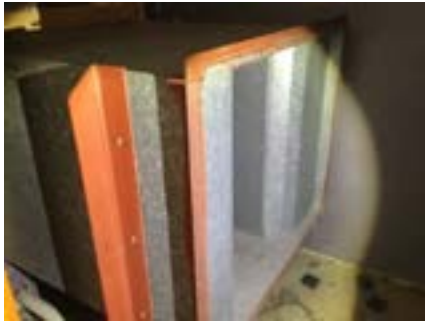
PHOTO NO.: J154351-001-PHOTO088
 RESULT: SMF - POSITIVE
 BUILDING/LEVEL: B00E - LEVEL ONE
 ROOM/LOCATION: ER1009 - PLANT ROOM - VARIOUS THROUGHOUT
 FEATURE/MATERIAL: DUCTWORK INSULATION - INSULATION MATERIAL
 SAMPLE NO.: -

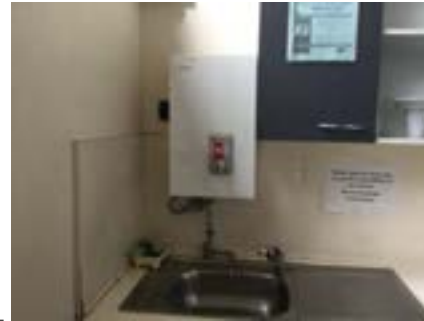
PHOTO NO.: J154351-001-PHOTO091
 RESULT: SMF - PRESUMED POSITIVE
 BUILDING/LEVEL: B00E - LEVEL ONE
 ROOM/LOCATION: ER1012 - KITCHENETTE - ABOVE SINK
 FEATURE/MATERIAL: HOT WATER SERVICE INSULATION - INSULATION MATERIAL
 SAMPLE NO.: -

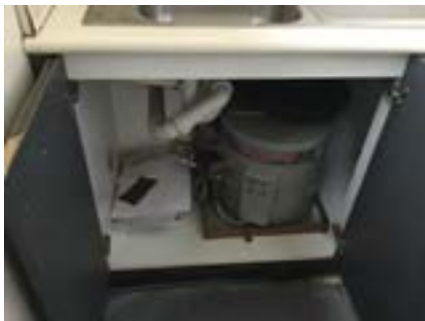
PHOTO NO.: J154351-001-PHOTO090
 RESULT: SMF - PRESUMED POSITIVE
 BUILDING/LEVEL: B00E - LEVEL ONE
 ROOM/LOCATION: ER1012 - KITCHENETTE - BELOW SINK
 FEATURE/MATERIAL: HOT WATER SERVICE INSULATION - INSULATION MATERIAL
 SAMPLE NO.: -
