Asbestos in Grounds Management Plan

Lidcombe Public School (2394), Lidcombe,
NSW

Document Asbestos in Grounds Management Plan
 Ref 60535203
 Date 15-Jun-2020
 Prepared by Pano Sklavos
 Reviewed and Authorised by Marc Wydro

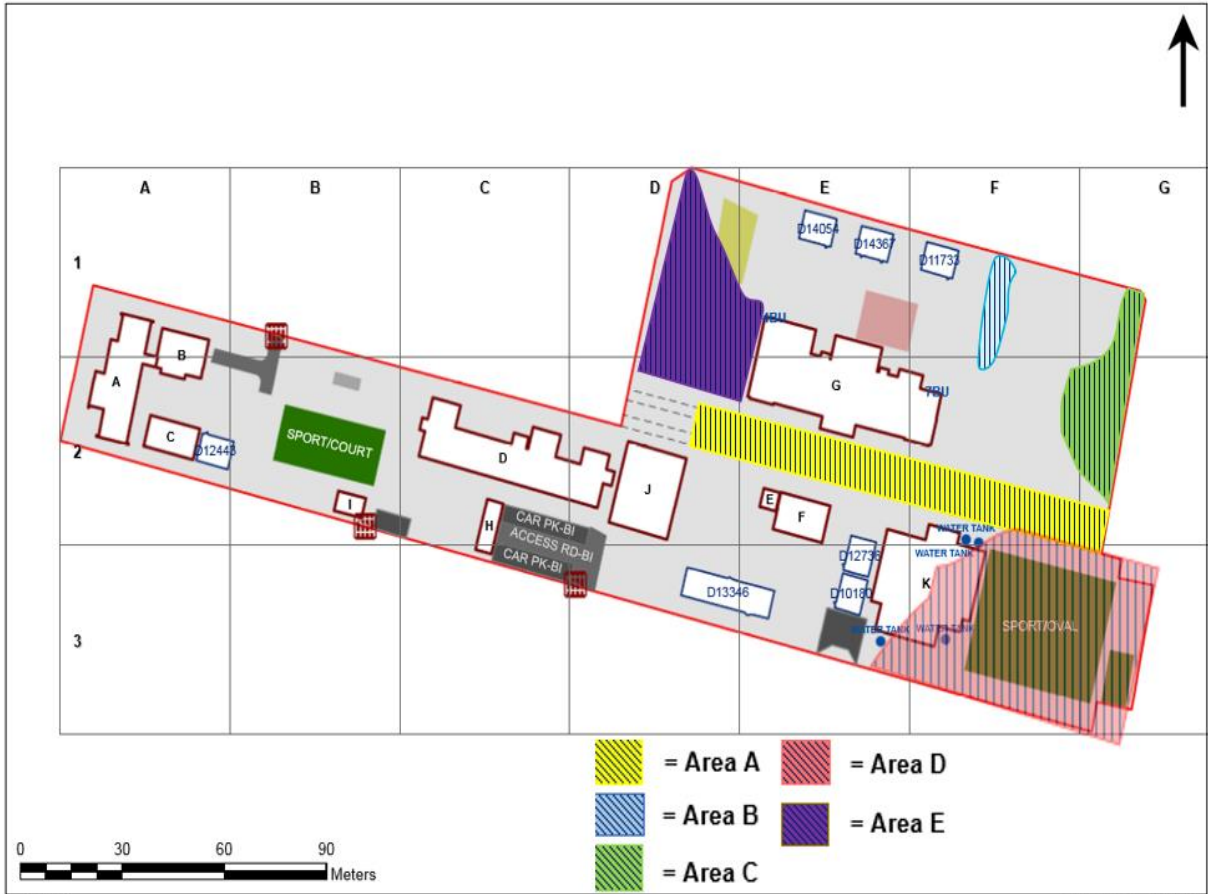
Appendix A. Site Plan

Where possible only 'Areas' identified in SSAMP, 2013 Site Plan have been recorded in **Appendix A.**

KEY
'Area'

A summary of asbestos in grounds occurrences and remediation works completed at the school (recorded in SSAMP, 2013) is provided in **Appendix D, Table D1** Where possible only 'Areas' identified in SSAMP, 2013 Site Plan have been recorded in **Appendix A**.

The location, type, condition and accompanying risk assessment of asbestos identified in grounds at the Site has been taken from the SSAMP, 2013 and is recorded in the asbestos in grounds register detailed in **Appendix D, Table D2** . Where possible only 'Areas' identified in SSAMP, 2013 Site Plan have been recorded in **Appendix A**.
