NSW DEPARTMENT OF EDUCATION
C/O - PUBLIC WORKS ADVISORY

LAGUNA STREET PUBLIC SCHOOL

ASBESTOS IN GROUNDS MANAGEMENT PLAN

JUNE 2020

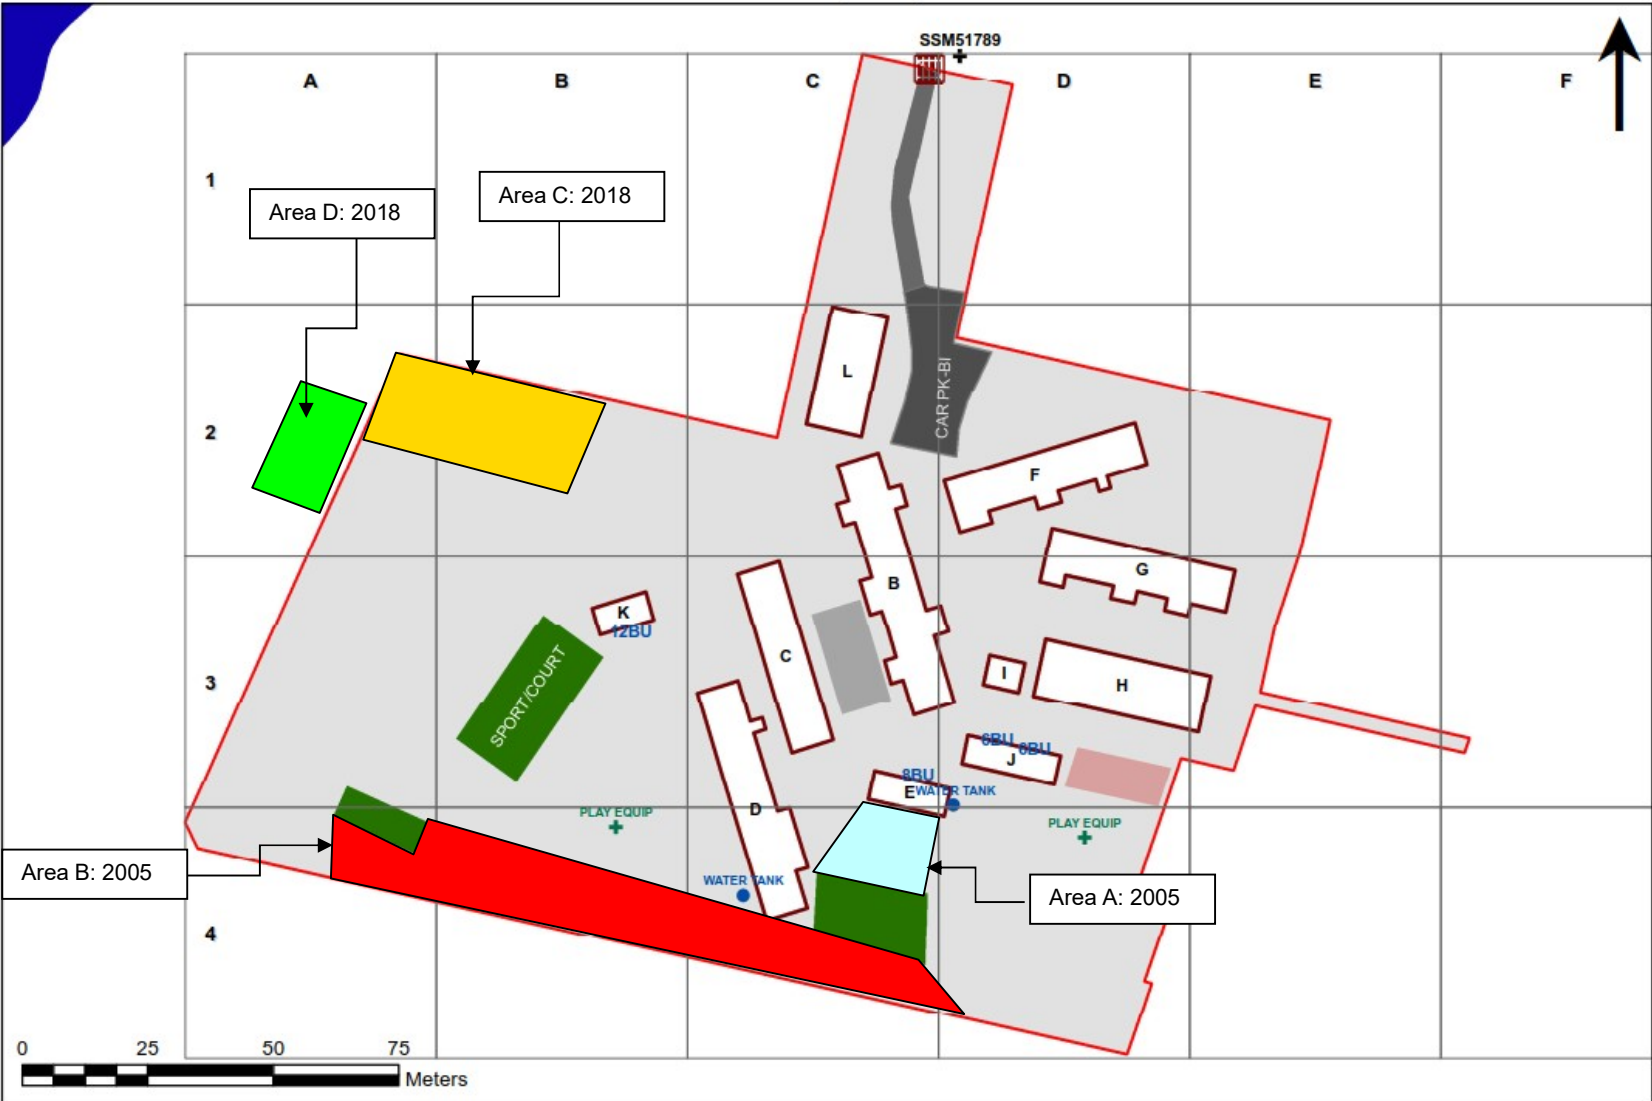
4230 - Laguna Street Public School
Site Plan (12073)

The approximate location of each area is detailed on the Site Plan in Appendix A.
