**INDEPENDENT
ENVIRONMENTAL AUDIT
REPORT**

Jindabyne Education Campus, 207 Barry Way,
Jindabyne, NSW 2627

SINSW
21 September 2023
AU122214 R2

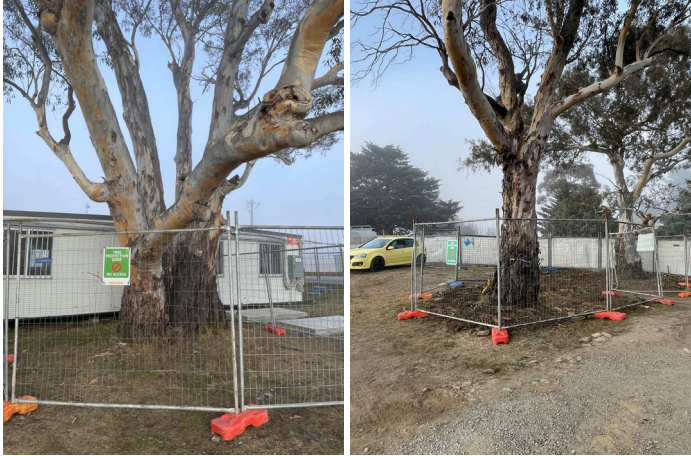
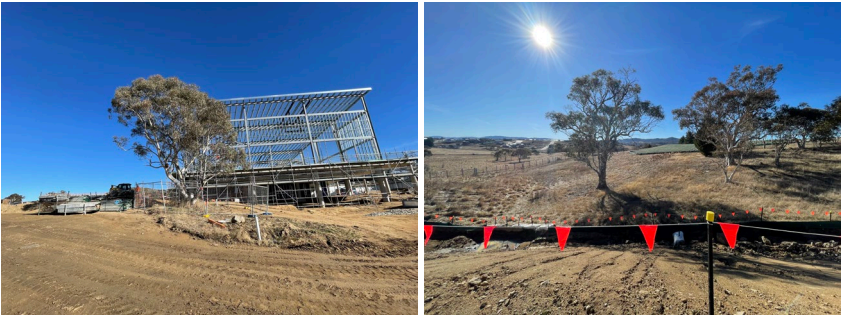
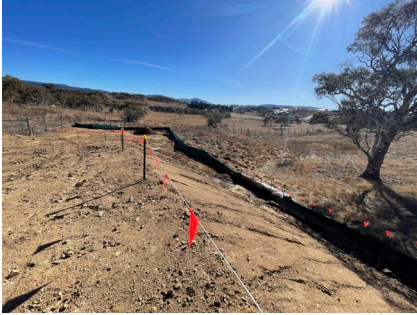
<p>Photo Number: G94, G202, G203, G204, G215, G230</p>	<p>Date: 25/7/2023</p>

<p>Description:</p> <p>Tree Protection Zones established around retained trees with appropriate signage.</p> <p>No work or materials stored within TPZ.</p> <p>Nesting boxes still present in TPZ along Barry Way</p> <p>Appropriate cordoning of biodiversity zones consistent with Plans (north eastern portion of site).</p>

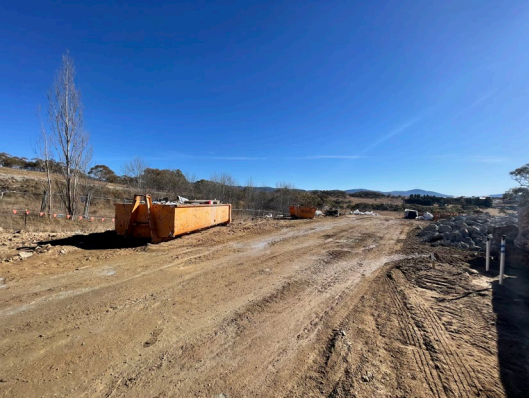
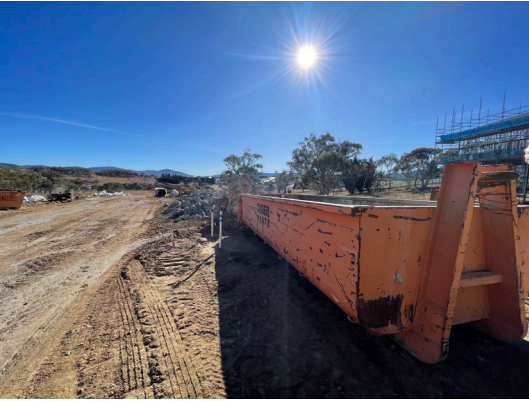
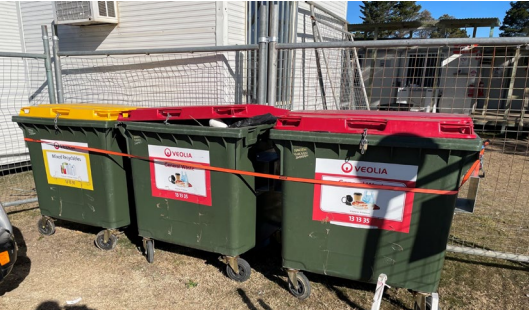
<p>Photo Number: G106, G207, G252</p>	<p>Date: 25/7/2023</p>

<p>Description: Waste storage and segregation area in the northern portion of site</p>

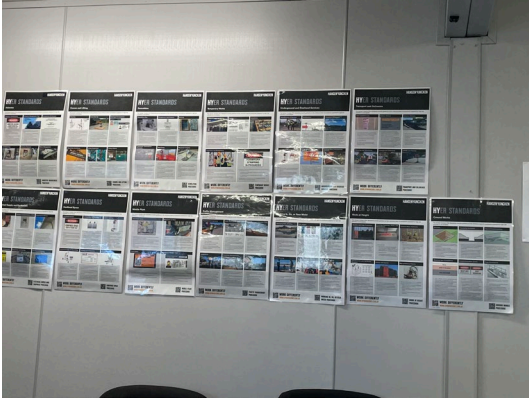
Photo Number: G221	Date: 25/7/2023

<p>Description:</p> <p>Higher risk standards information</p>
