## 5. Wildlife survey results and implications

Table 1. Summary of wildlife survey results and implications

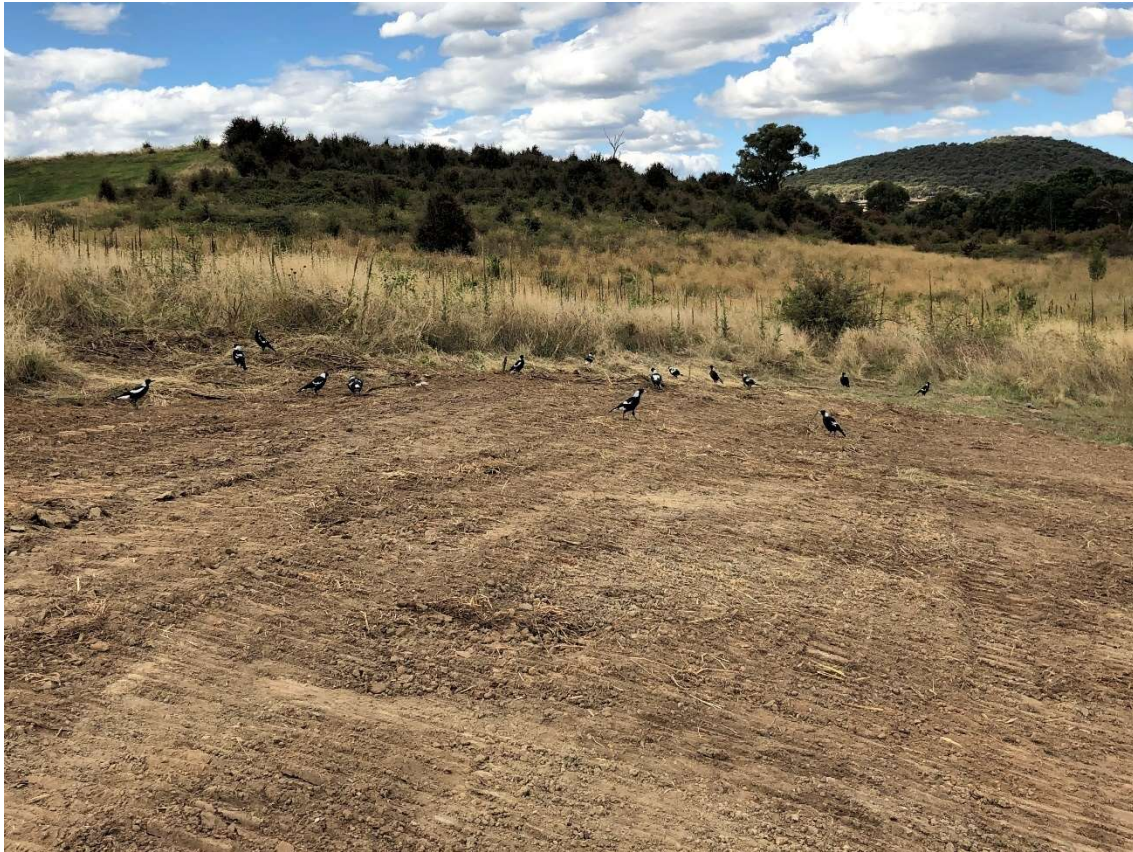
Australian Magpie <i>Gymnorhina tibicen</i>	High	Common species in all habitats around JHS. 31 seen feeding on freshly-graded soil onsite in Feb 2022.	Groups may be attracted to feed on invertebrates in disturbed soil. Likely to be local birds only	Neutral - small numbers could nest in landscaping trees, but most onsite foraging habitat will be lost
Masked Lapwing <i>Vanellus miles</i>	High	Small numbers present around water bodies and in irrigated grassland	Small numbers could be attracted to disturbed soil and ponding at night.	Not likely to be present due to lack of habitat

Photograph 1. Part of flock of 30 Magpies feeding on recently graded soil at JHS site.

- Minimising ponding from interruptions to drainage by appropriate shaping, using silt barriers to facilitate drainage without erosion
- Ensuring that waste foodstuffs are not accessible to birds on the construction site by signage and provision of secure bins
- Using direct seeding rather than spray-grassing for planting verges of road, bus zone, drop-off area and paths.

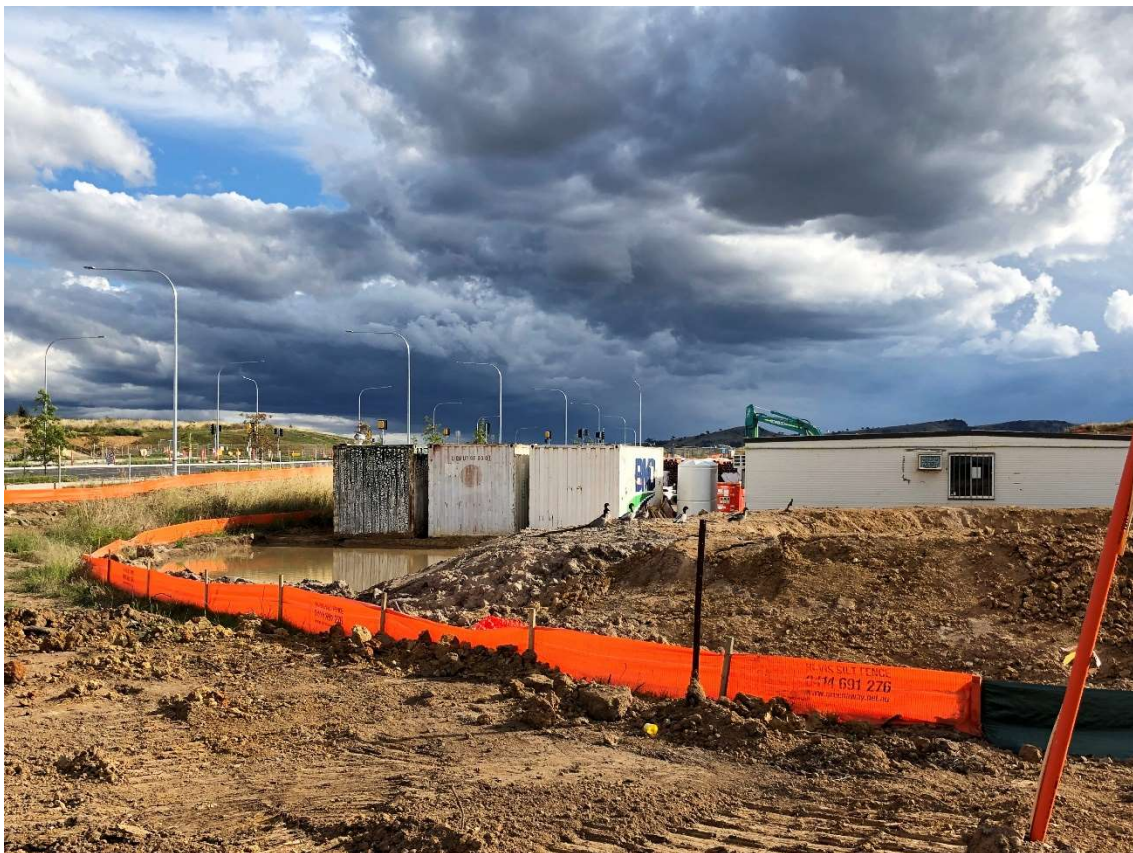
Some birds may at times be attracted to the construction site to feed on prey items exposed by turning of soil, to temporary ponding caused by interrupted drainage and/or to waste foodstuffs (if not secured). These include Australian (White) Ibis, Australian Magpie, Masked Lapwing, Australian Wood Duck, Little Raven and Australian Raven. Feral (and native Crested) Pigeons and Wood Ducks may feed on grassed verges after seeding. Attraction of Wood Ducks, Magpies, Galahs, Feral Pigeons, Australian Ravens, Little Ravens and Magpie-larks to the JHS and nearby construction sites was observed in February 2022 (see photographs). At the JHS site this is not expected to add significantly to aircraft hazards as birds are likely to be attracted for short periods and to be making low-level flights from local populations, and the construction site will be small compared to others nearby. An exception would be if Australian Ibis visited as they could fly higher through the flight path on their way from the Mugga Lane tip. Large birds such as these often circle on thermals to gain height before making longer movements. Mitigation measures are suggested in Section 6.

Photograph 2. Part of flock of 25 Wood Ducks at temporary pond and earth banks at construction site on Environa/Tompsitt Drive.

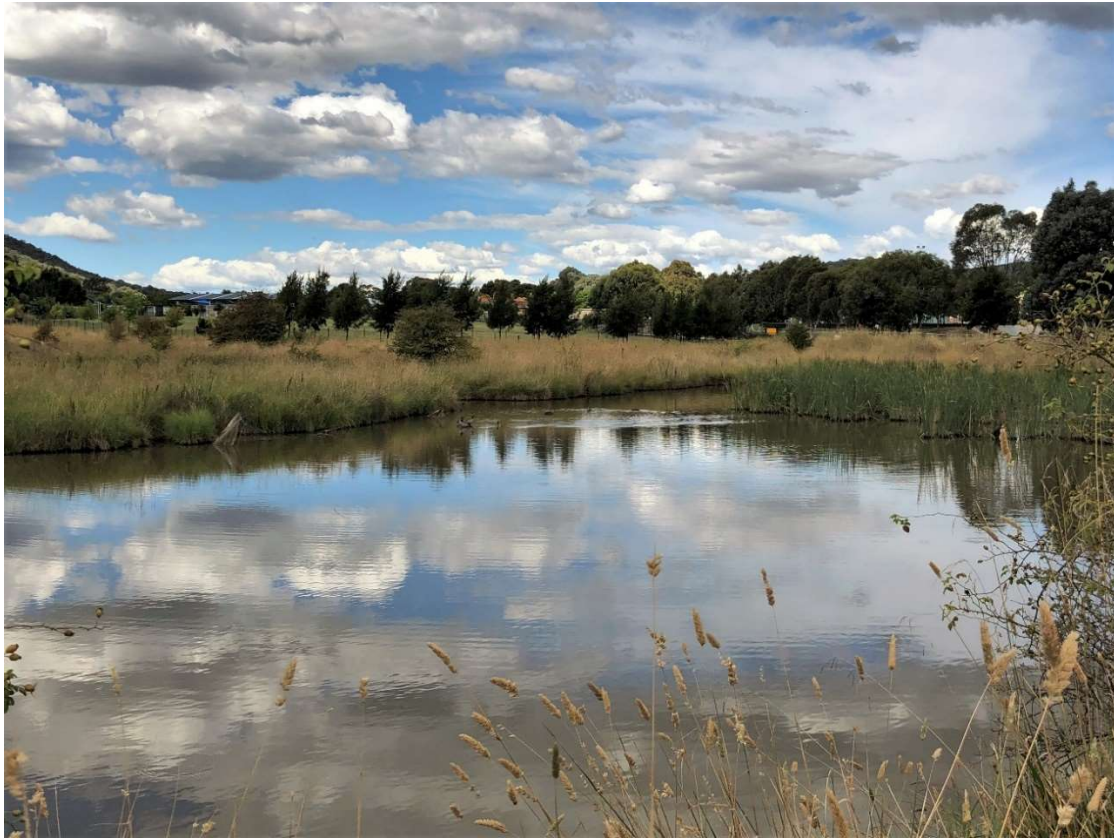
Pacific Black Duck <i>Anas superciliosa</i>	High	Small numbers occur in Lake Jerrabomberra and local ponds/dams	No likely effect	Disturbance may reduce use of pond on eastern boundary
European (Red) Fox <i>Vulpes vulpes</i>	High	Scats seen on JHS site, along Jerrabomberra Ck, on Environa Dr verge	Local foxes may investigate construction site at night	Fewer likely due to vegetation clearing but no effect on population near Airport
Silver Gull <i>Chroicocephalus novaehollandiae</i>	High (>9 birds) Moderate (<10)	Occasional at Lake Jerrabomberra	No likely effect	No likely effect
Yellow-tailed Black-Cockatoo <i>Calyptorhynchus funereus</i>	High	Small groups occur in forests and tree plantations	No likely effect	No likely effect unless many pine trees planted
Little Black Cormorant <i>Phalacrocorax sulcirostris</i>	High	Occasional at Lake Jerrabomberra	None, no habitat present	None, no habitat created or lost

Photograph 3. Small group of Wood and Black Ducks in pond on eastern boundary of JHS site.

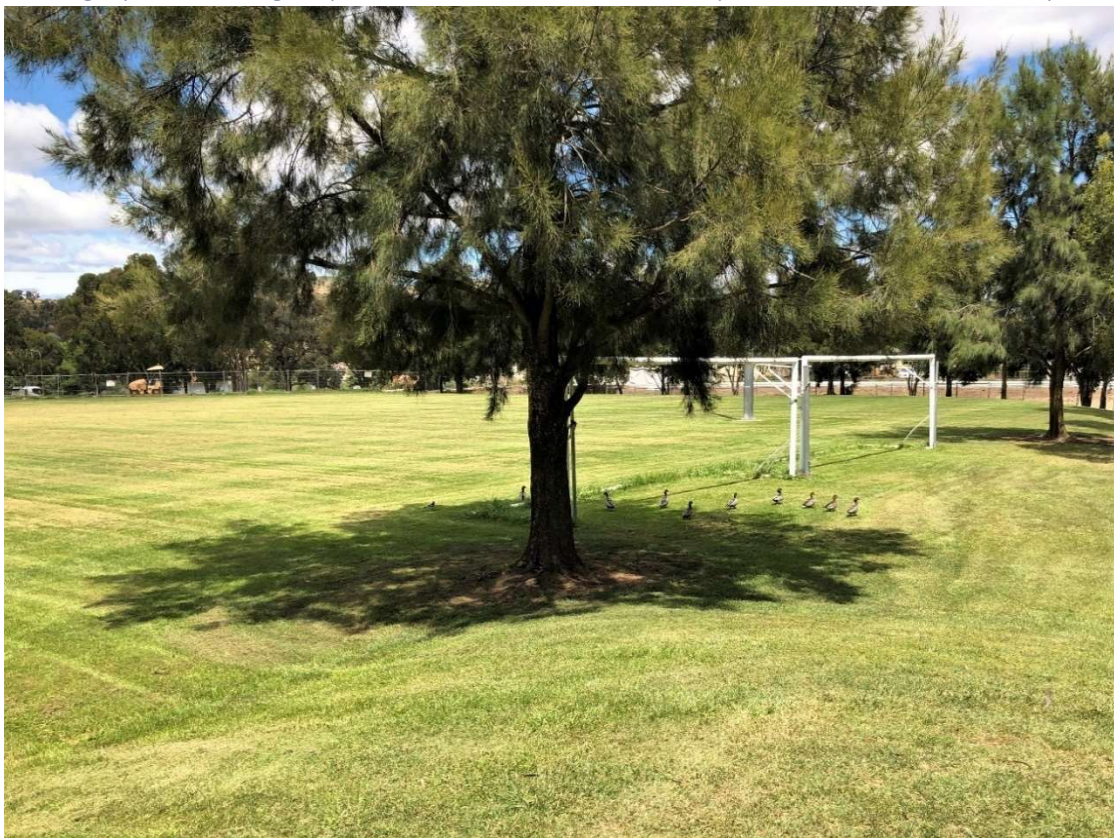
The landscape design appears to include little if any irrigated mown grass and, if implemented, this would minimise foraging habitat for a number of species of concern (Wood Ducks, Straw-necked Ibis, Australian Magpie, Masked Lapwing, Australian Raven, Magpie-lark). There are no playing fields and one small play area will use artificial grass. The use of unirrigated native grasses has been suggested for perimeter buffer plantings and to rehabilitate the unused southern and eastern slopes of the site and this should attract little wildlife of concern.

Photograph 4. Small group of Wood Ducks on David Madew playing fields adjacent to JHS site. (JHS project does not include additional playing fields)

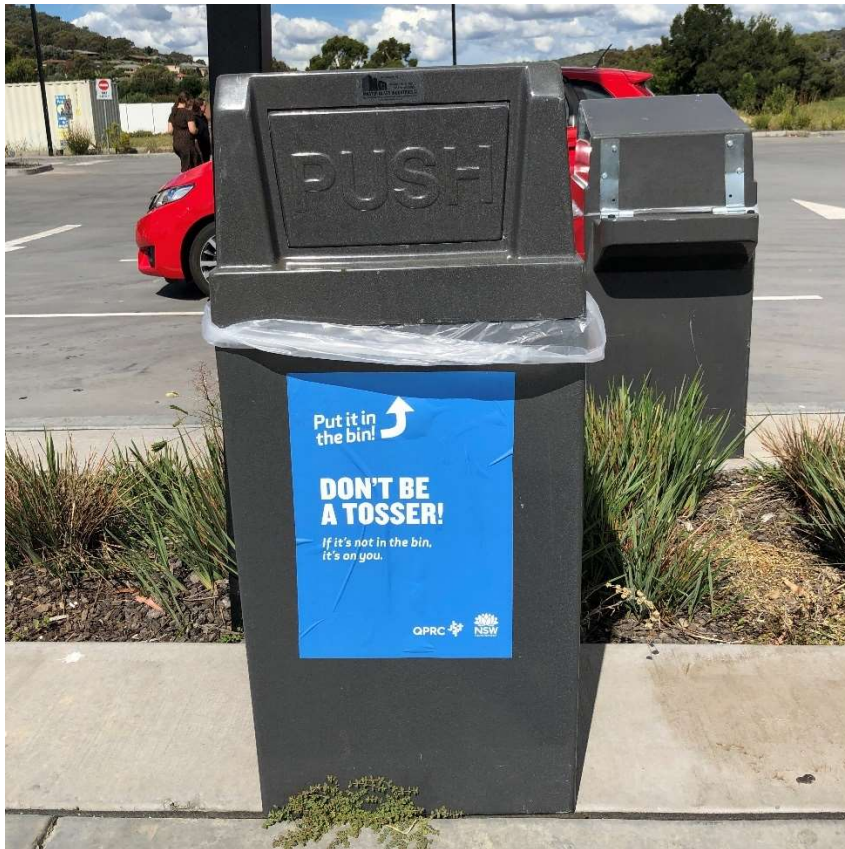
Photograph 5. Jerrabomberra, secure bin at fast food outlet.
