CRINGILA PUBLIC SCHOOL INDOOR AIR QUALITY RISK ASSESSMENT

Summary Report
14/06/2021 – 25/06/2021

Cringila Public School

35 Sheffield Street
Cringila NSW 2502

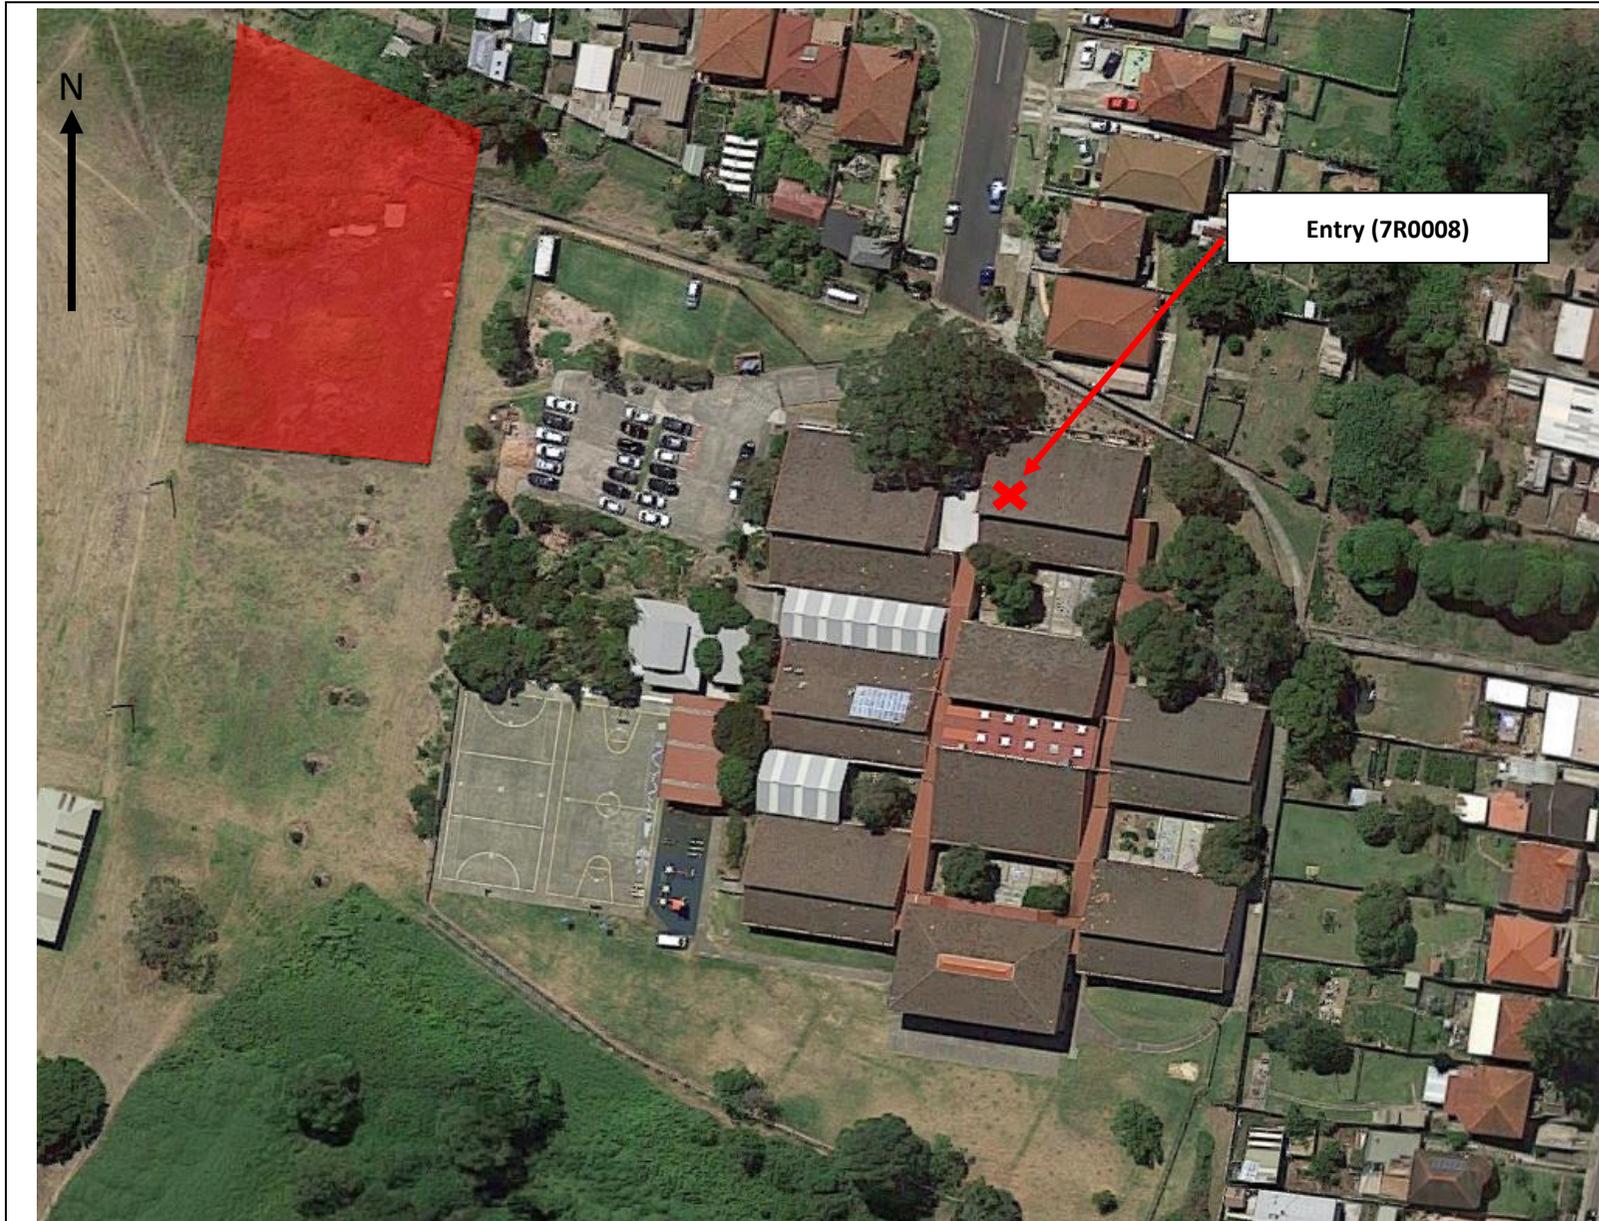
Appendix A: Site Map and Sampling Location

Site	Cringila Public School
Monitoring Location	Entry (7R0008)
Job Number	J172171
Report	IAQ-09
Version	1.0
