The following inspection is of the road surface, kerb and gutter to the western side of Allambie Road starting at the intersection of Arnhem Road and heading towards the intersection of Aquatic Drive at the end point.

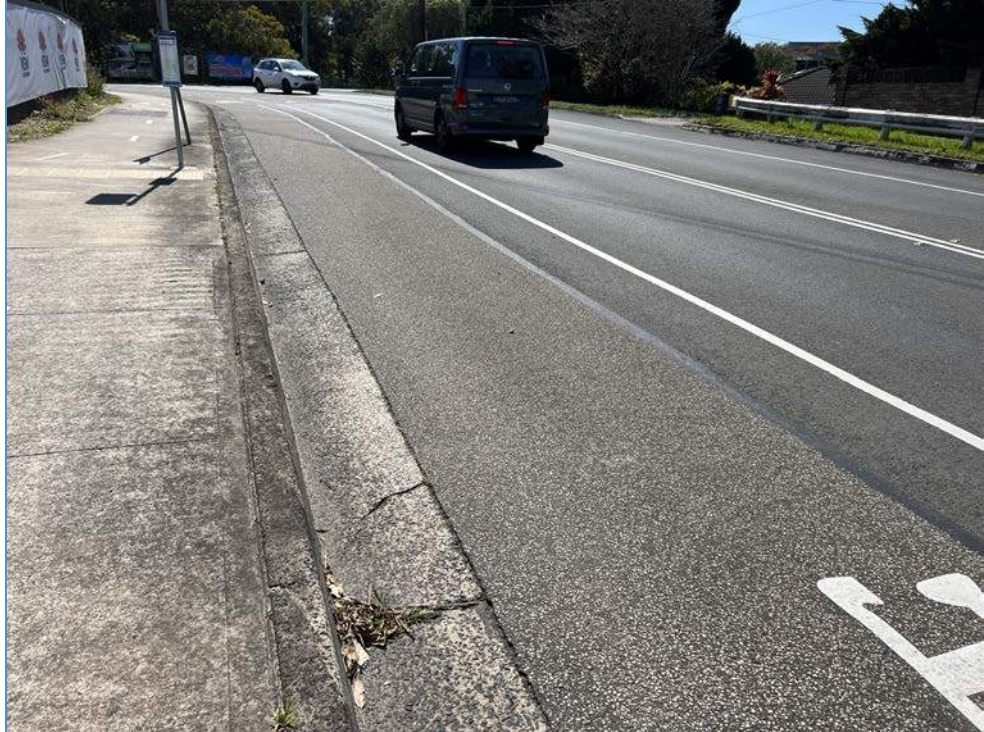
0m

General views of the road surface, kerb and gutter at the start point.
