The following inspection is of the footpath and Council strip to the eastern side of Allambie Road starting at the intersection of Aquatic Drive and Allambie Road and heading in a southerly direction towards the end point at Arnhem Road, Allambie Heights.

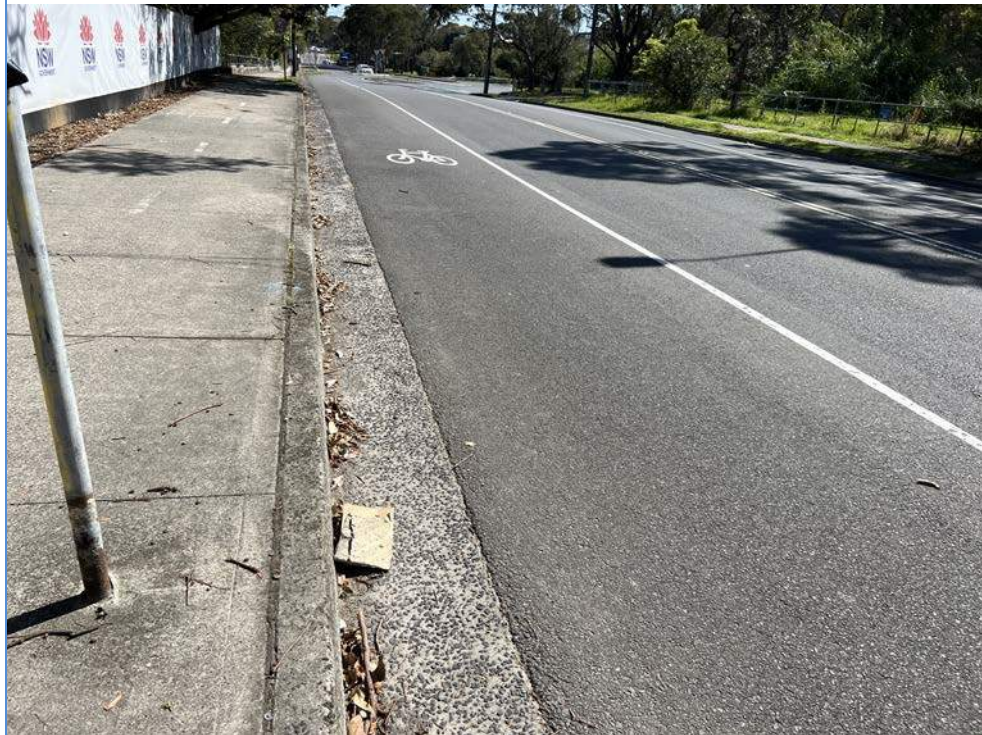
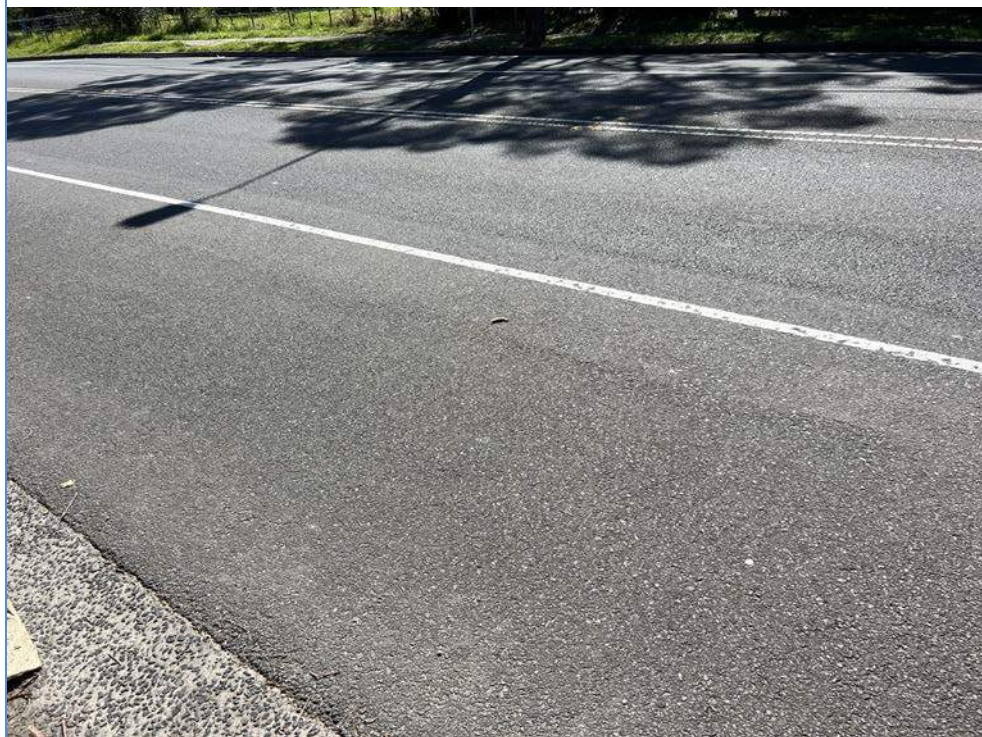
90m

General views of the road surface, kerb and gutter.

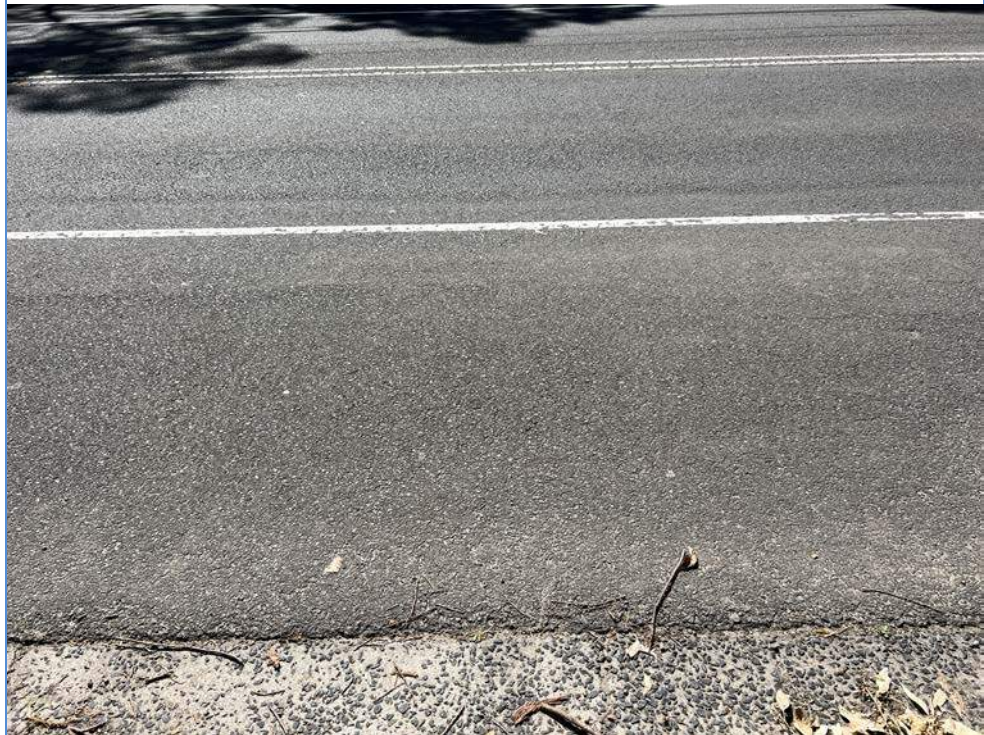
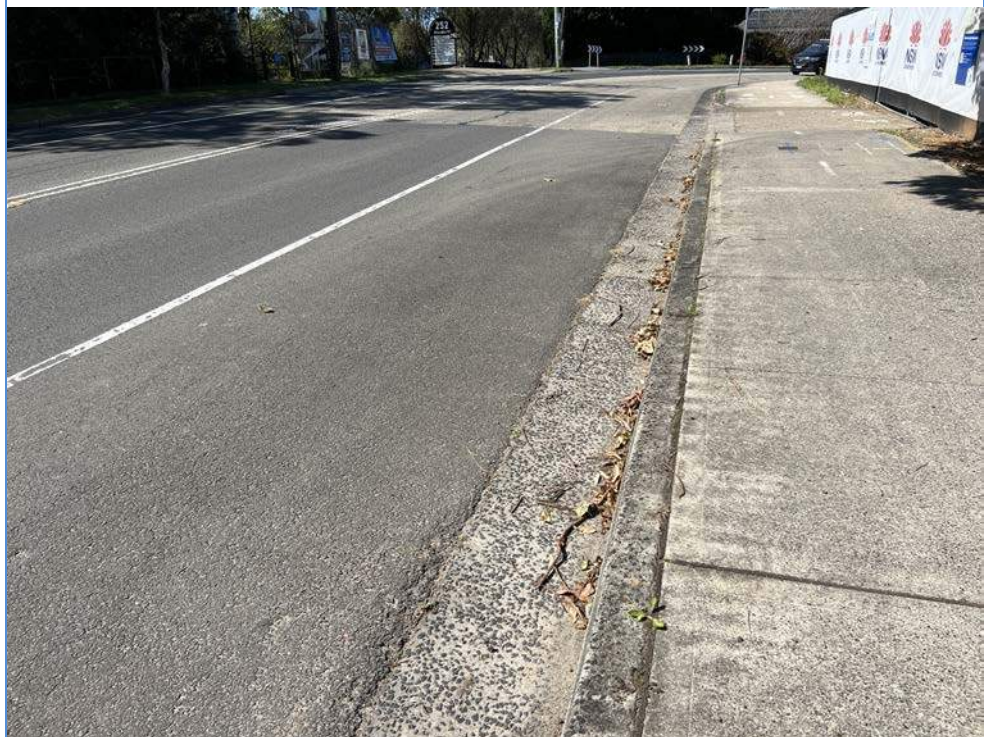
90m

General views of the road surface, kerb and gutter.

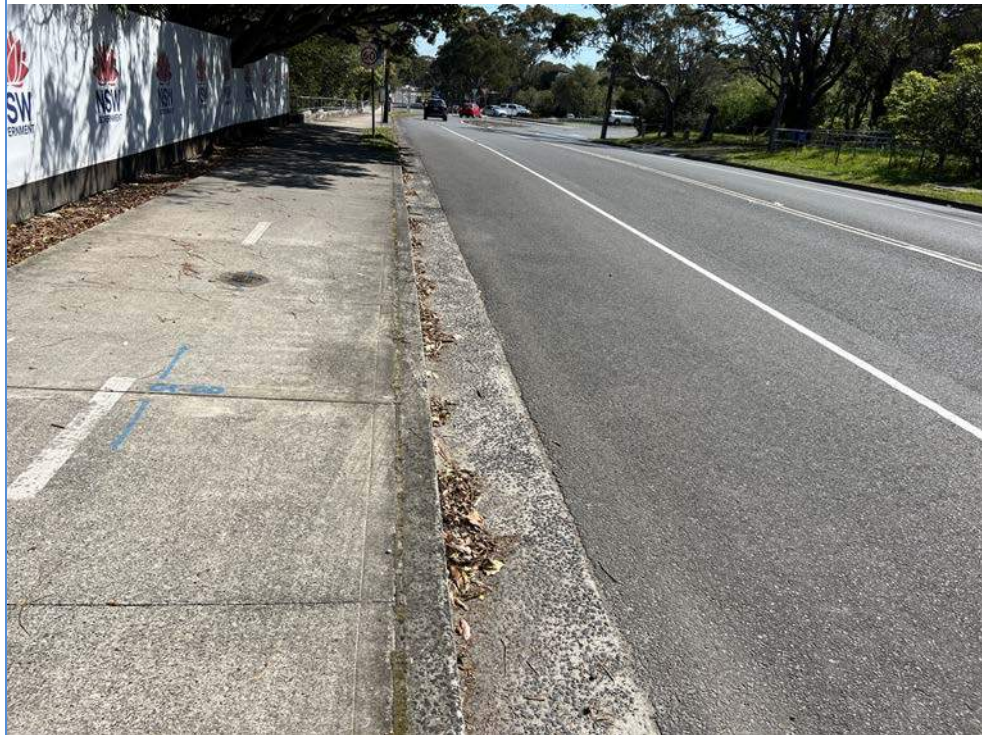
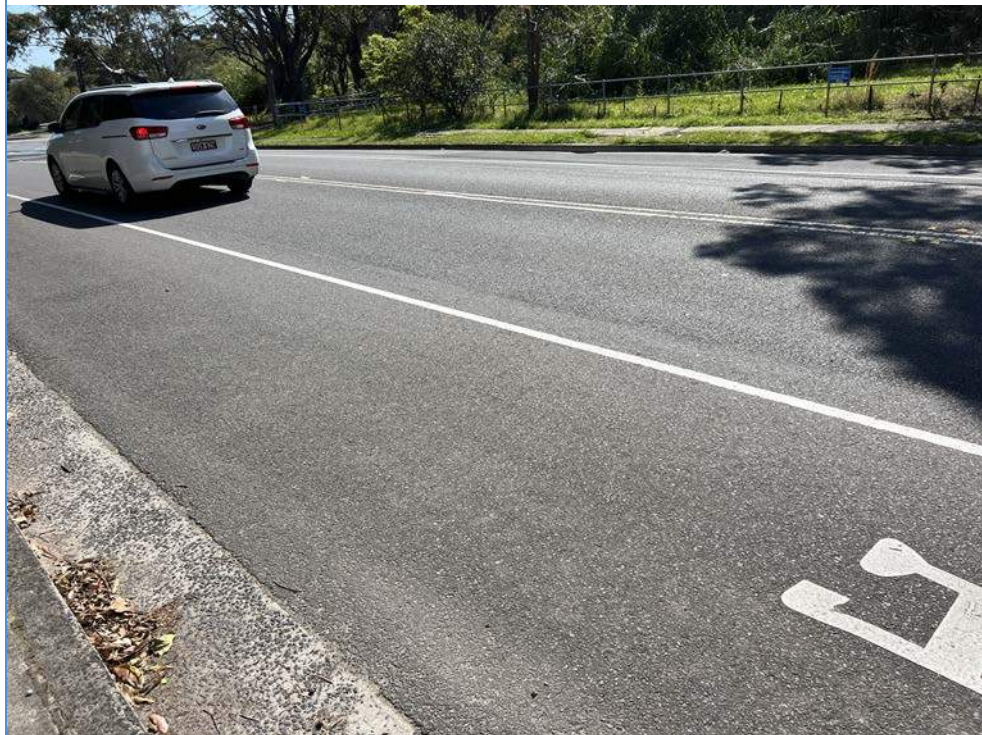
100m

General views of the road surface, kerb and gutter.

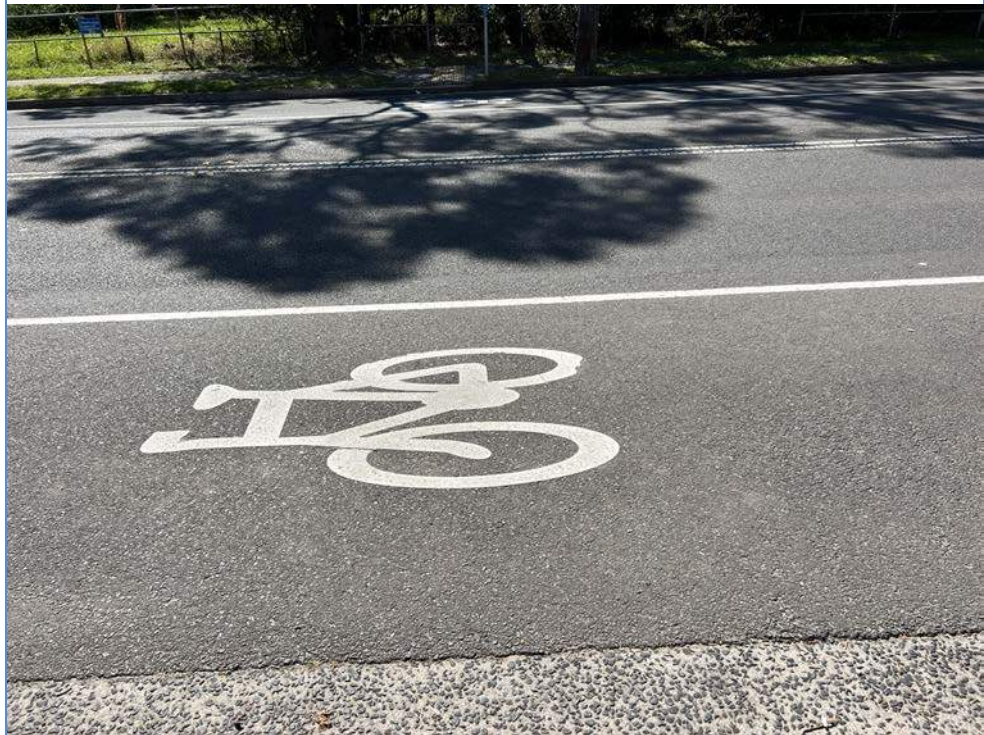
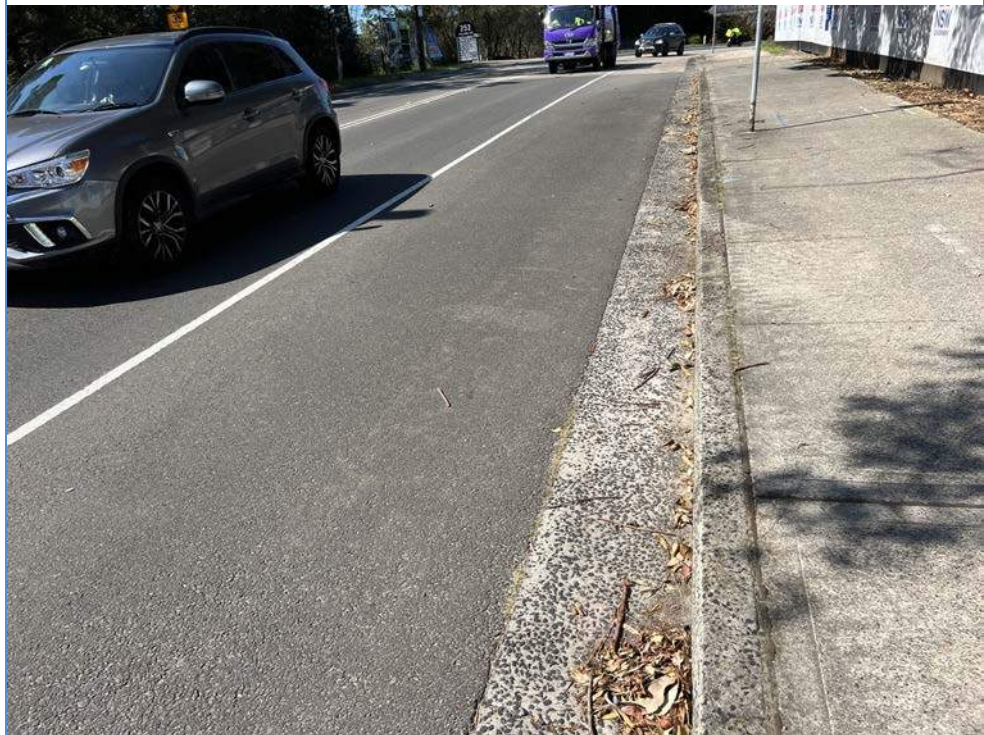
100m

General views of the road surface, kerb and gutter.

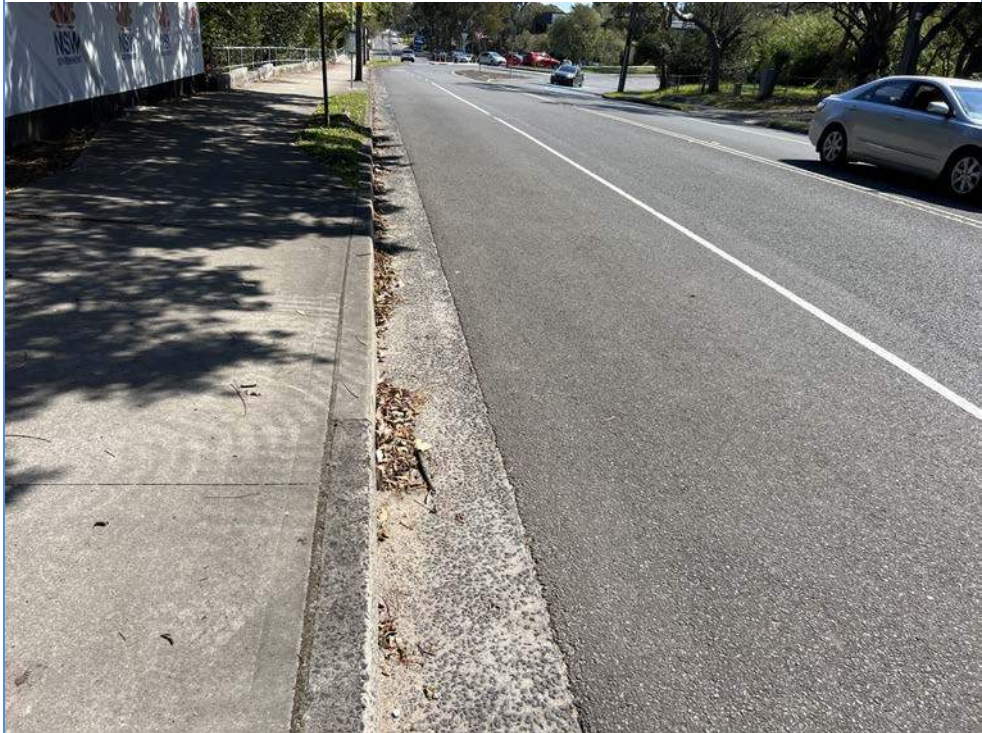
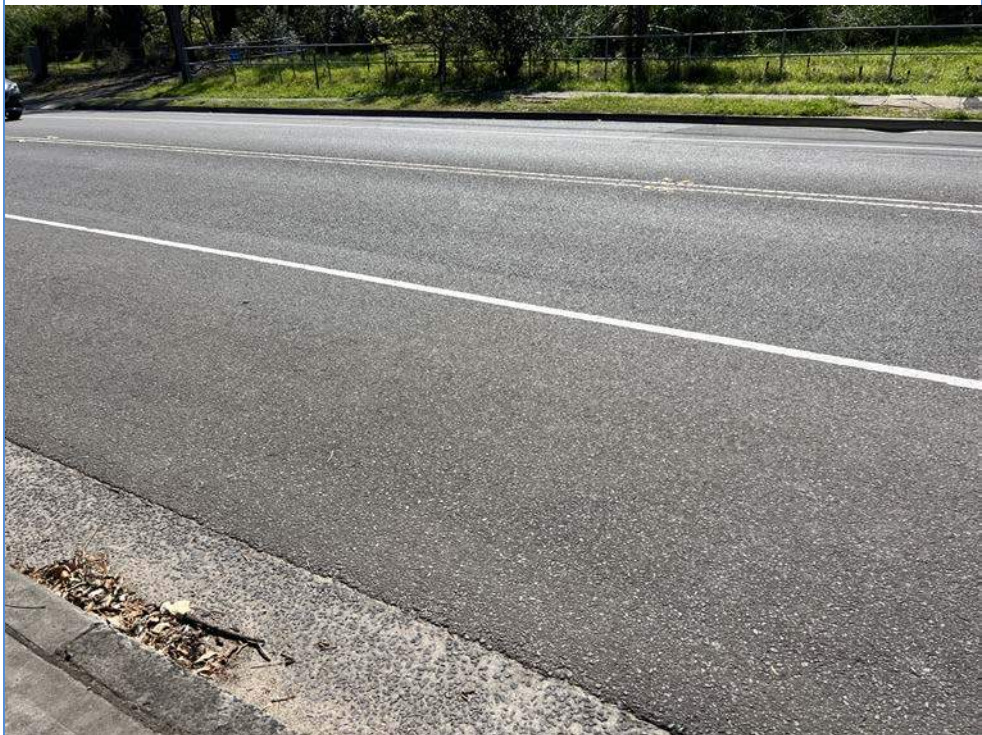
110m

General views of the road surface, kerb and gutter.

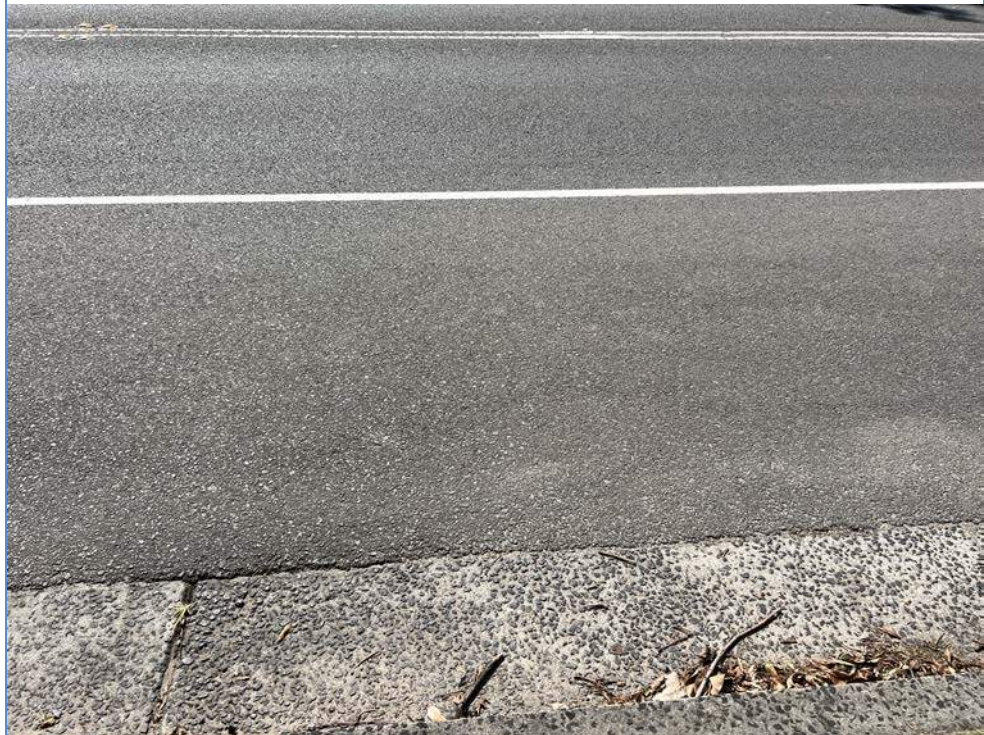
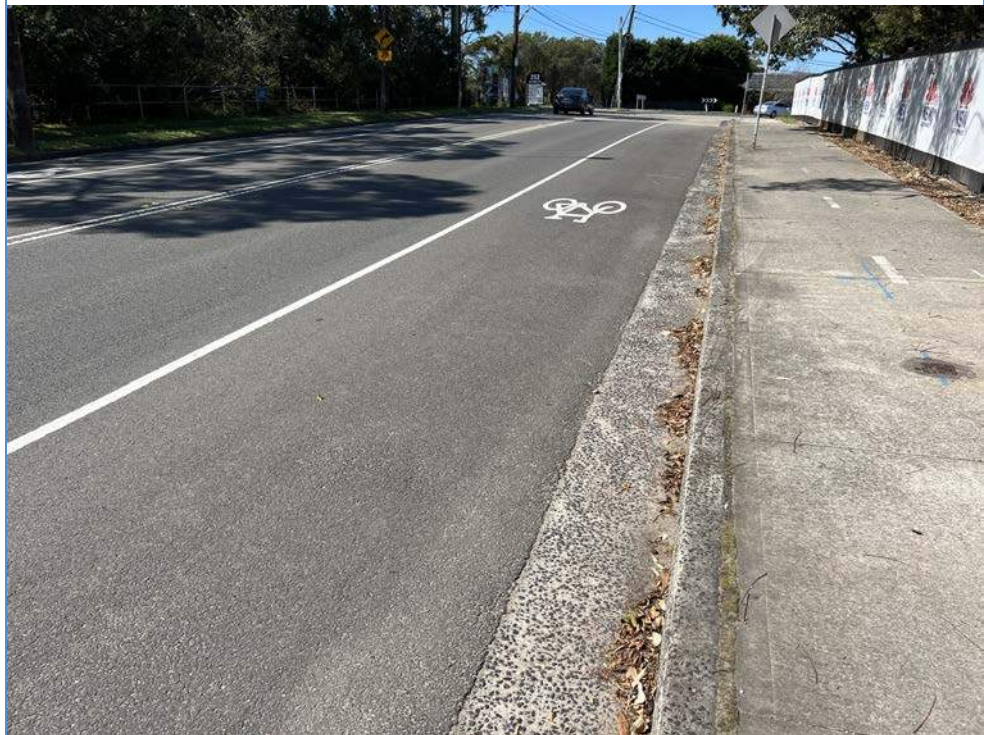
110m

General views of the road surface, kerb and gutter.

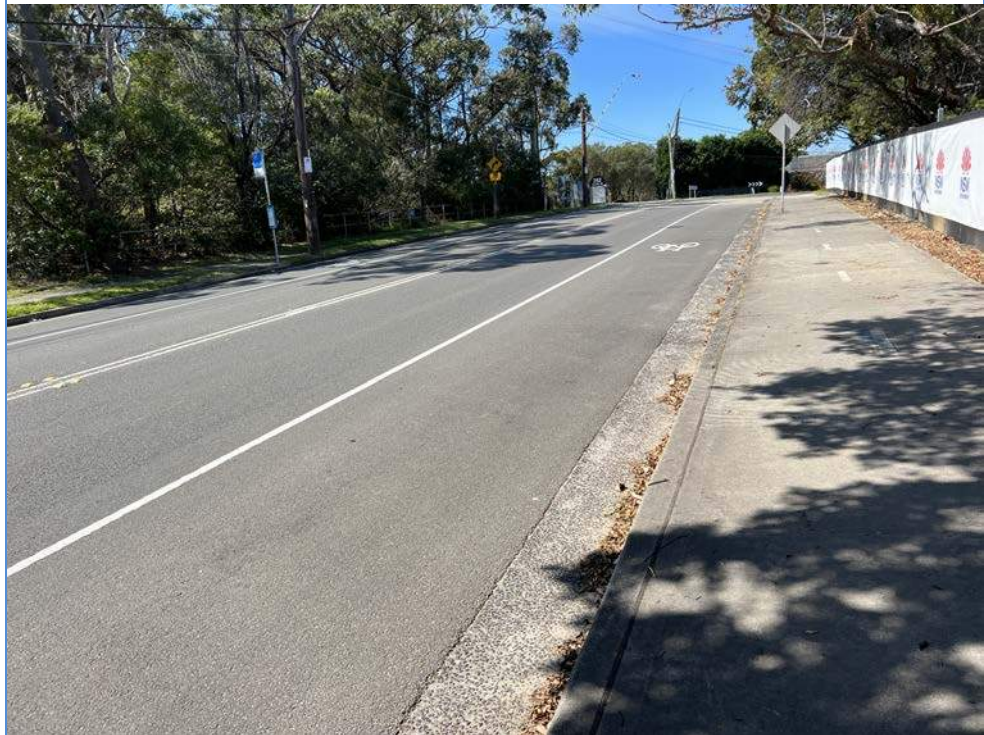
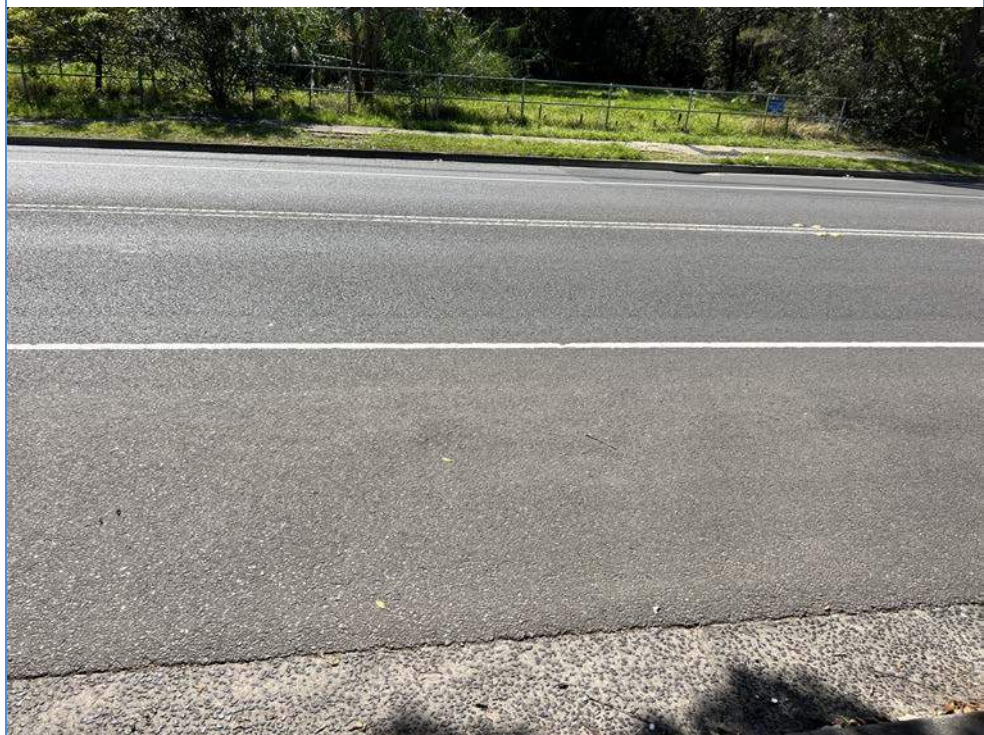
120m

General views of the road surface, kerb and gutter.

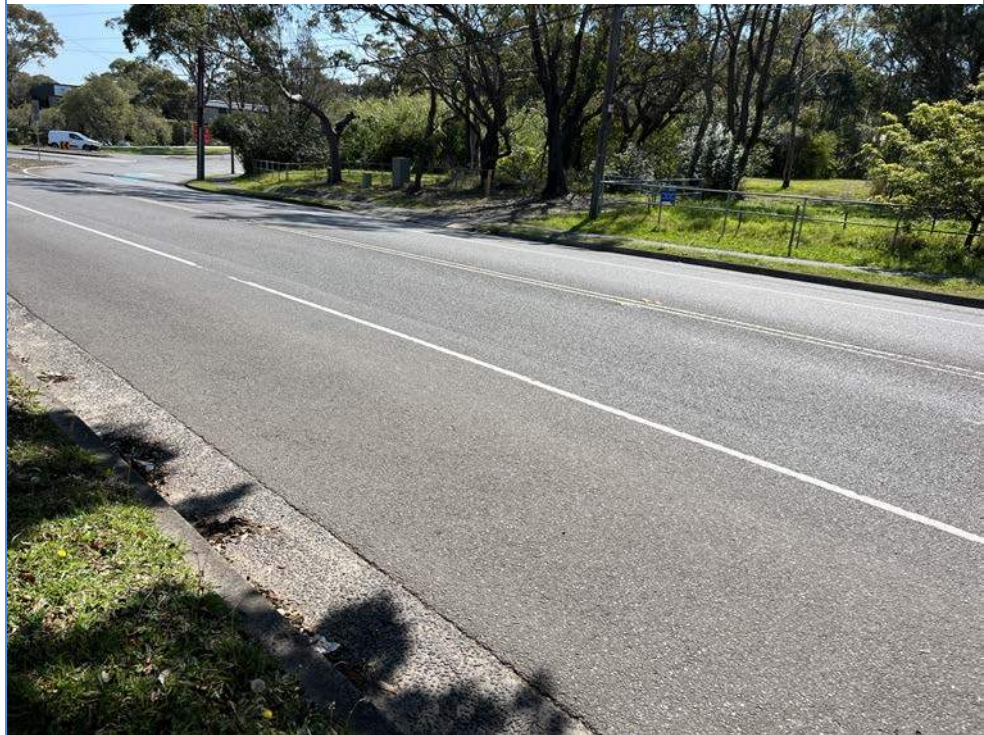
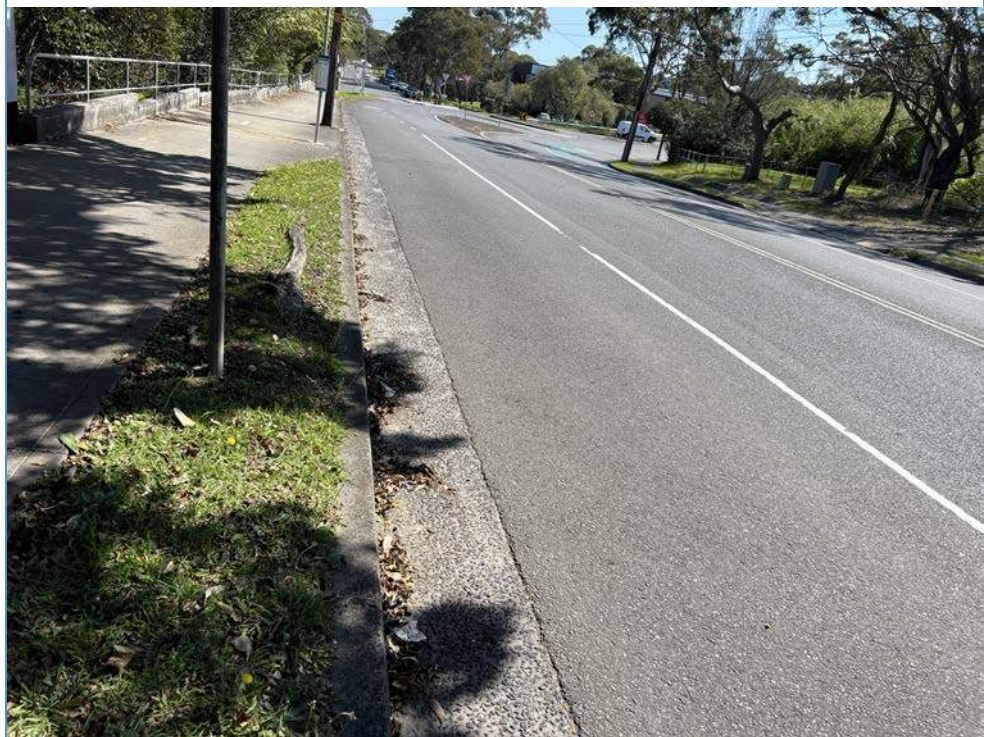
120m

General views of the road surface, kerb and gutter.

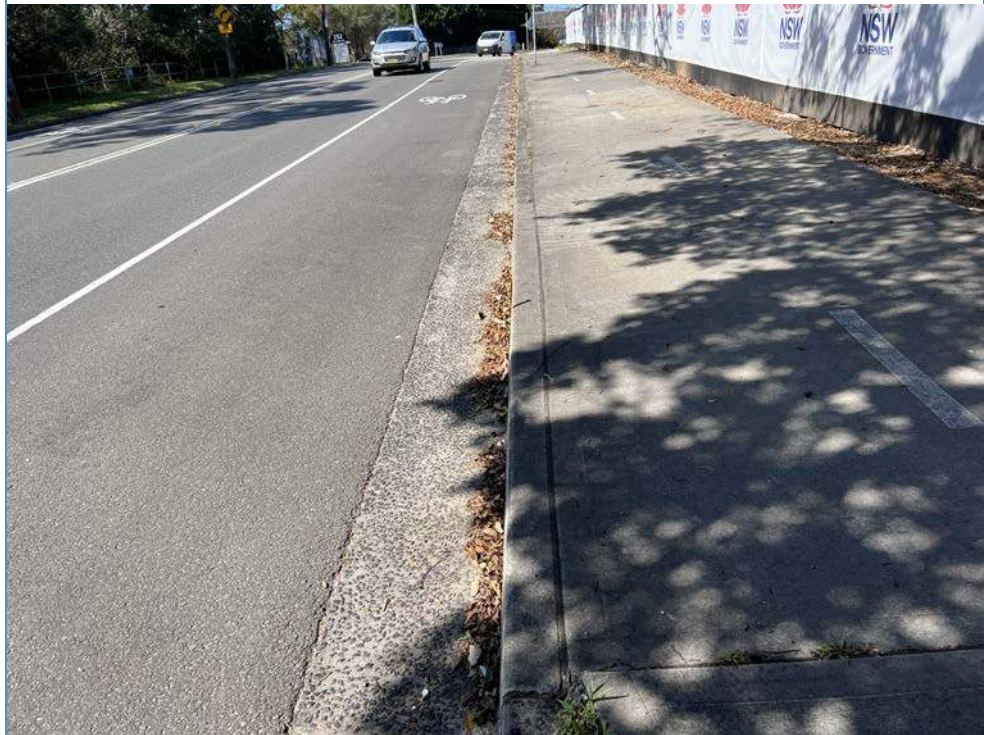
120m

General views of the road surface, kerb and gutter.

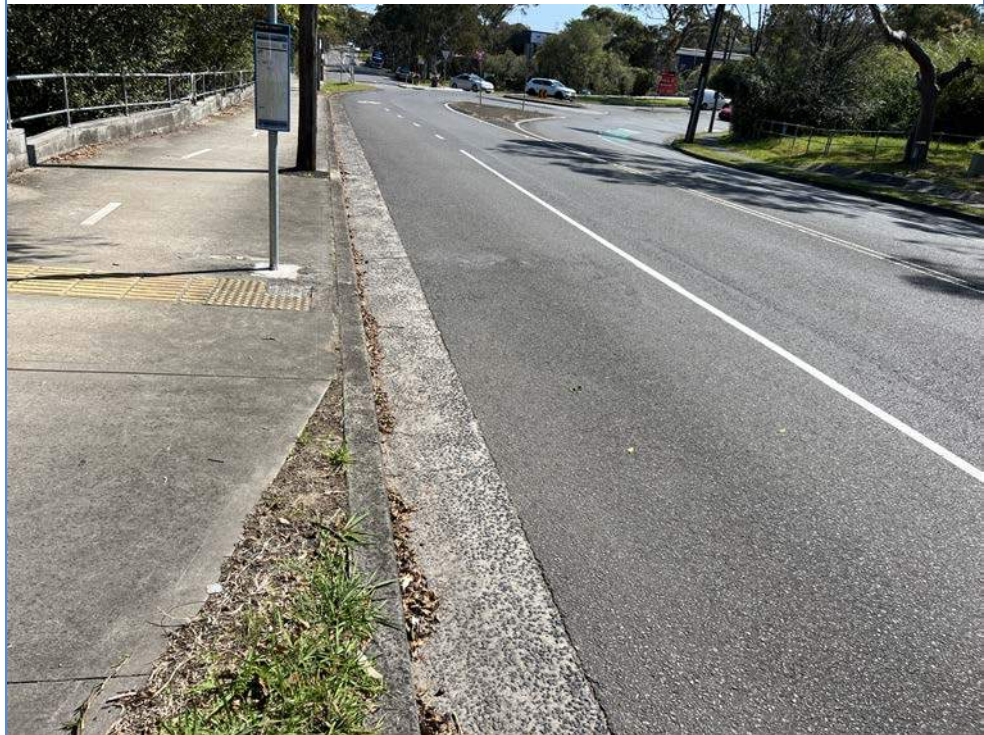
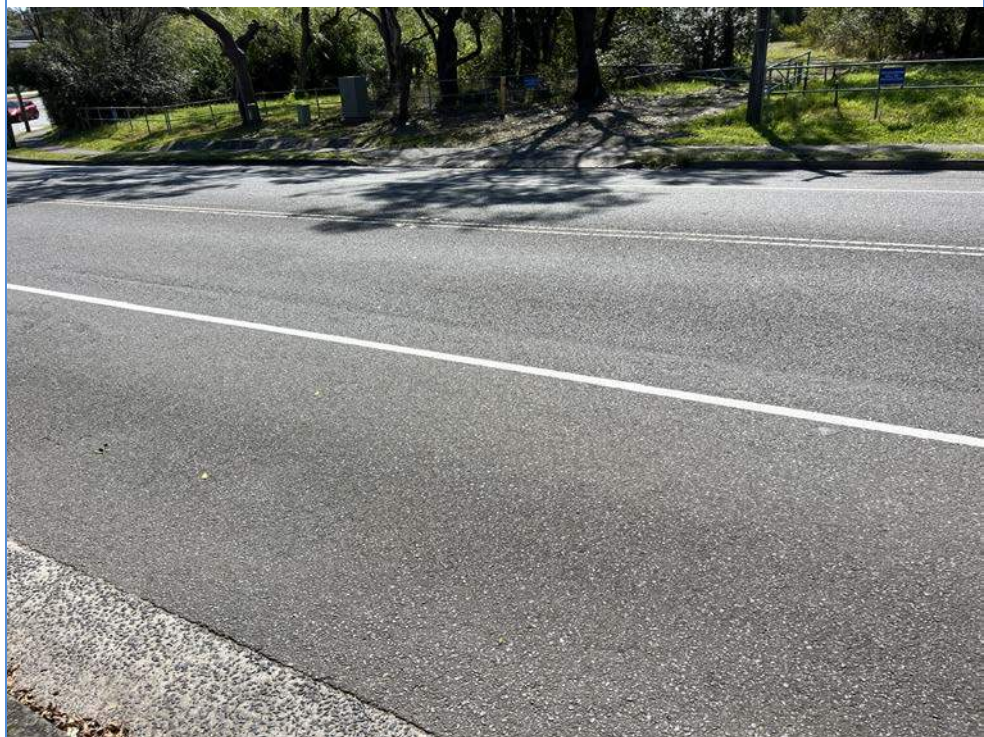
130m

General views of the road surface, kerb and gutter.

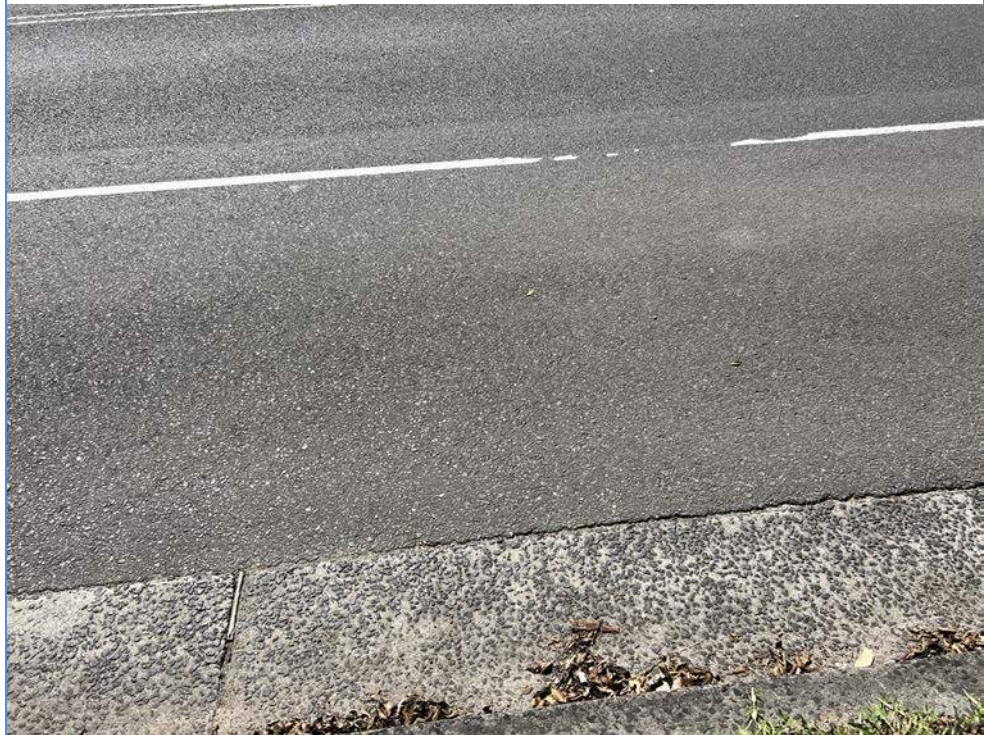
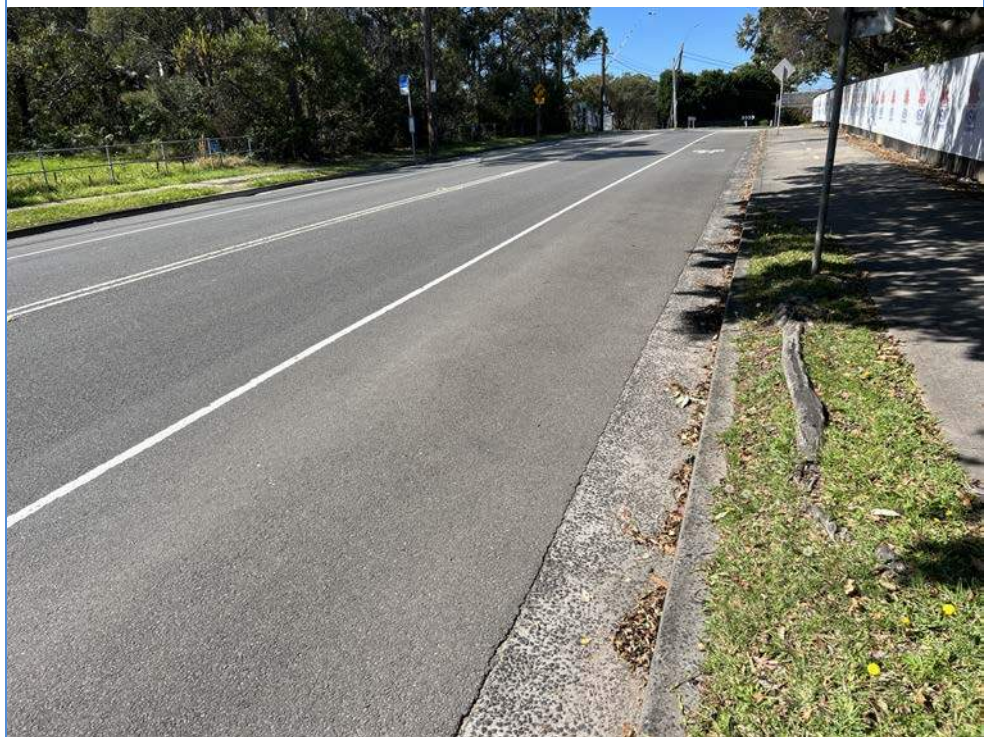
130m

General views of the road surface, kerb and gutter.

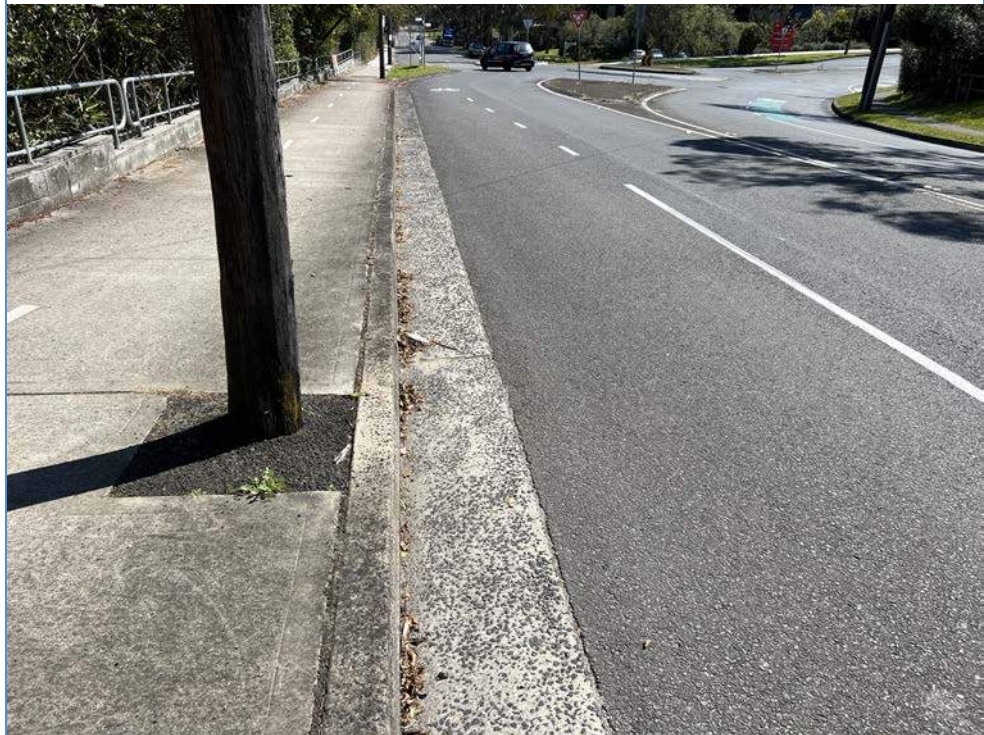
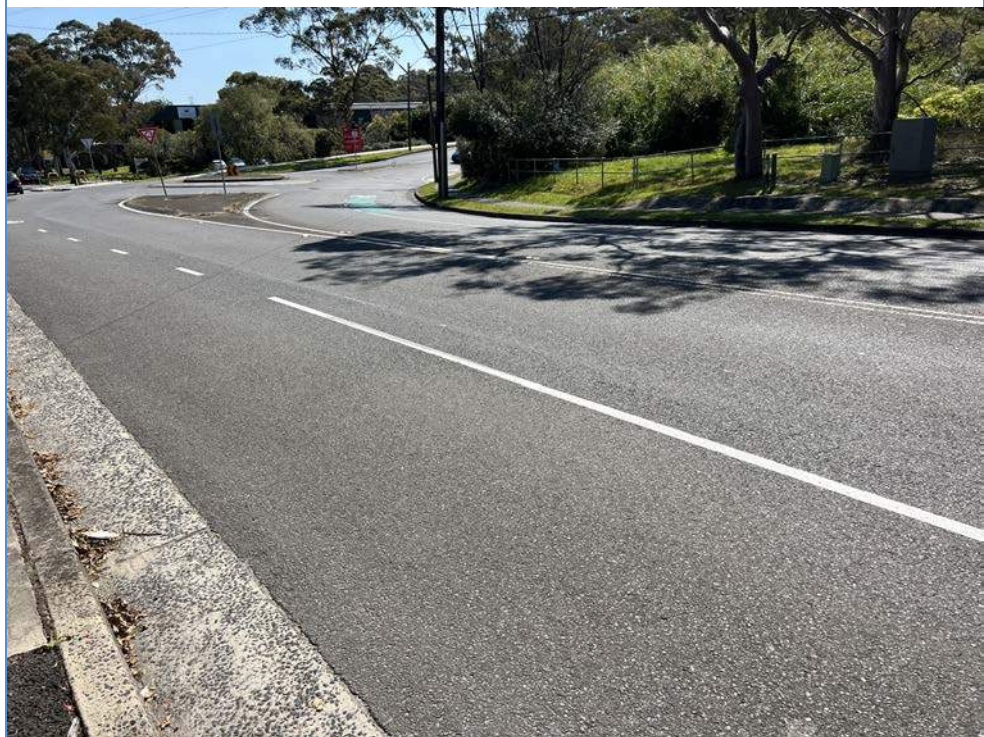
140m

General views of the road surface, kerb and gutter.

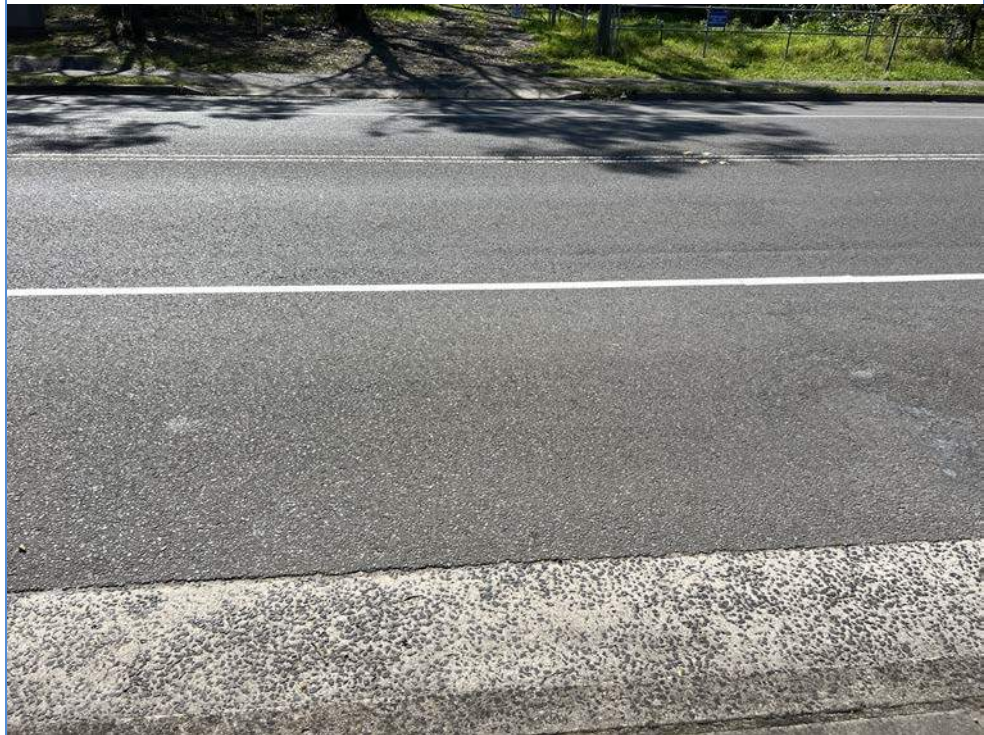
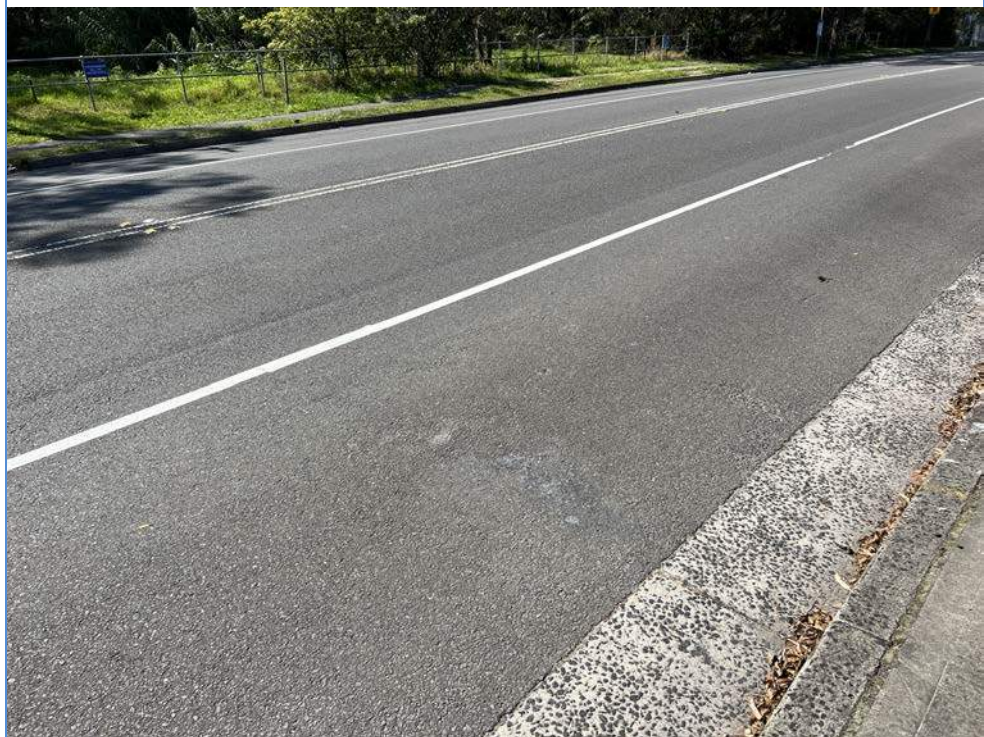
140m

General views of the road surface, kerb and gutter.

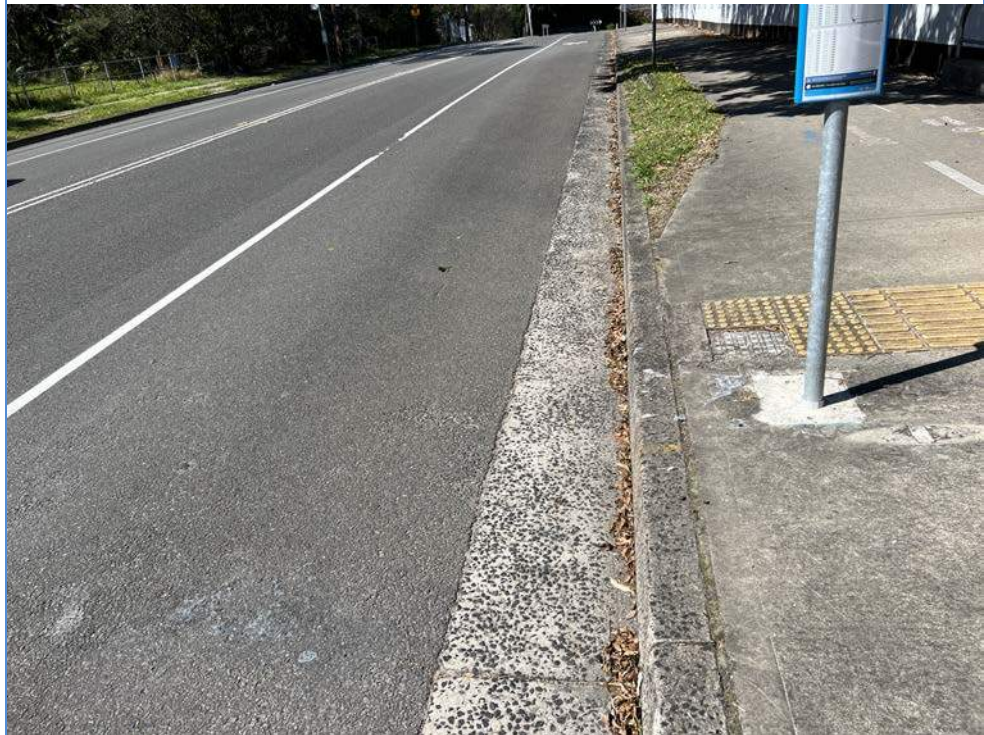
140m

General views of the road surface, kerb and gutter.

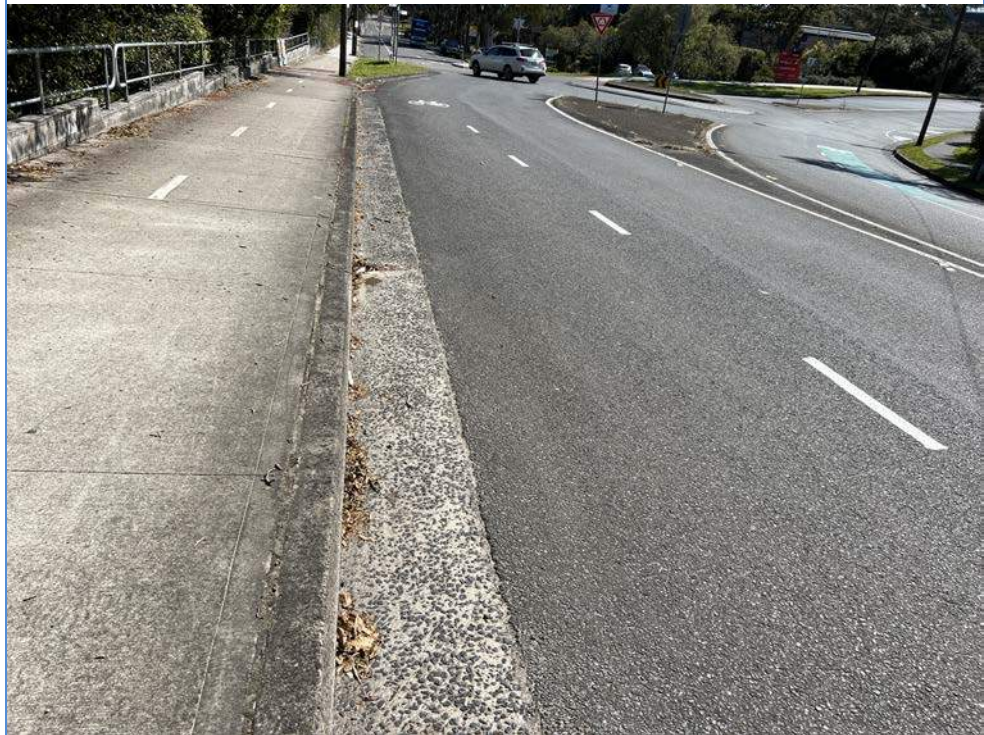
150m

General views of the road surface, kerb and gutter.

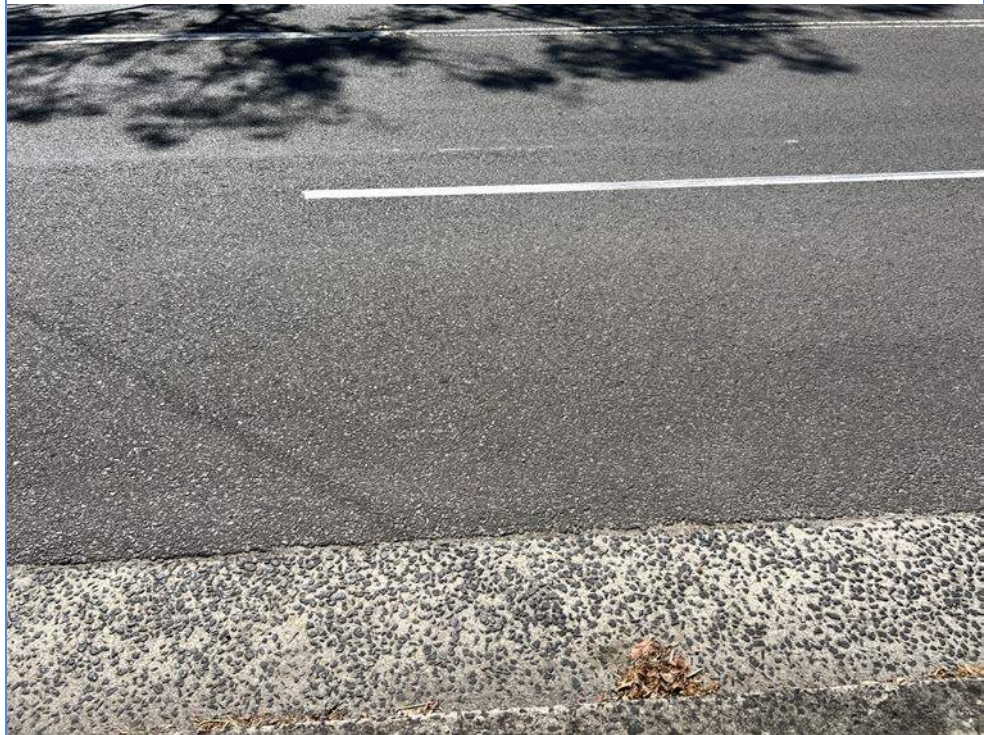
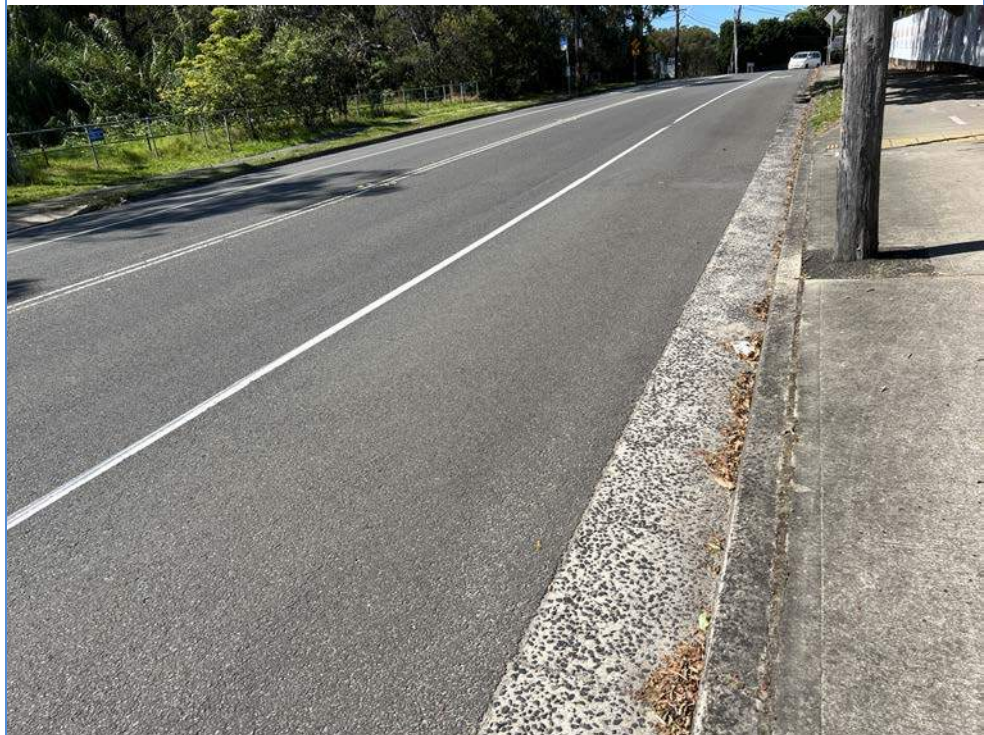
150m

General views of the road surface, kerb and gutter.

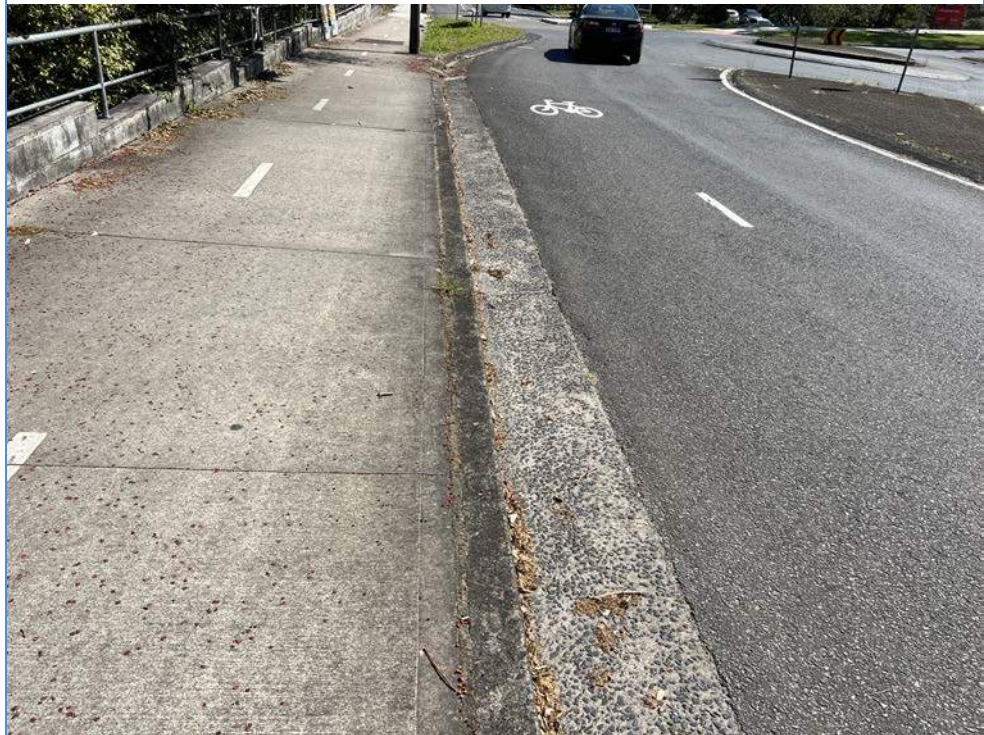
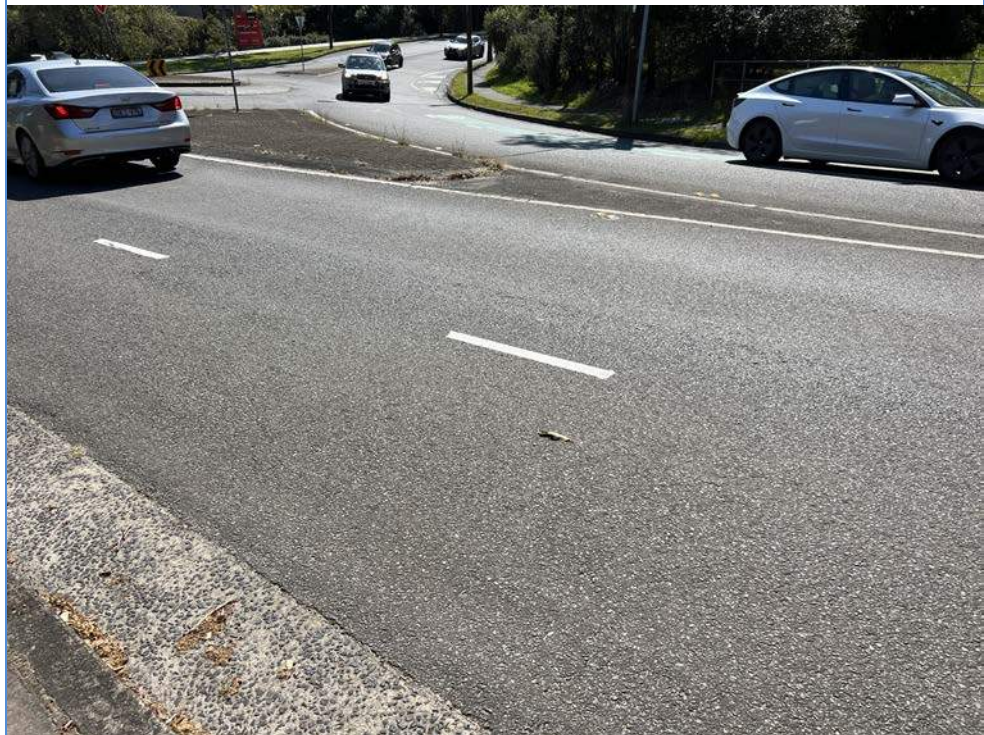
160m

General views of the road surface, kerb and gutter.
