The following inspection is of the footpath and Council strip to the eastern side of Allambie Road starting at the intersection of Aquatic Drive and Allambie Road and heading in a southerly direction towards the end point at Arnhem Road, Allambie Heights.

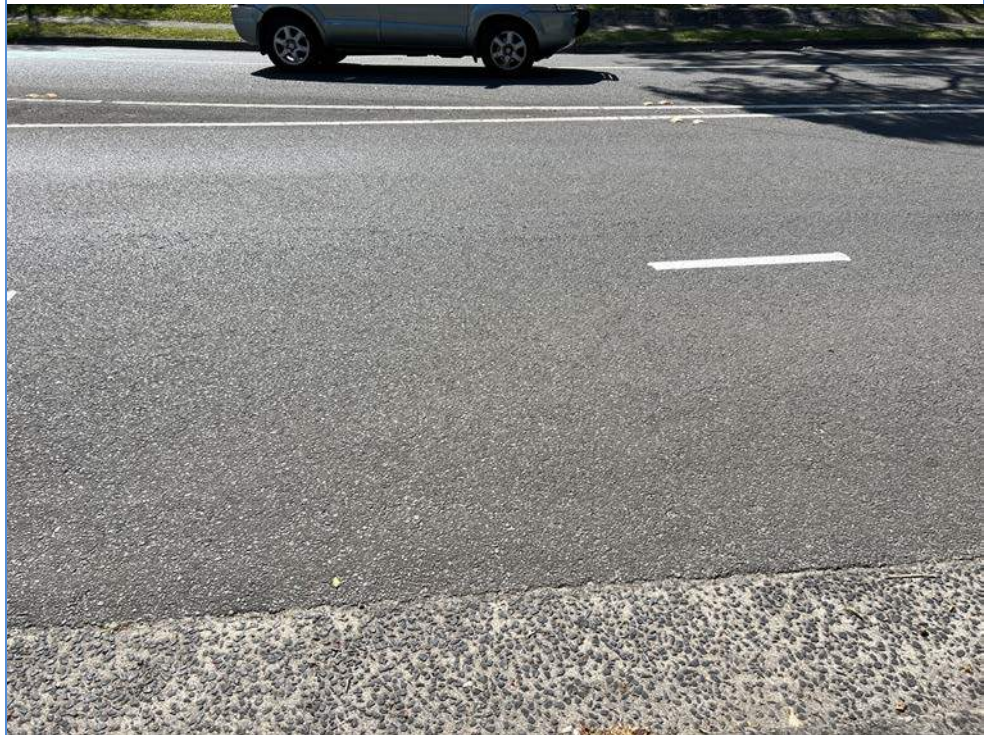
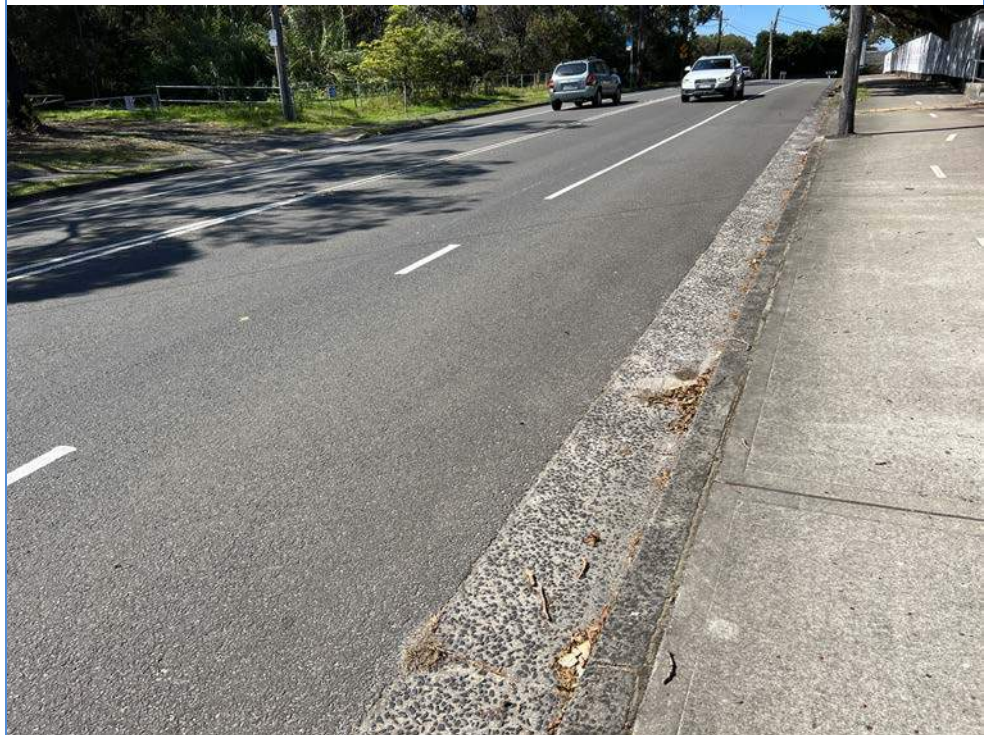
160m

General views of the road surface, kerb and gutter.

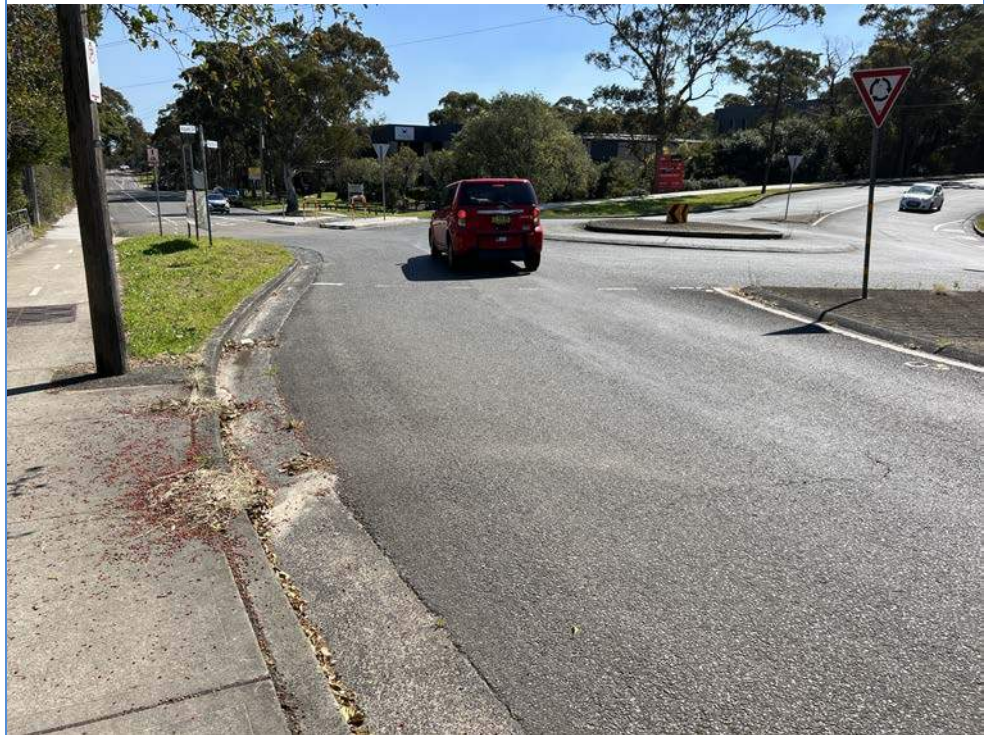
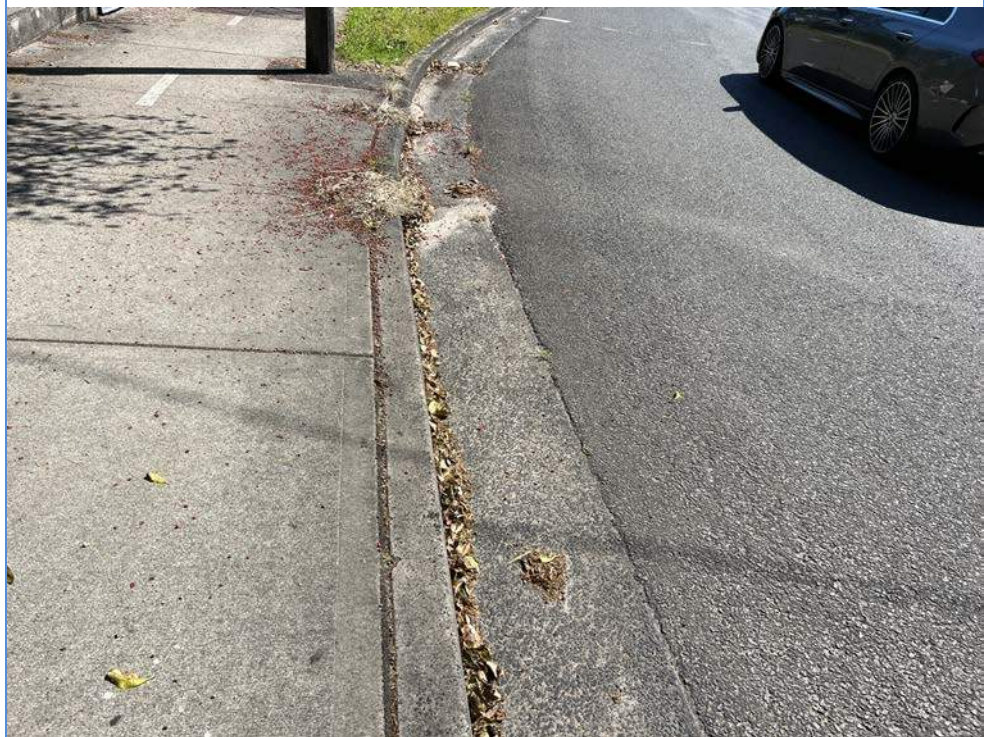
170m

General views of the road surface, kerb and gutter.

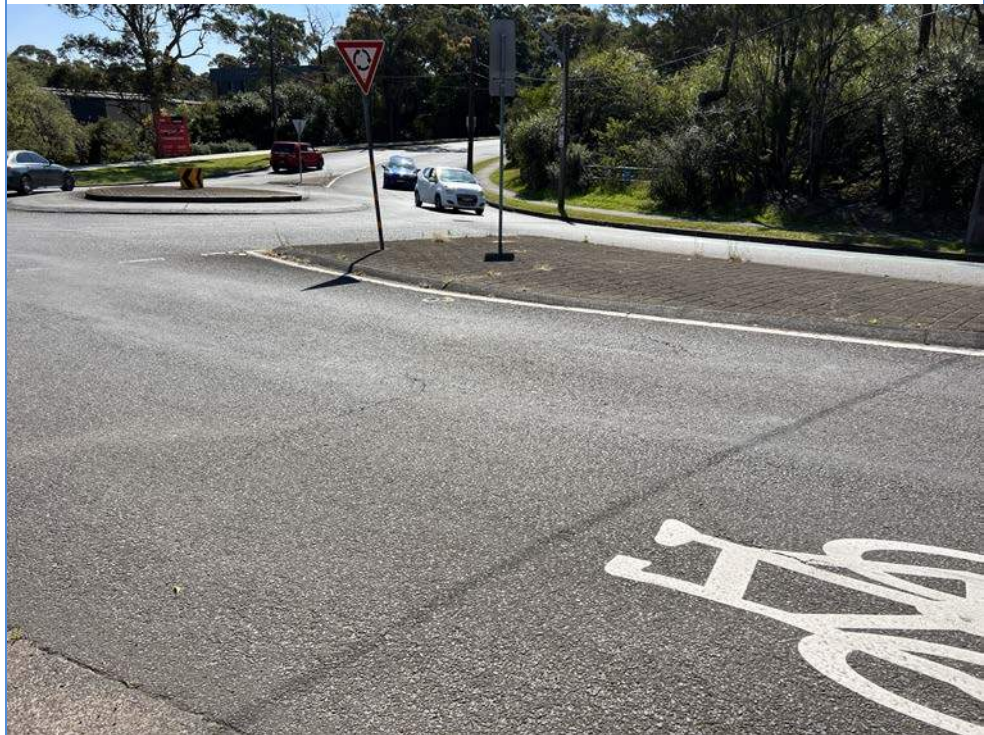
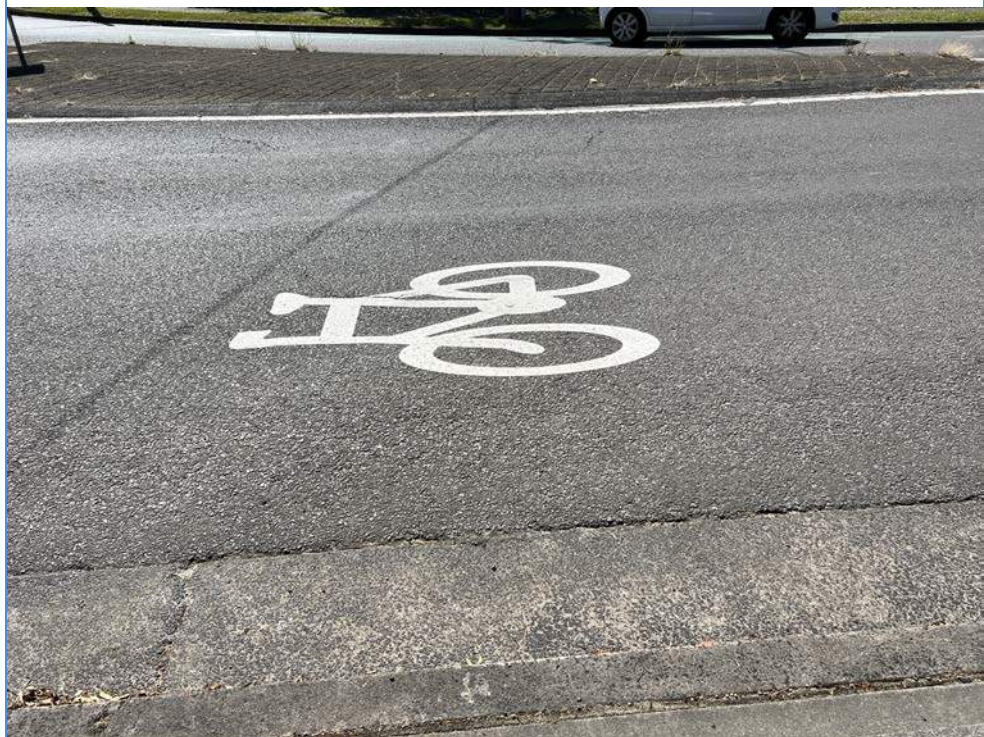
170m

General views of the road surface, kerb and gutter.

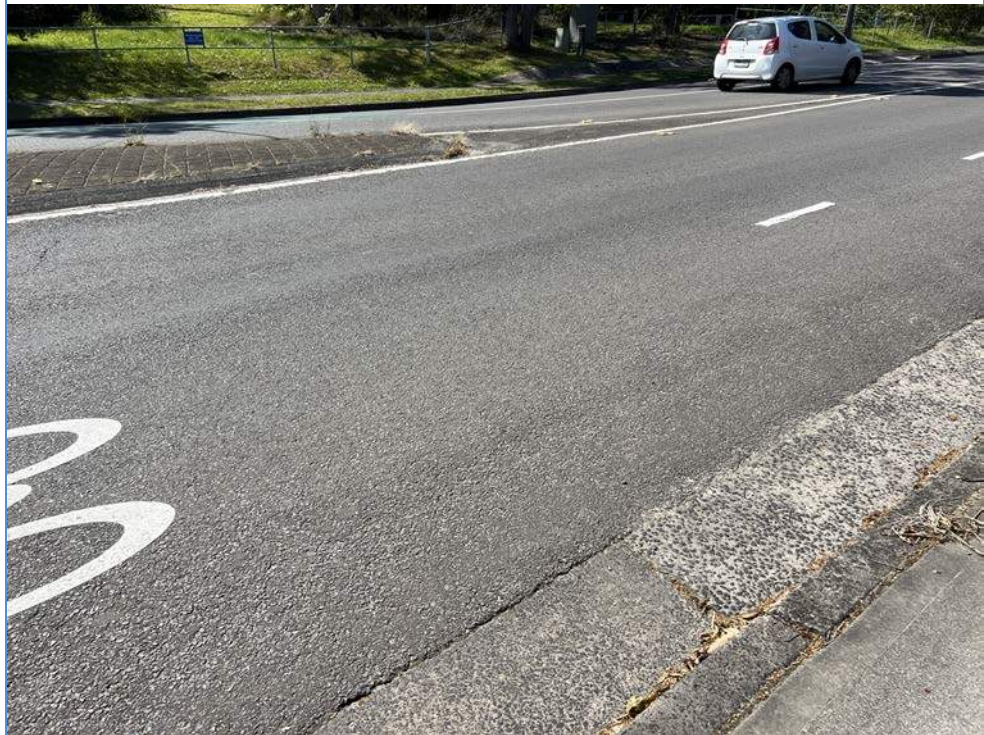
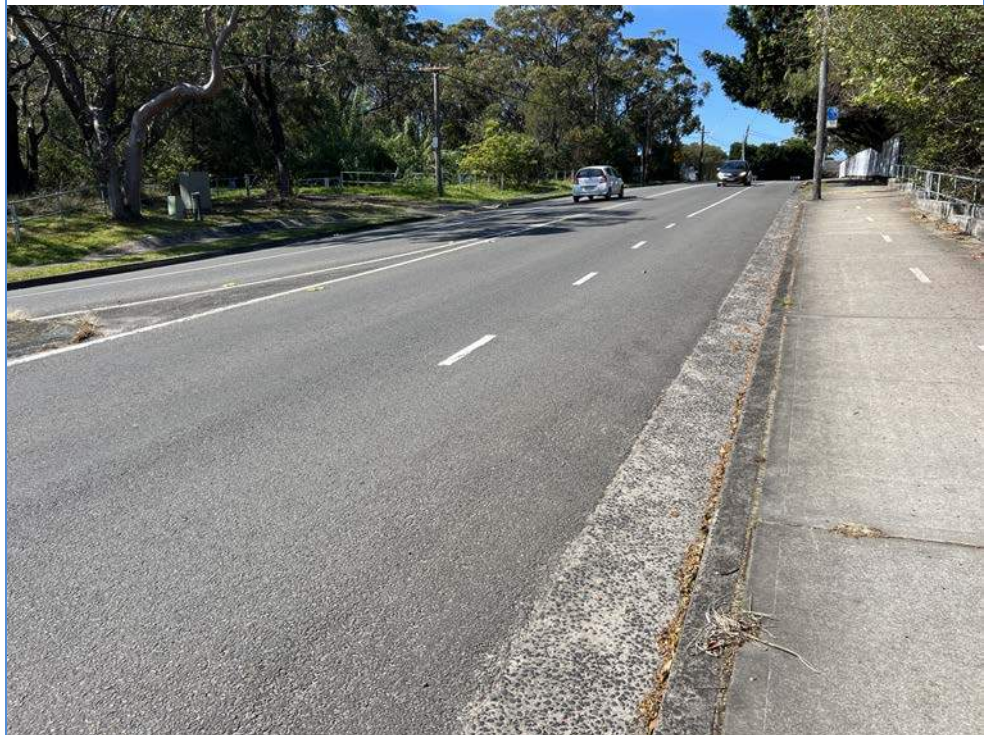
170m

General views of the road surface, kerb and gutter.

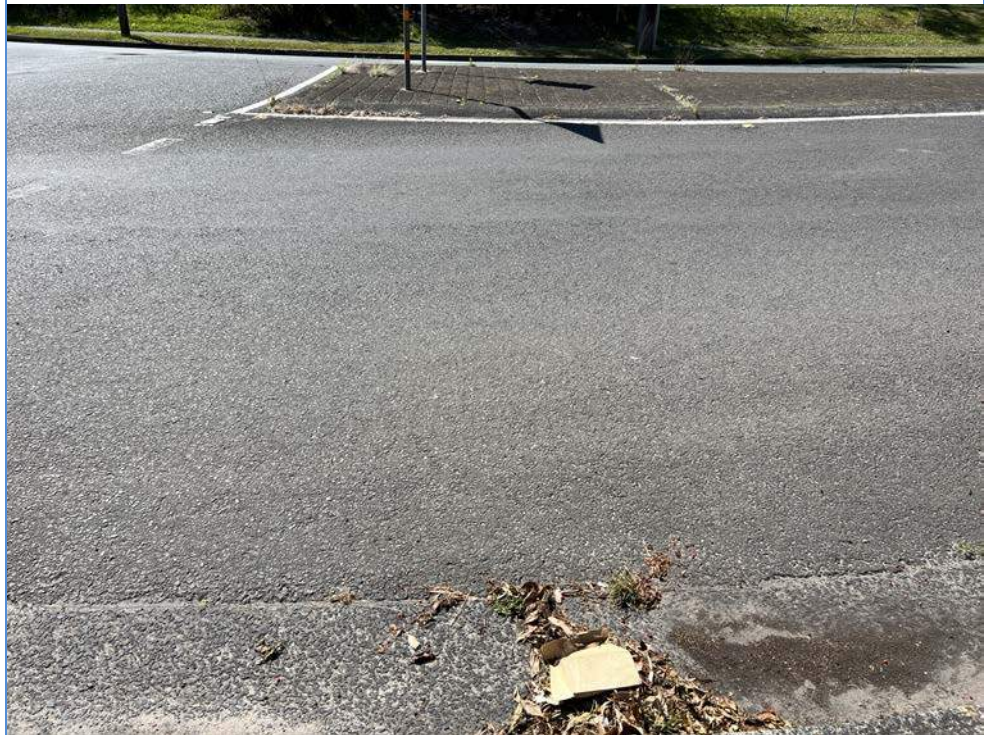
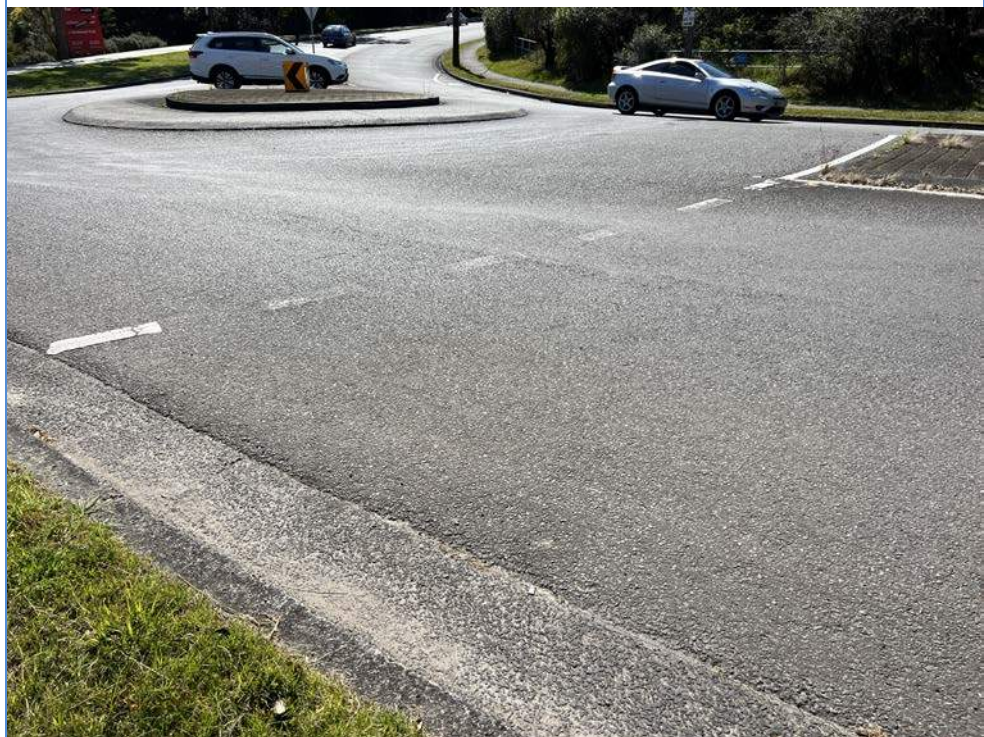
180m

General views of the road surface, kerb and gutter.

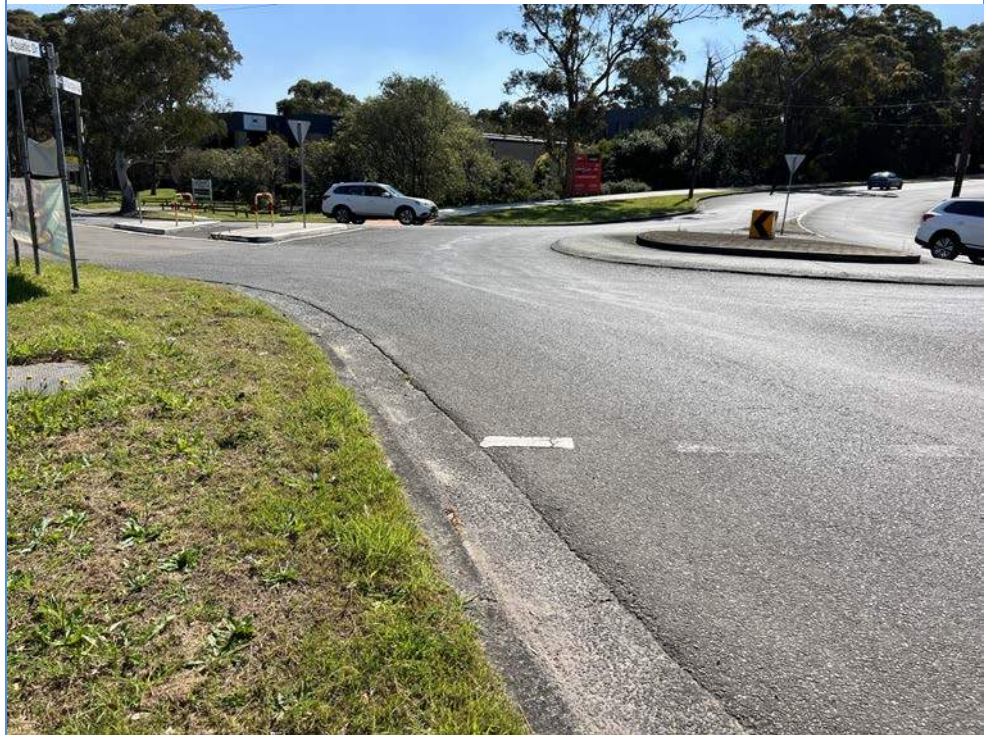
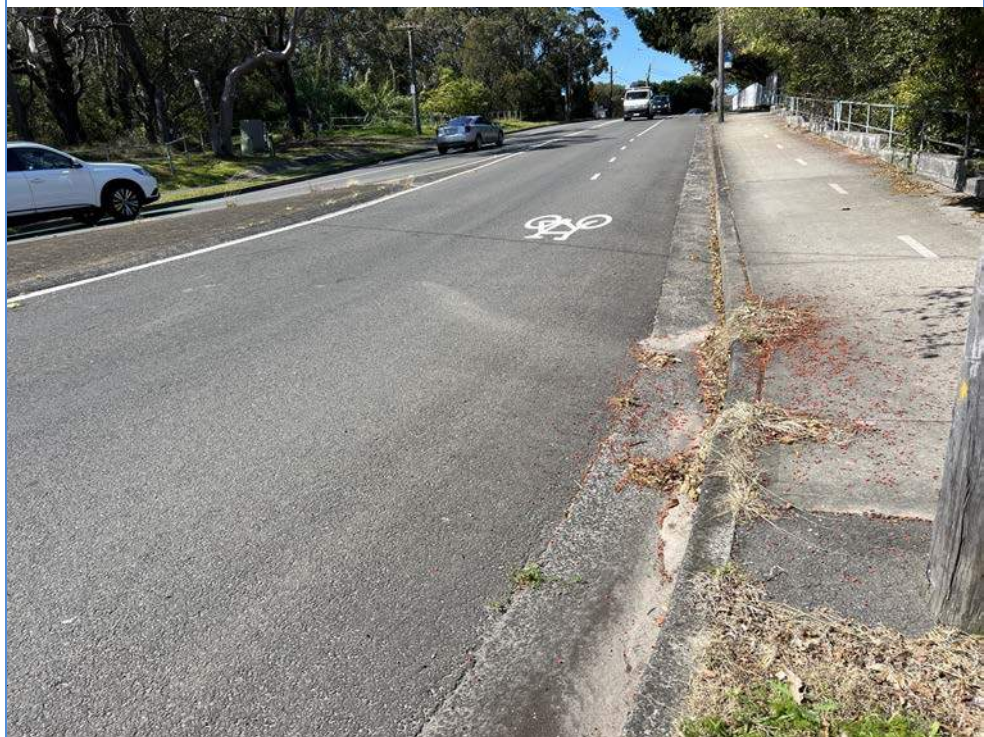
180m

General views of the road surface, kerb and gutter.

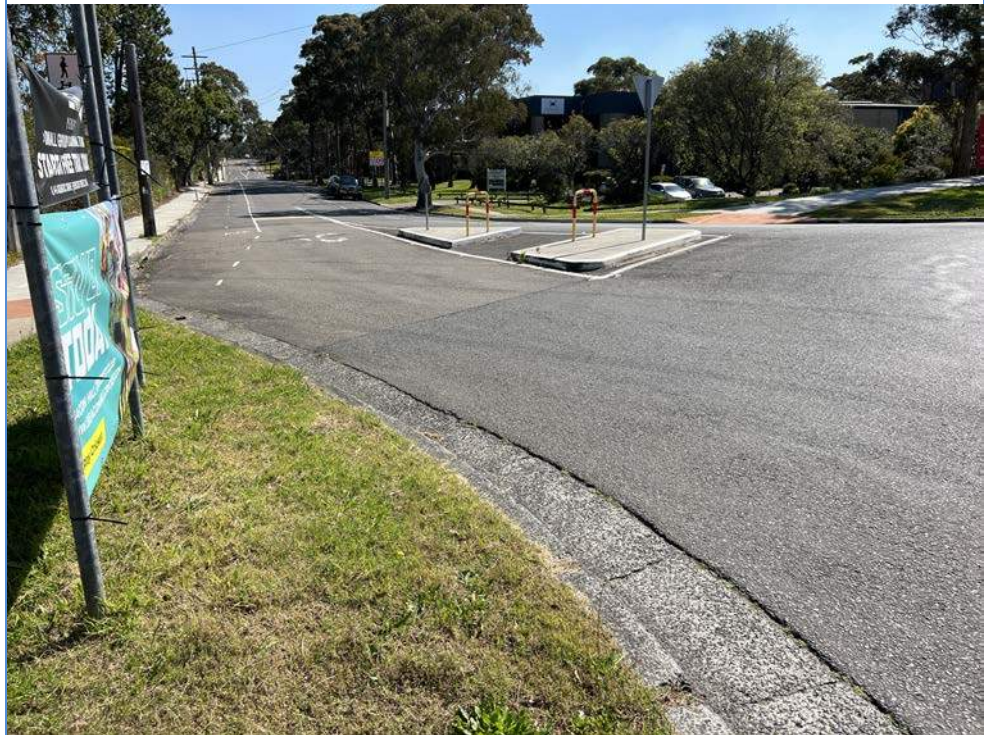
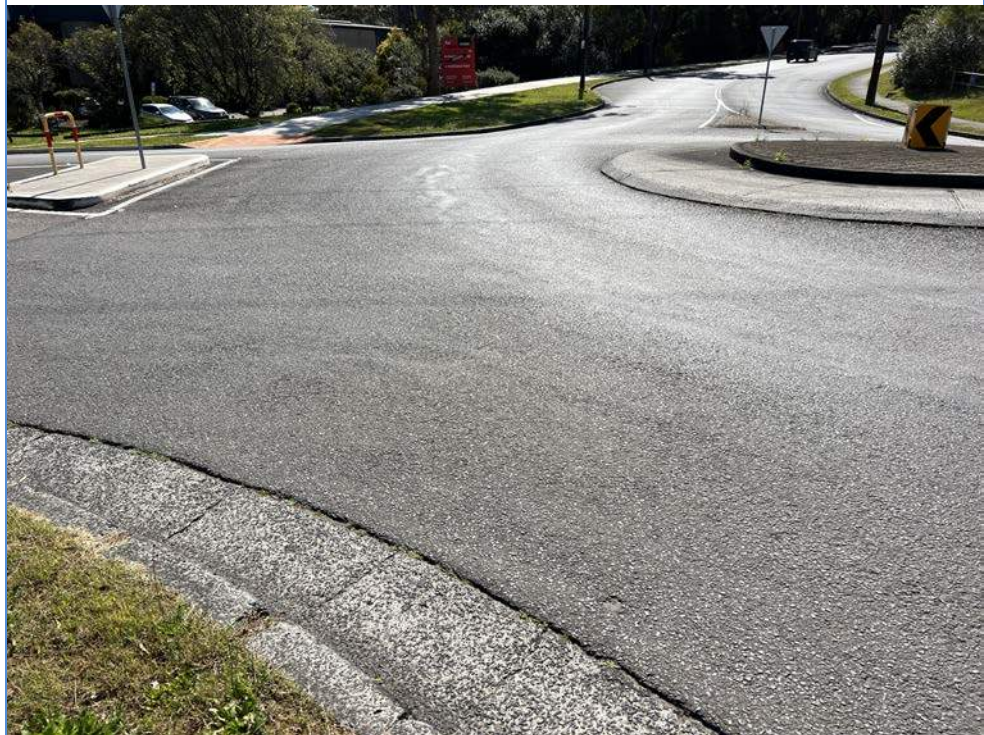
190m

General views of the road surface, kerb and gutter.

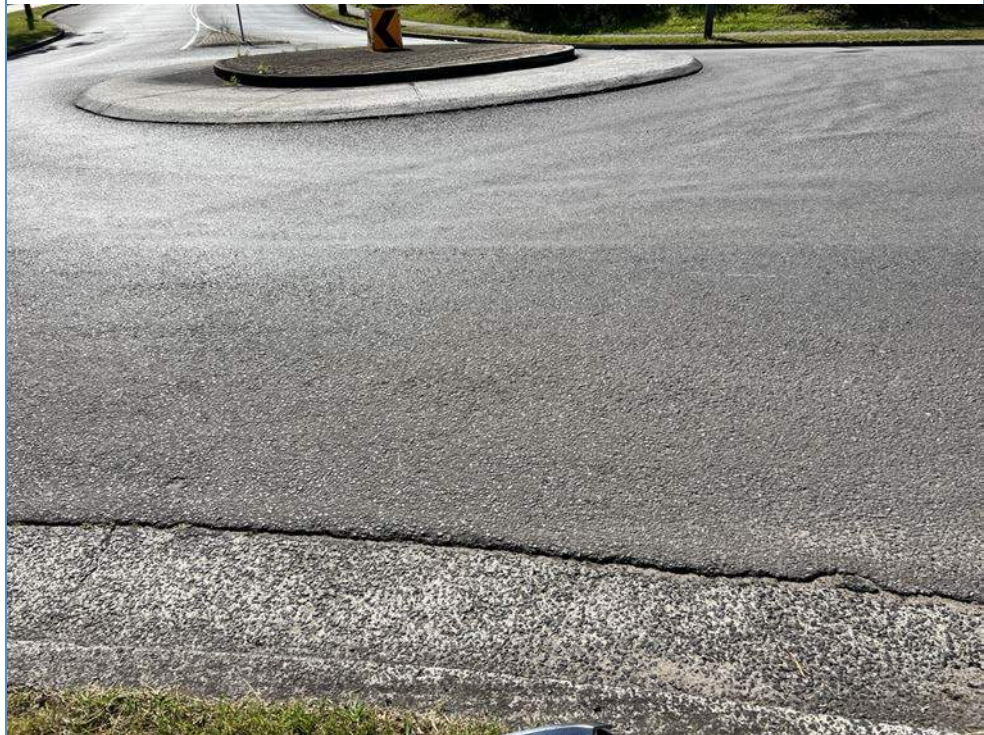
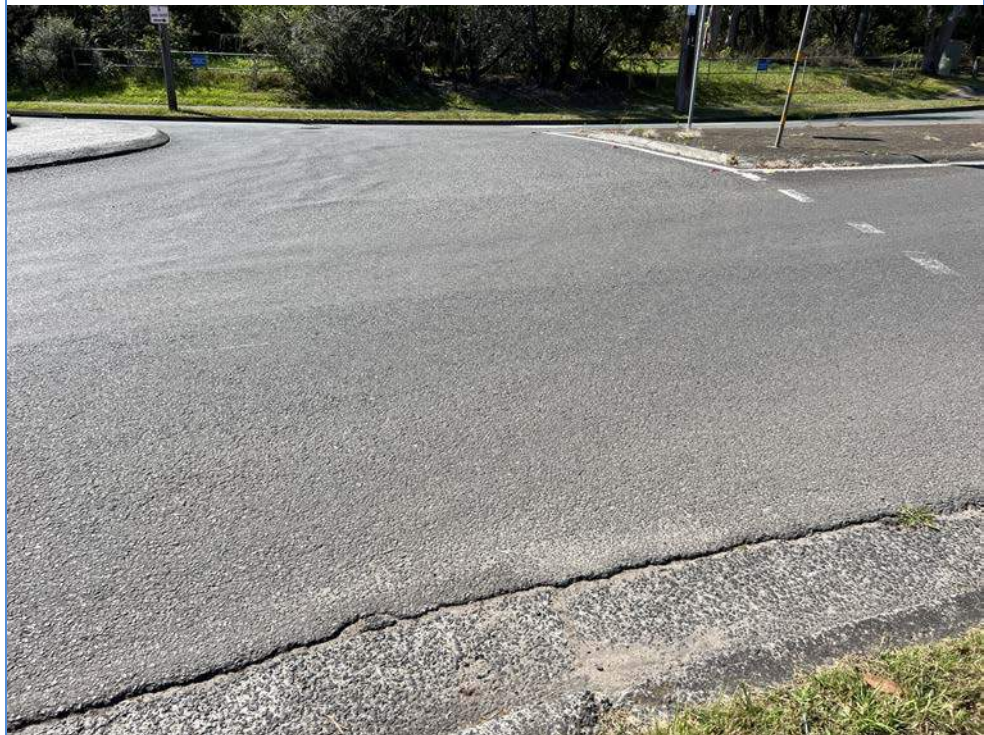
190m

General views of the road surface, kerb and gutter.

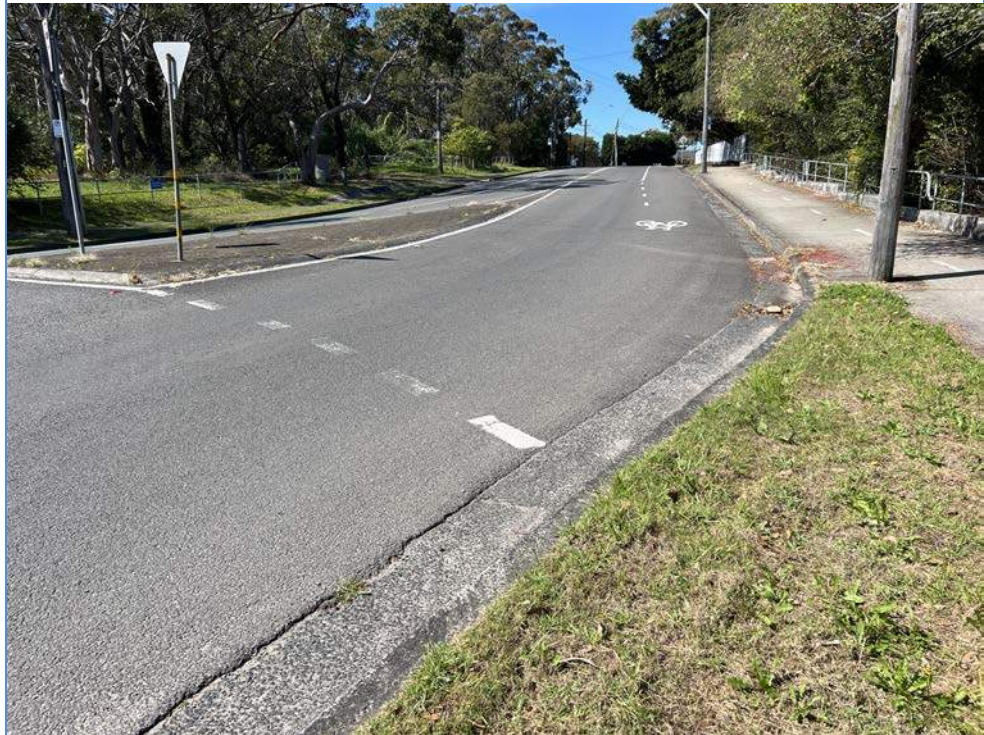
190m

General views of the road surface, kerb and gutter at the end point.

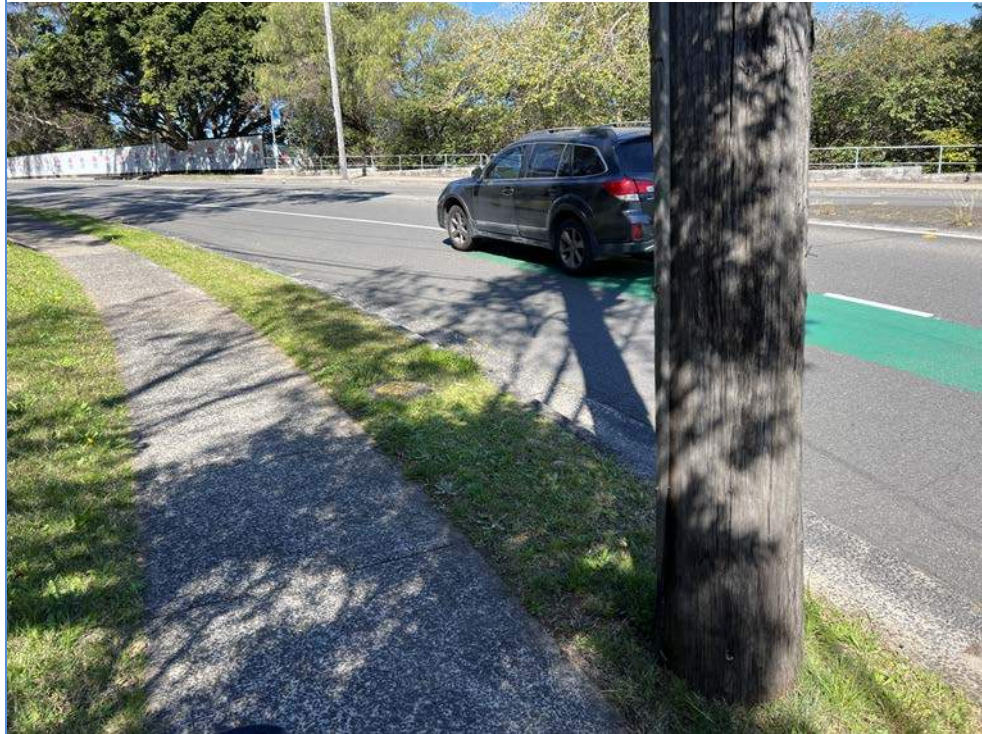
0m

General view of the footpath and Council strip looking from the starting point at the intersection of Allambie Road and Aquatic Drive, Allambie heights.

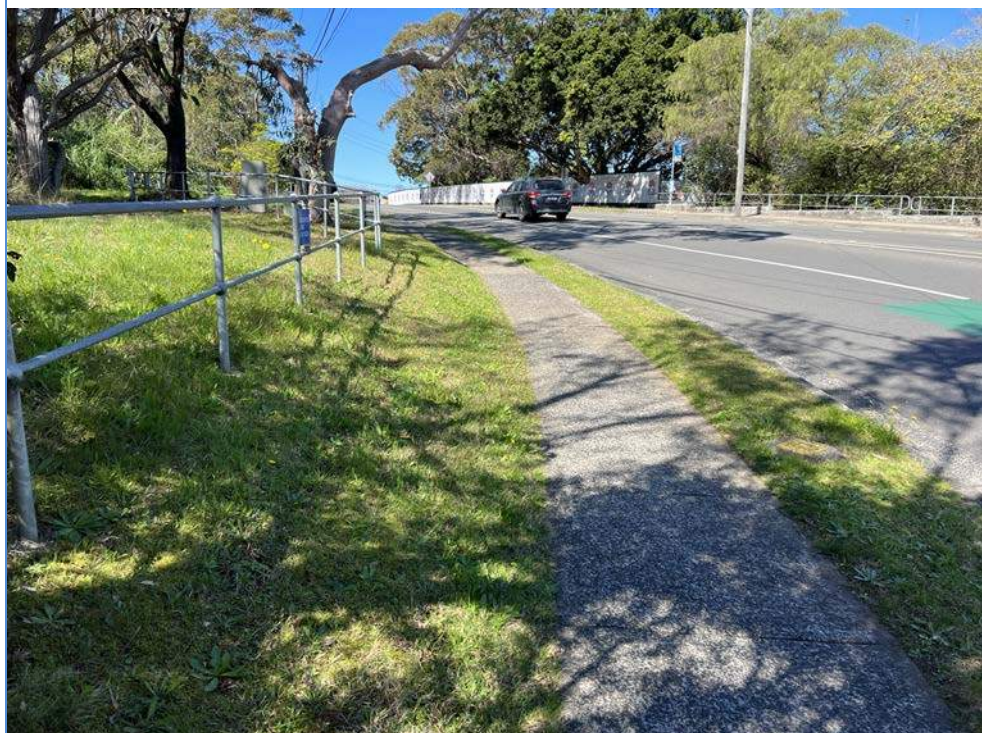
3m	<p>View of the inspection lid to the Council strip.</p>  
10m	<p>General view of the footpath and Council strip.</p>

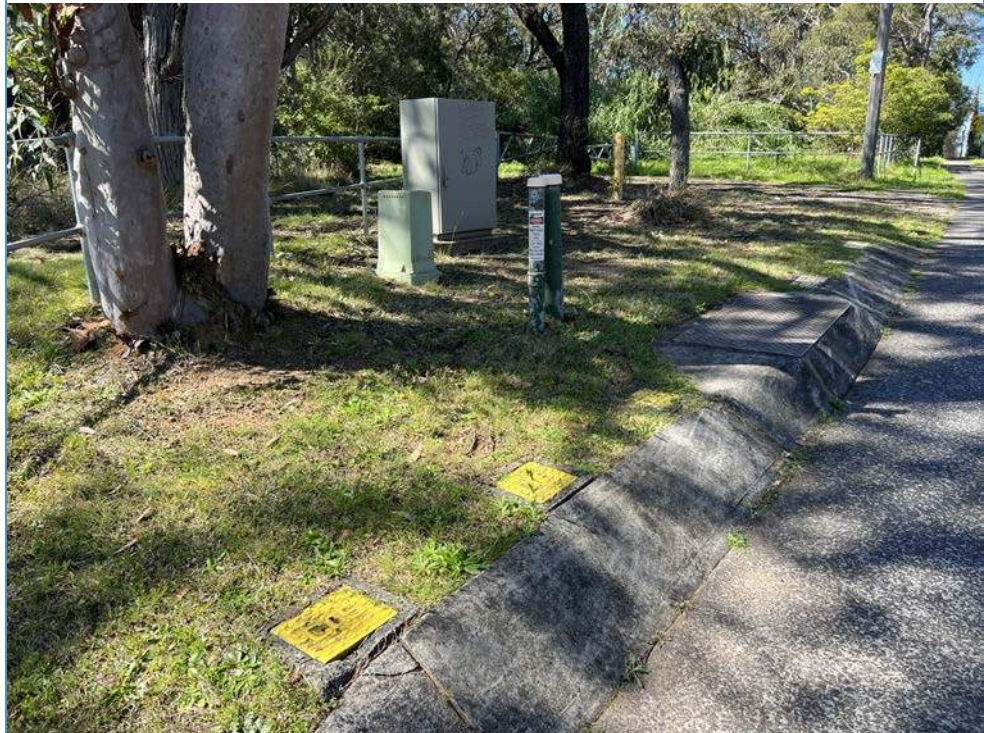
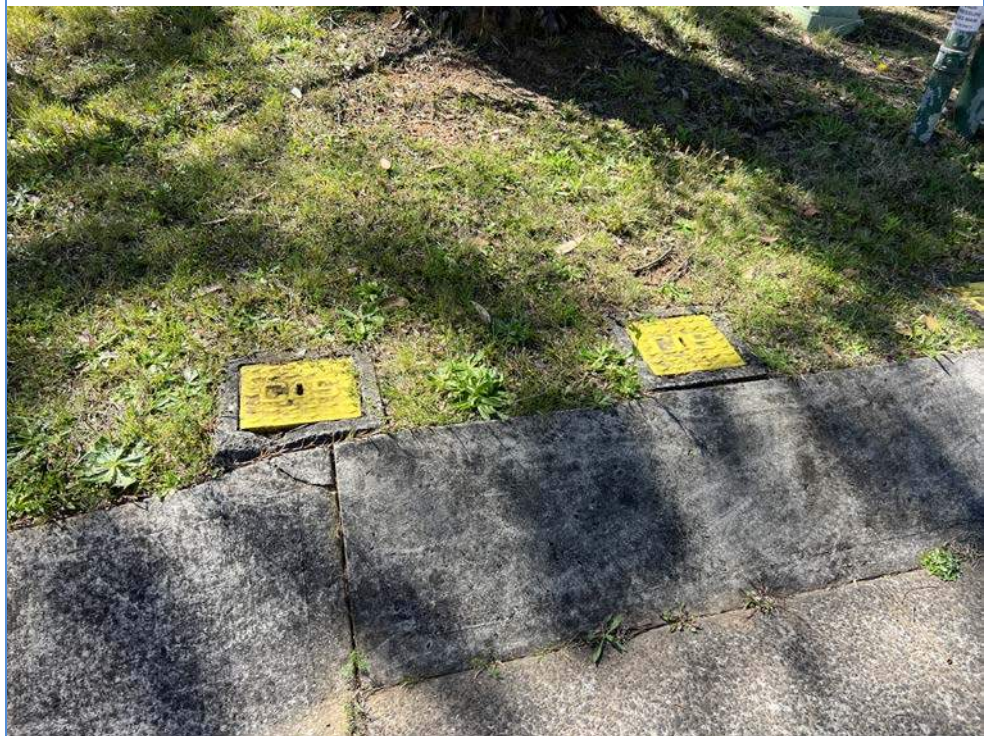
15m

Views of the services and inspection lids adjoining the footpath.

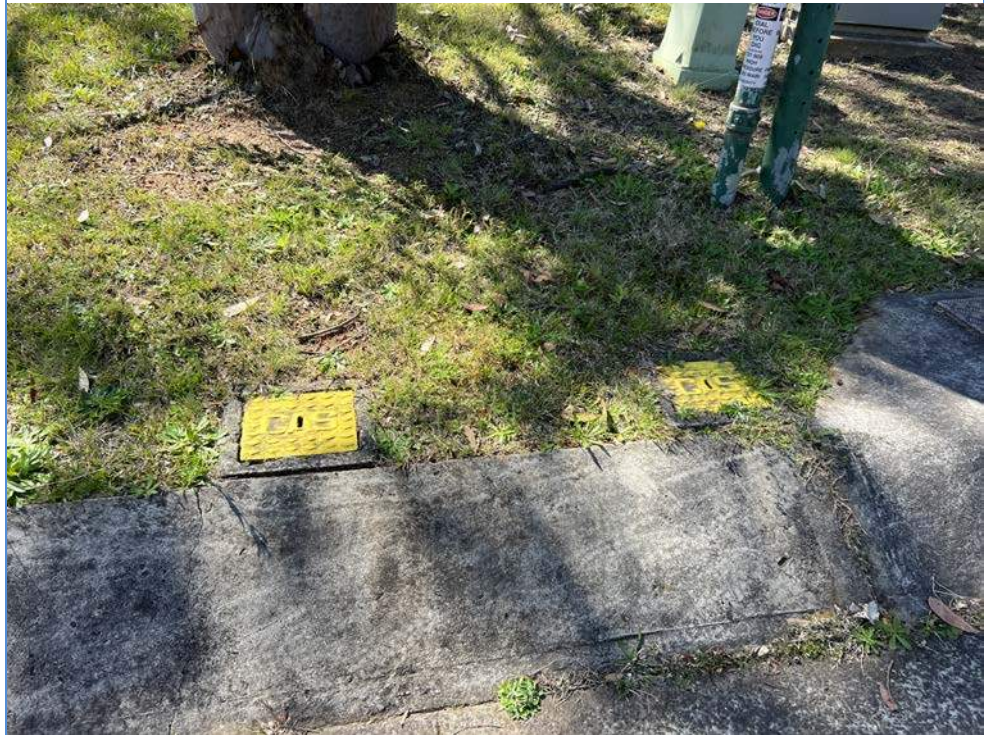
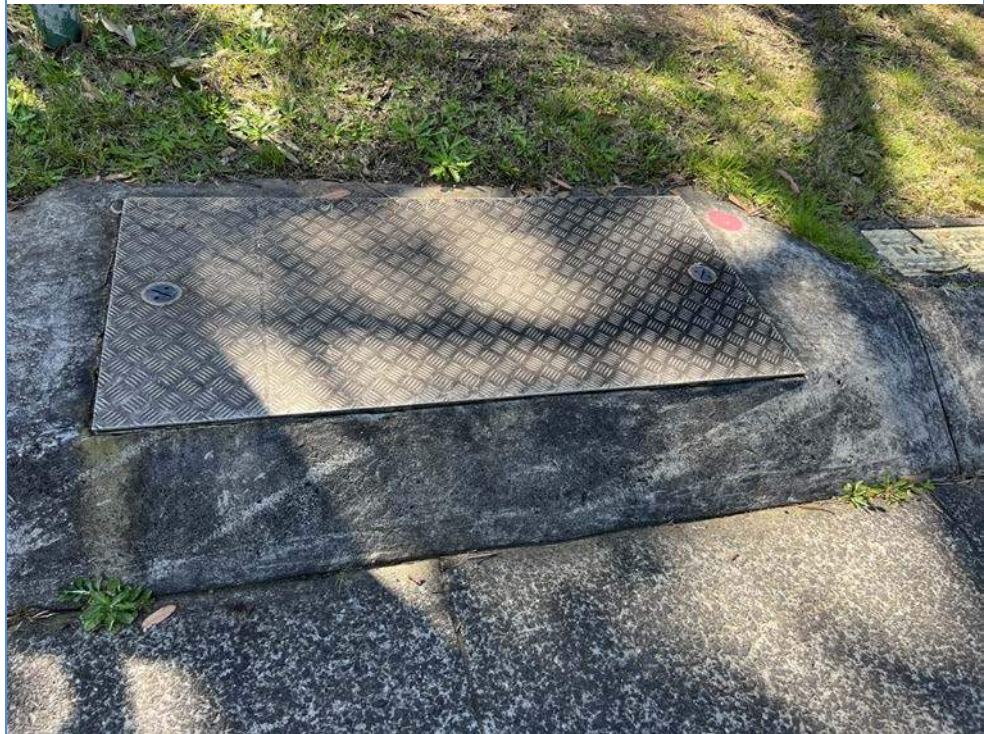
15m

Views of the services and inspection lids adjoining the footpath.

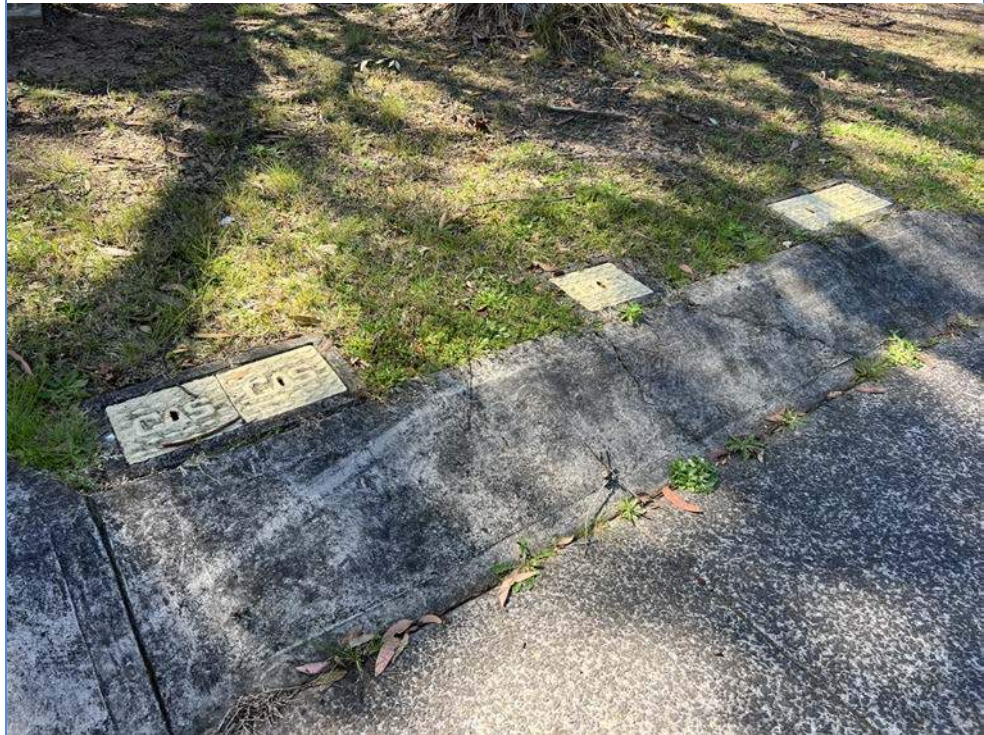
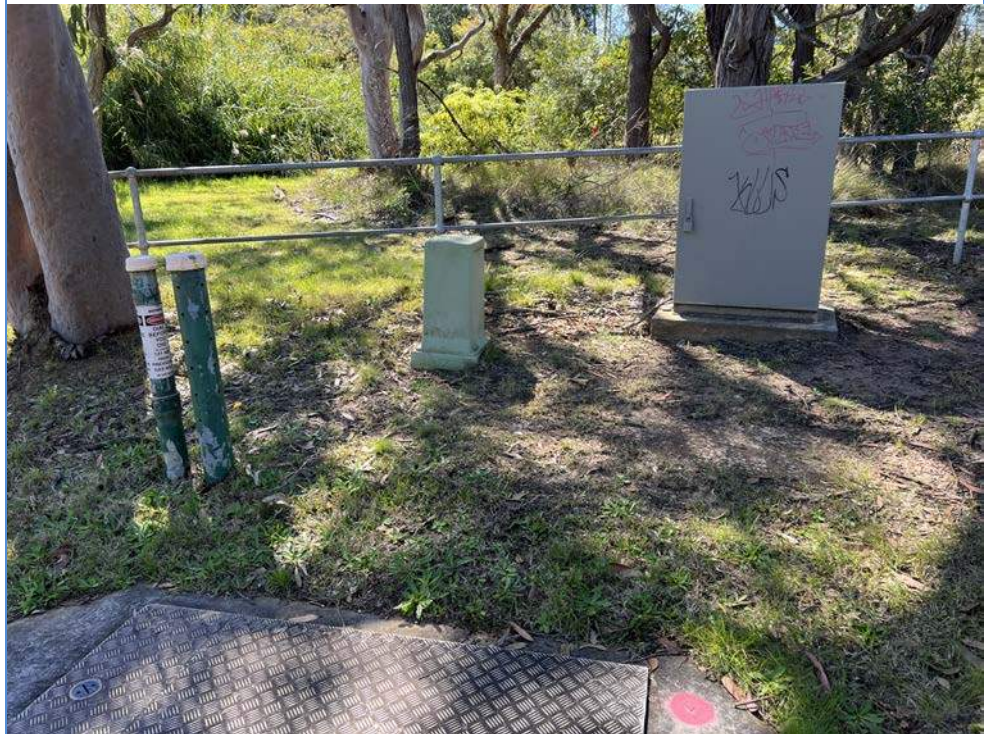
15m

Views of the services and inspection lids adjoining the footpath.
