Report on  
Hazardous Building Materials (HBM) Survey

Hastings Secondary College - Port Macquarie Campus  
16 Owen Street, Port Macquarie

Prepared for  
School Infrastructure NSW  
on behalf of Department of Education

Project 89754.01  
April 2021

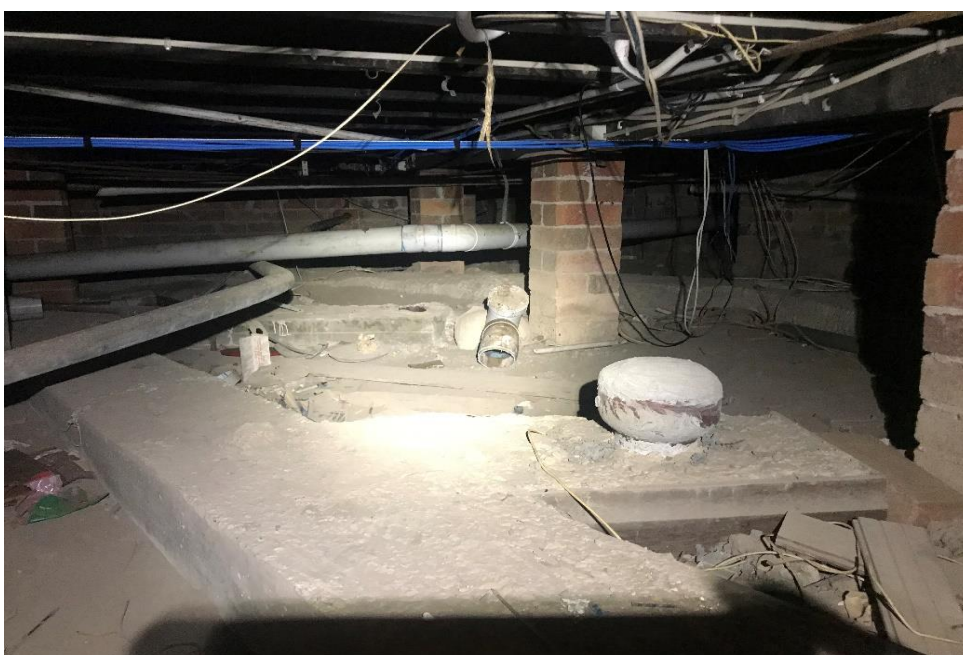
Photograph 4: B00A, building subfloor, throughout, materials in general, no asbestos identified visually however access limited.

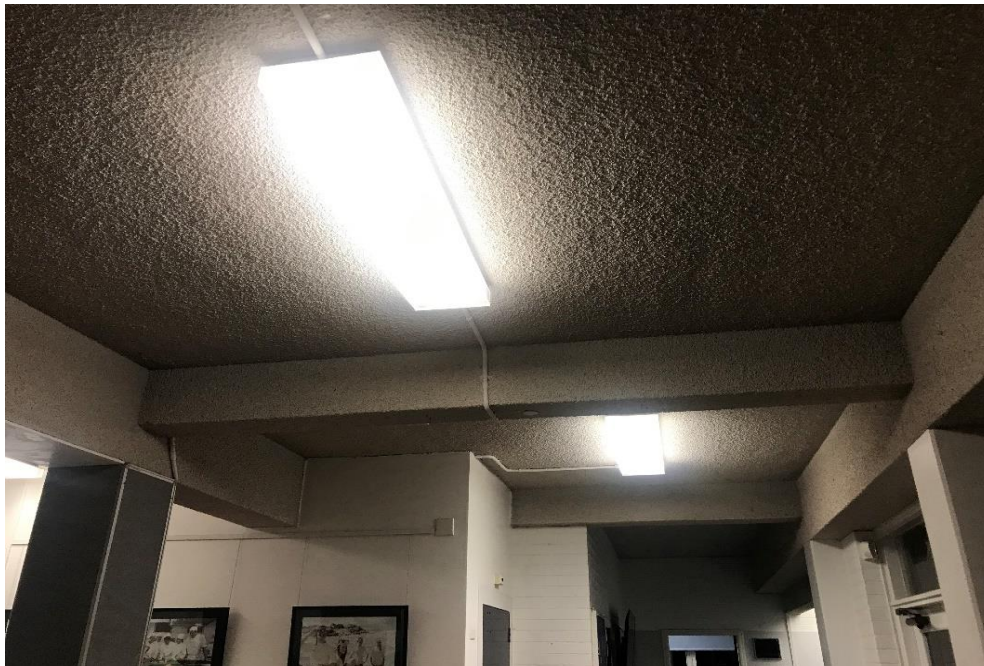
Photograph 6: B00A, AR0022, ceiling, eastern end of room, vermiculite, no asbestos detected by analysis, SMF detected.

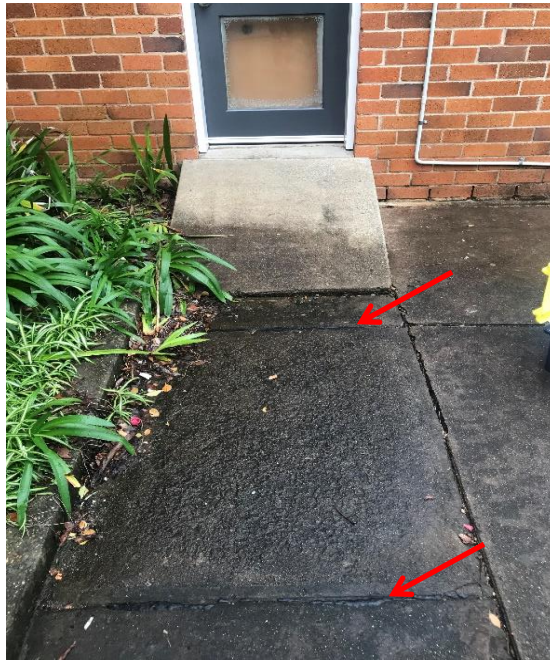
Photograph 15: B00A, exterior, paving outside AR0036, expansion gap, bitumastic, asbestos detected by analysis.

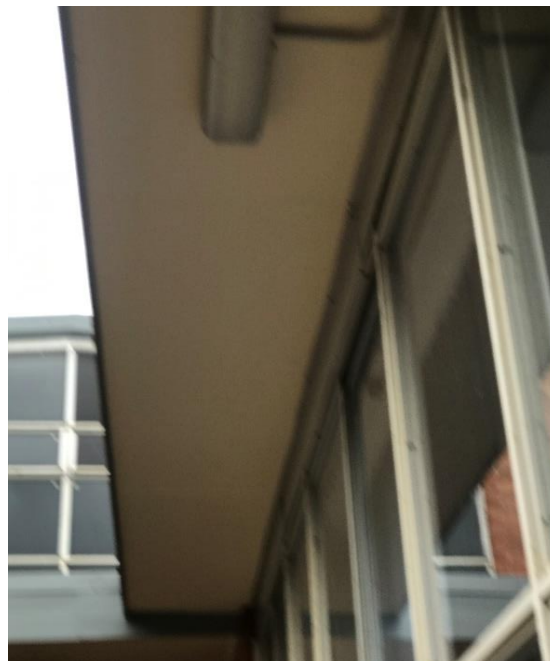
Photograph 16: B00A, exterior, eave lining adjacent wheelchair ramp (north of AR0019 and AR0020), fibre cement, asbestos detected by analysis.

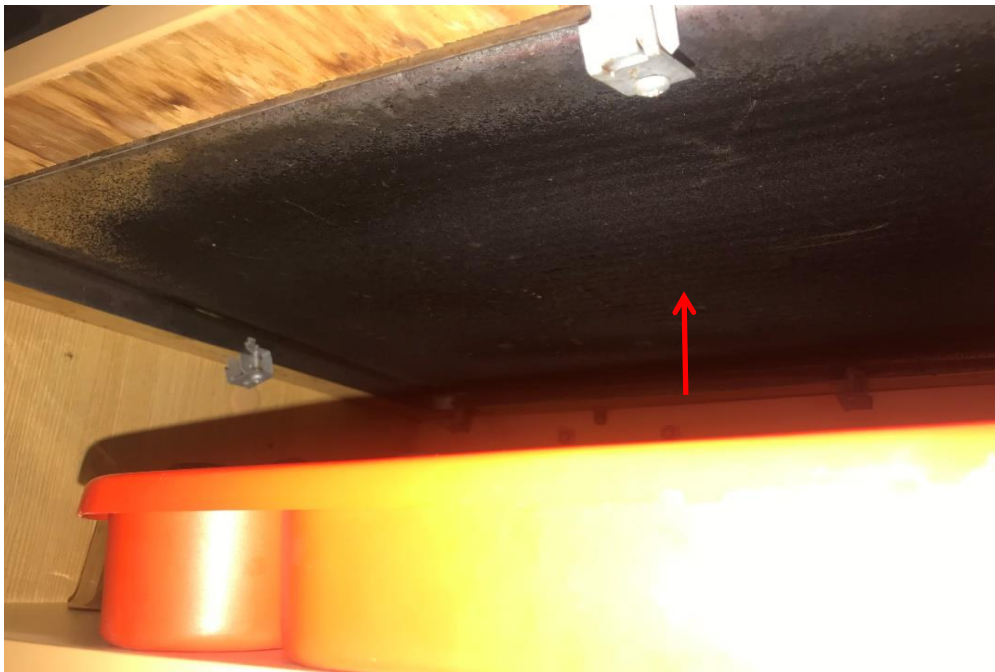
Photograph 12: B00B, BR1002, underside of sink, bituminous lining, asbestos detected by analysis.

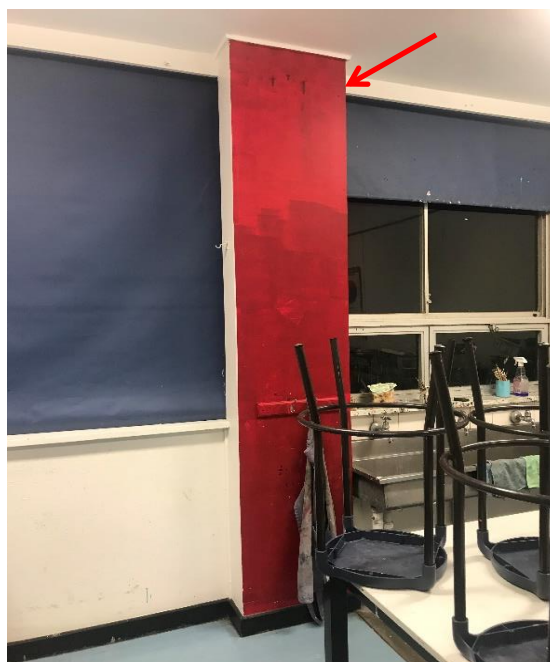
Photograph 13: B00B, BR1014, north wall, red building box, internal material(s), unknown.

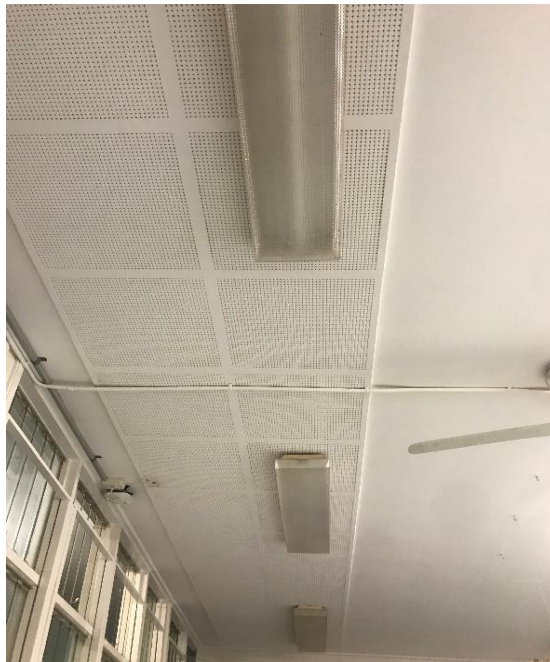
Photograph 24: B00B, rooms and areas in general, fluorescent light fittings in general, capacitors, insulating oil, PCB (assumed).

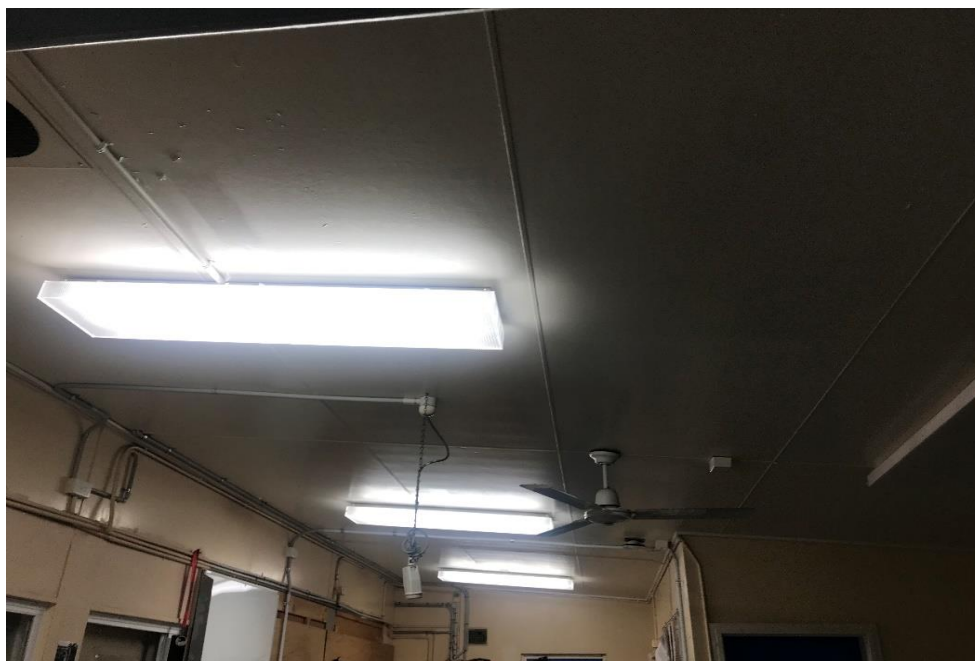
Photograph 4: B00C, CR0001, ceiling, fibre cement sheeting, asbestos detected by analysis.

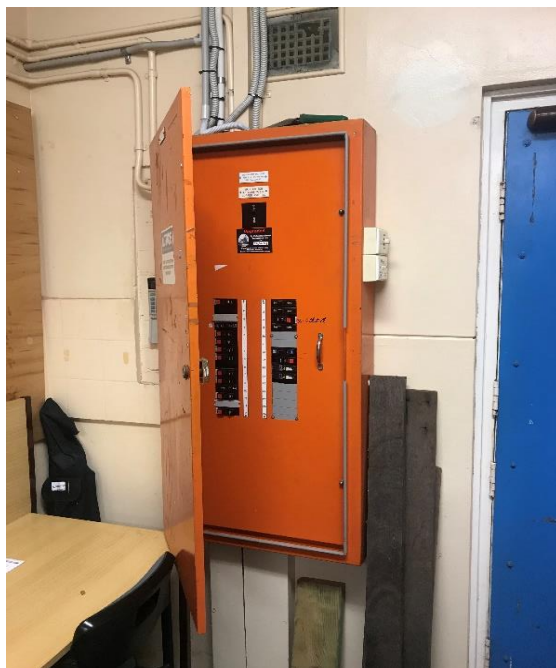
Photograph 5: B00C, CR0001, electrical cabinet, resinous board, asbestos (assumed).

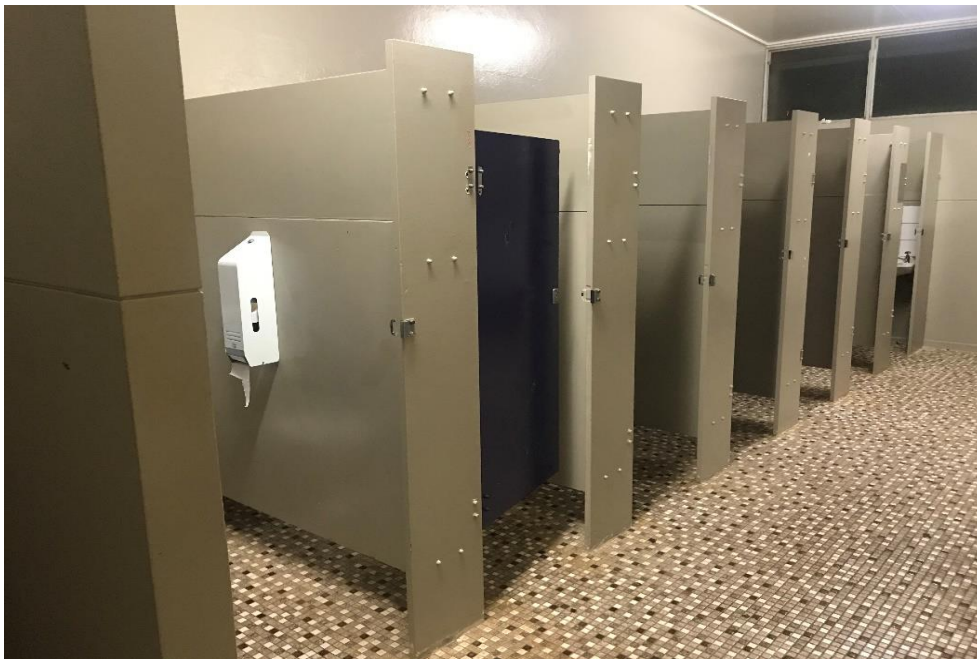
Photograph 8: B00C, CR0010, cubicles, partition walls, fibre cement board, asbestos detected by analysis.

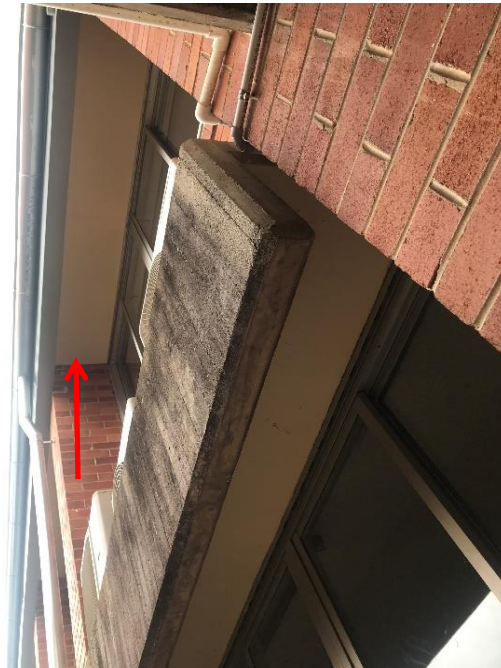
Photograph 1: B00L, exterior, western eave, fibre cement, asbestos detected by analysis.

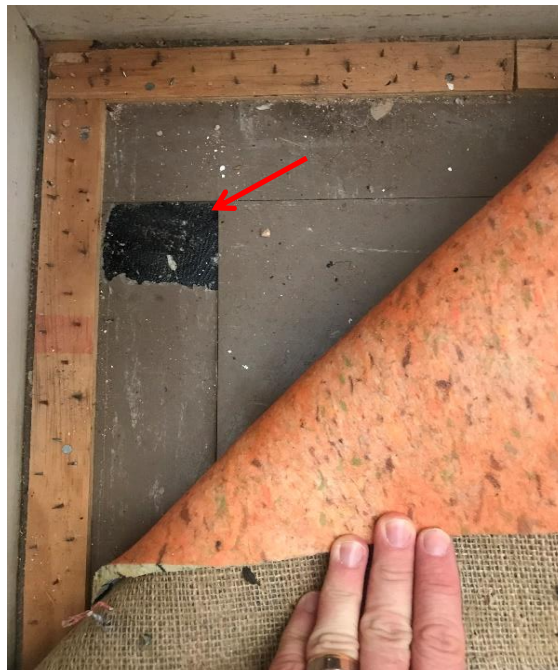
Photograph 12: Typical bituminous adhesive below vinyl tiles with white streaks, asbestos detected by analysis.

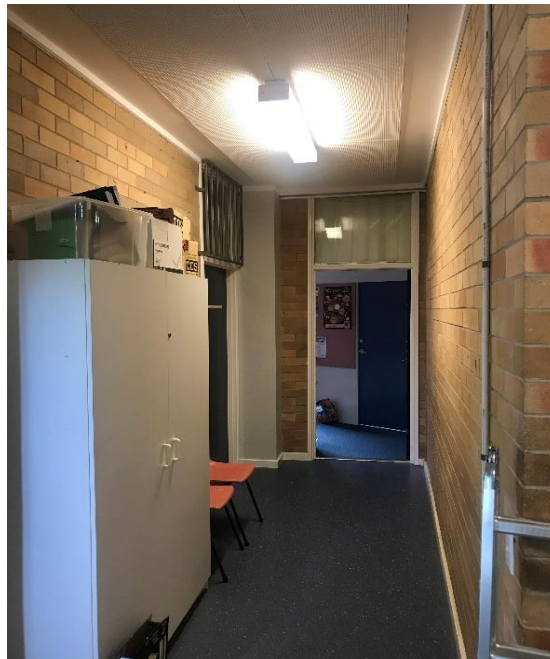
Photograph 14: B00L, LR1019, ceiling, top of perforated plaster tiles, insulation, SMF (assumed).

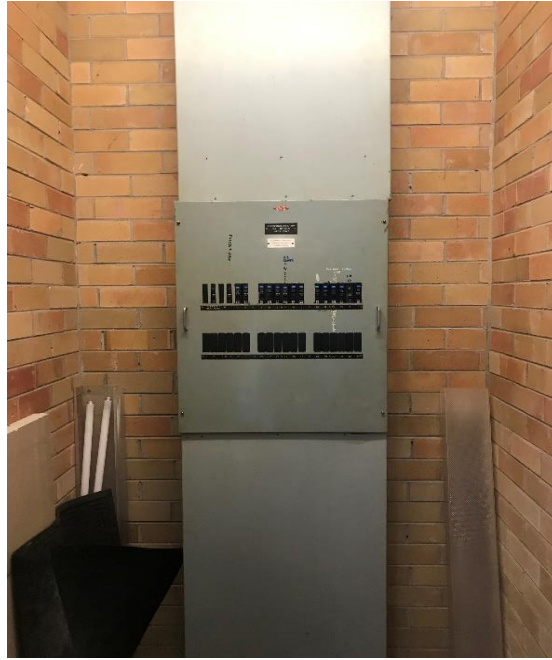
Photograph 19: B00L, LR1027 (adjacent west LR1028), enclosed within electrical cabinet, resinous backing board(s) and/or other components, asbestos (assumed).

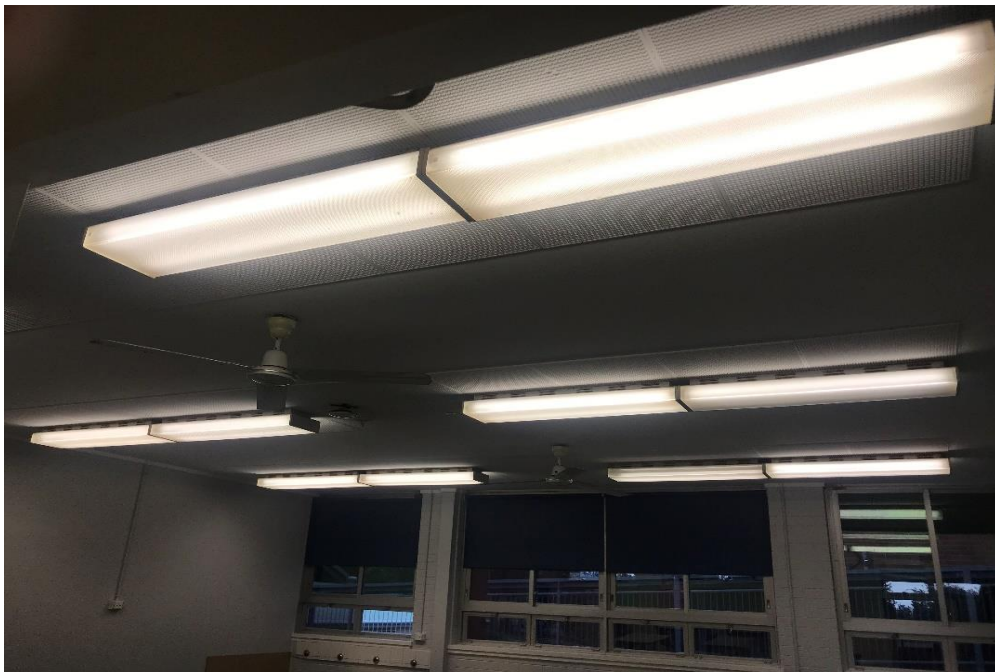
Photograph 22: B00L, rooms and areas in general, fluorescent light fittings in general, capacitors, insulating oil, PCB (assumed).

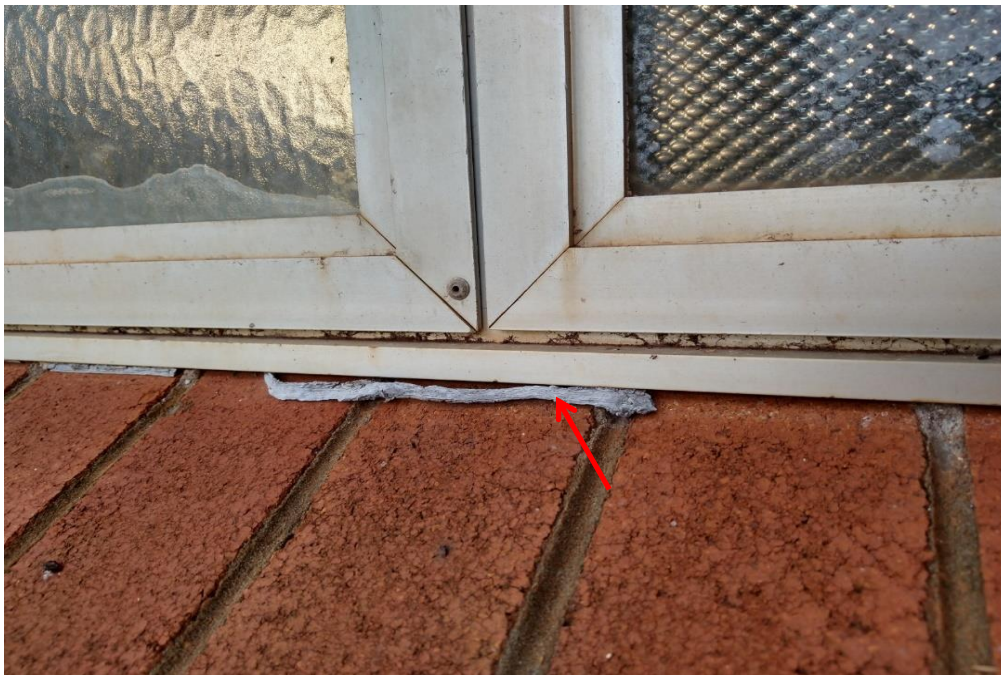
Photograph 4: B00T, exterior, window frames, putty/mastic, asbestos detected by analysis.

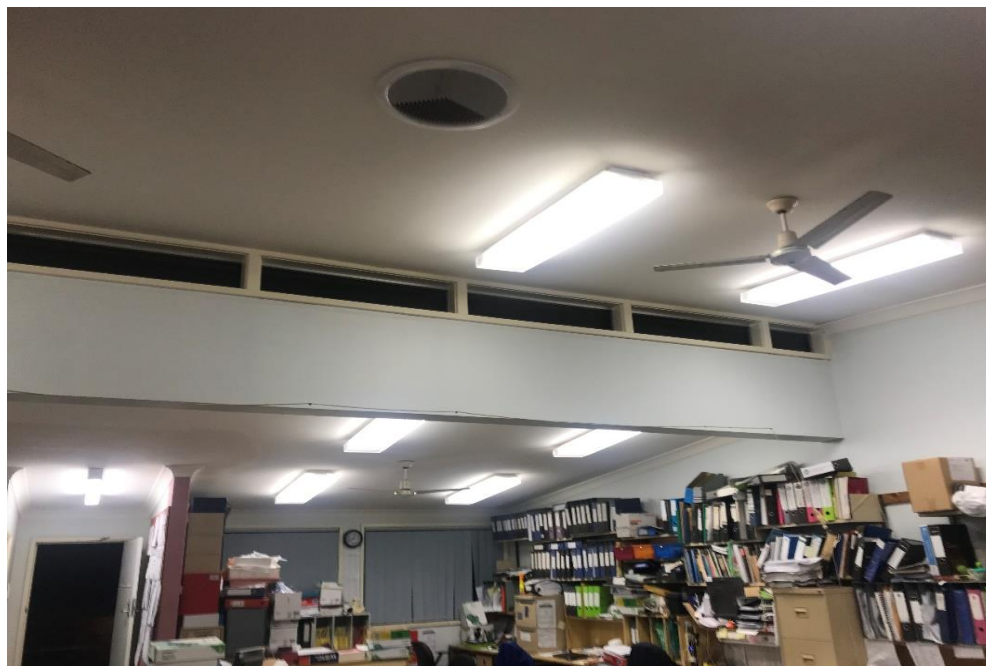
Photograph 6: BTAS, TAS-R0013, ceiling lining(s), fibre cement, asbestos detected by analysis.
