The following inspection is of the kerb, gutter and road surface to the north side of Aquatic Drive starting at number 4 – 6 Aquatic Drive, heading east and finishing at the roundabout at the intersection of Aquatic Drive and Allambie Road.

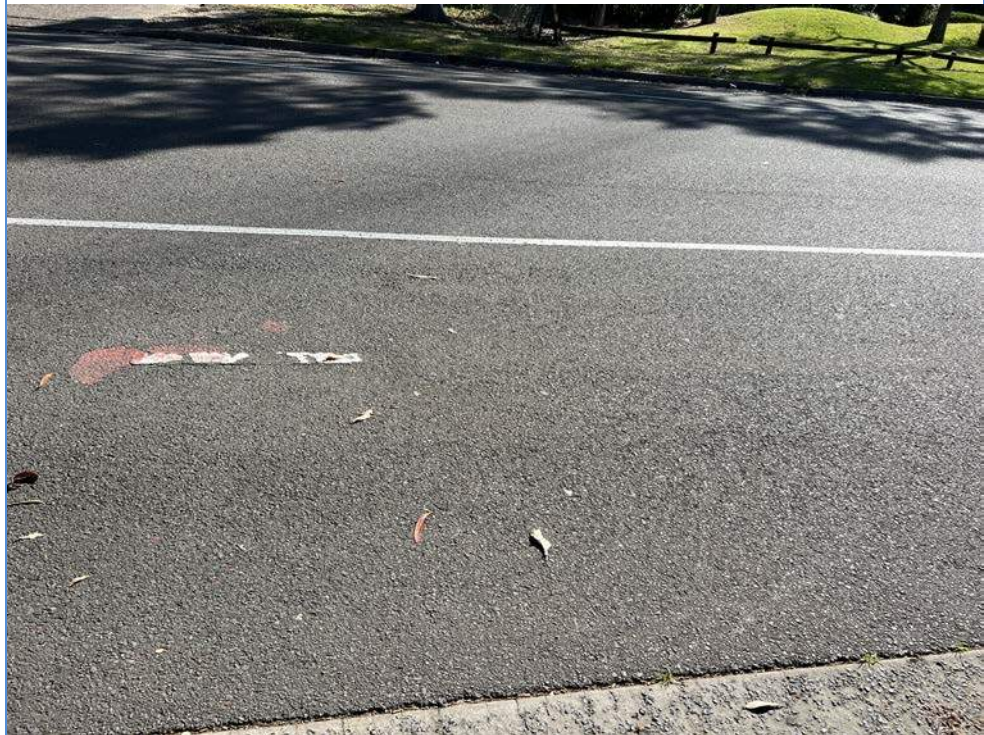
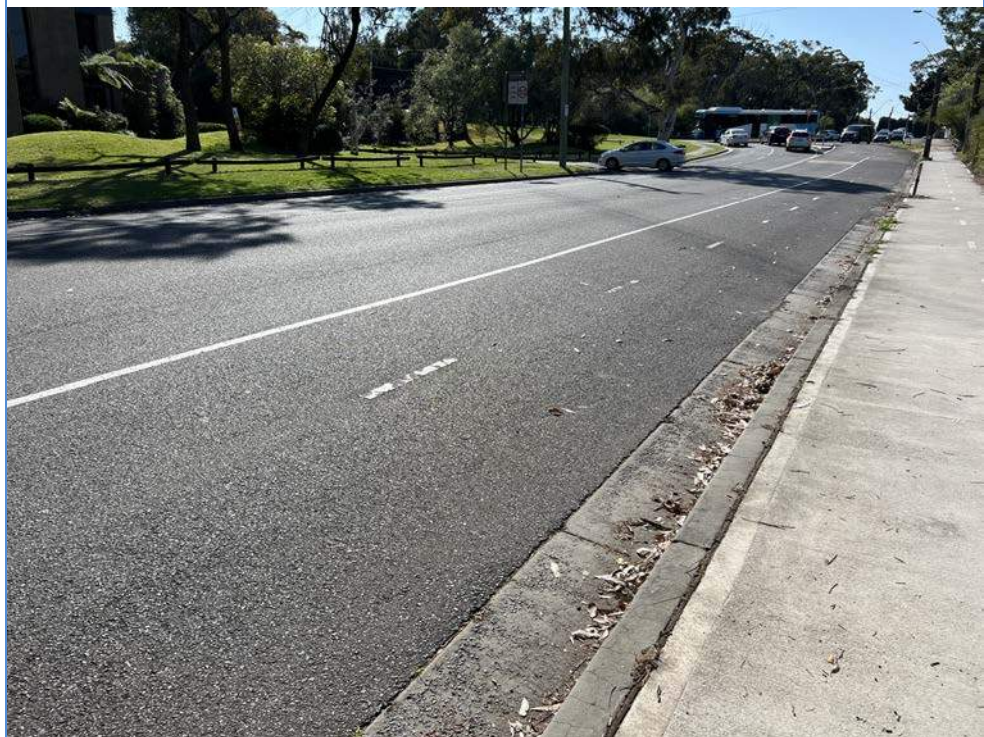
90m

General views of the road surface.

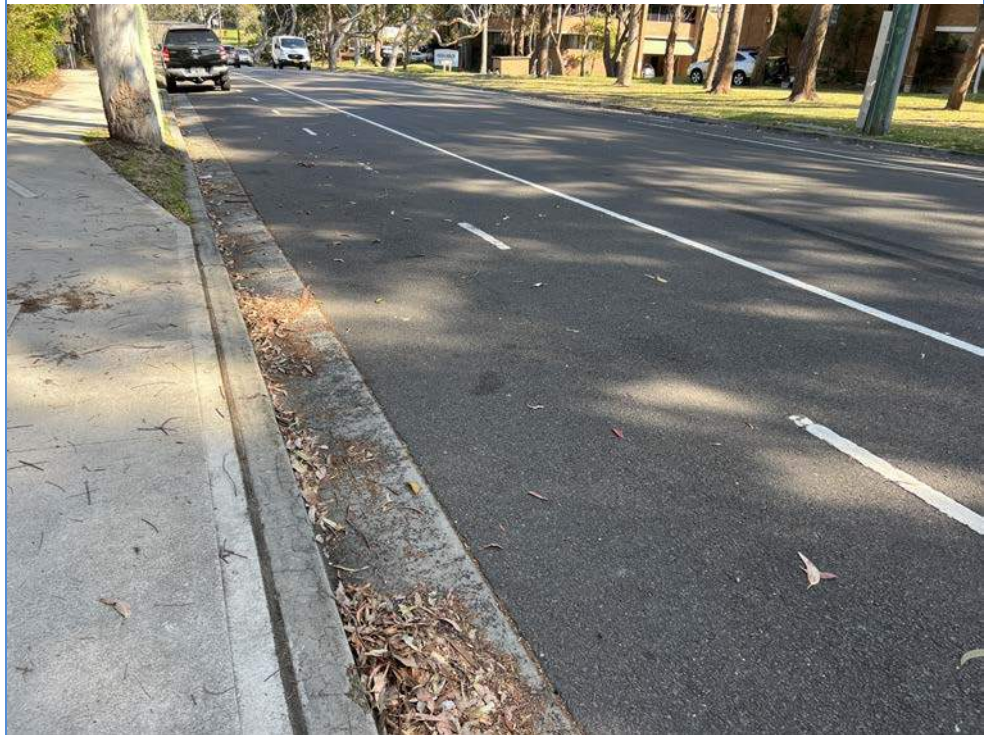
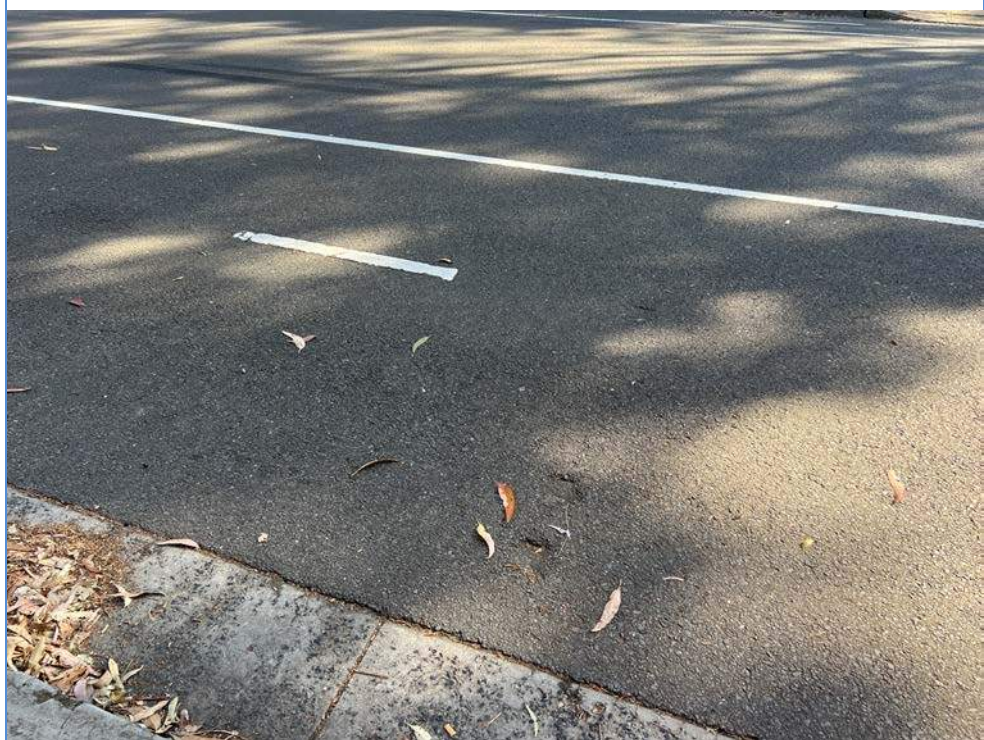
100m

General views of the road surface.

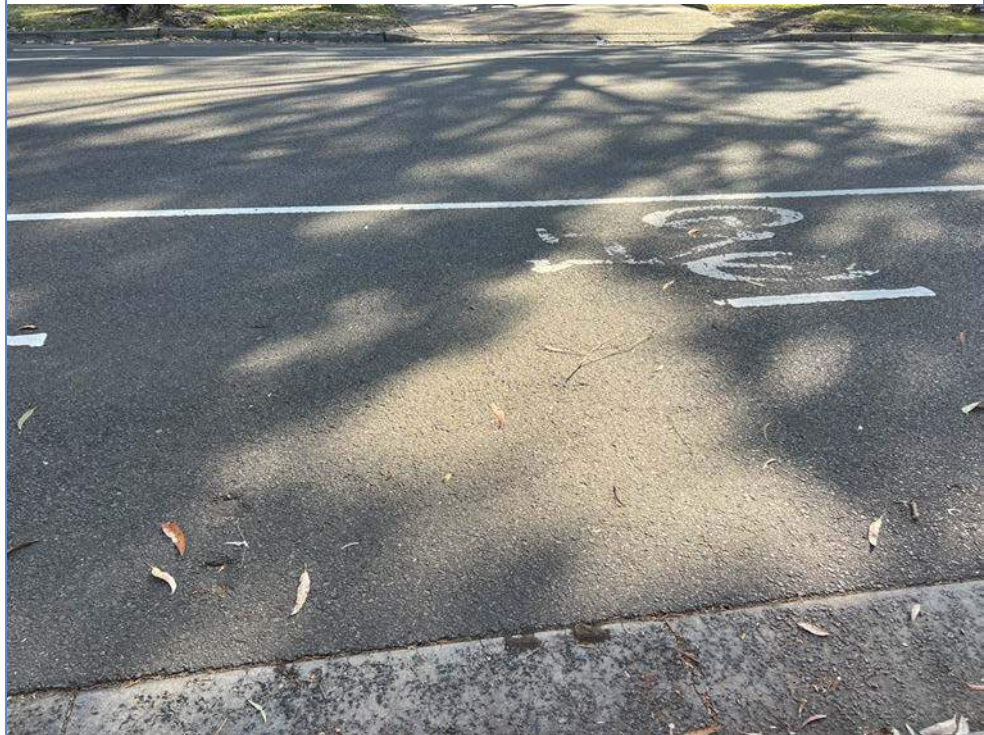
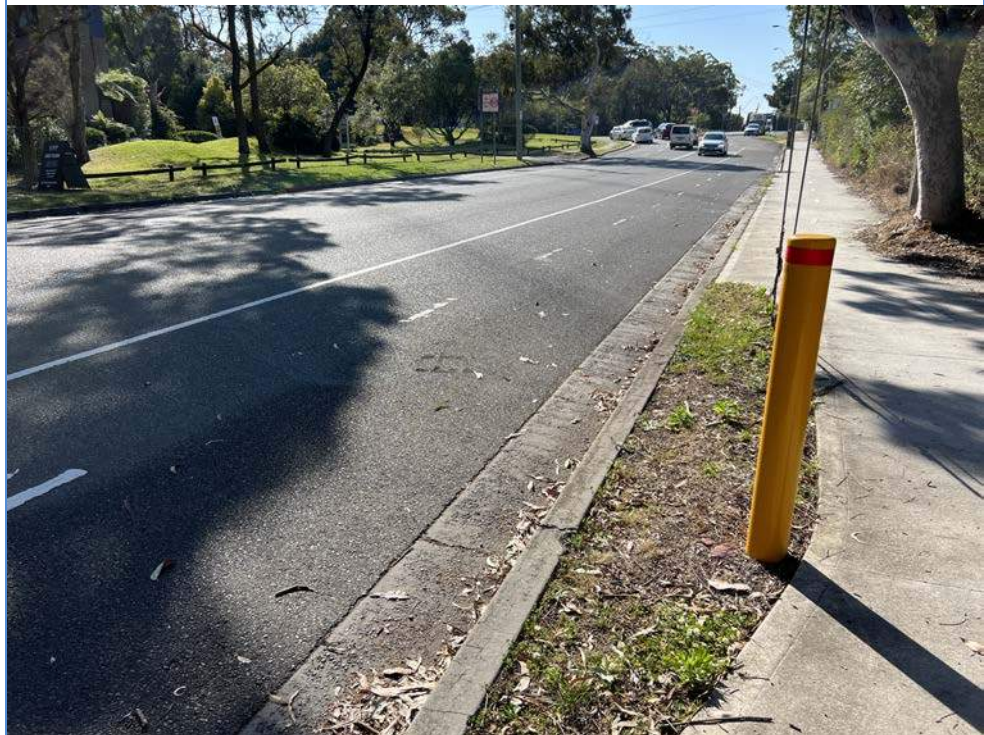
100m

General views of the road surface.

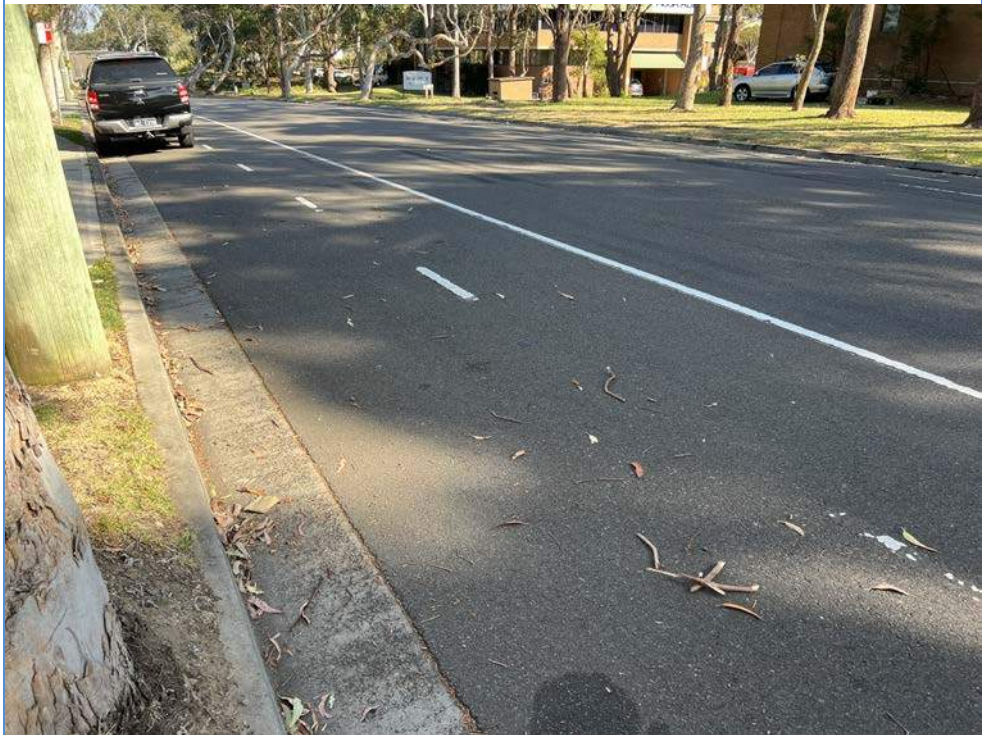
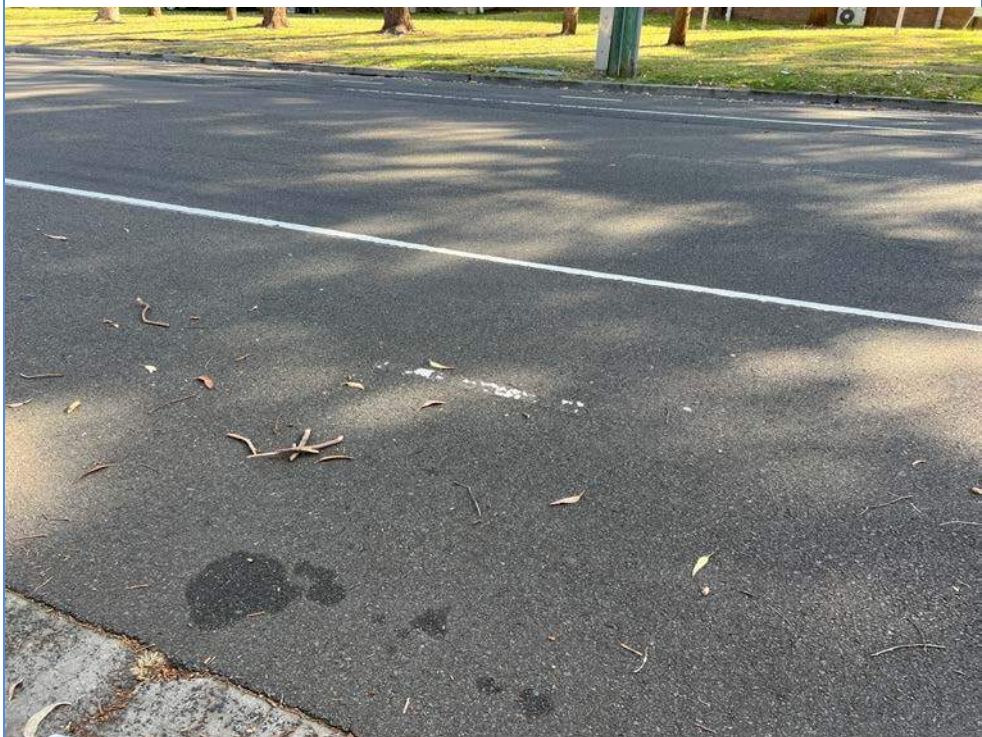
110m

General views of the road surface.

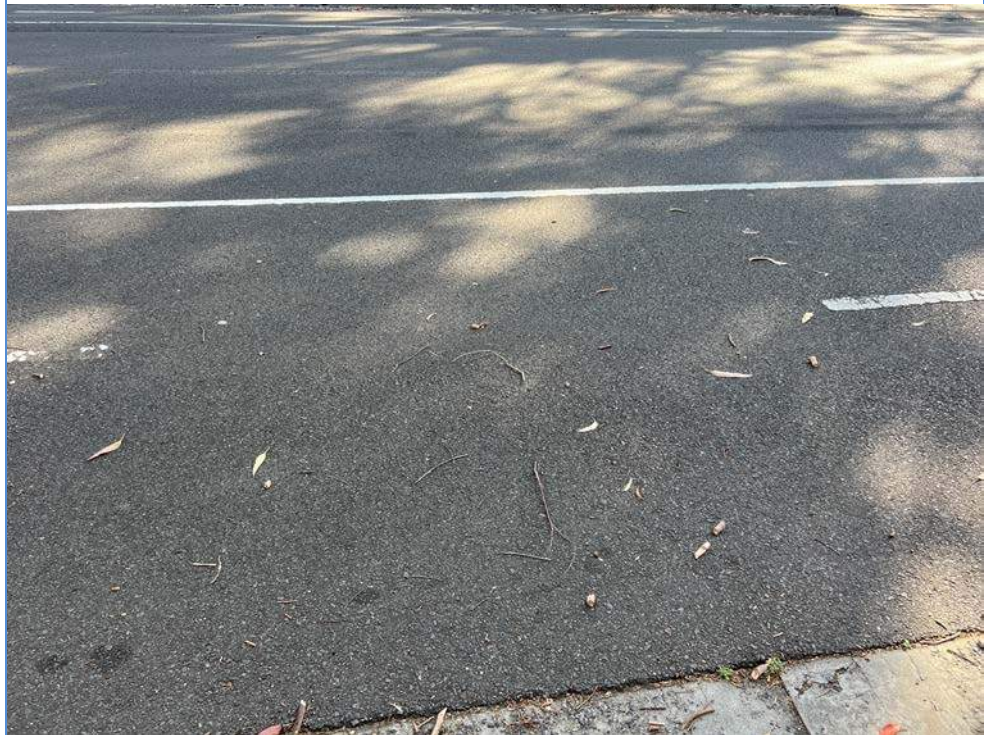
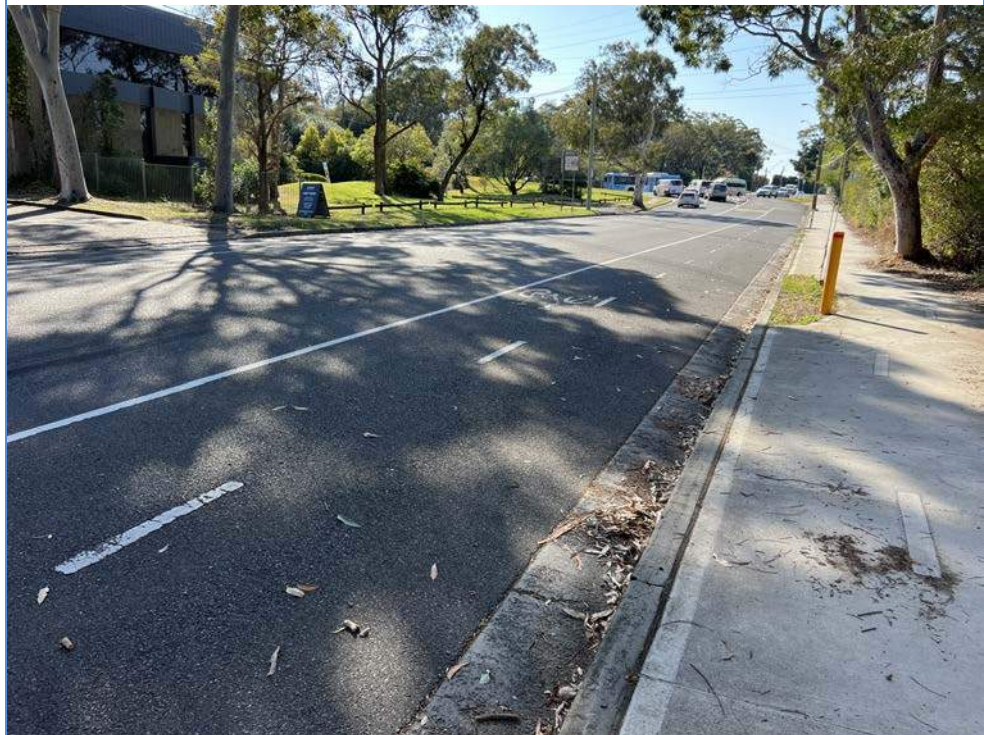
110m

General views of the road surface.

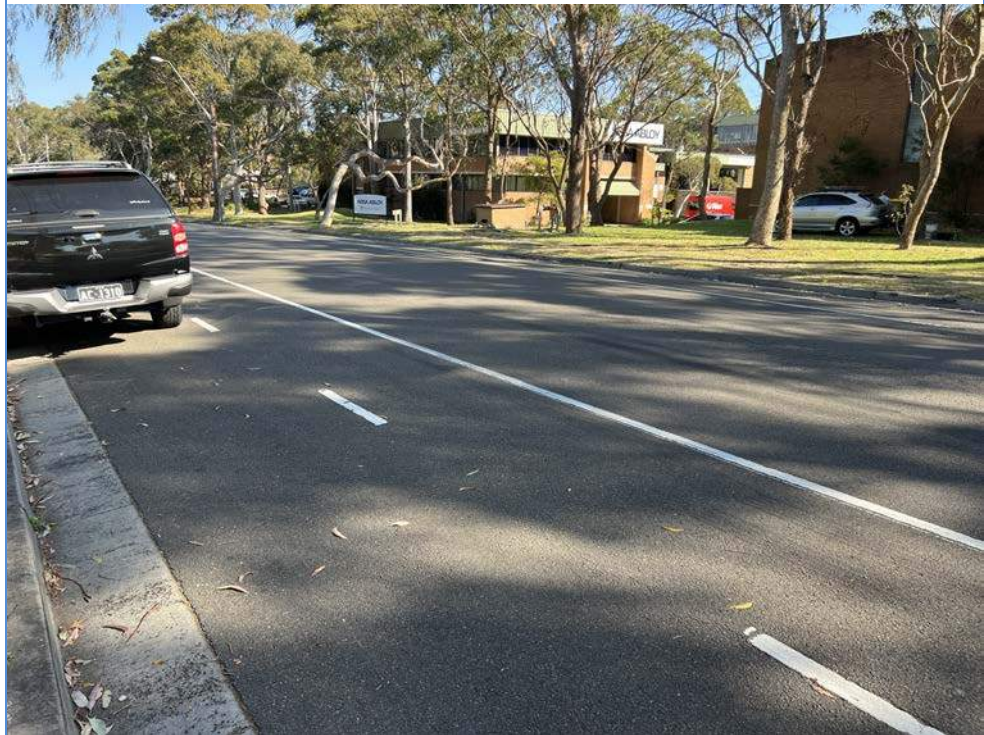
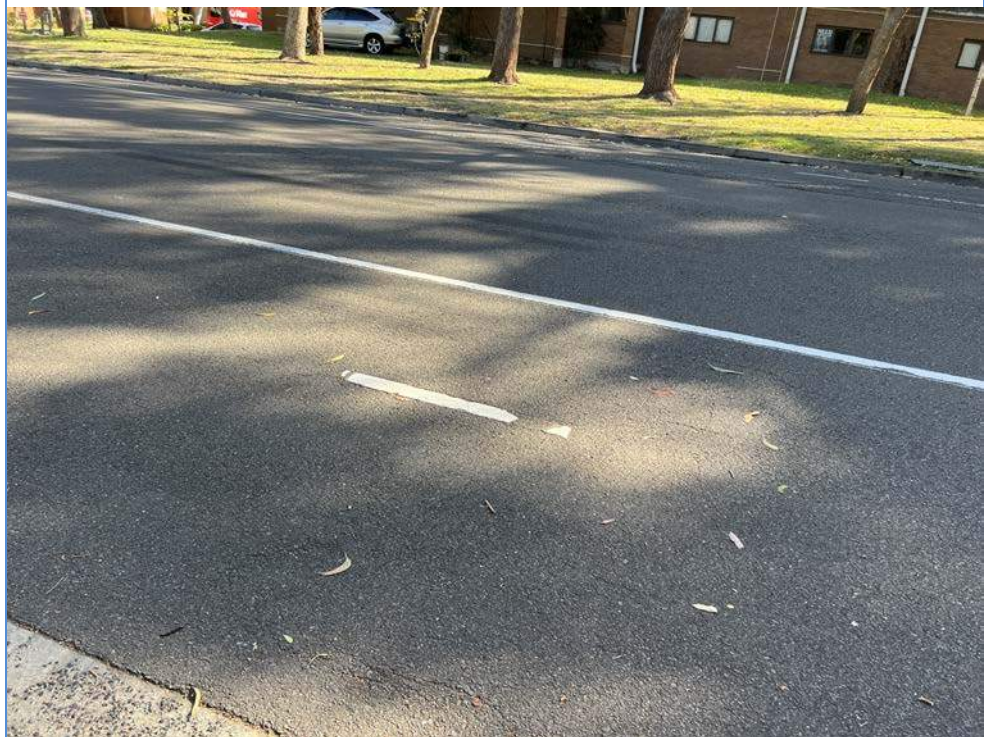
120m

General views of the road surface.

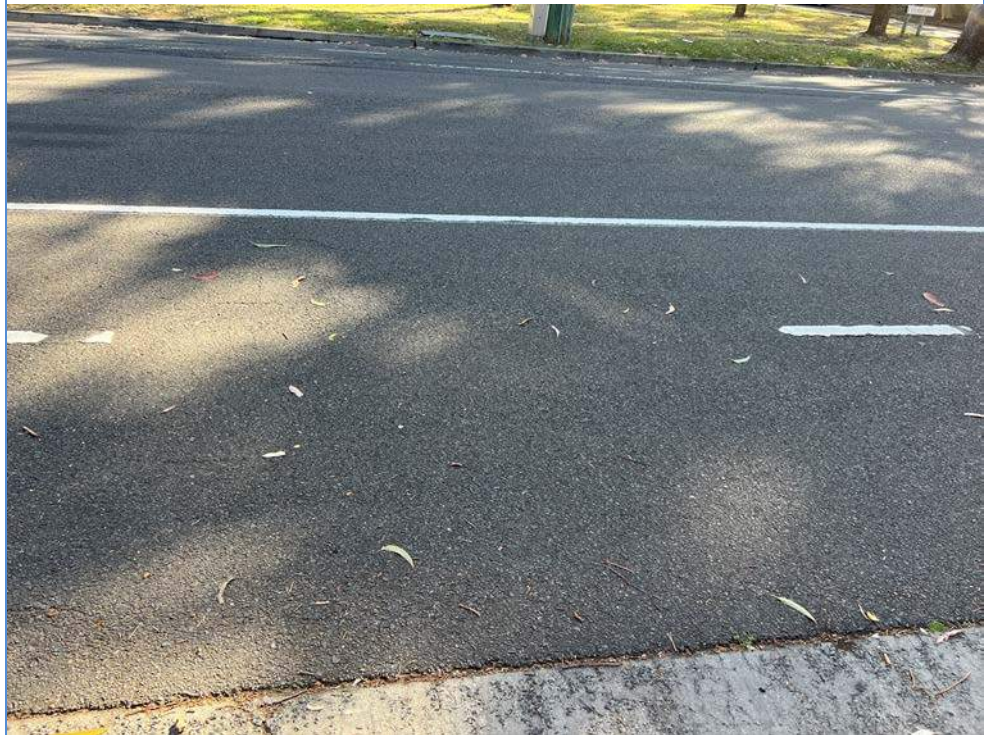
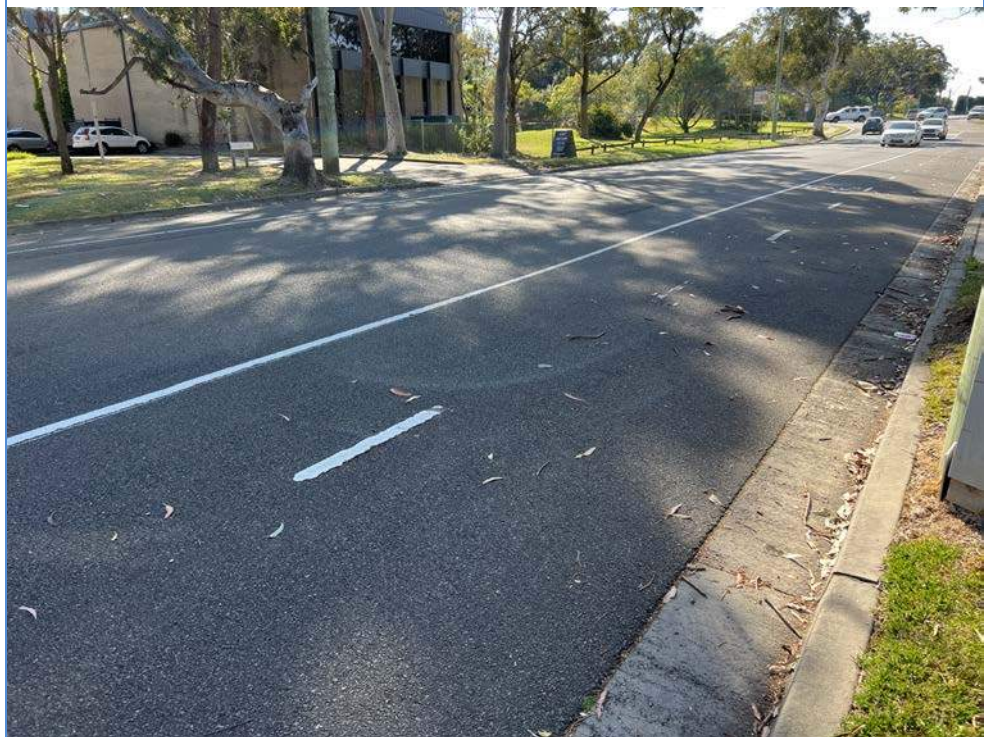
120m

General views of the road surface.

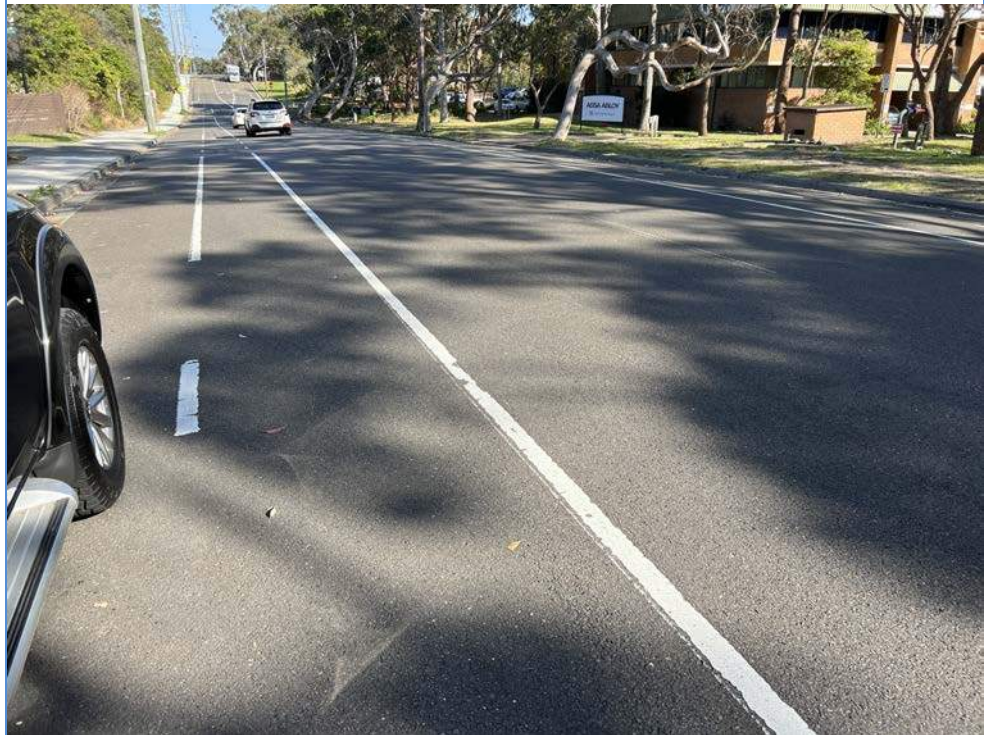
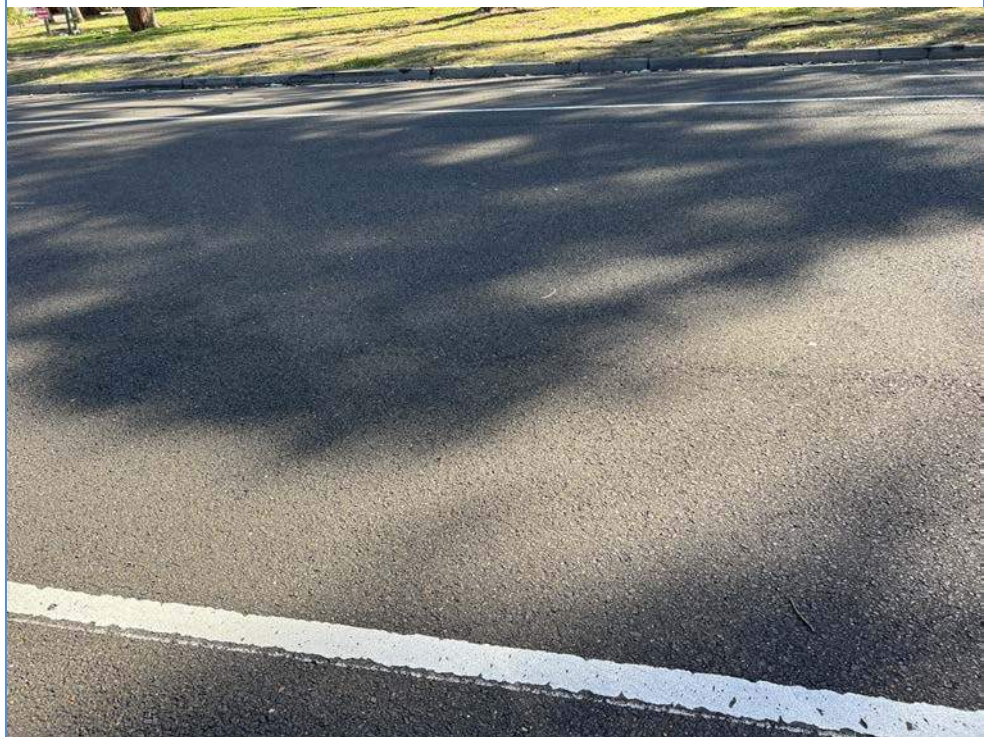
130m

General views of the road surface.

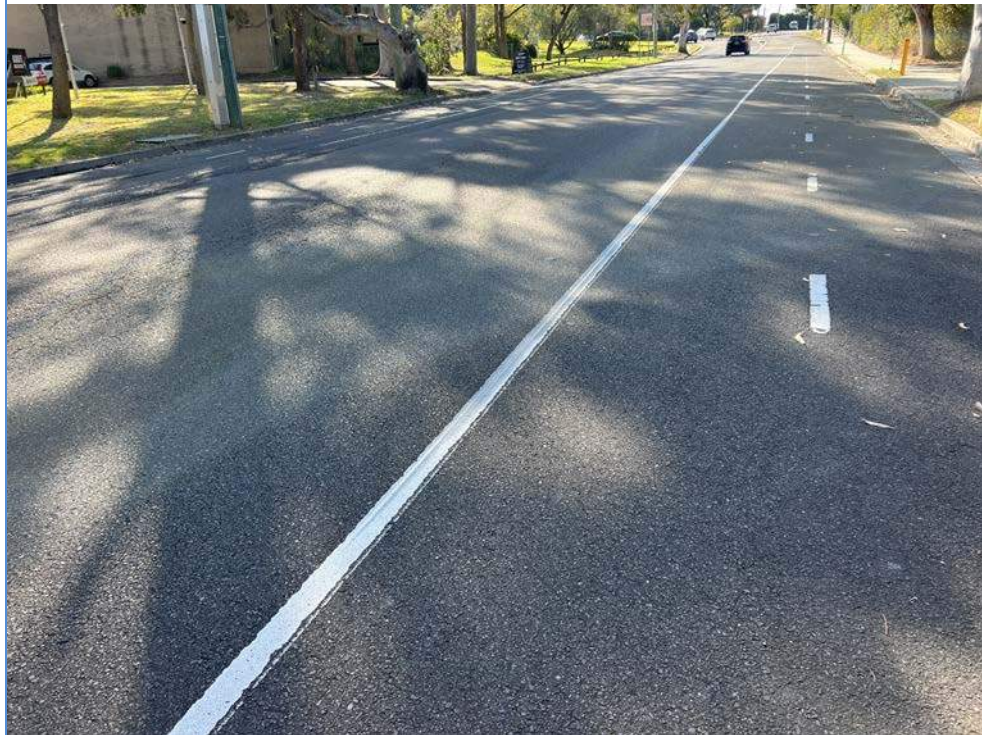
130m

General views of the road surface.

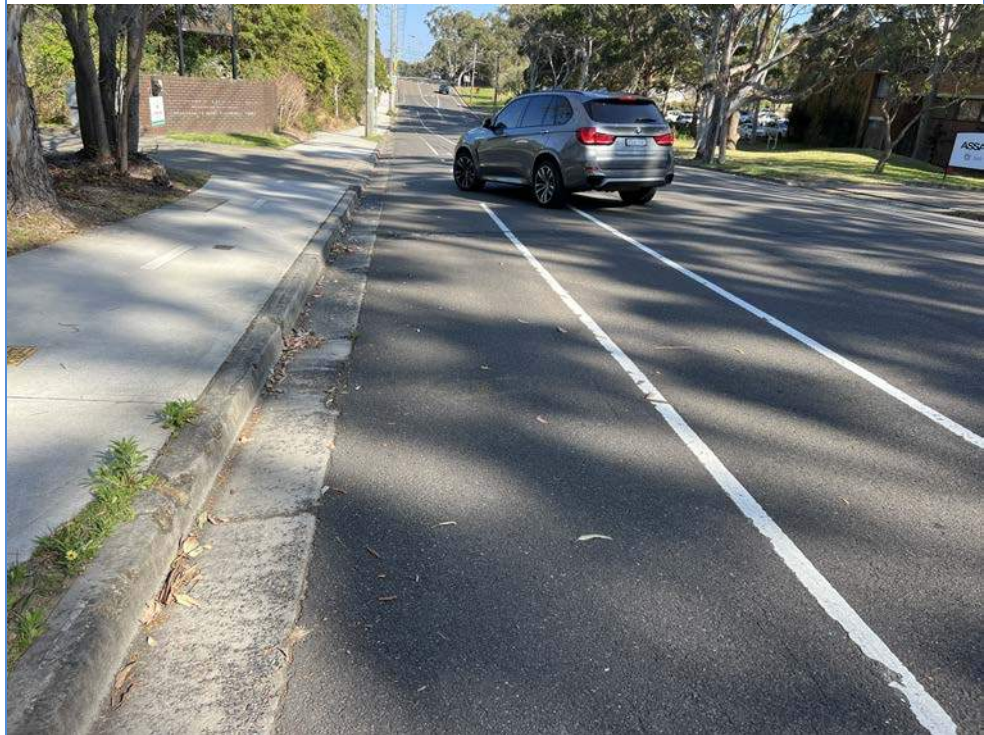
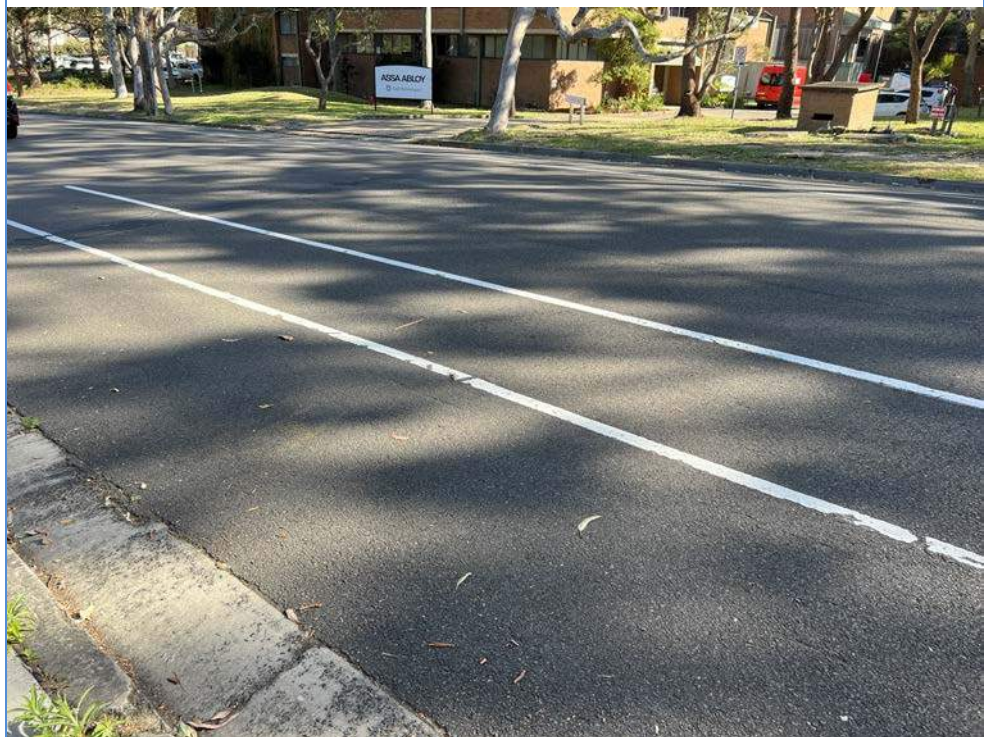
140m

General views of the road surface.

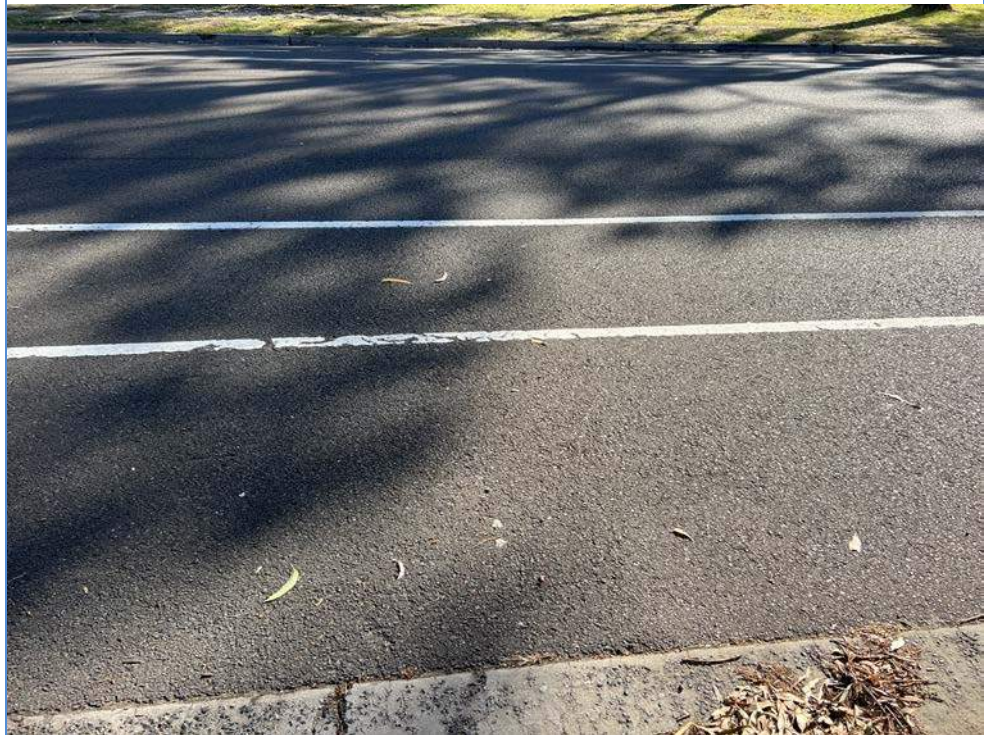
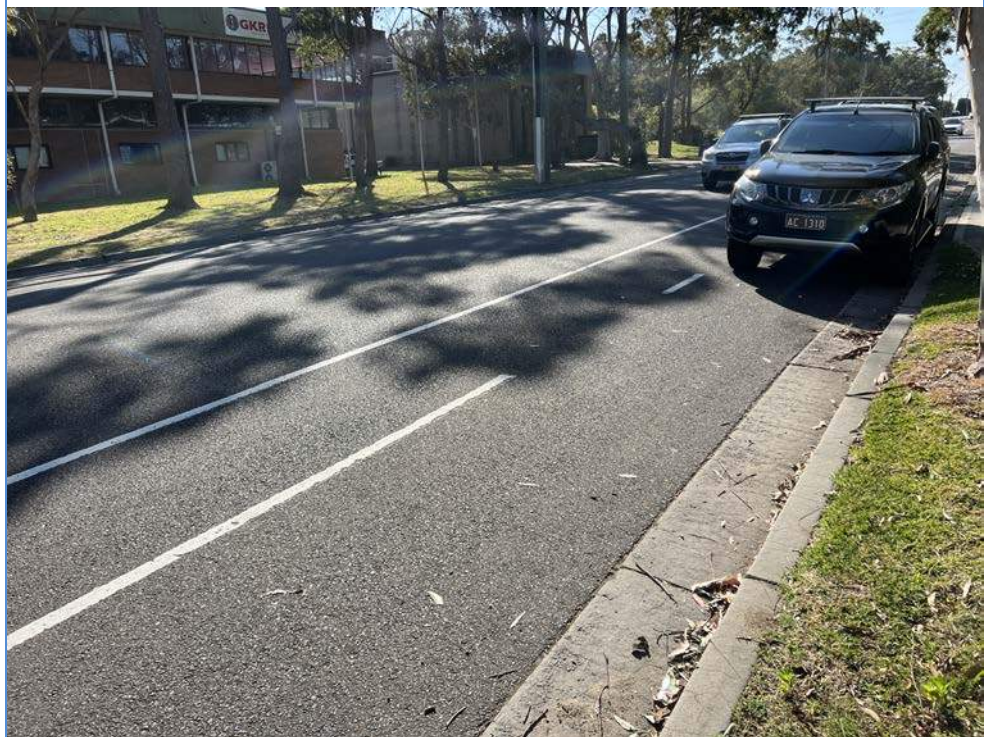
140m

General views of the road surface.

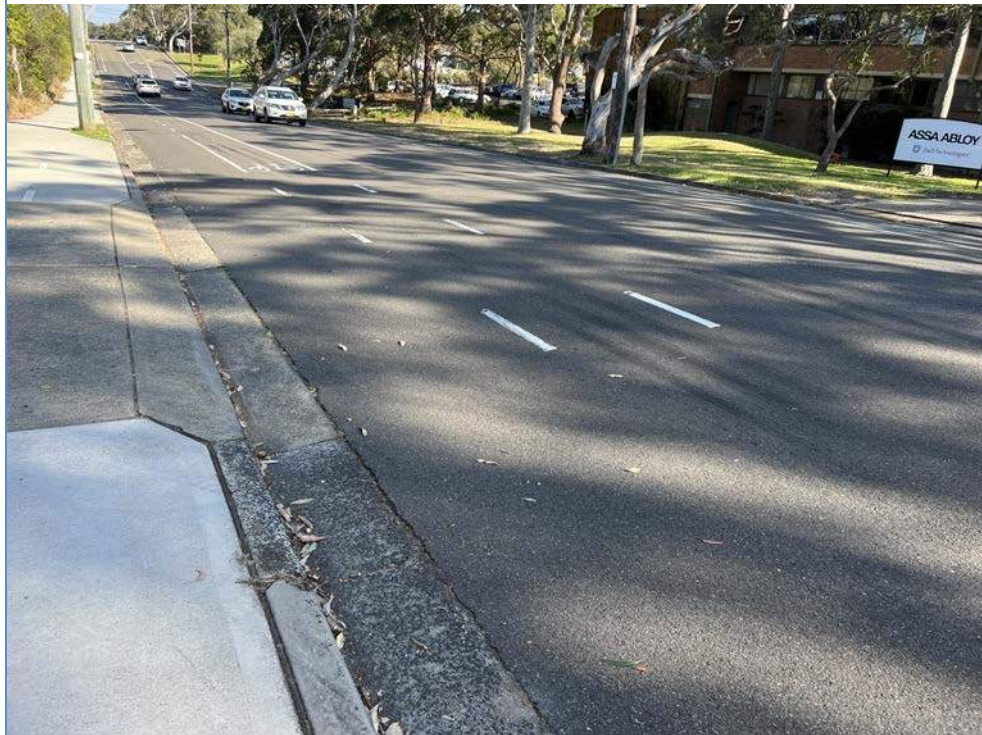
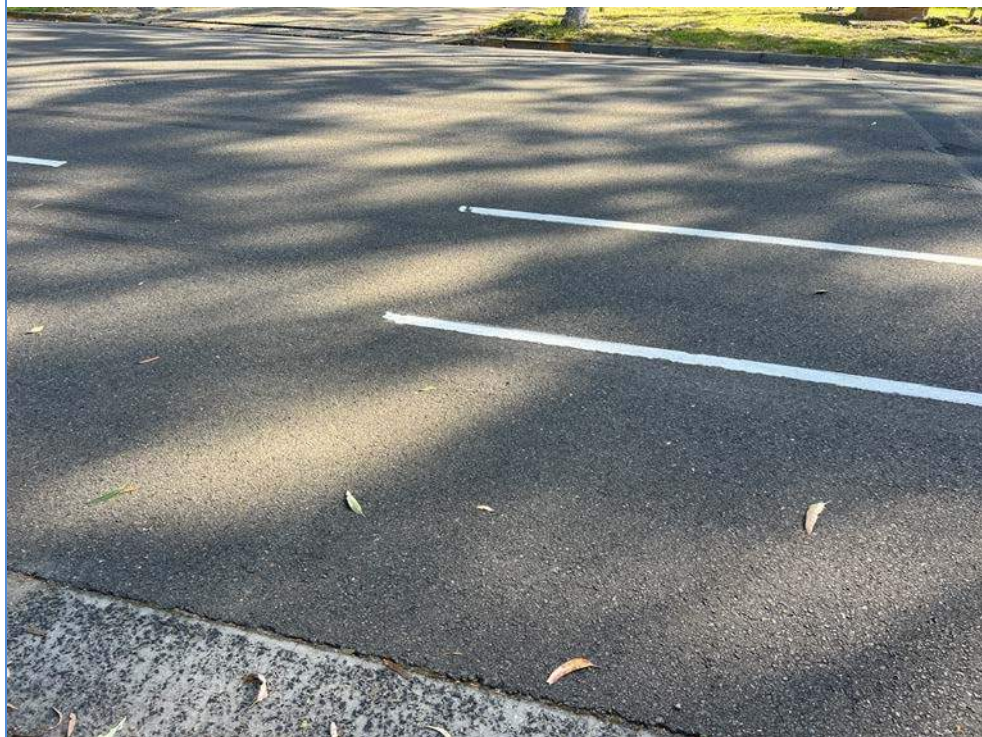
150m

General views of the road surface.

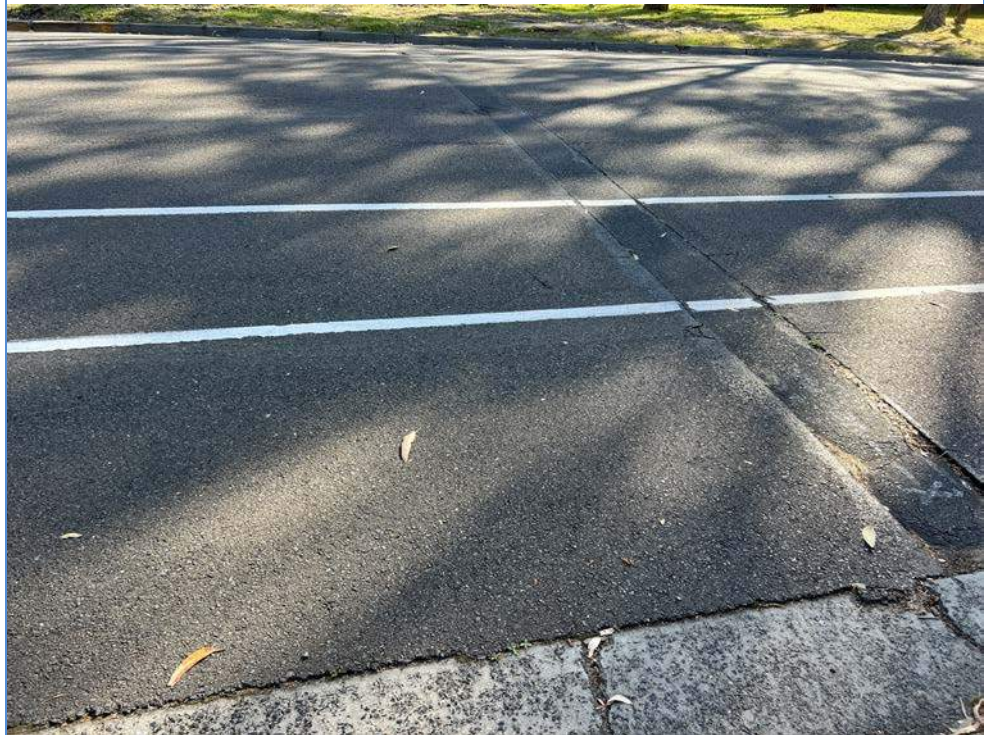
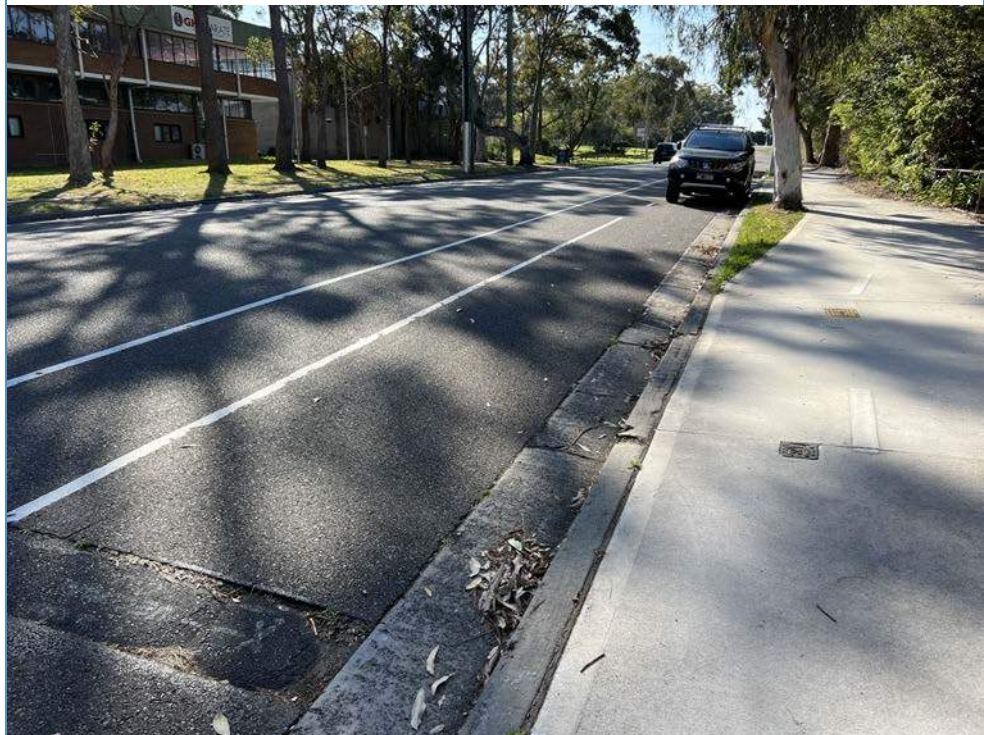
150m

General views of the road surface.

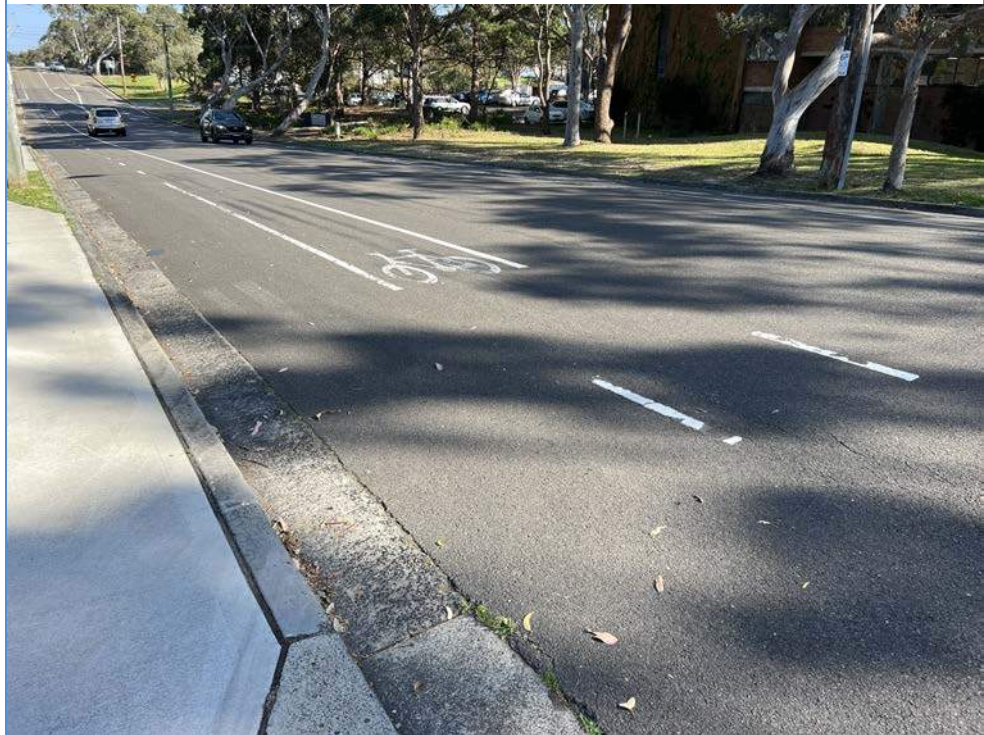
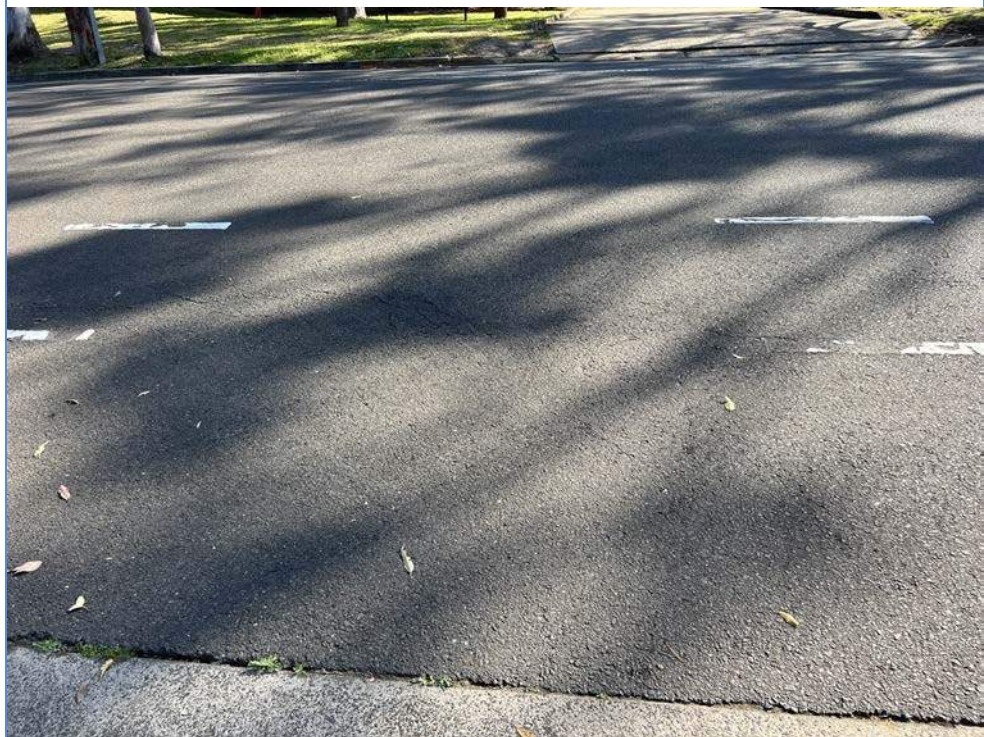
160m

General views of the road surface at the end point.

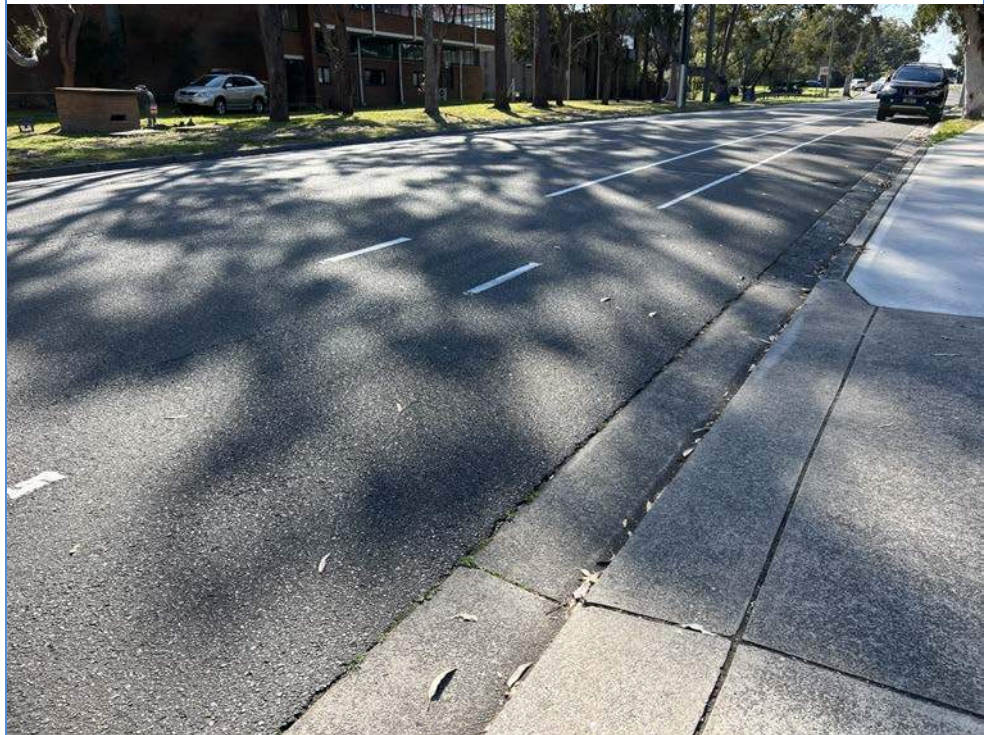
160m

General views of the road surface at the end point.

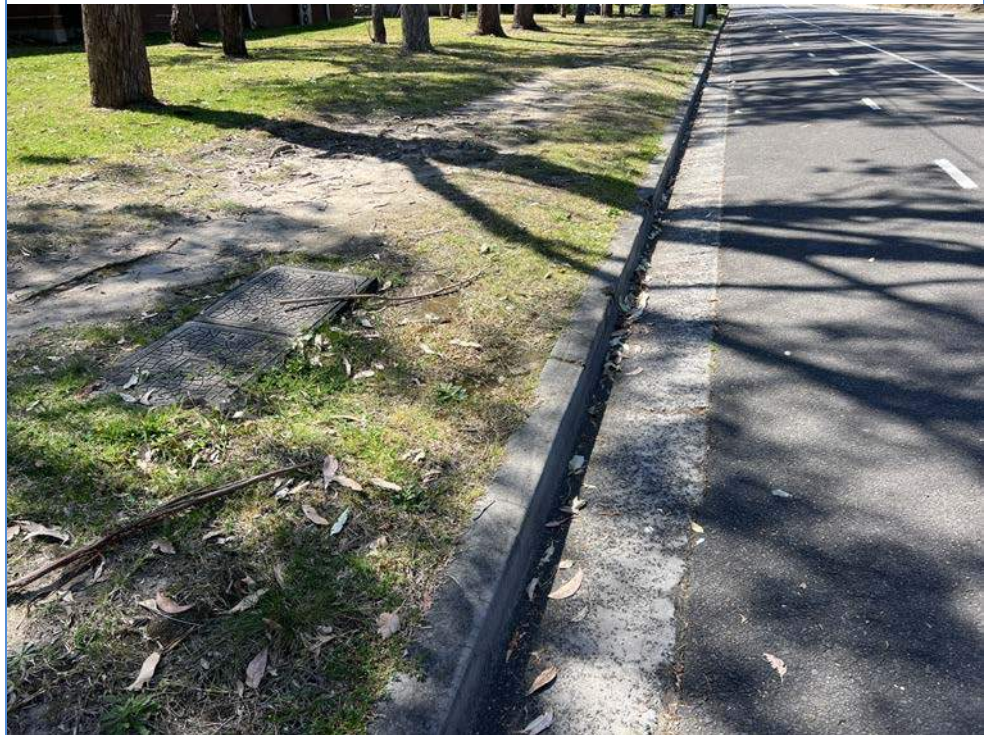
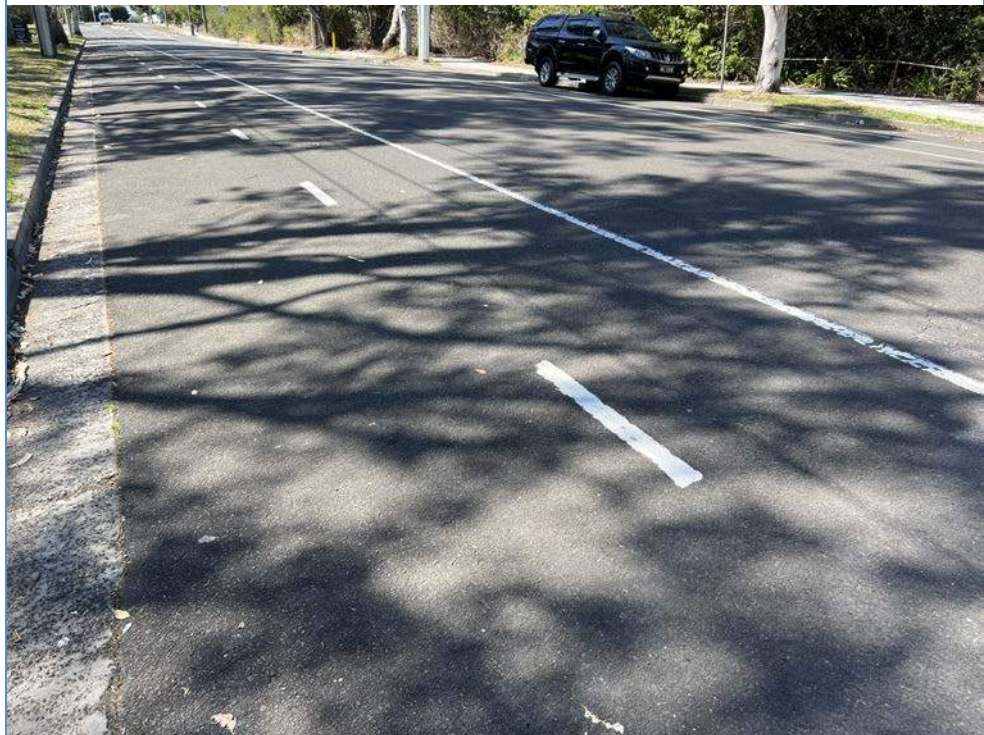
15m

General views of the kerb, gutter and road surface.

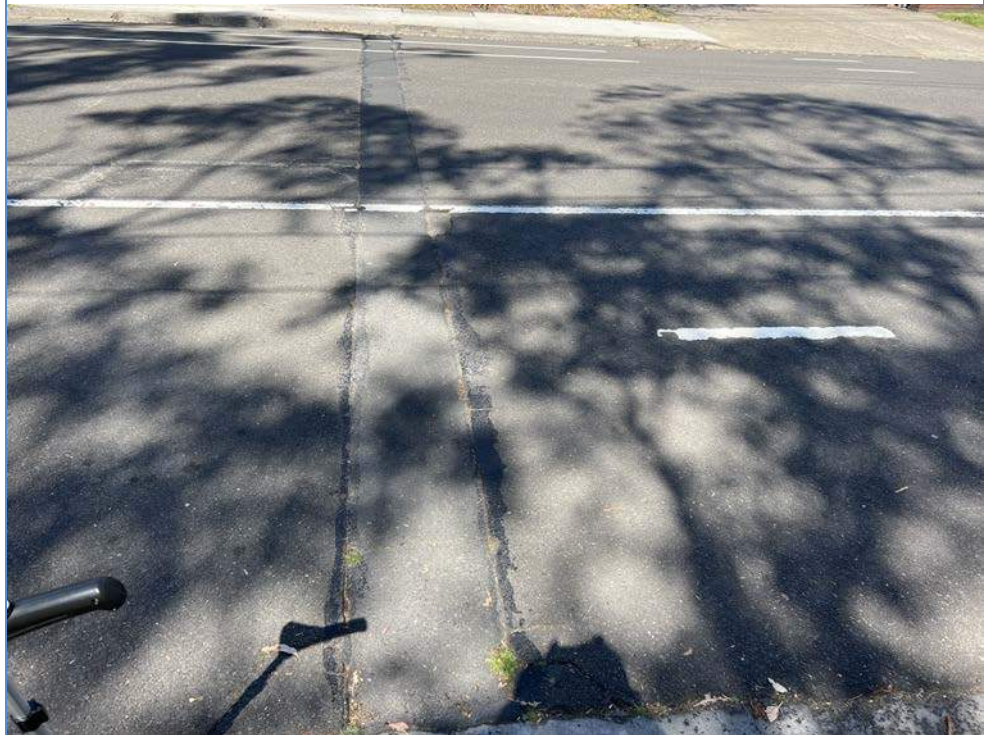
15m

General views of the kerb, gutter and road surface.
