The following inspection is of the kerb, gutter and road surface to the north side of Aquatic Drive starting at number 4 – 6 Aquatic Drive, heading east and finishing at the roundabout at the intersection of Aquatic Drive and Allambie Road.

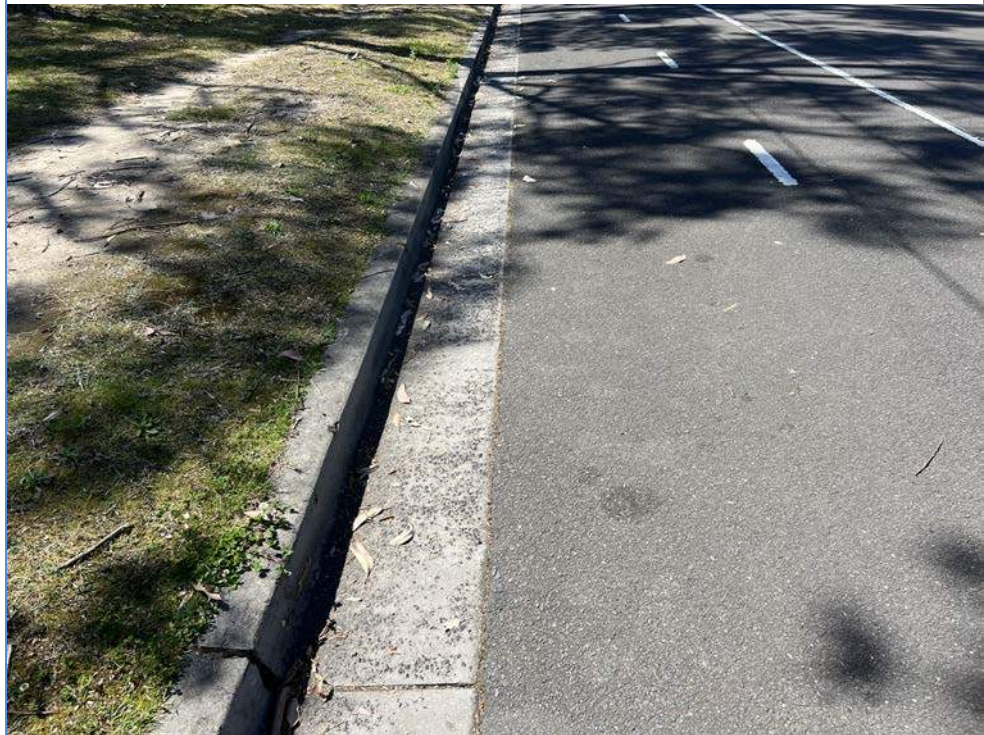
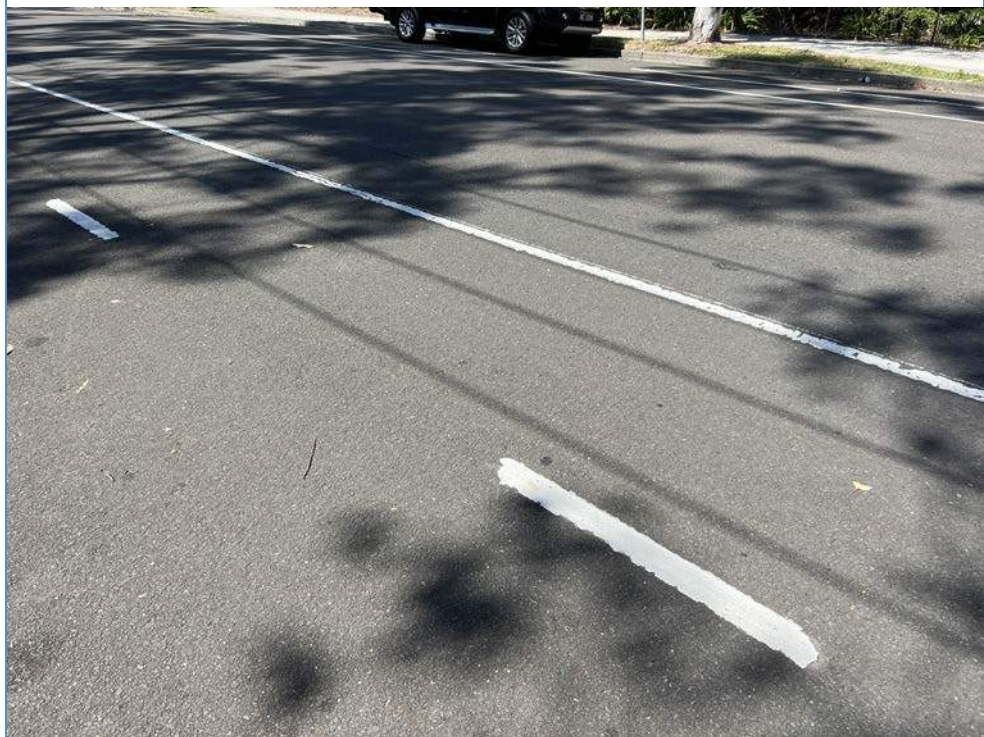
20m

General views of the kerb, gutter and road surface.

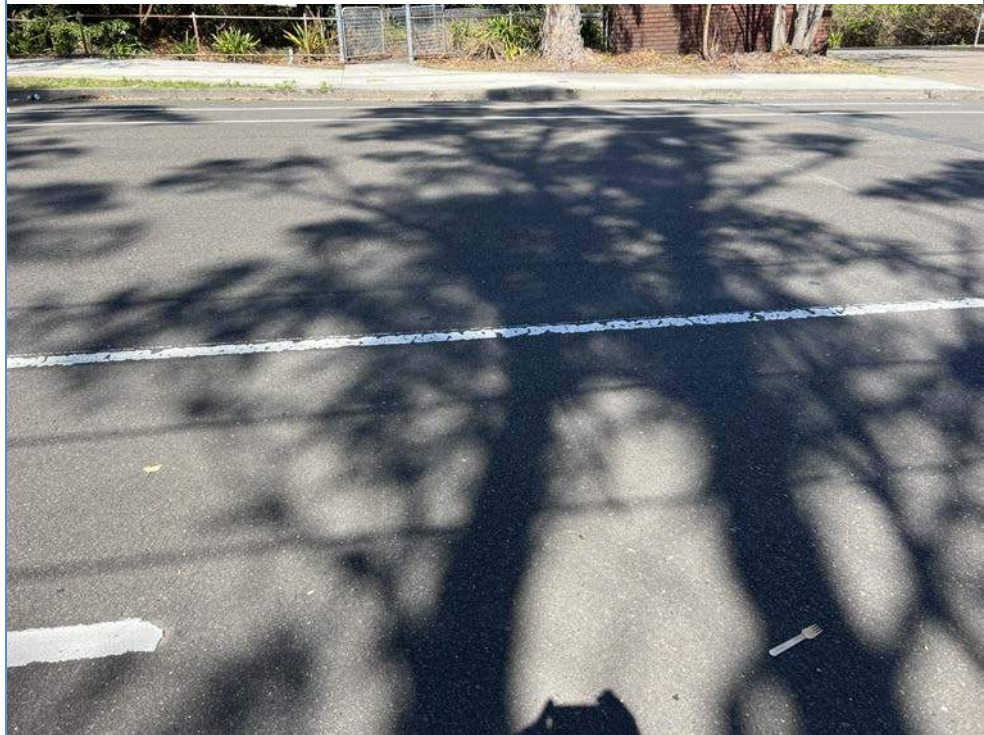
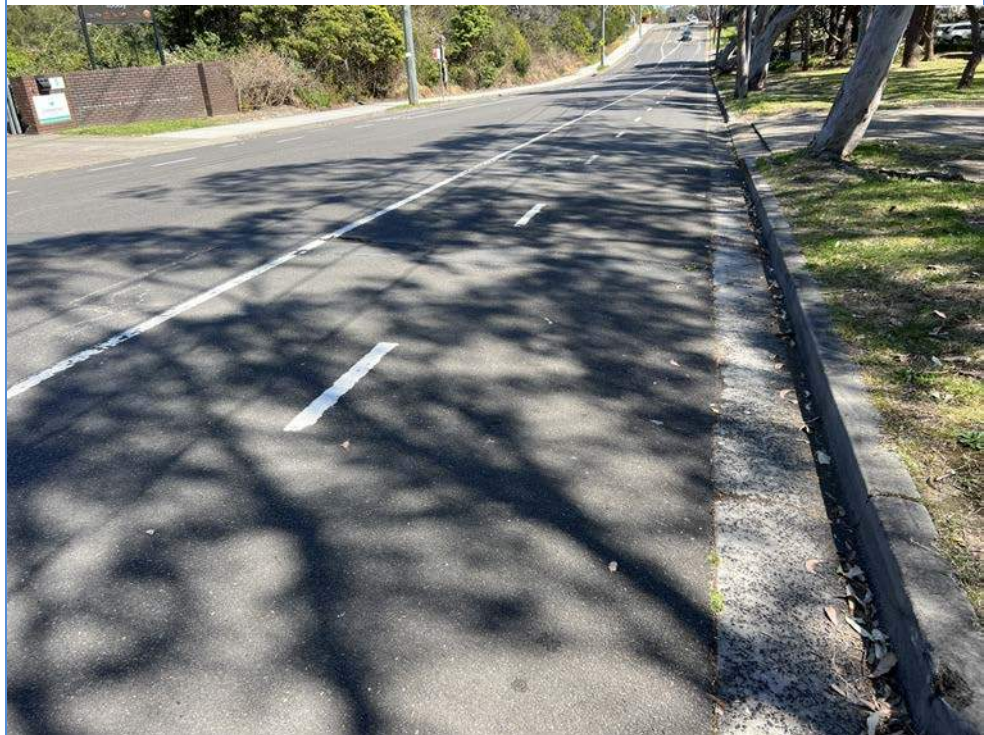
20m

General views of the kerb, gutter and road surface.

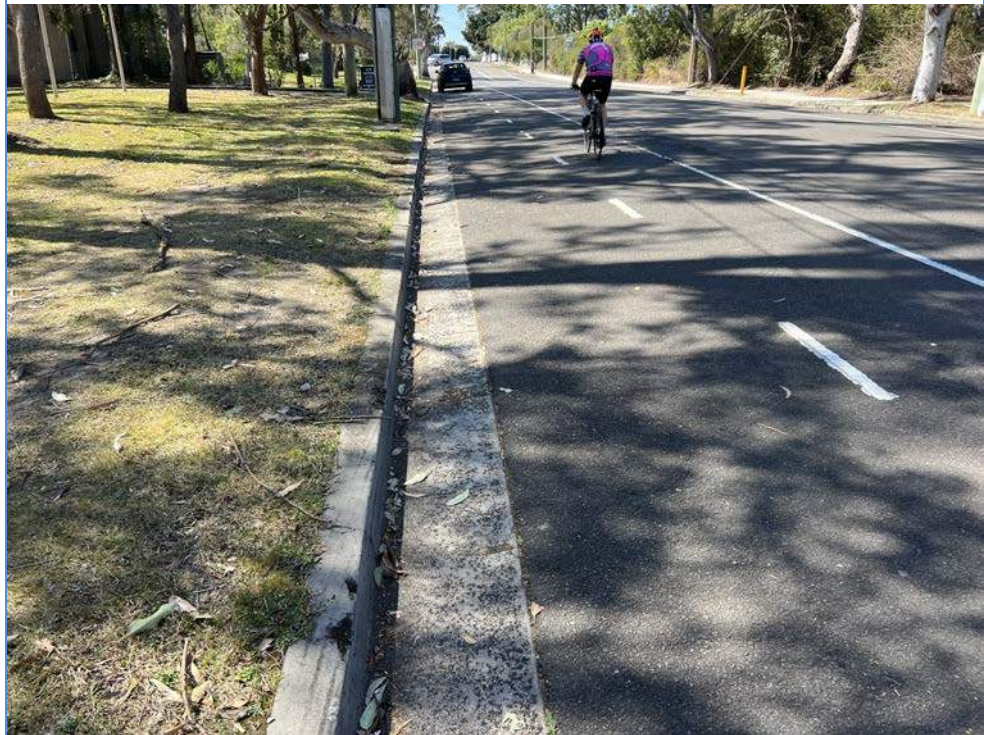
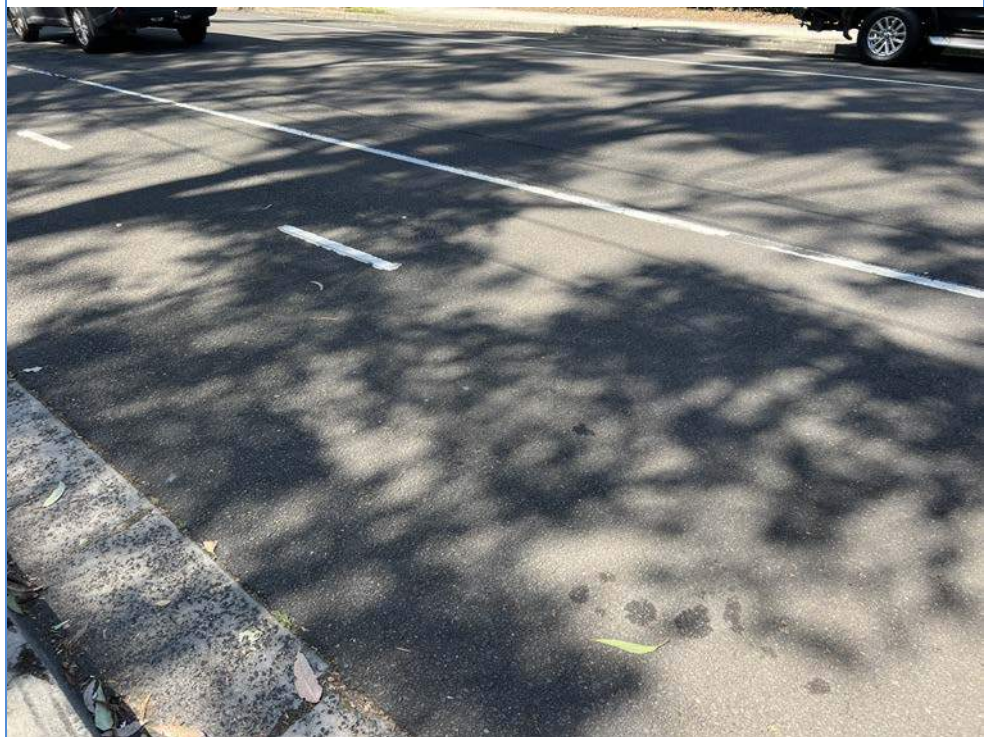
30m

General views of the kerb, gutter and road surface.

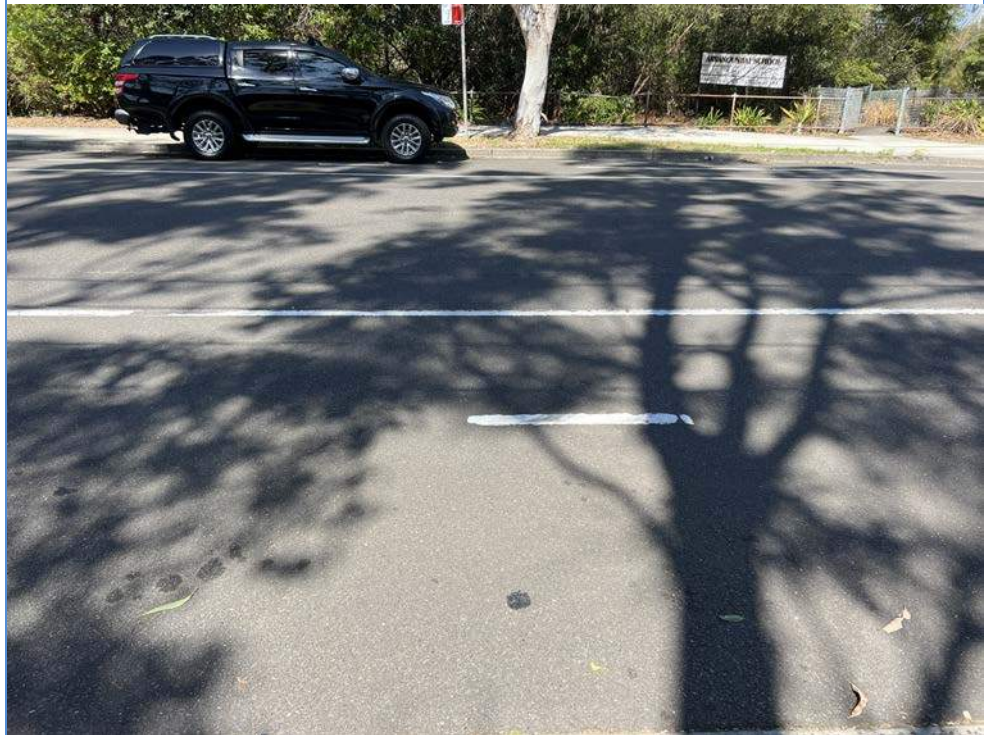
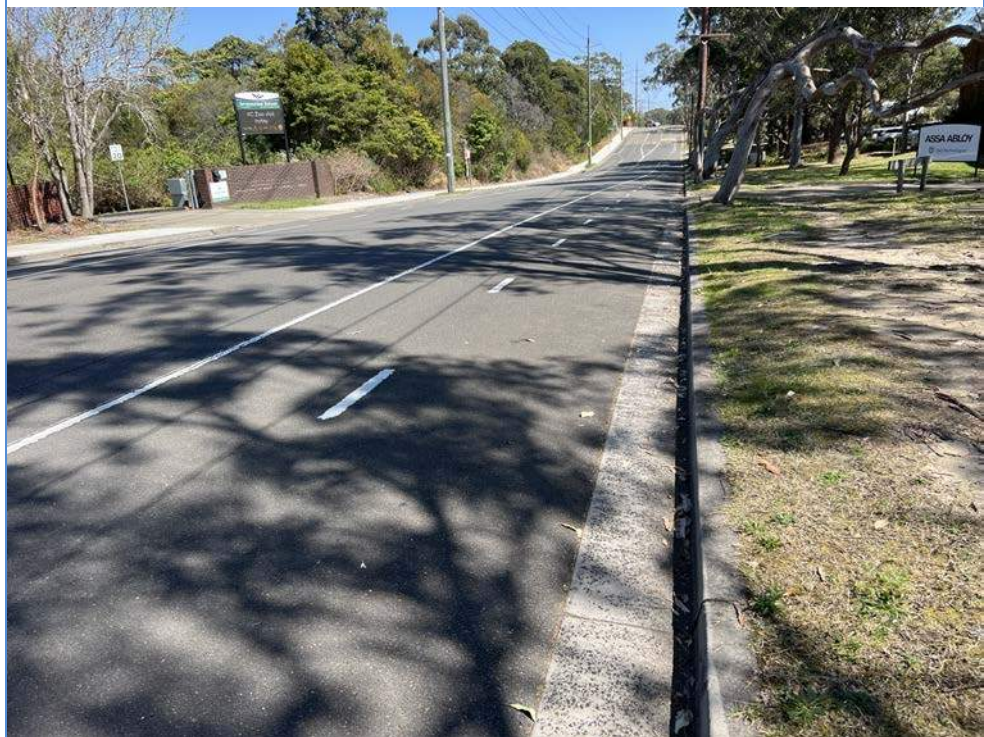
30m

General views of the kerb, gutter and road surface.

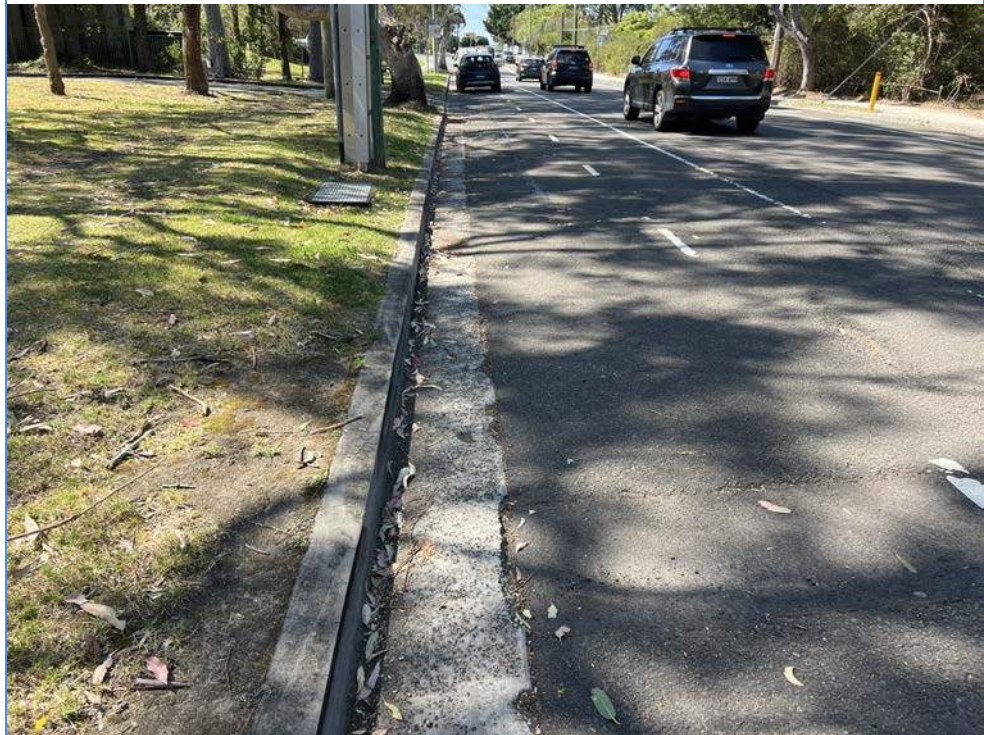
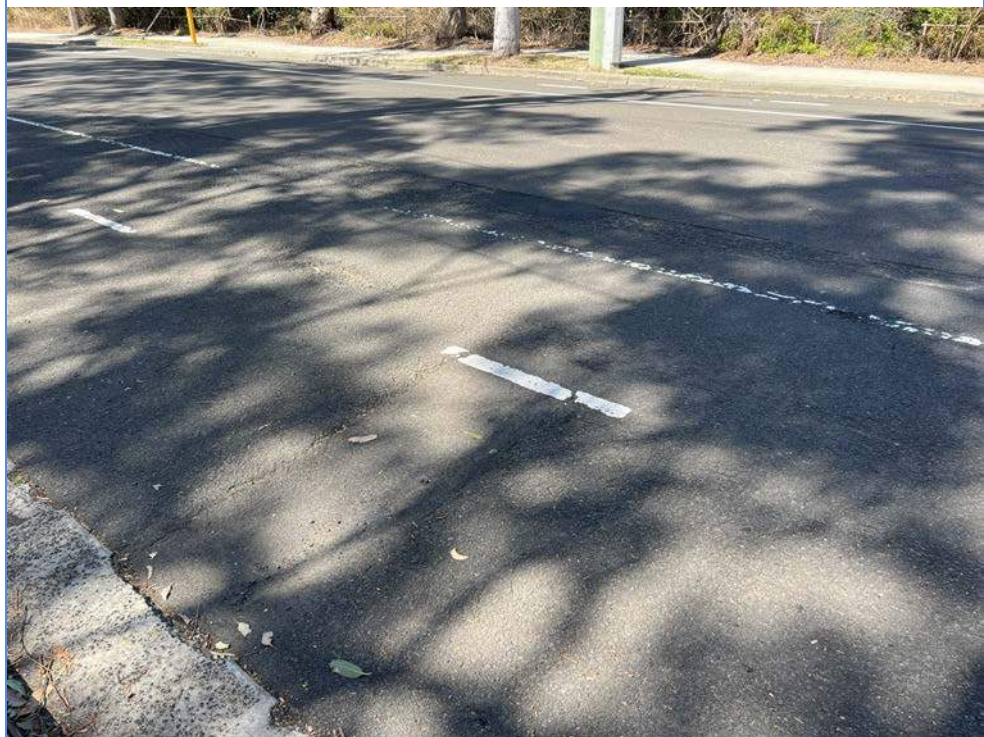
40m

General views of the kerb, gutter and road surface.

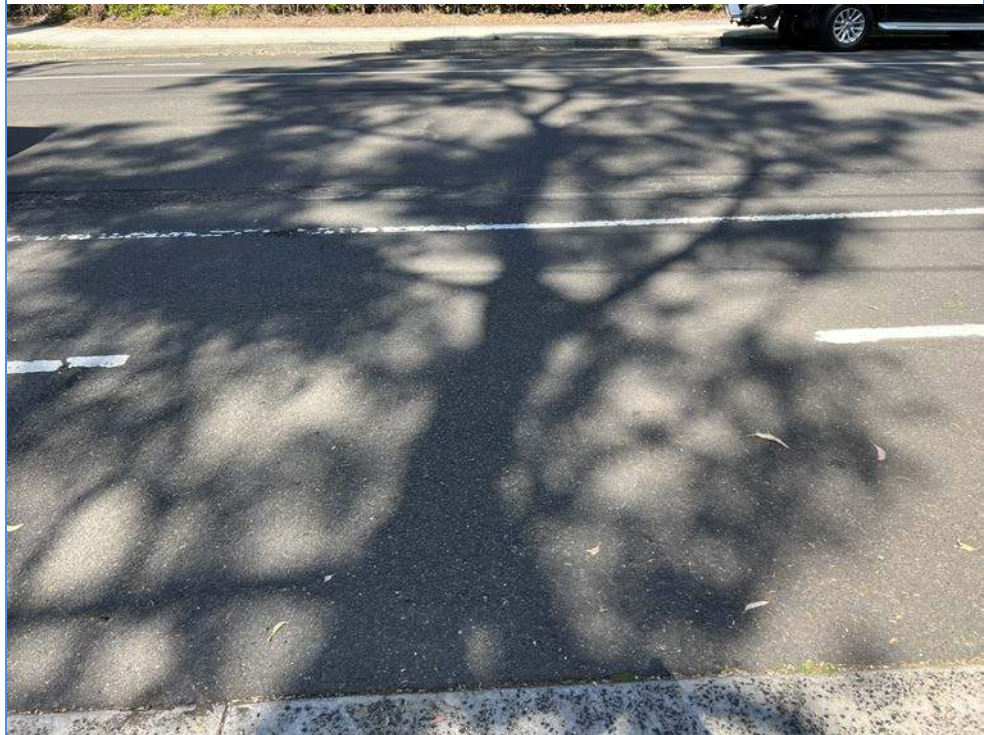
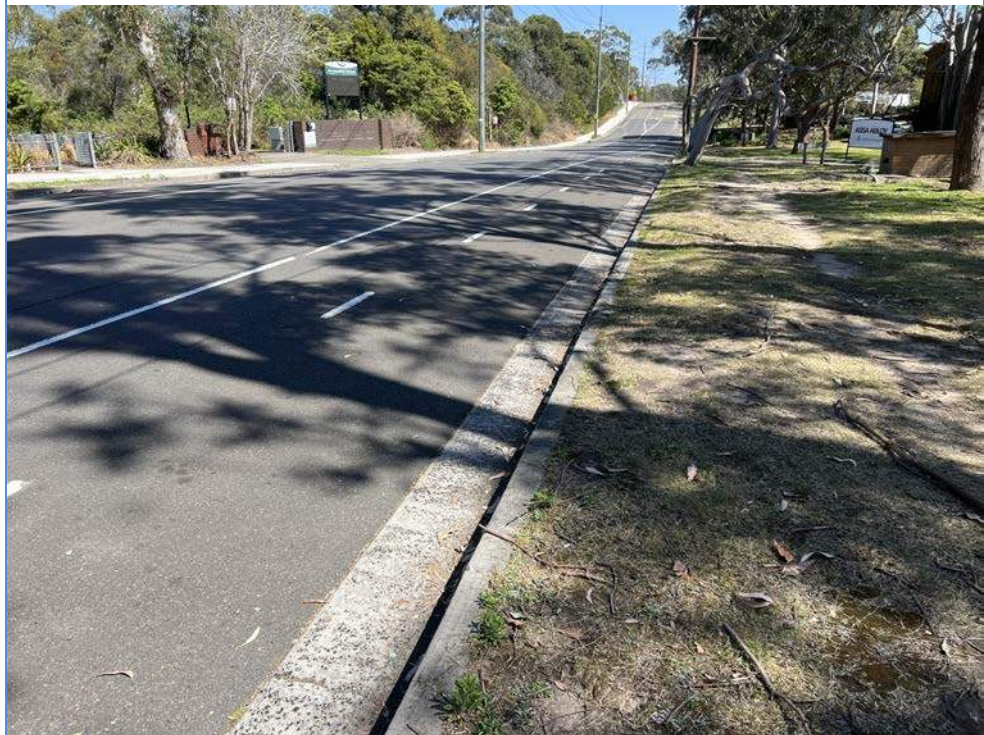
40m

General views of the kerb, gutter and road surface.
